## Road Condition & Vehicle Compliance Report

| Report # | 58 |
| Project Name | Alle-Catt Wind |
| Location | Town of Freedom |

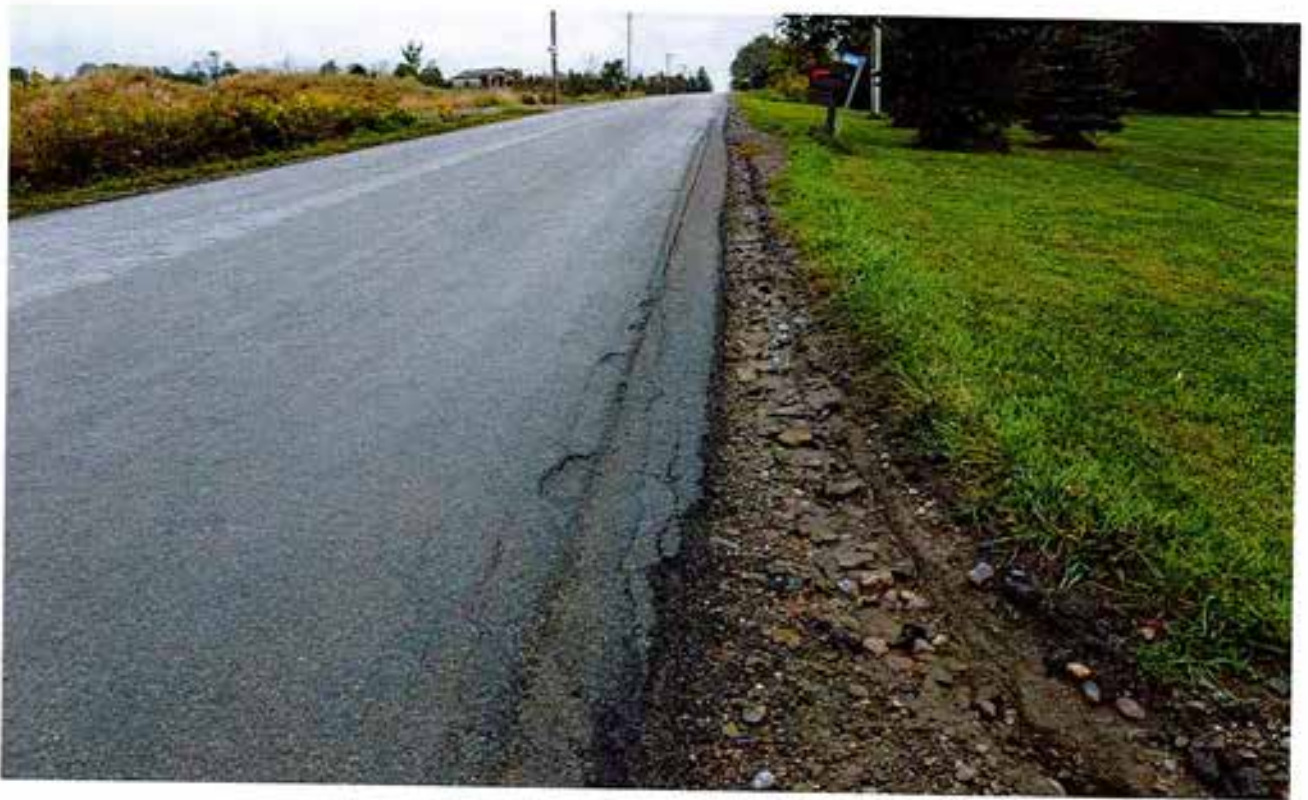
North Road North edge and shoulder deterioration near 11614

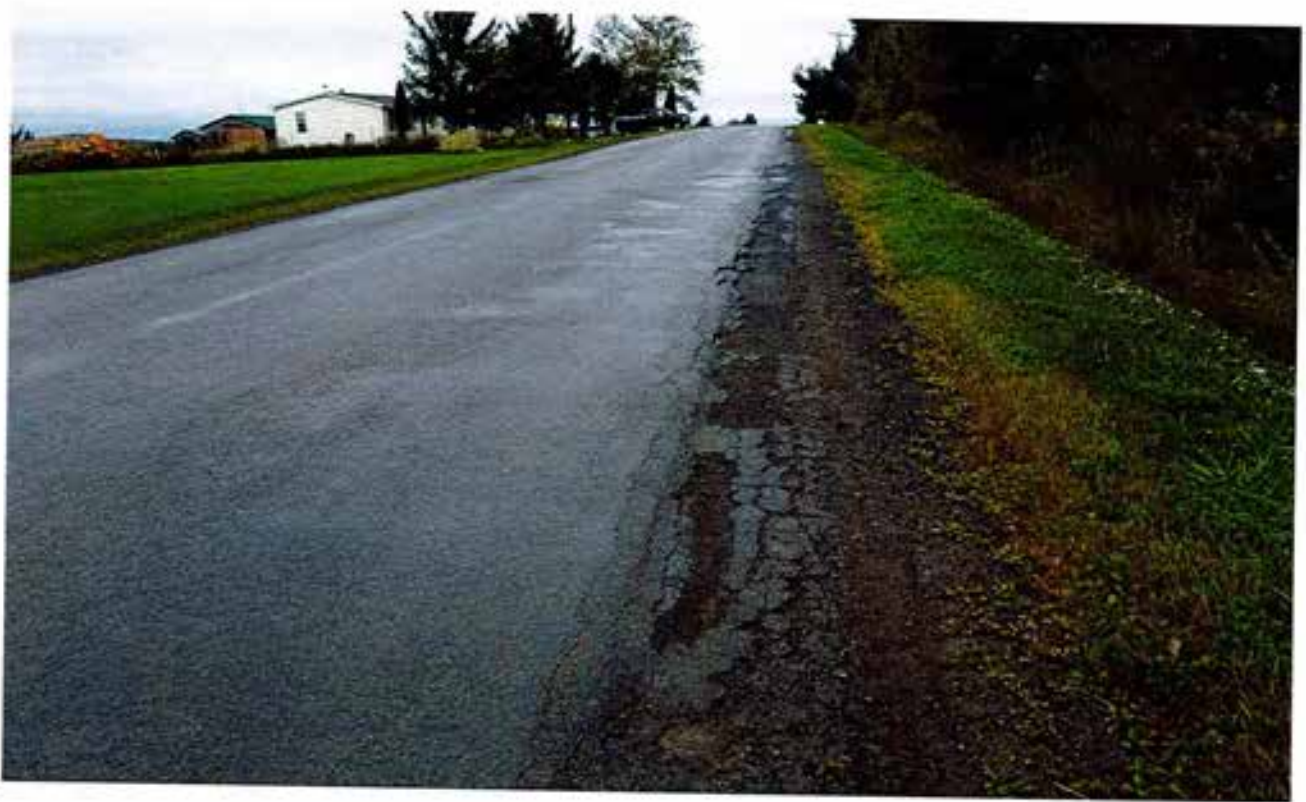
North Road lane and edge deteriorating with South of 11875

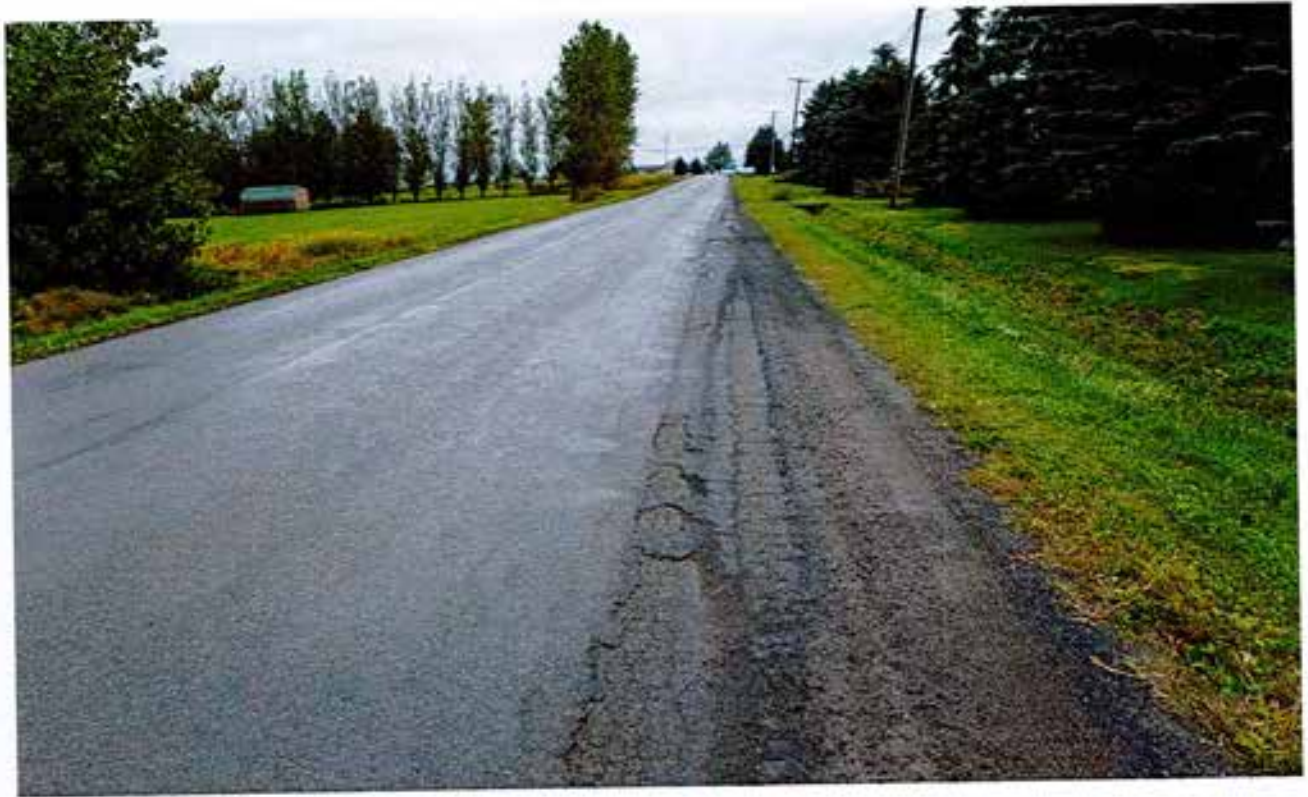
North Road lane, edge, and shoulder deterioration near 11980

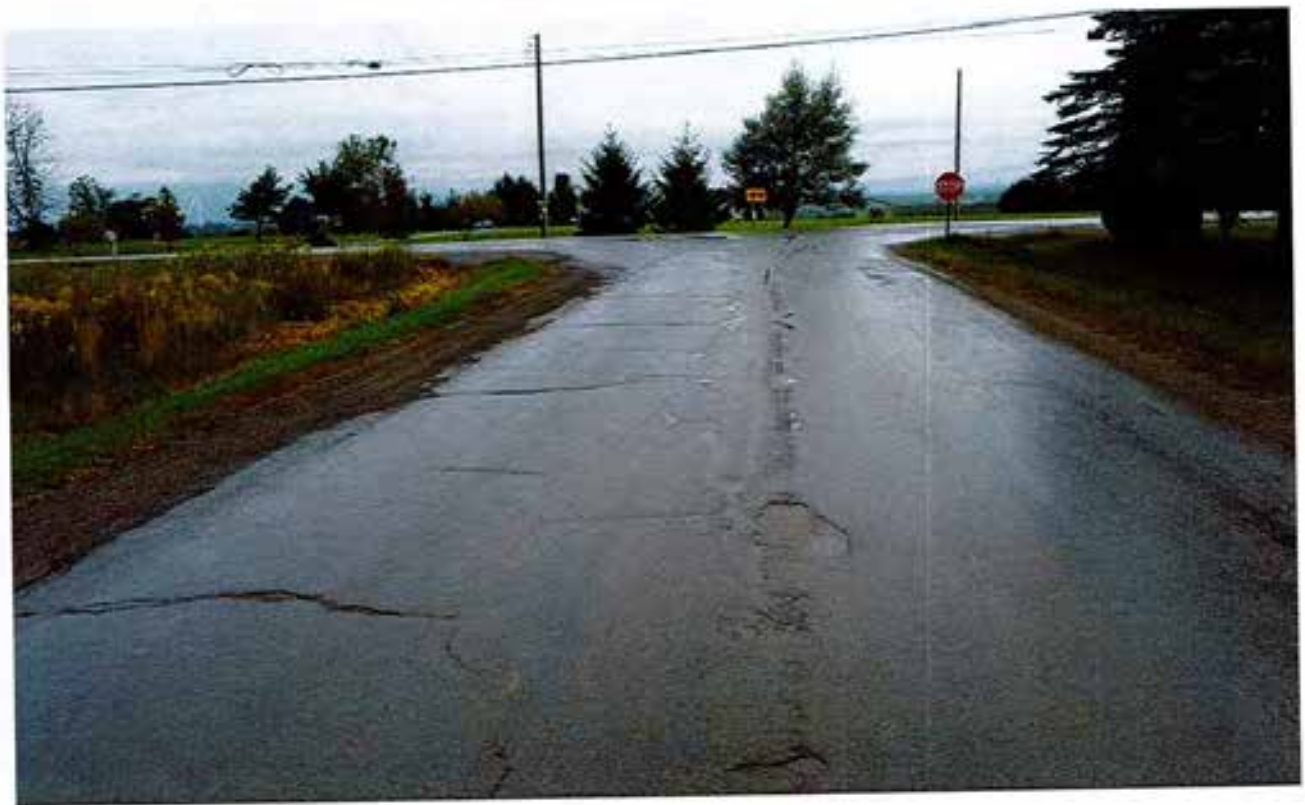
Lane deterioration North Rd near intersection with Bray Rd

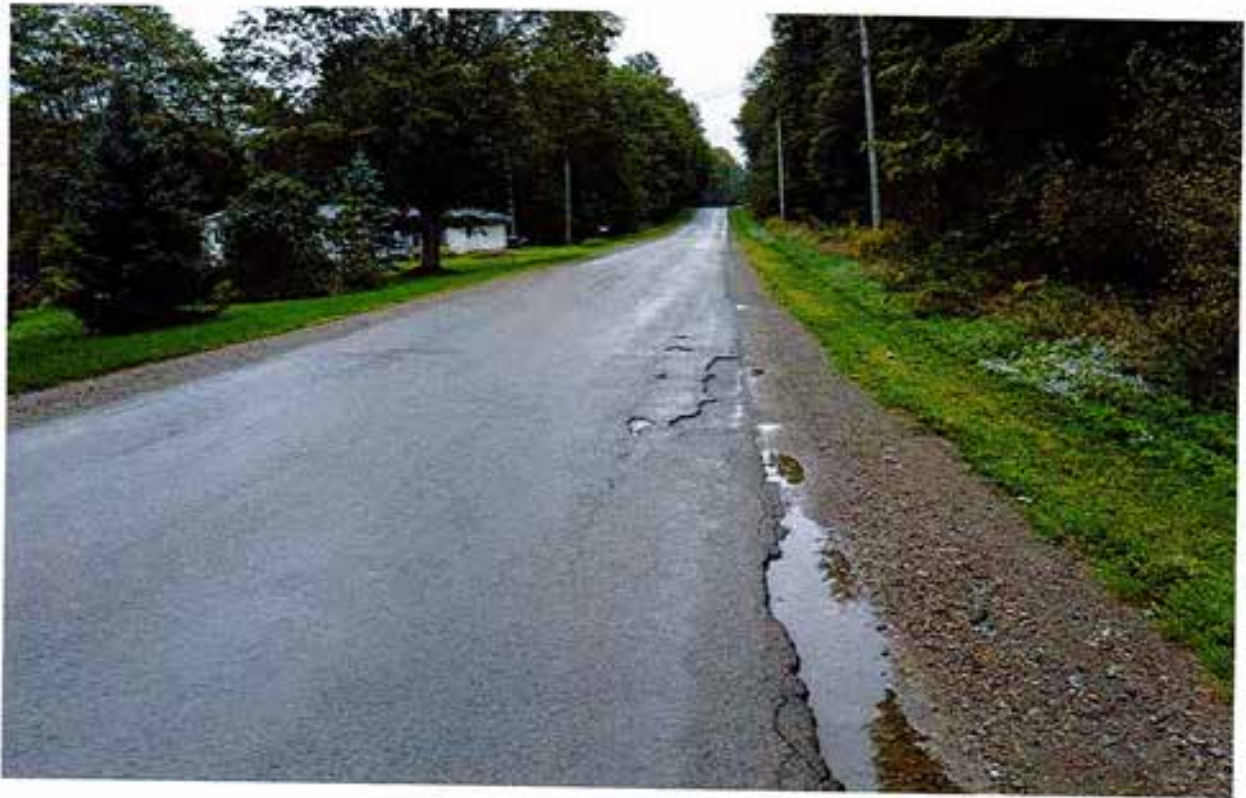
Eagle Street lane and East edge deterioration near 994

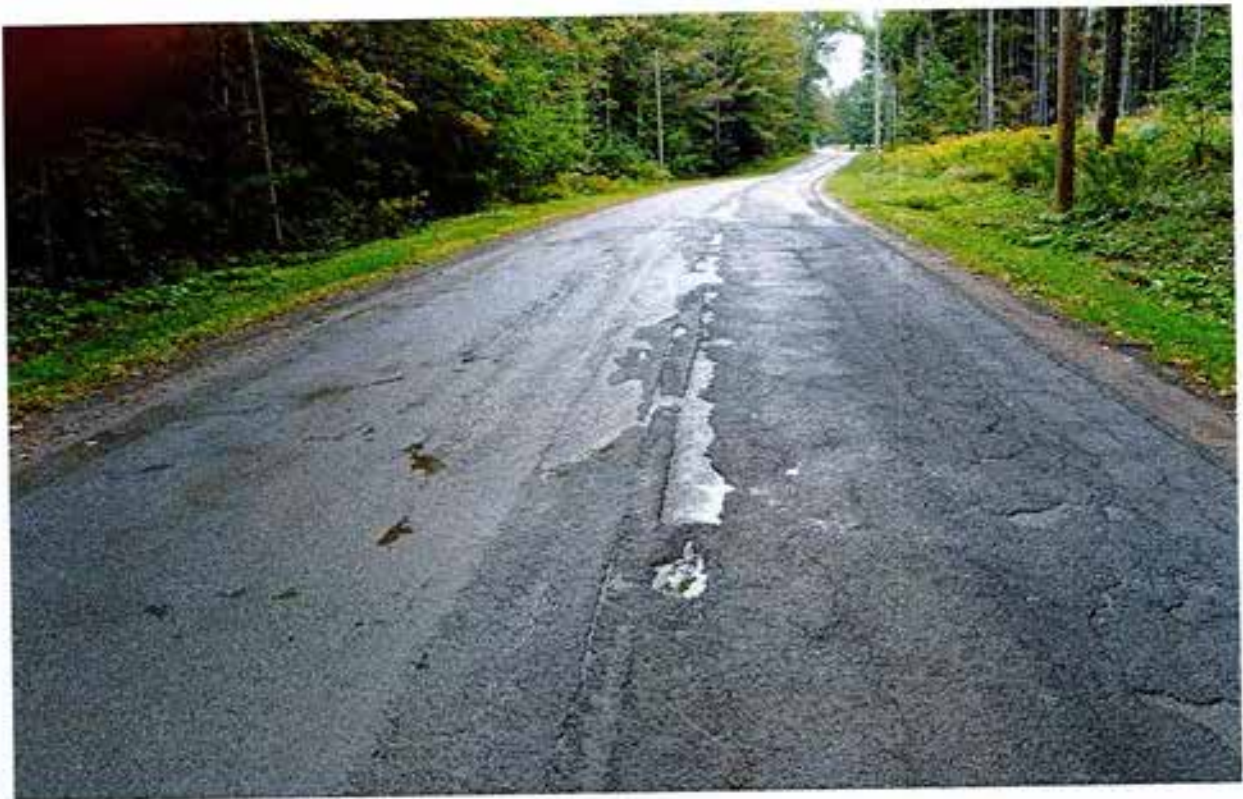
Eagle Street lane deterioration near 915

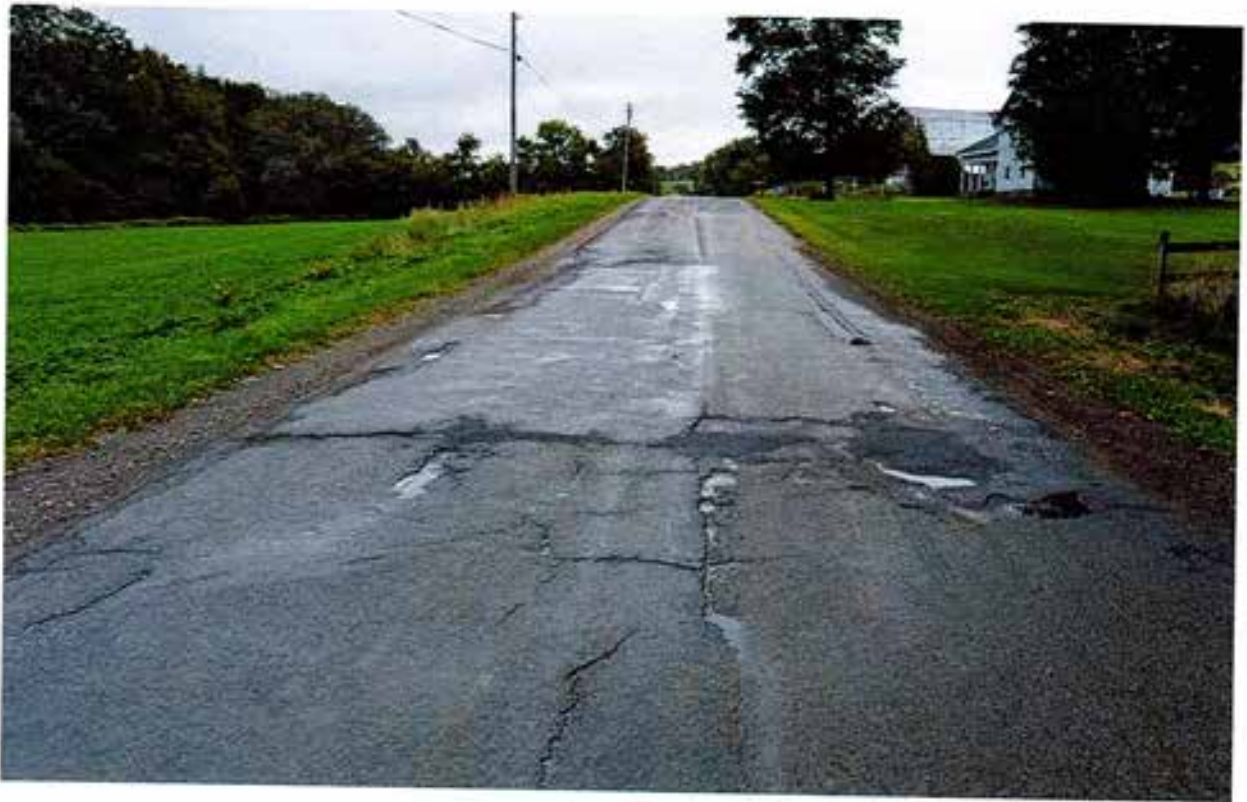
Eagle Street lane deterioration South of 849

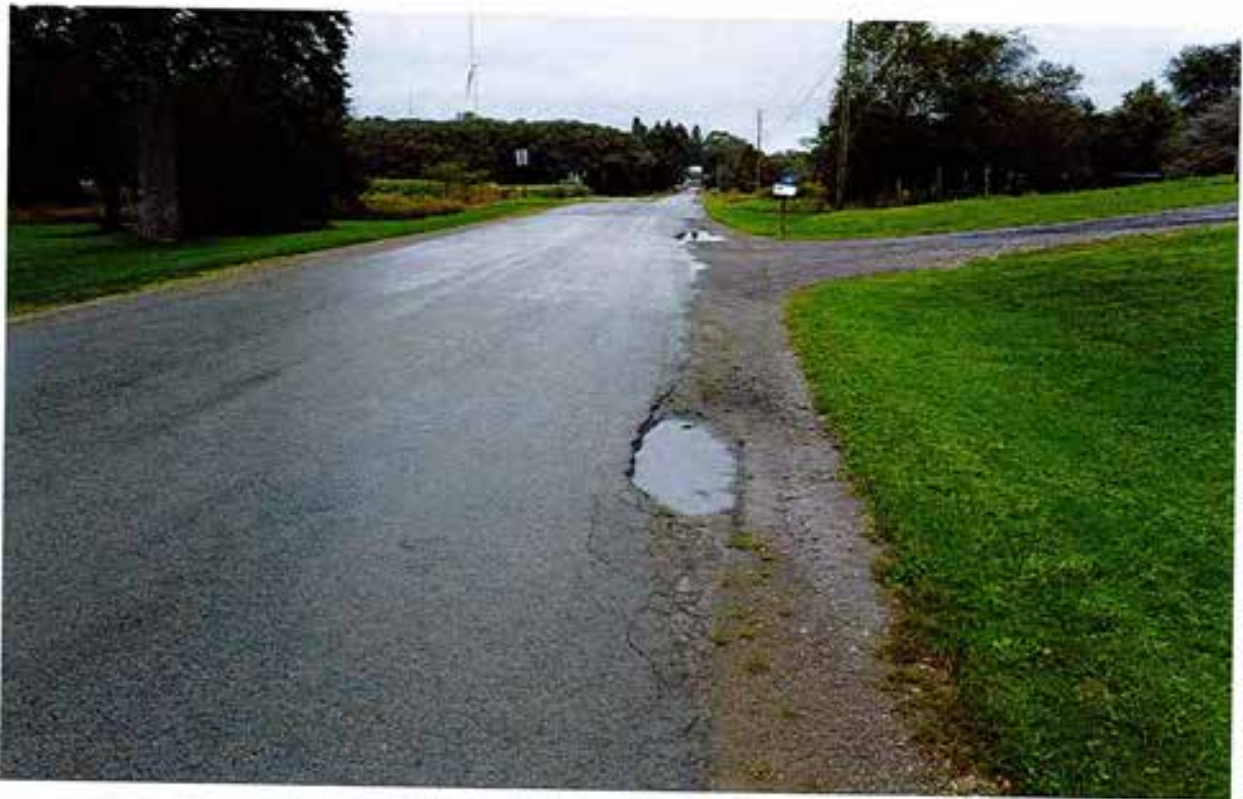
Eagle Street East edge and shoulder deterioration near 757

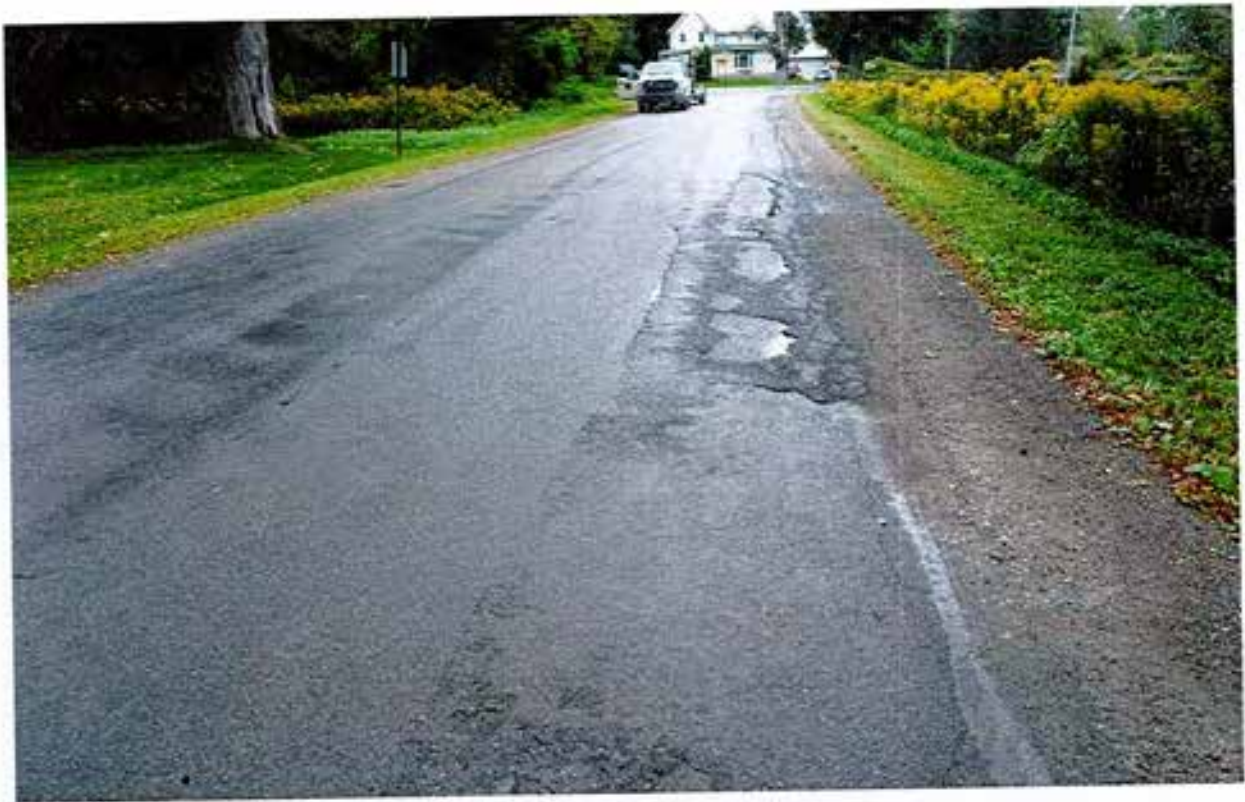
Eagle Street East lane deterioration near 708

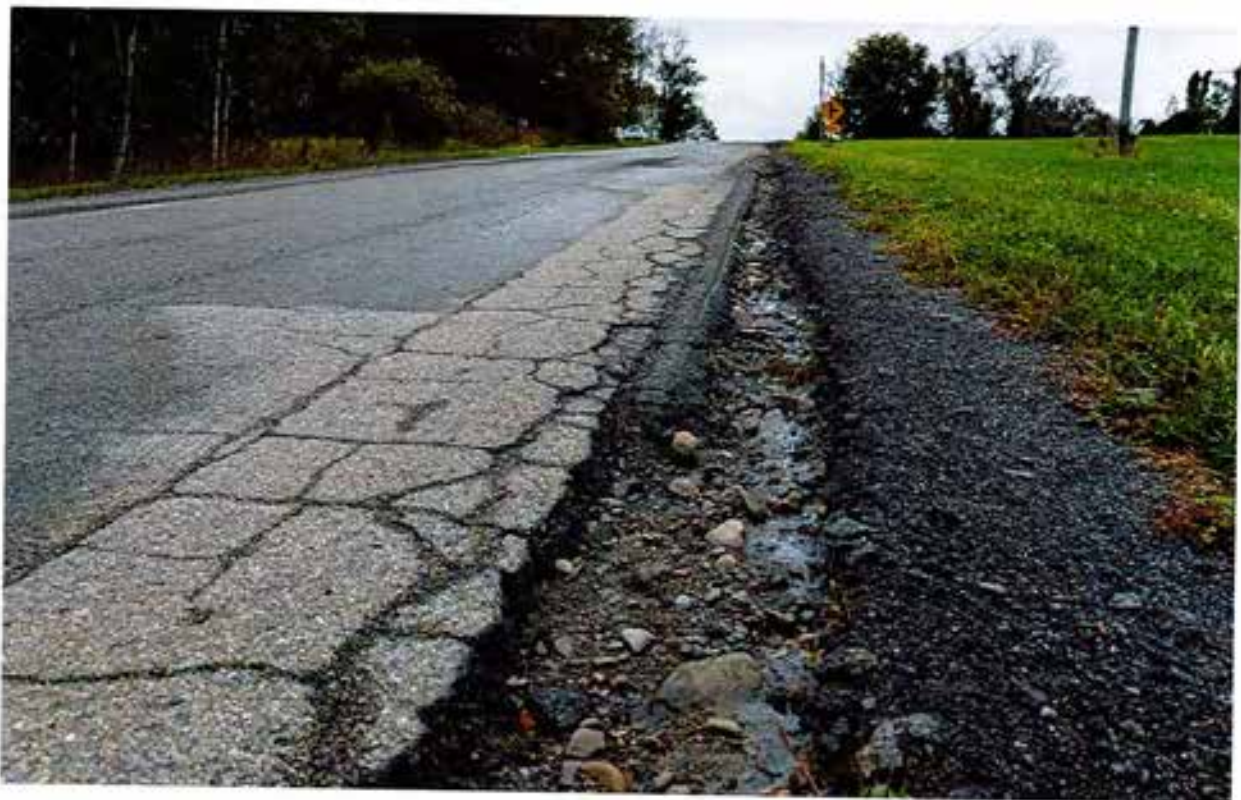
Hughes Road edge and shoulder deterioration on North and South sides East of 951

| Maintenance Needed: | - Repair shoulder |

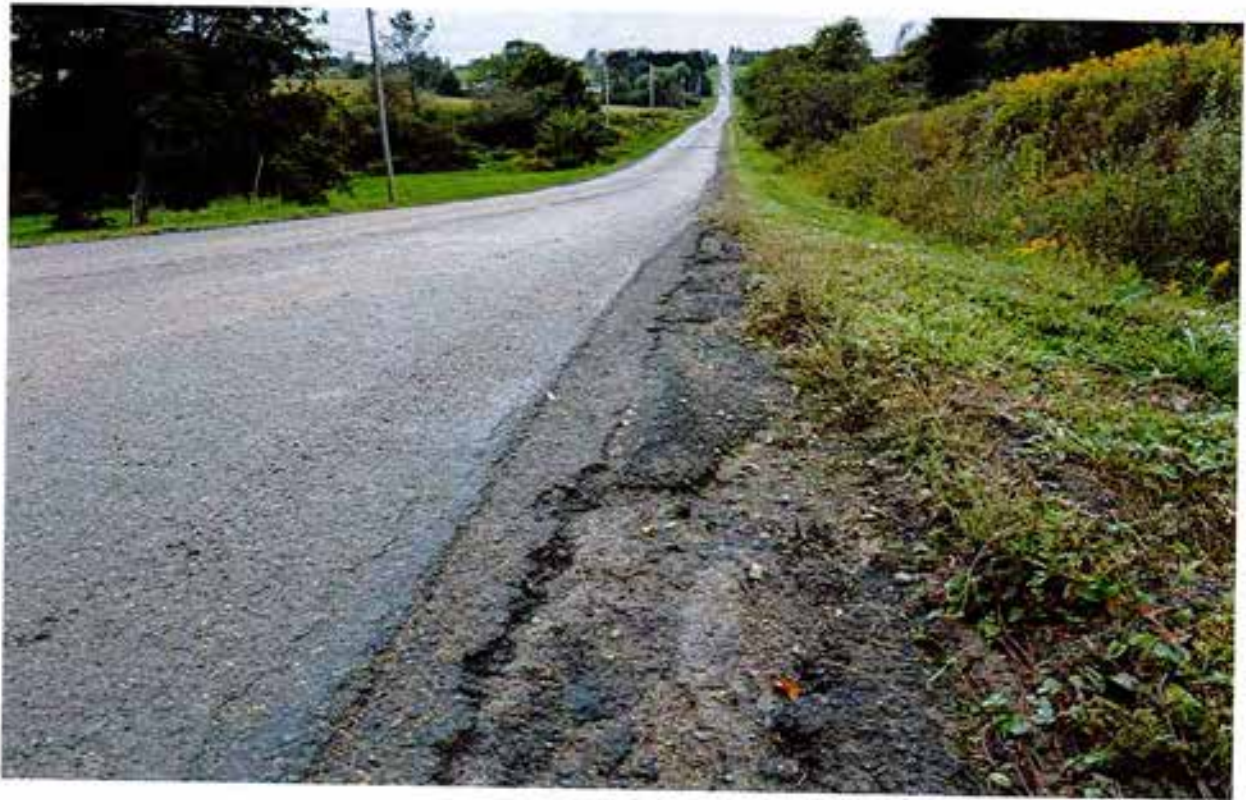
Bray Road North edge and shoulder deteriorating from +/-113 to +/-2473

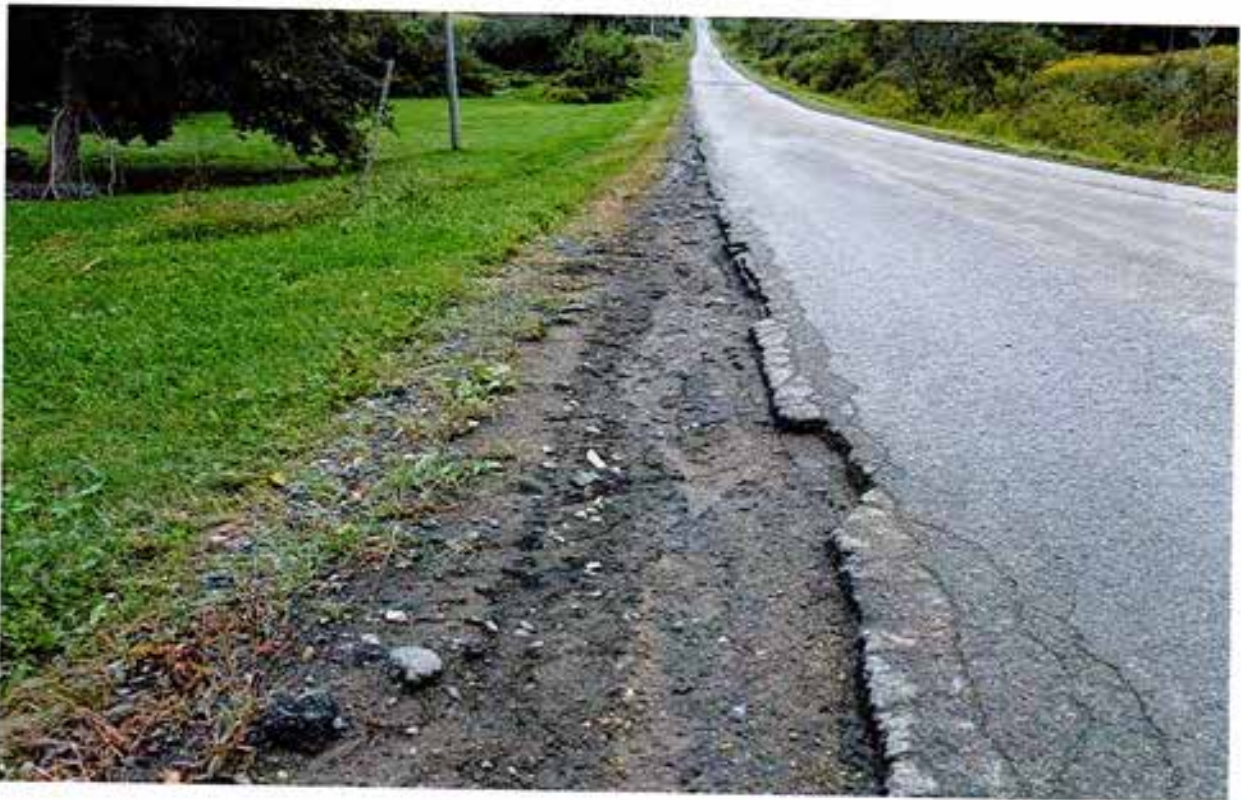
Bray Road South edge and shoulder West of 113

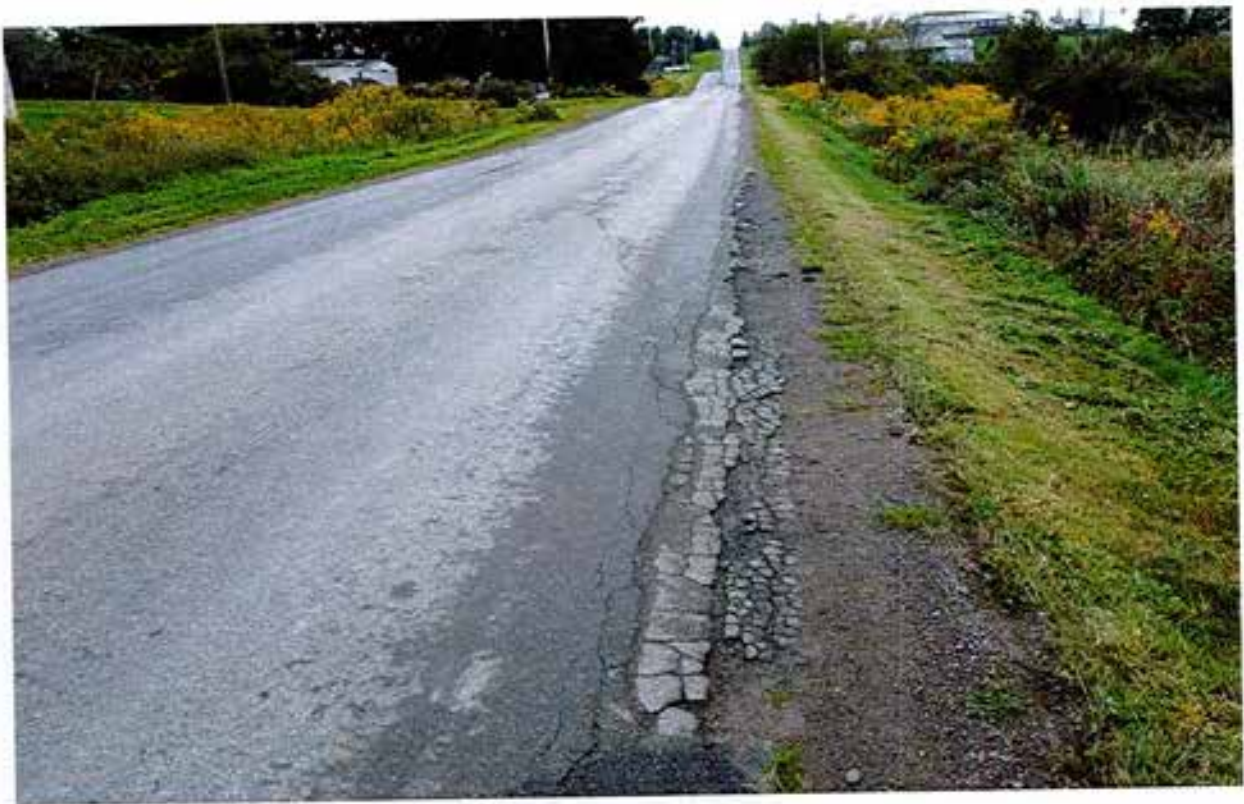
Bray Road North edge deteriorating near 223

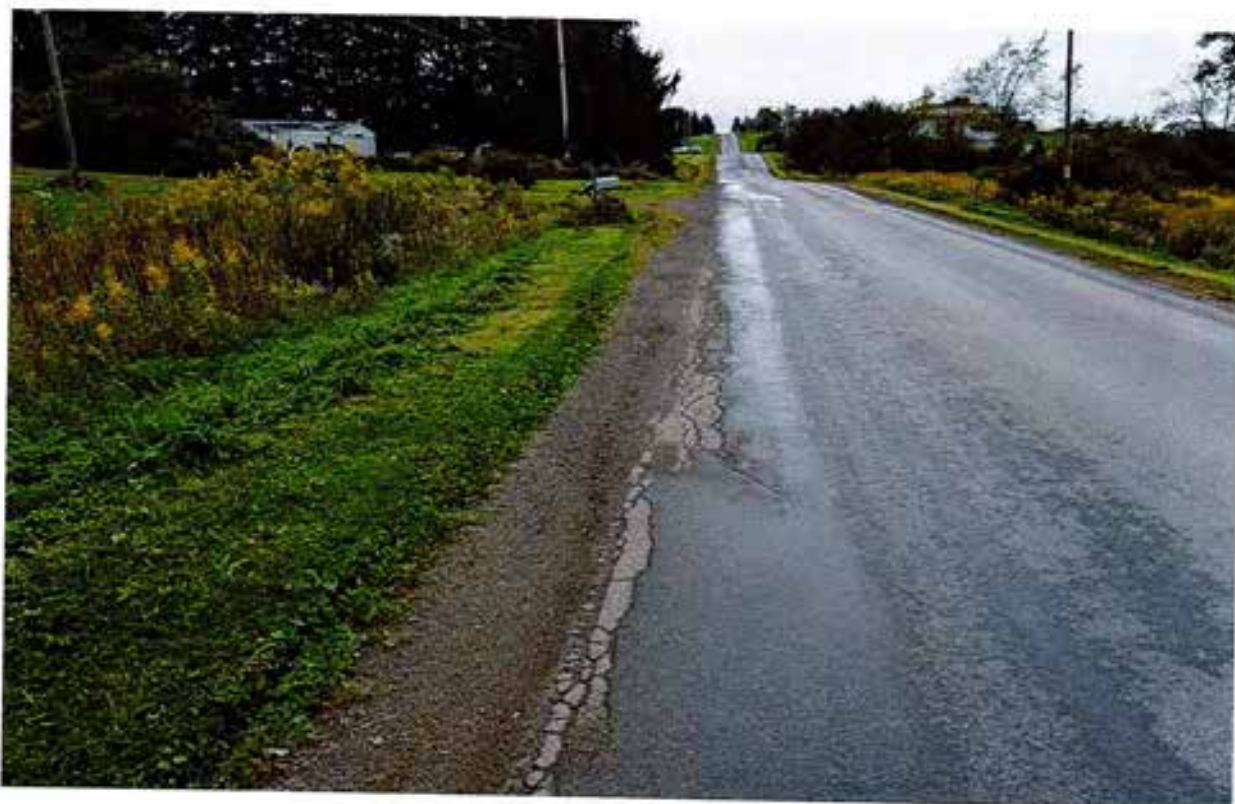
Bray Road South edge and shoulder deteriorating near 223

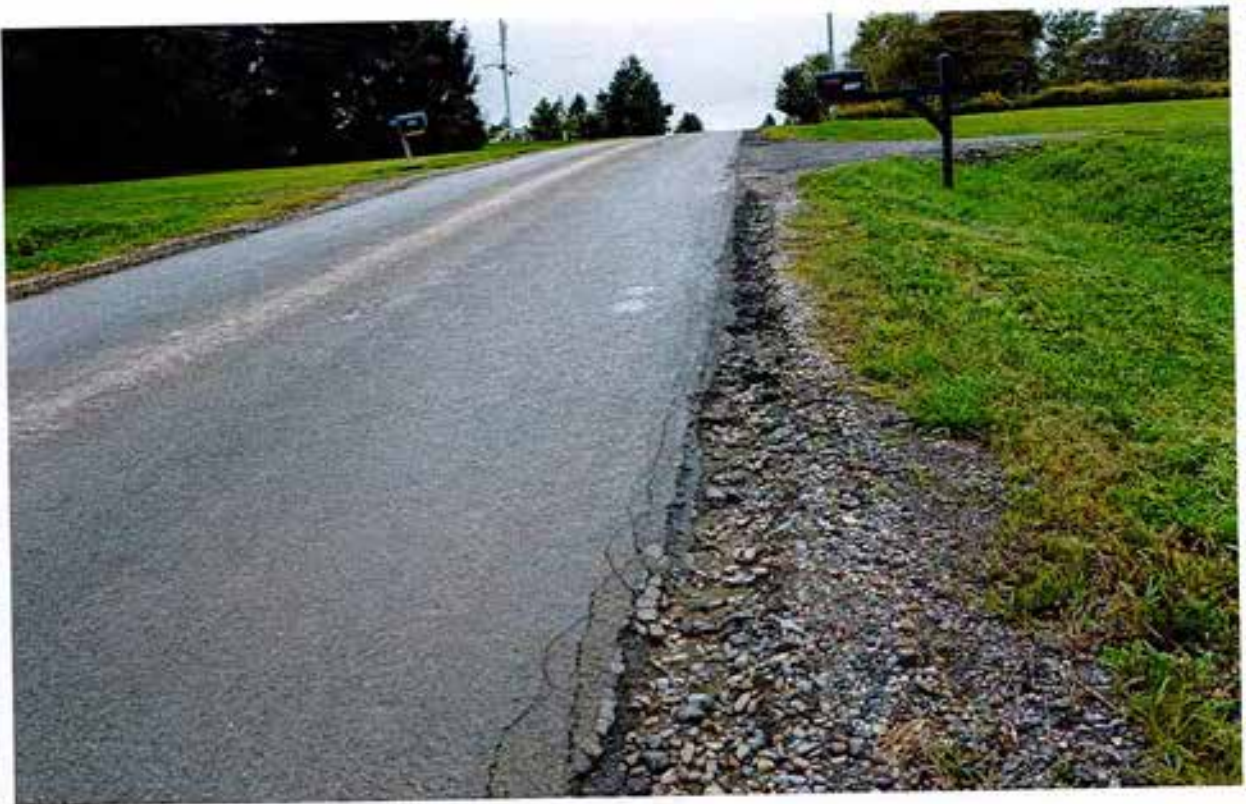
Bray Road North edge and shoulder deteriorating near 2317

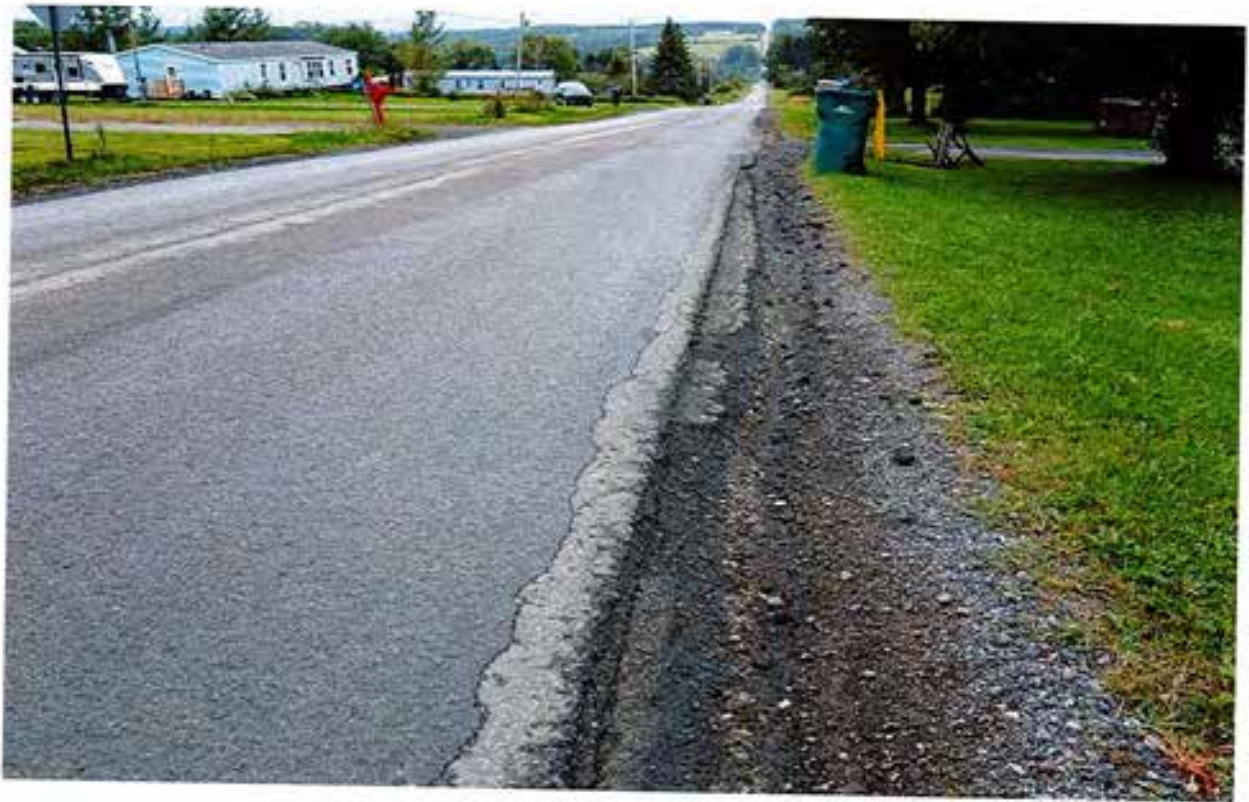
Bray Road North edge and shoulder deteriorating near 2231

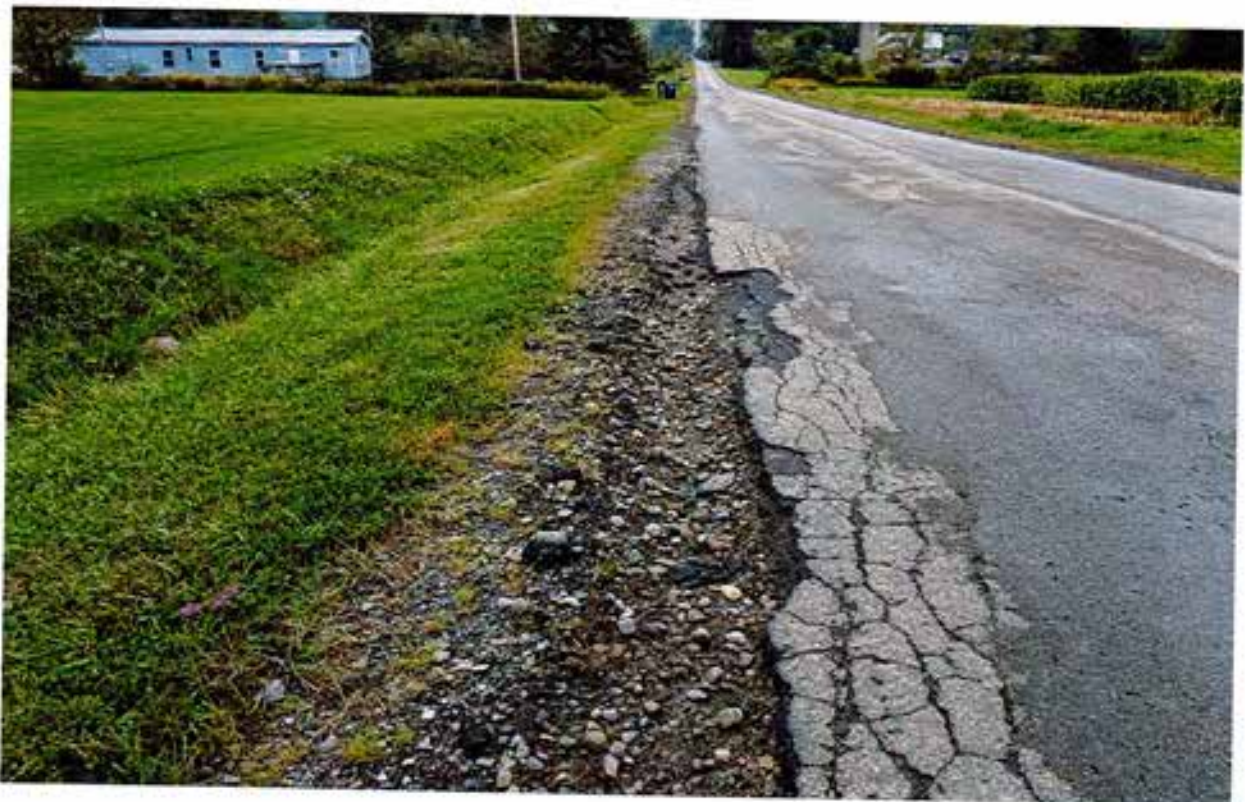
Bray Road South edge and shoulder deteriorating near 409

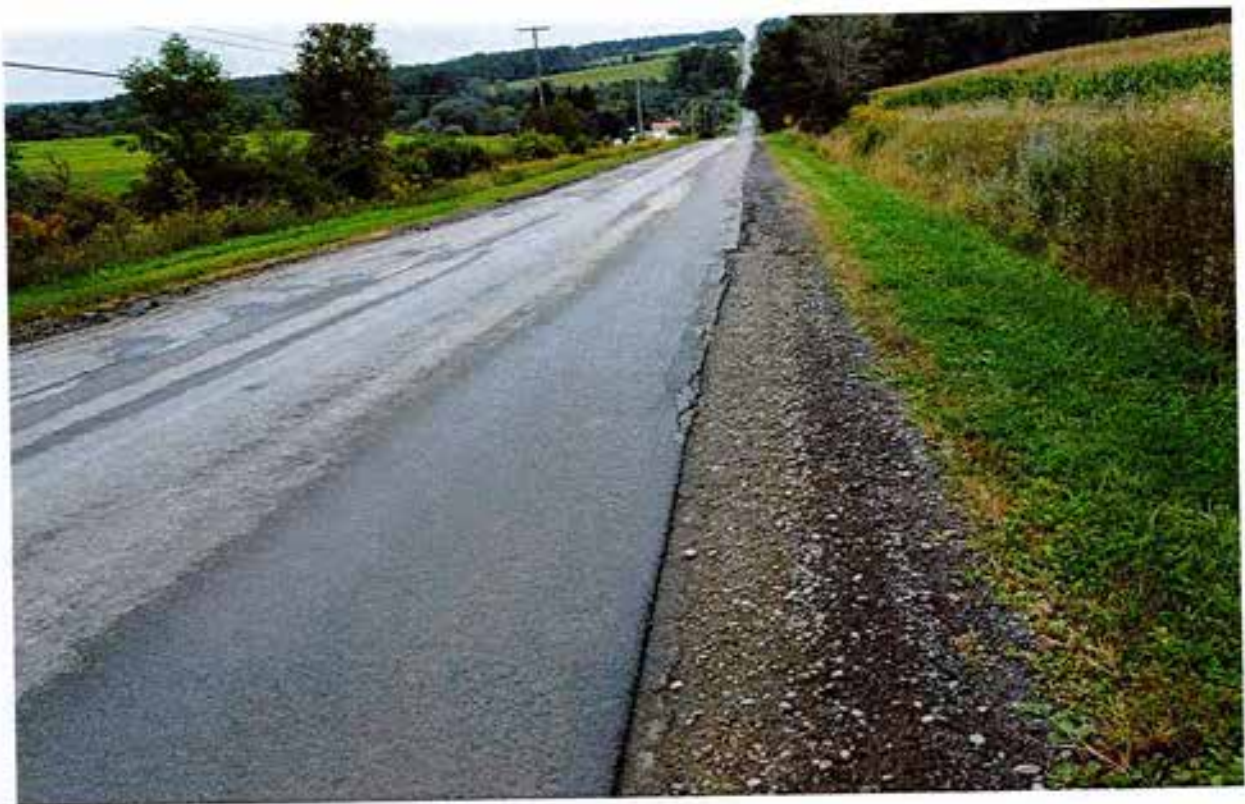
Bray Road North edge and shoulder deteriorating from 475 to Eagle Street

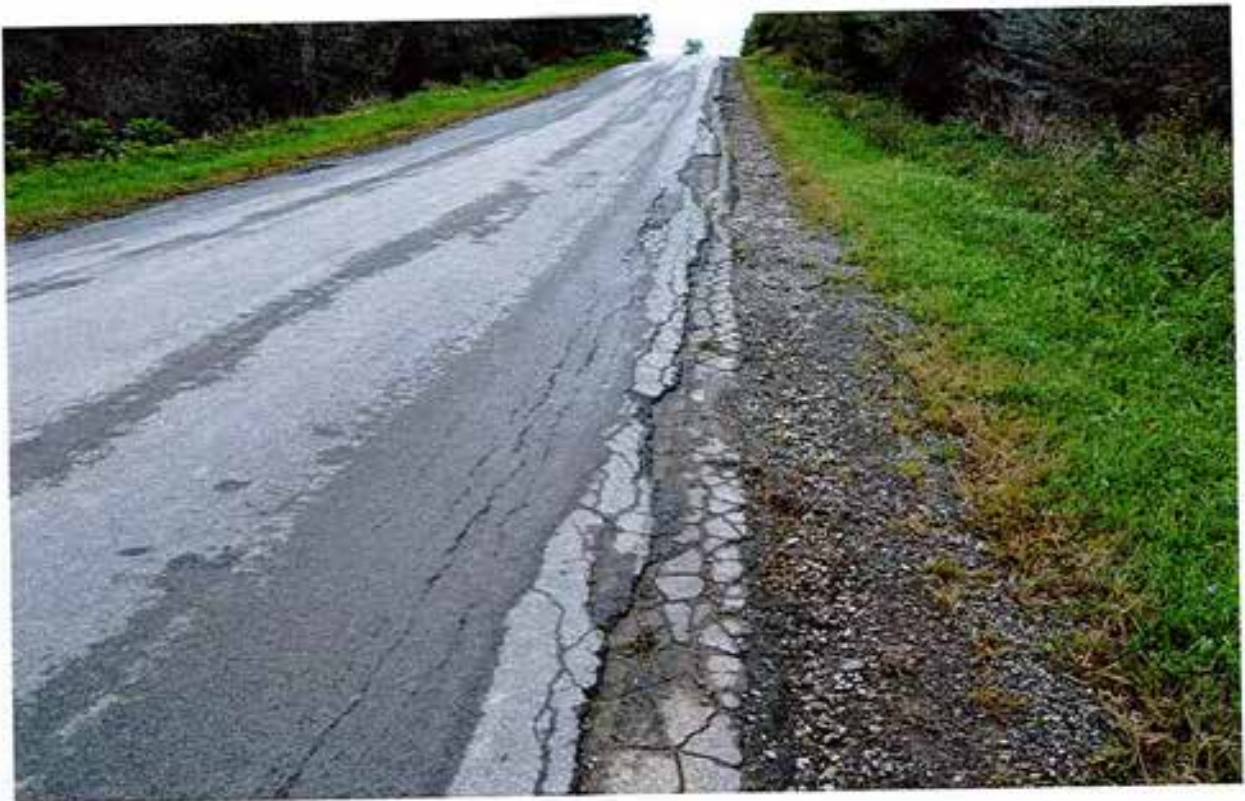
Bray Road North edge and shoulder deteriorating from Eagle Street to +/- 2801

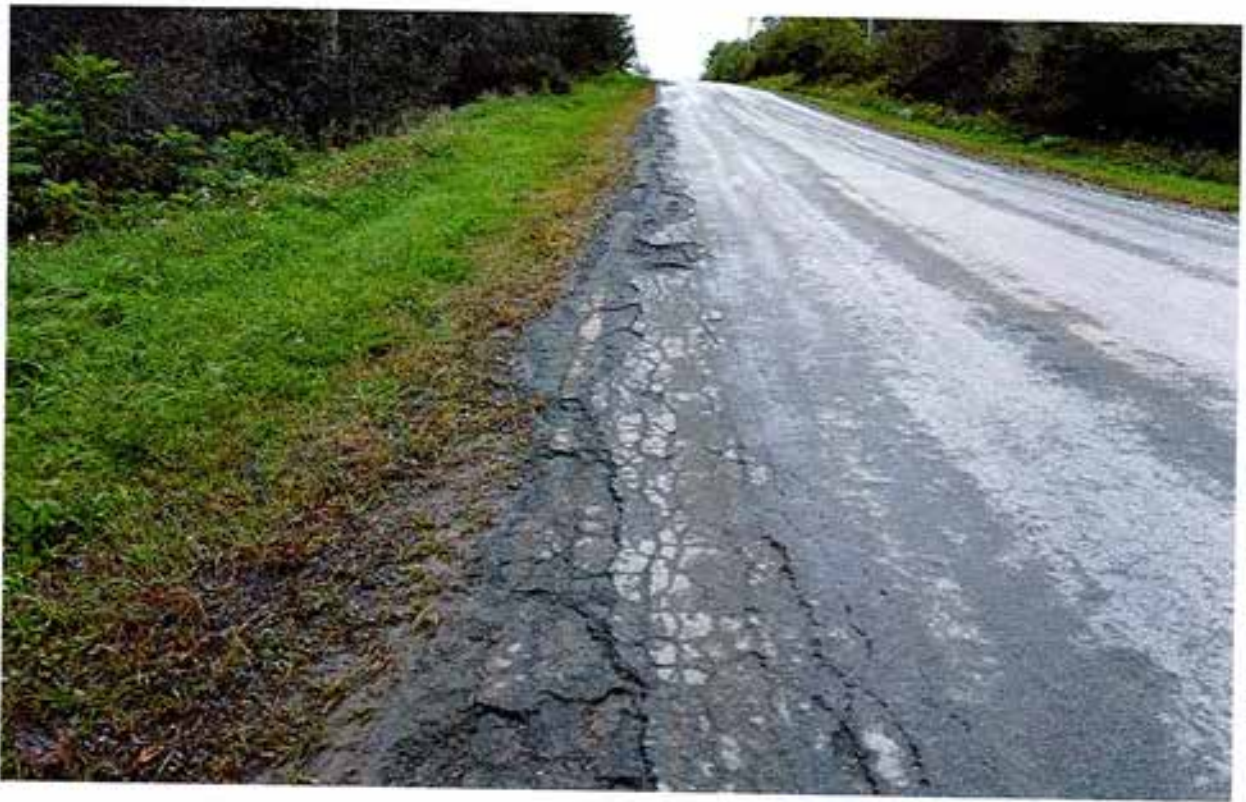
Bray Road South edge and shoulder deteriorating from Eagle Street to +/- 2801

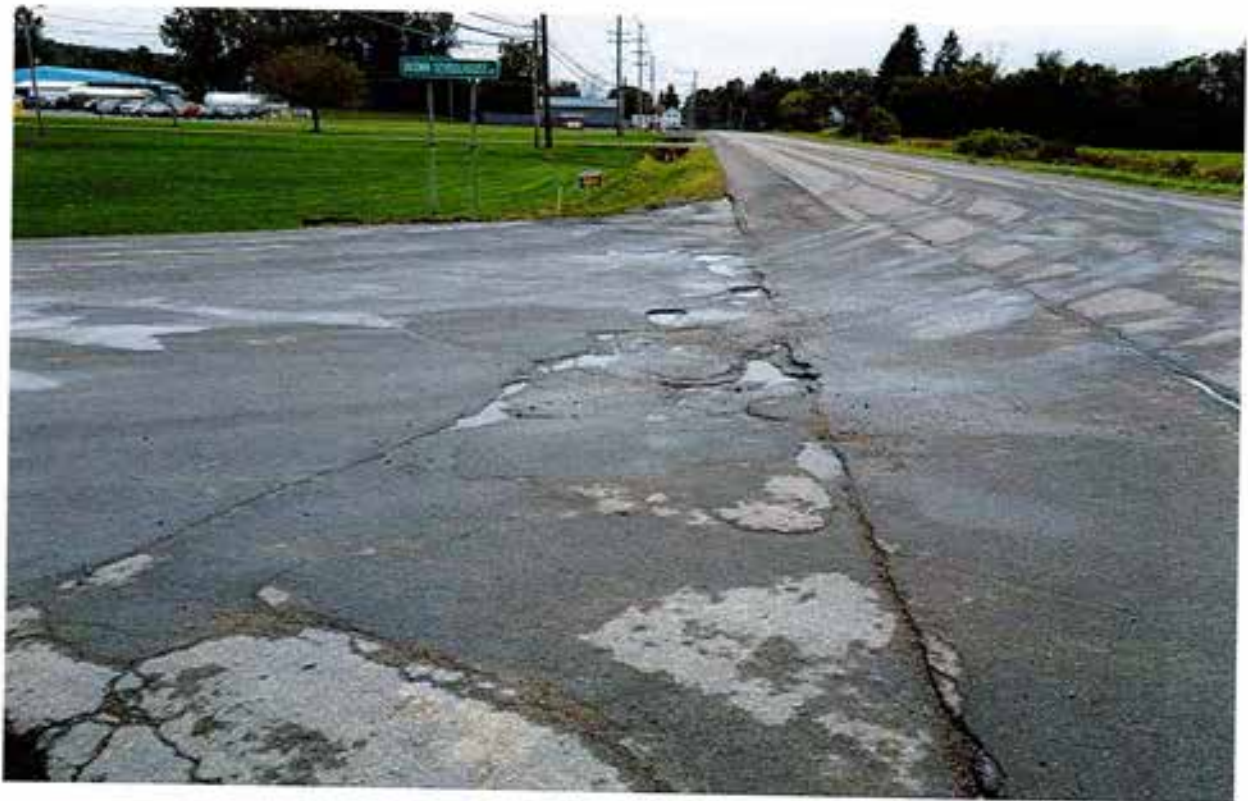
Brown Schoolhouse Road lane deterioration near intersection with Route 98

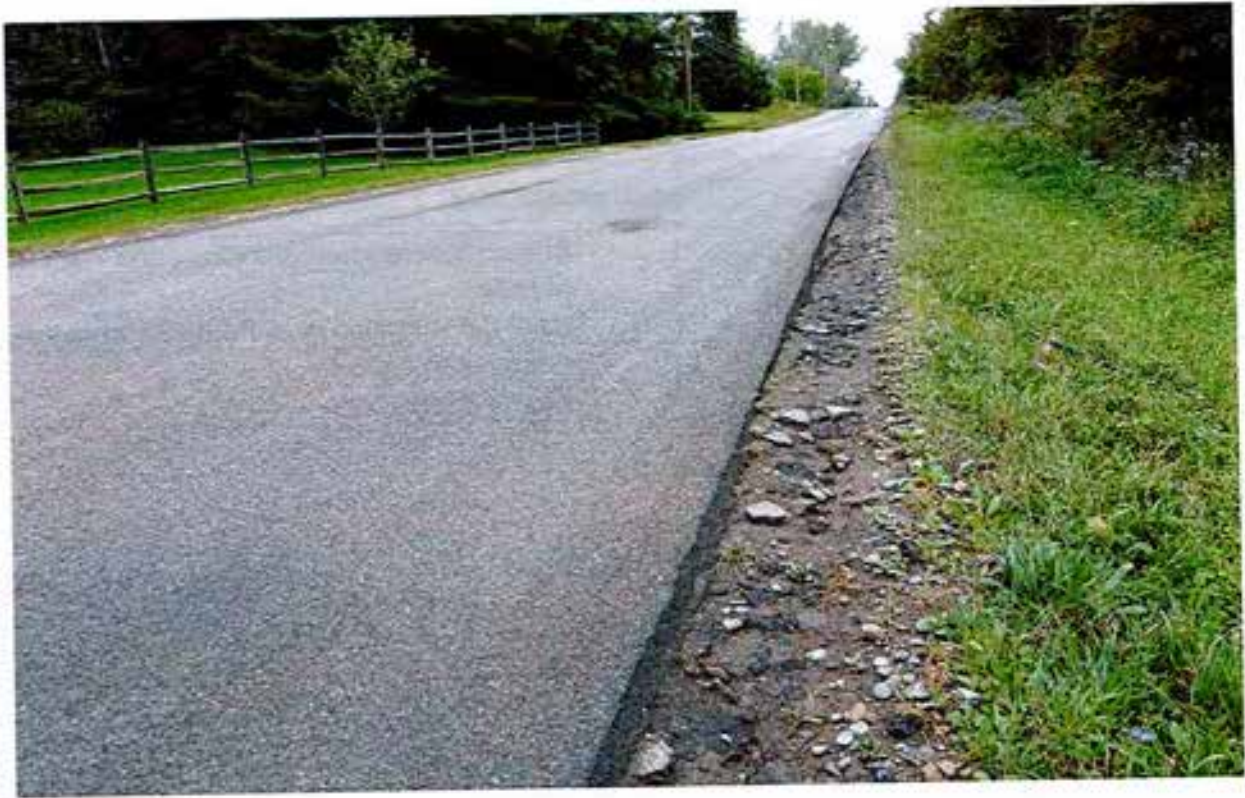
Brown Schoolhouse Road West shoulder near 11770
