## Road Condition & Vehicle Compliance Report

| Report # | 58 |
| Project Name | Alle-Catt Wind |
| Location | Town of Freedom |

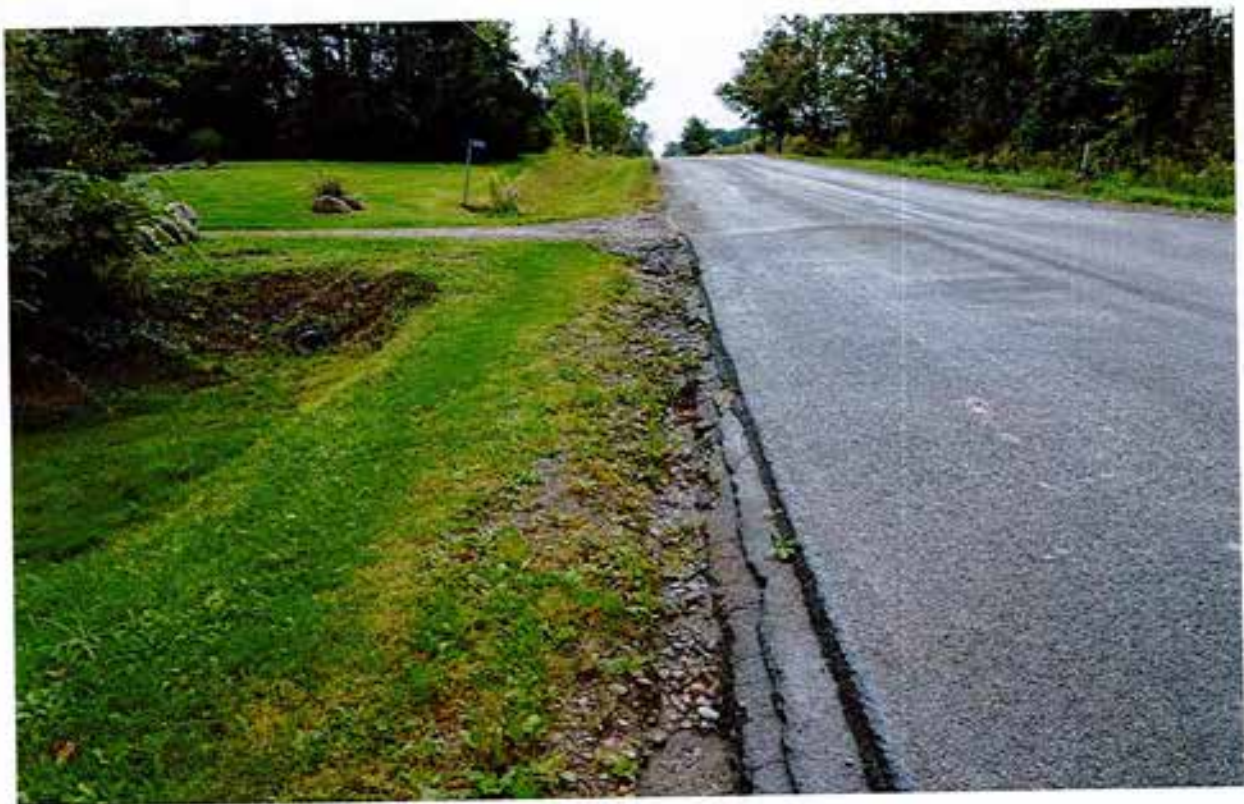
Brown Schoolhouse Road East edge and shoulder deterioration from 11754 to 11740

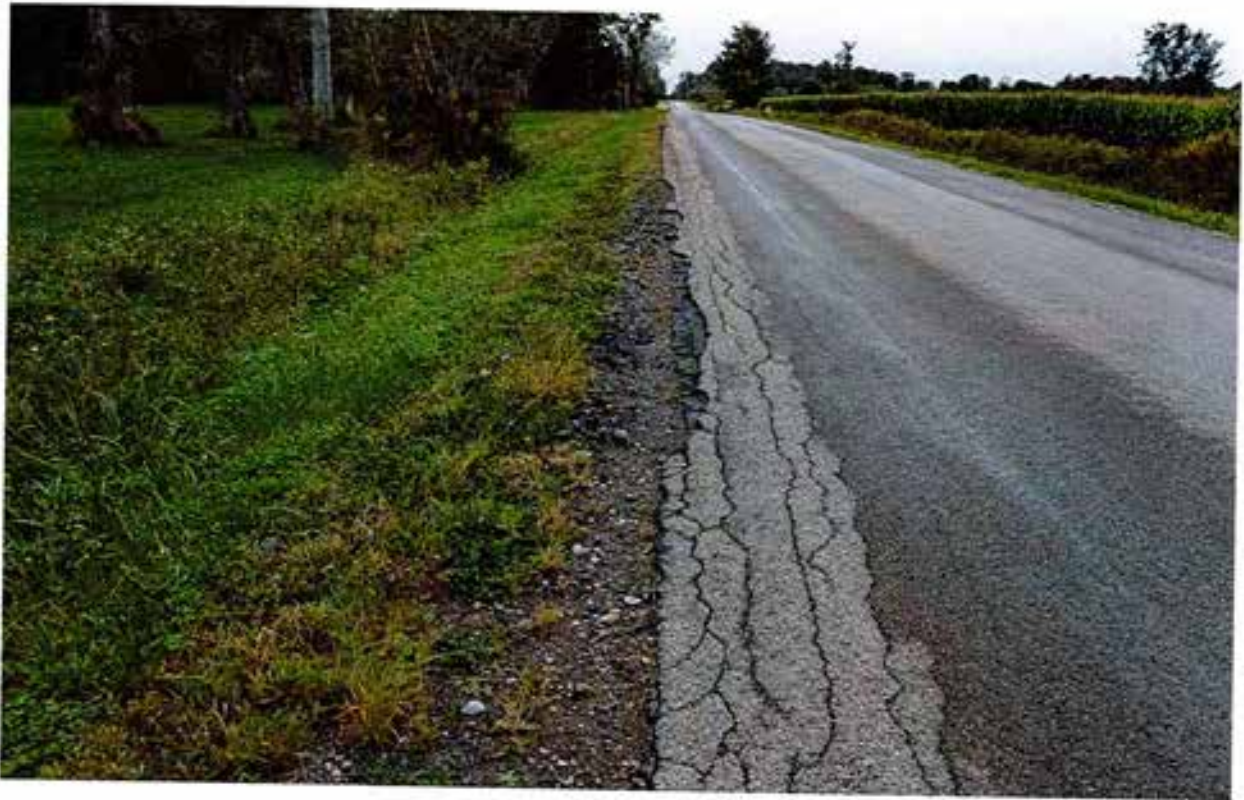
Brown Schoolhouse Road East shoulder deterioration South of 11748

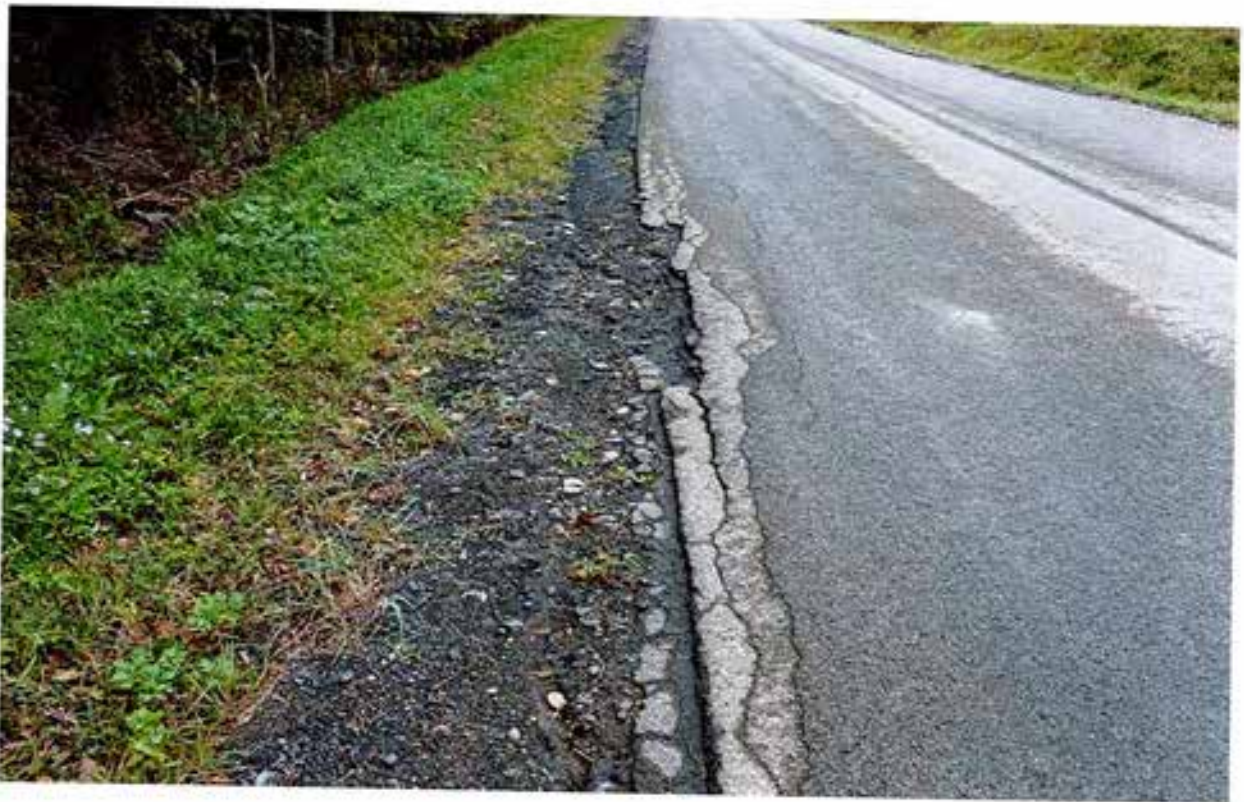
Brown Schoolhouse Road West shoulder North of 11448

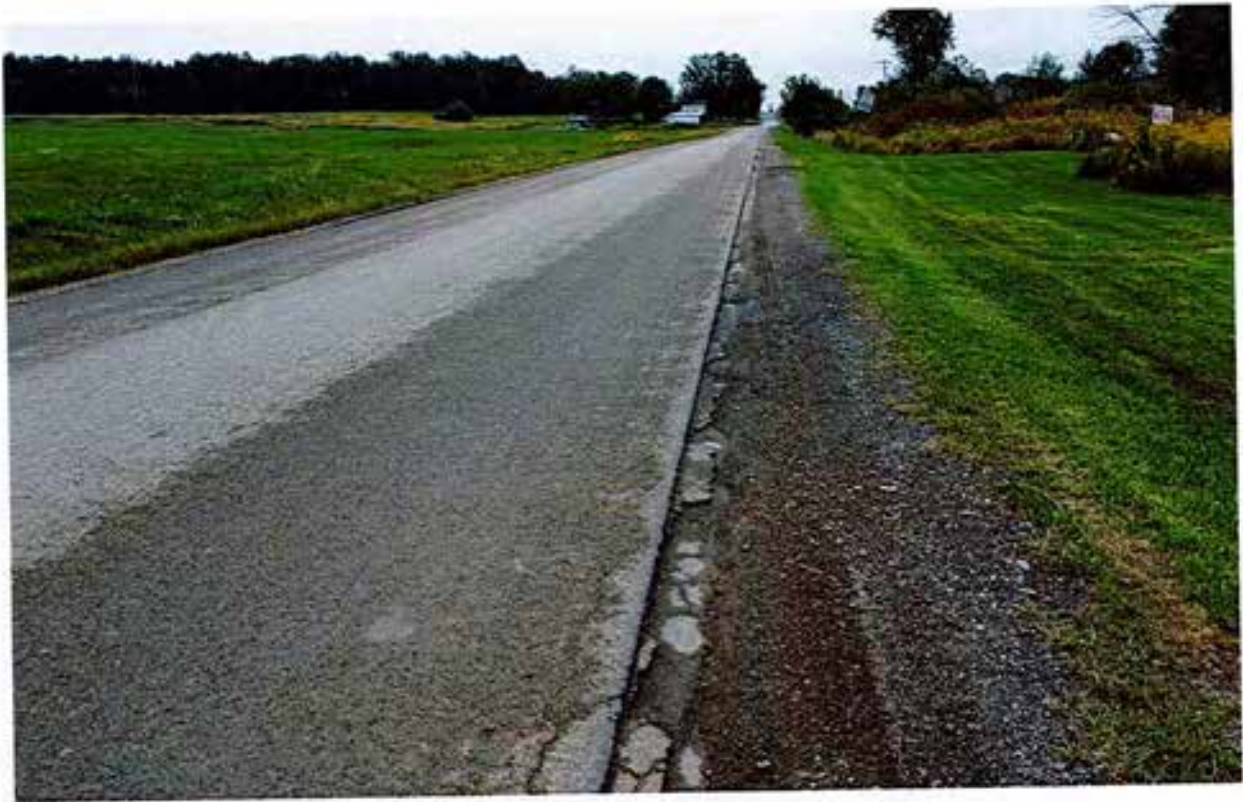
Brown Schoolhouse Road West shoulder deterioration from 11354 to 11258

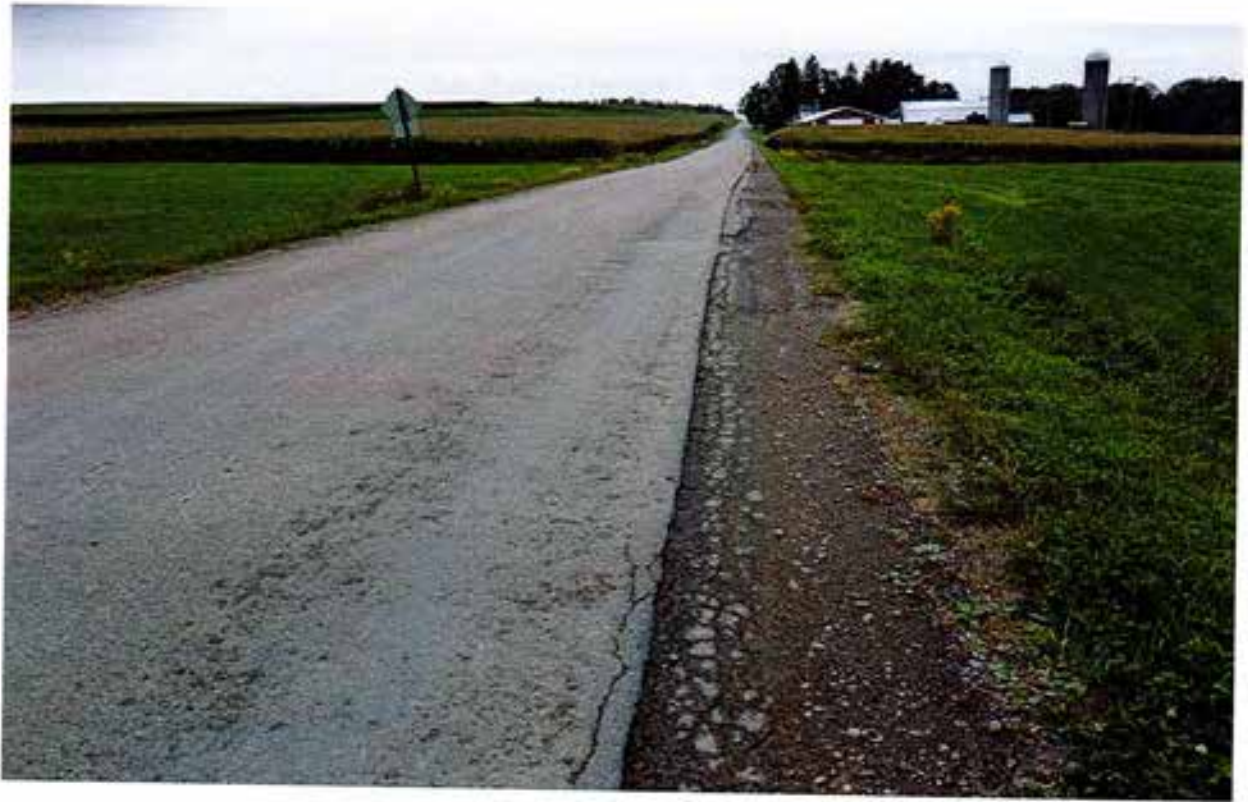
Brown Schoolhouse Road West shoulder deterioration from 11214 to 11123

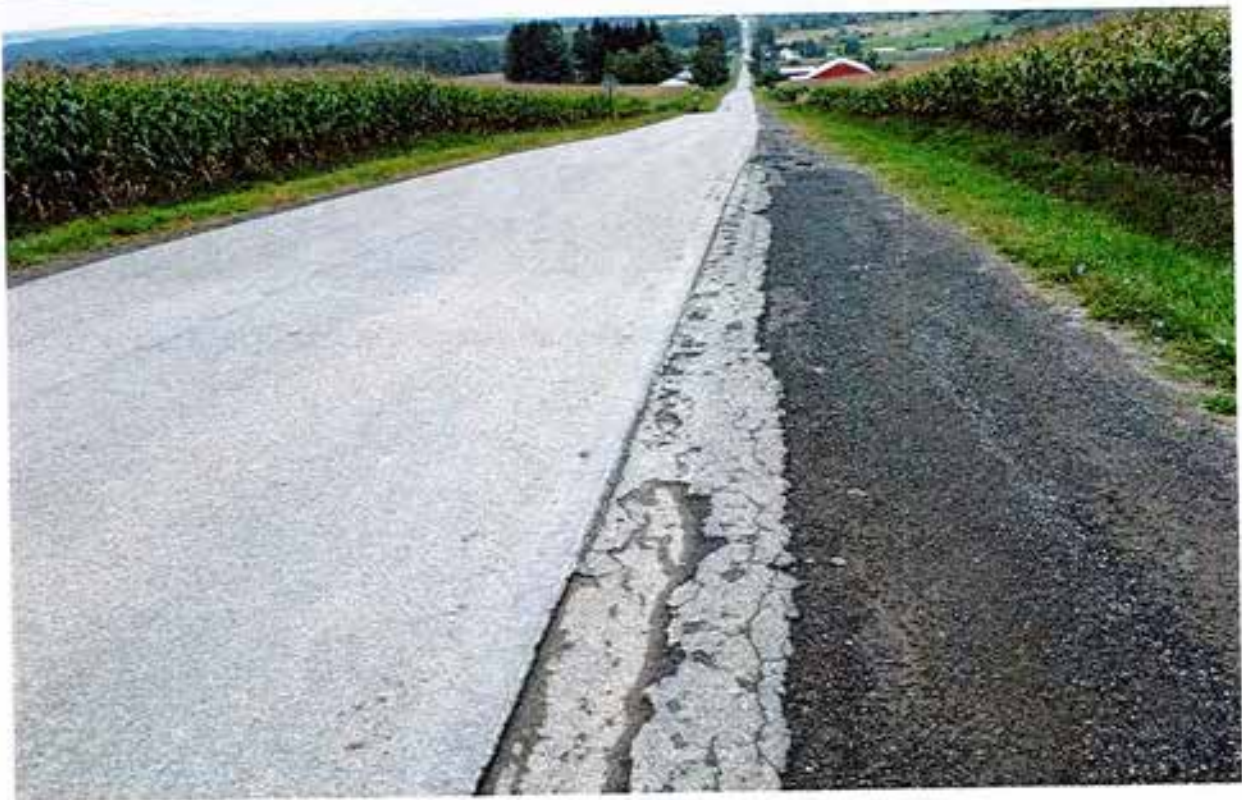
Fisher Blake Road North edge and shoulder deterioration near intersection with Brown Schoolhouse Road

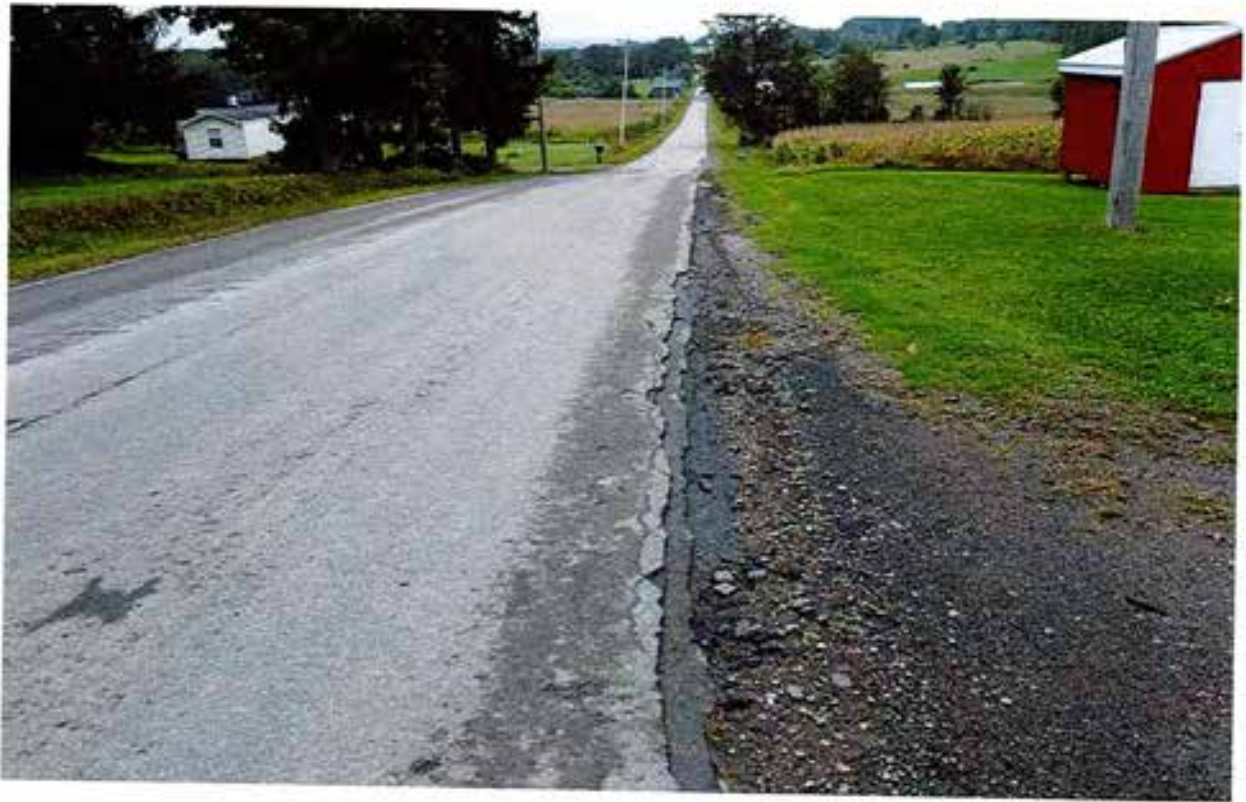
Fisher Blake Road edge and shoulder deterioration near 2177

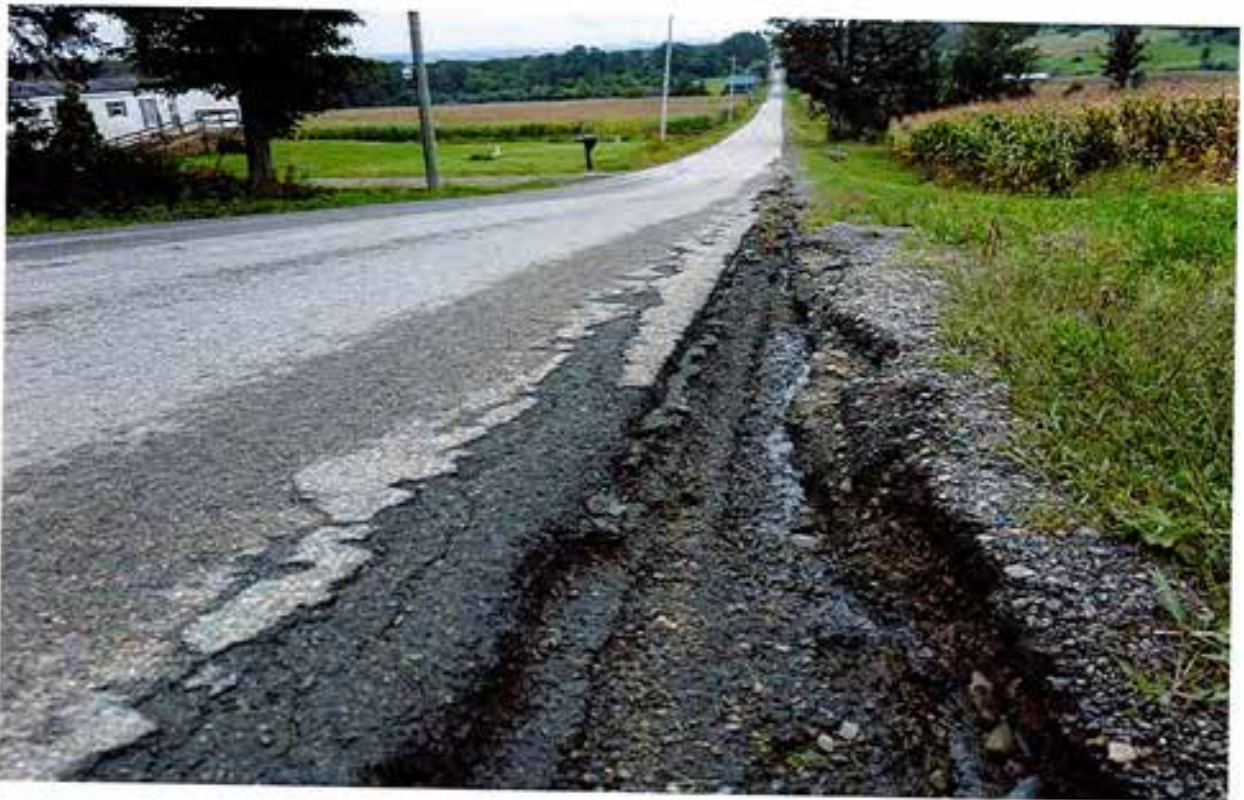
Fisher Blake Road North edge and shoulder deterioration near 2195

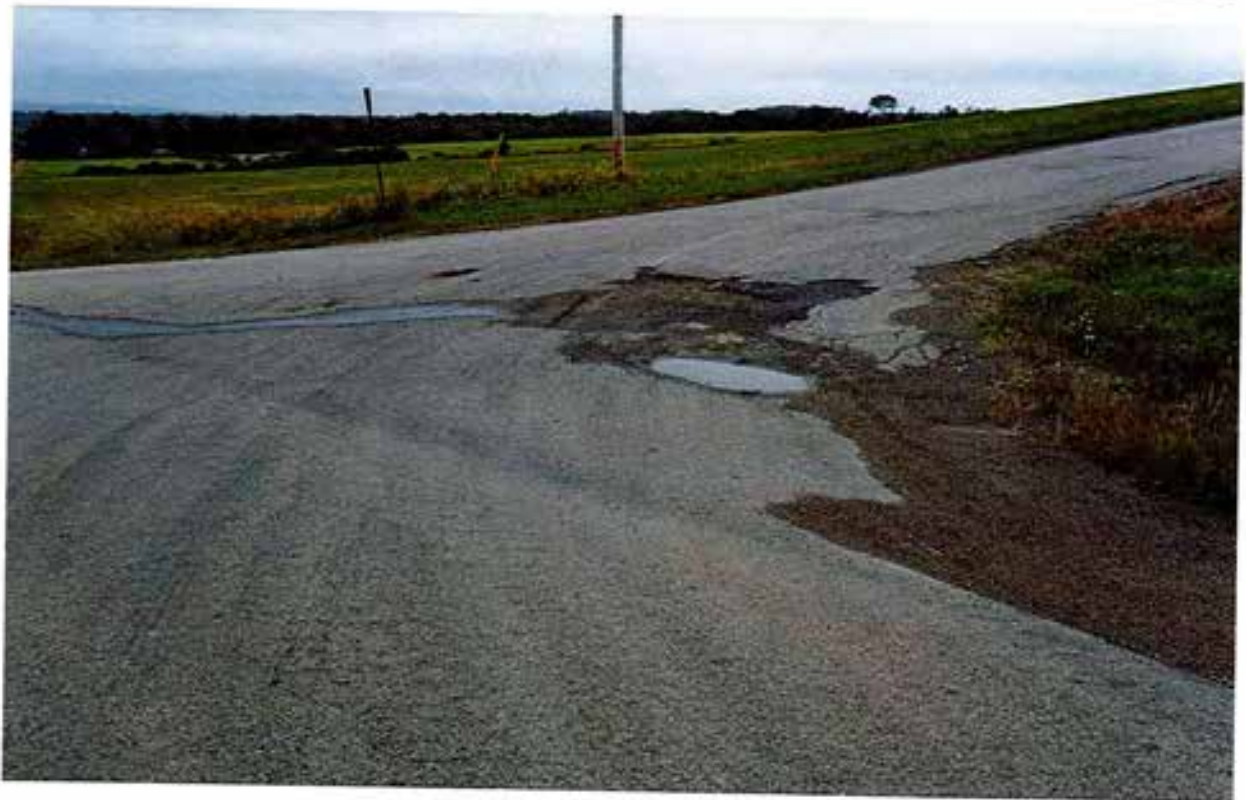
Edmunds Road intersection of Brown School House

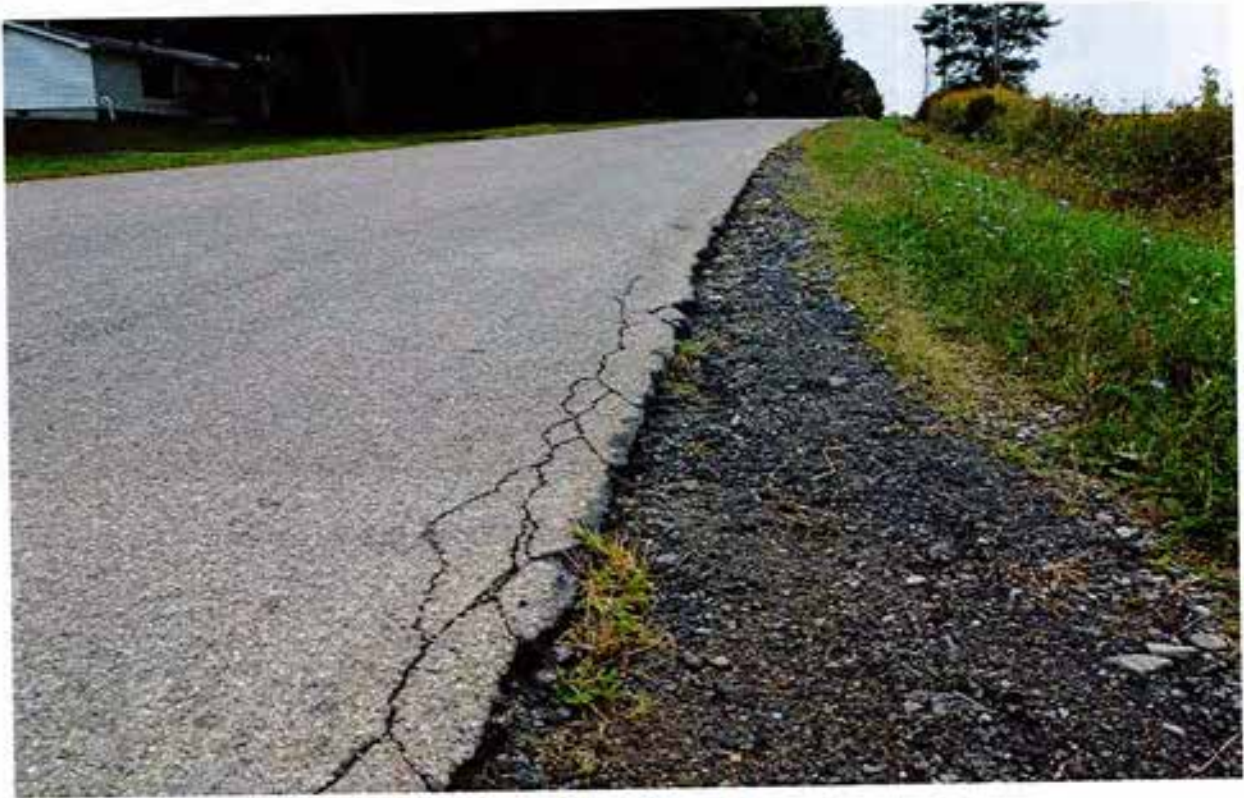
Edmunds Rd Southeast edge and shoulder deteriorating near 1812

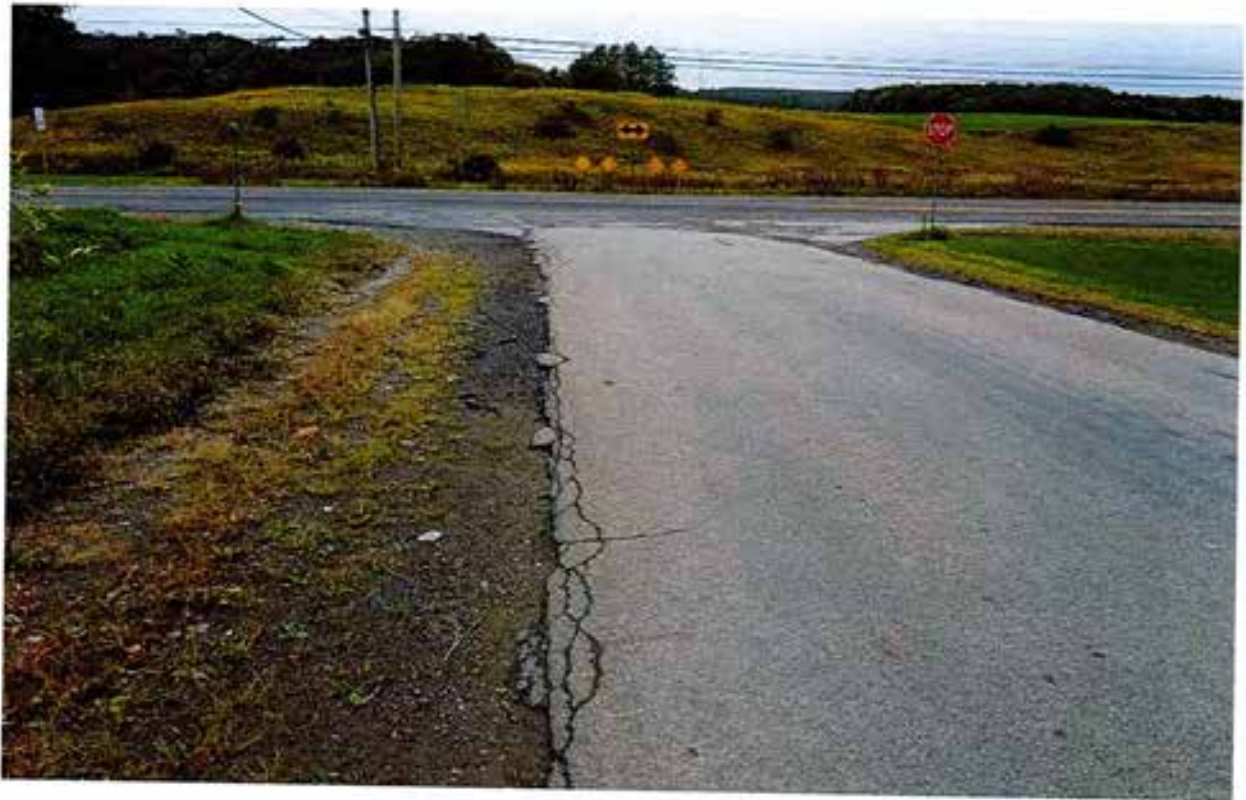
Edmunds Rd lane and shoulder deterioration on North and South sides of Rd near intersection with Maple Grove

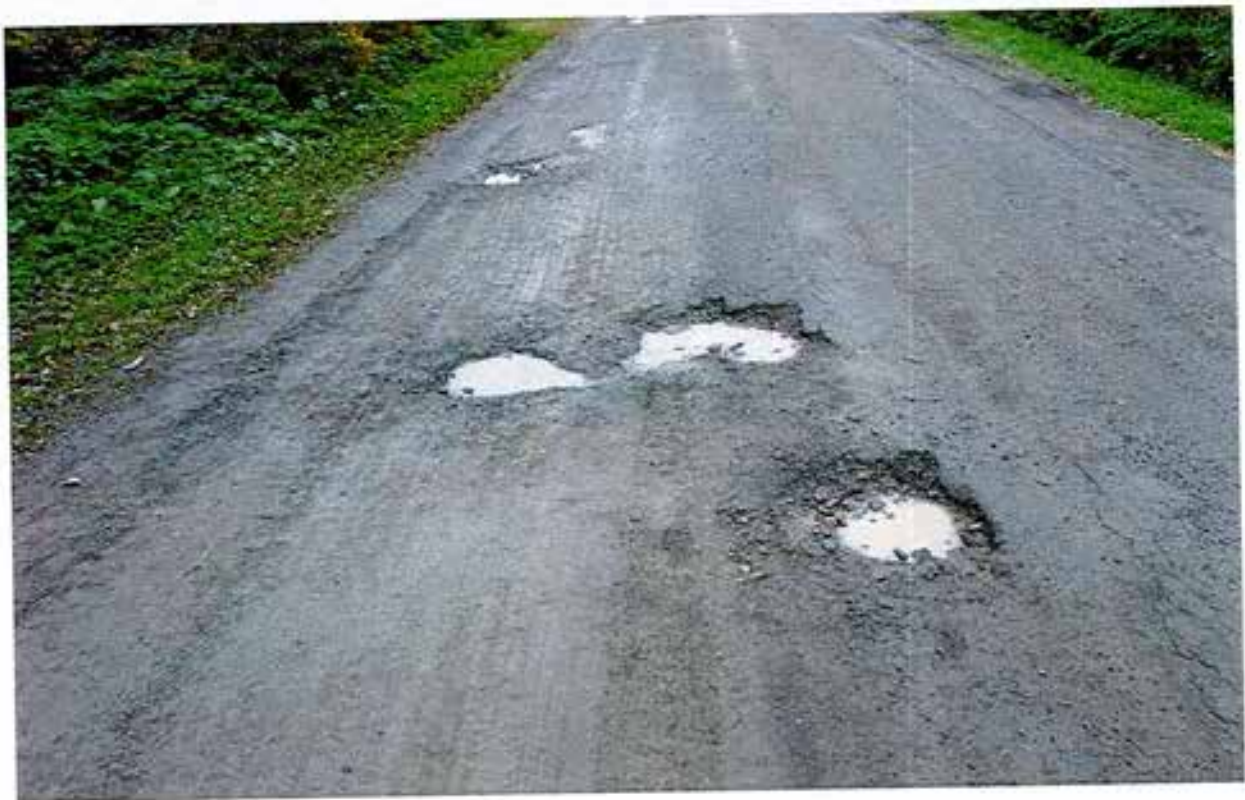
Strong Road potholes

| Maintenance Needed: | - Apply QPR to significant potholes |

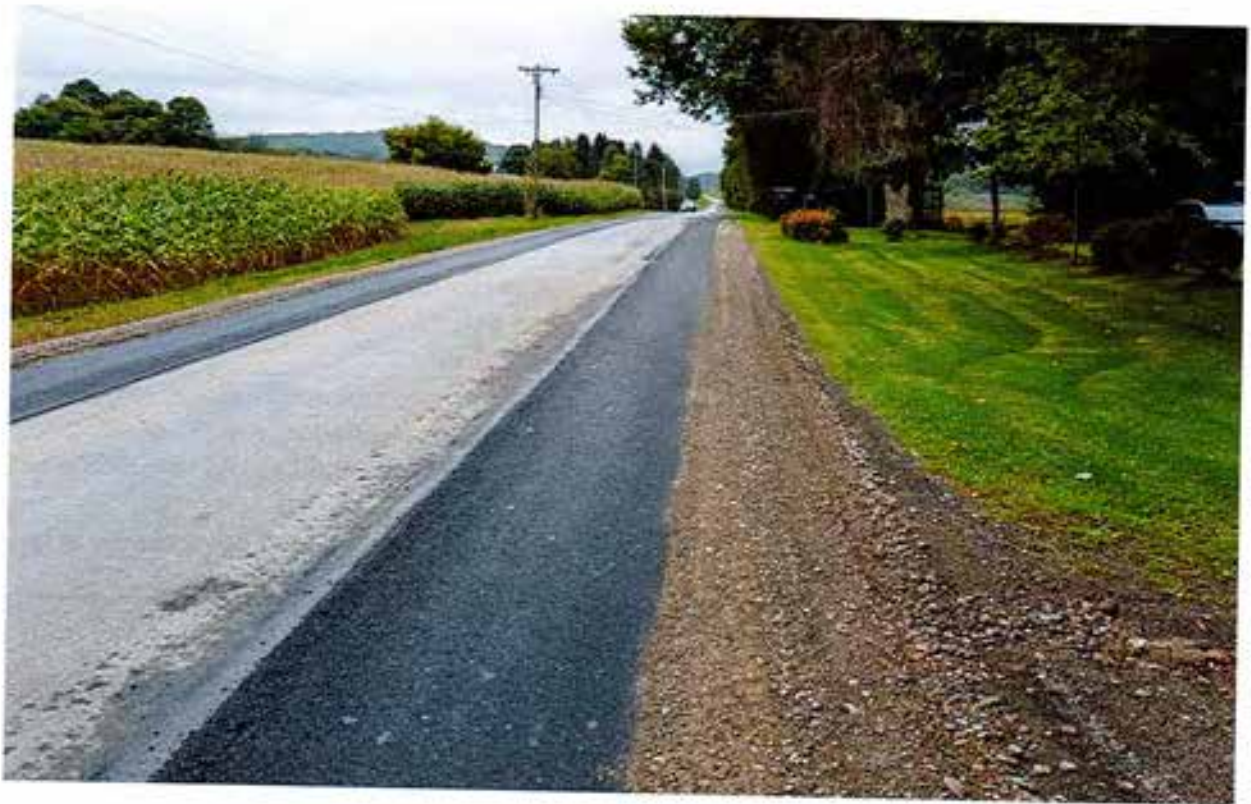
Siloam Road South shoulder deterioration near 1675 (REPAIRED)

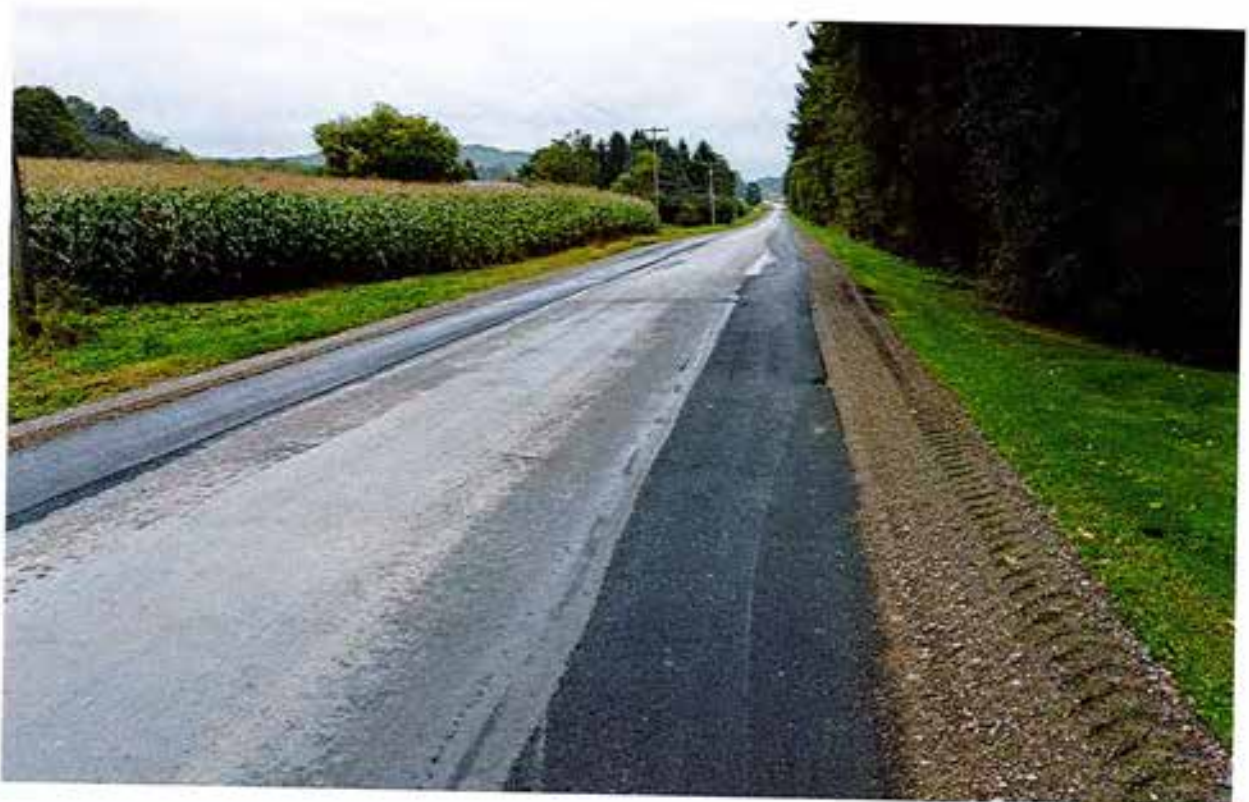
Siloam Road North and South shoulder deterioration from +/- 1675 to +/- 1579 (REPAIRED)

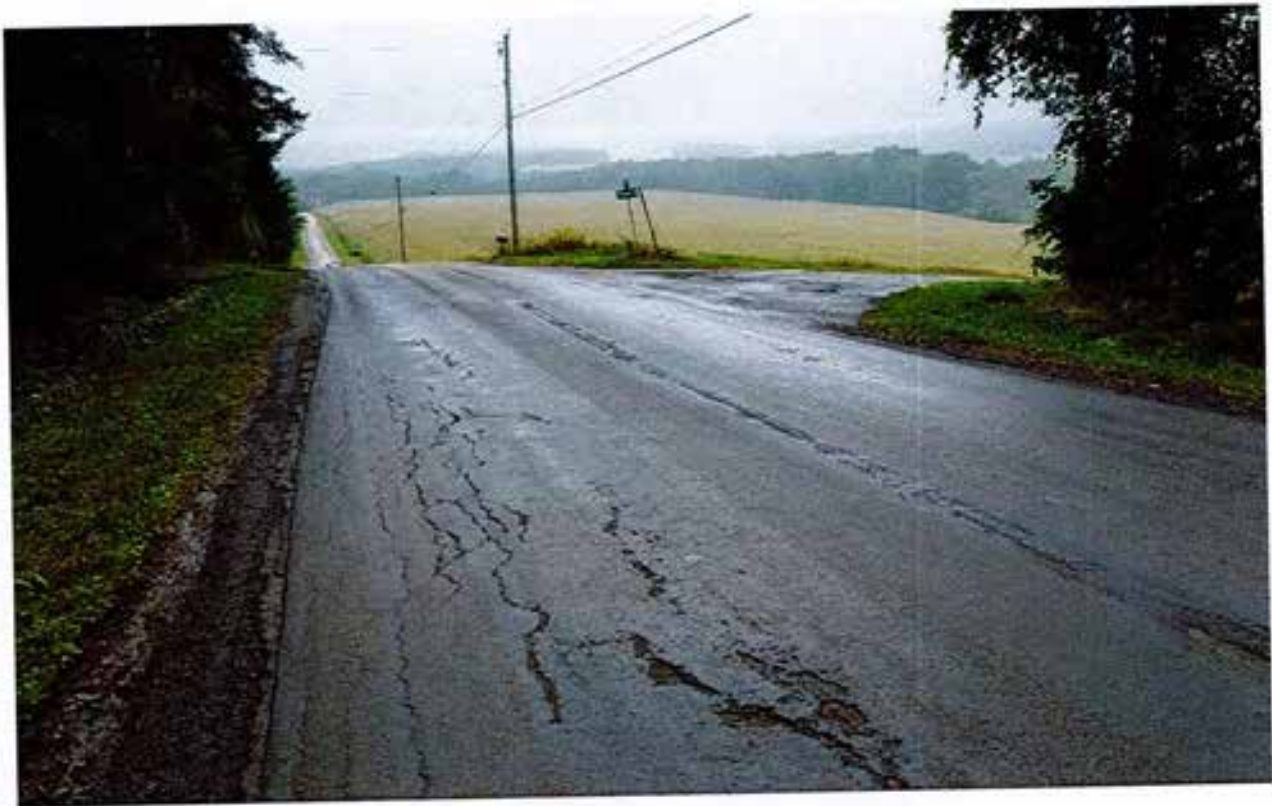
Galen Hill Road intersection with Phillippi Rd lane deterioration

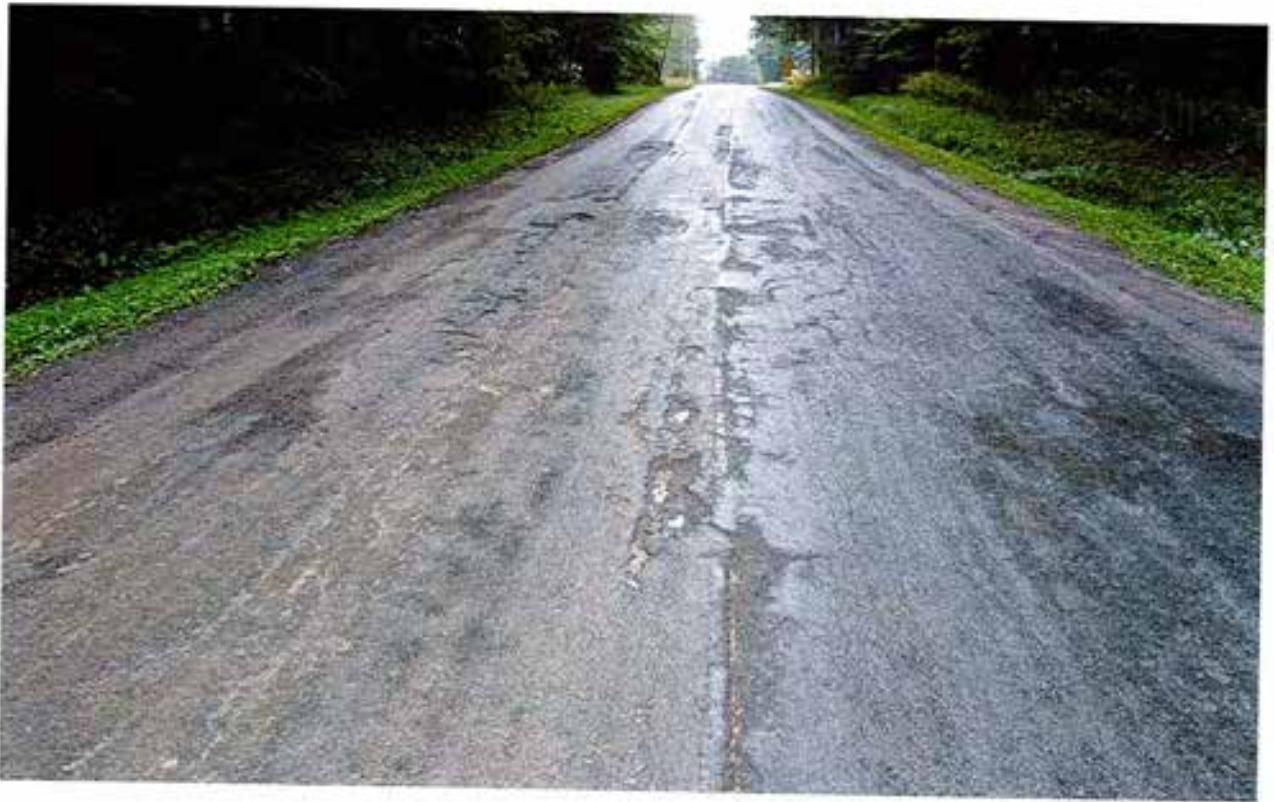
Galen Hill Road lane deterioration from Phillippi Rd to 10553

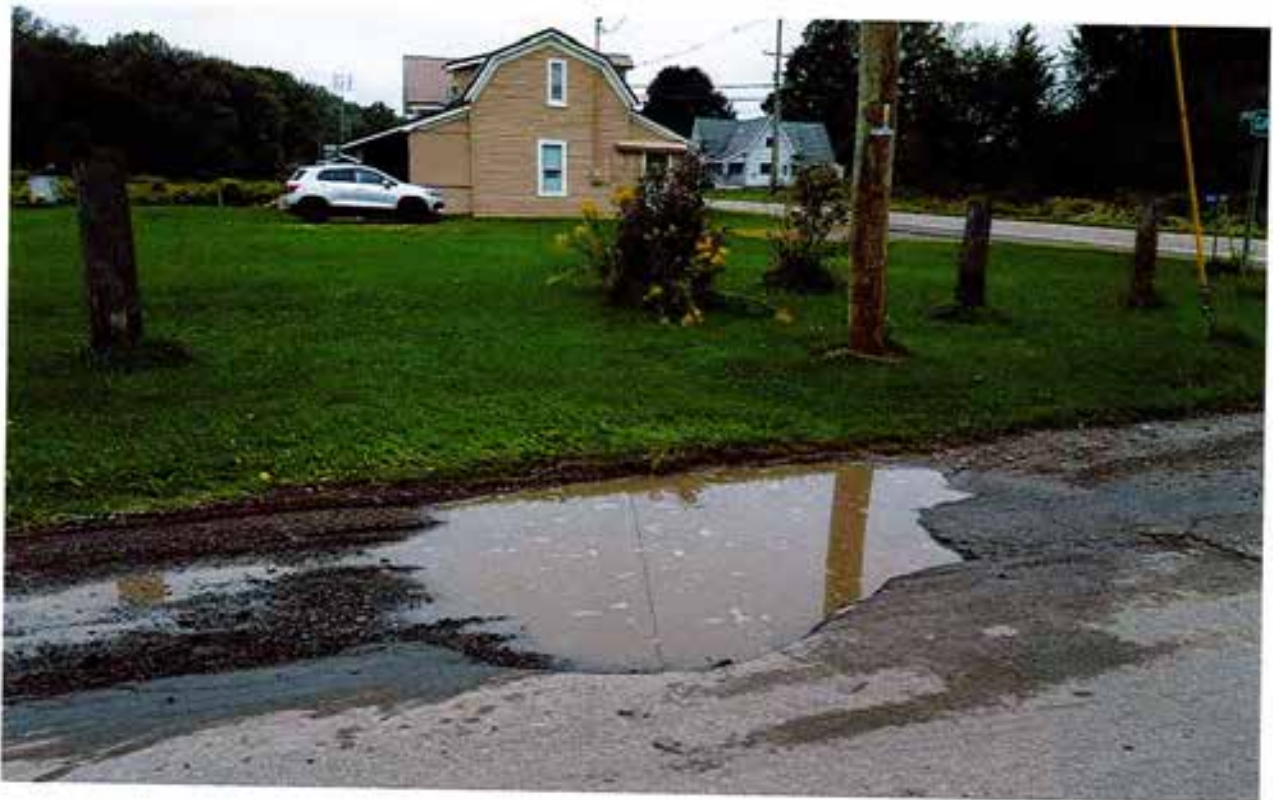
Galen Hill Rd pothole at intersection of Route 98

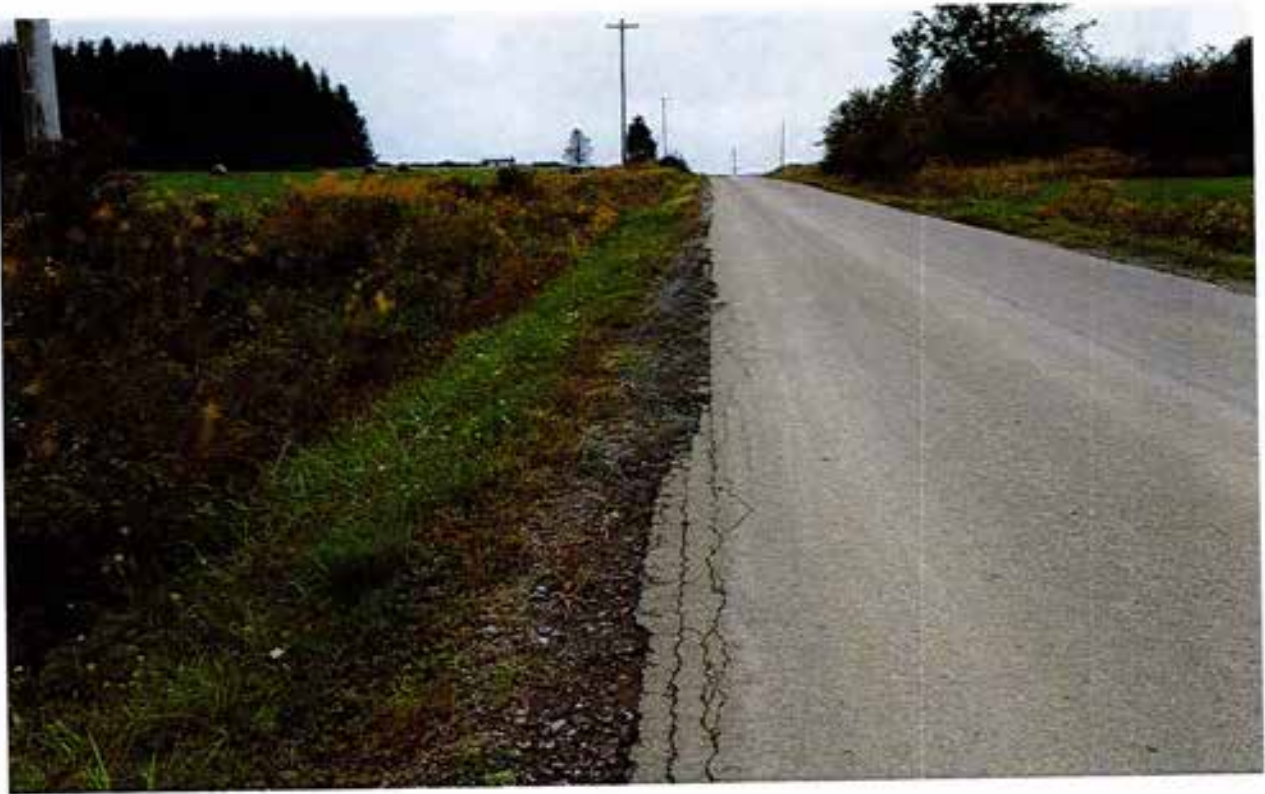
Galen Hill West edge and shoulder deterioration North of 10075

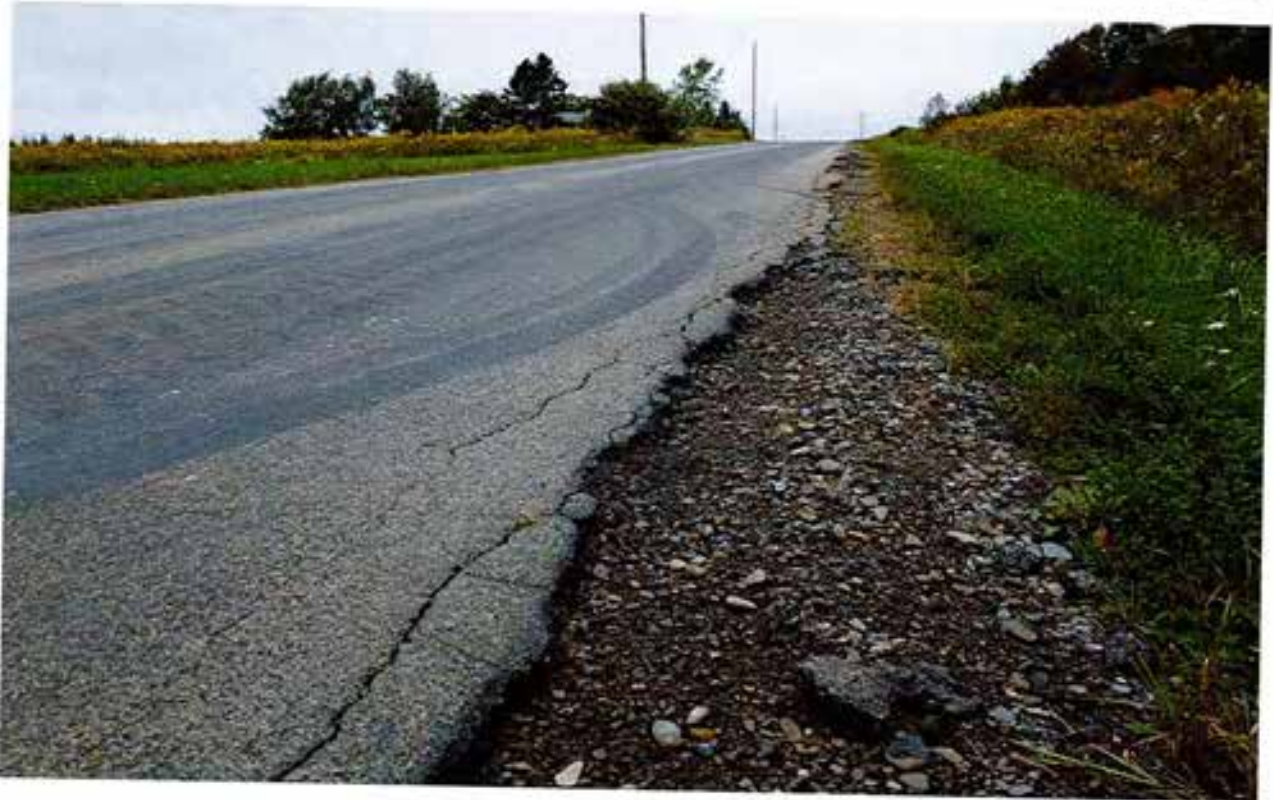
Sandbank Road East edge and shoulder deterioration near 9999

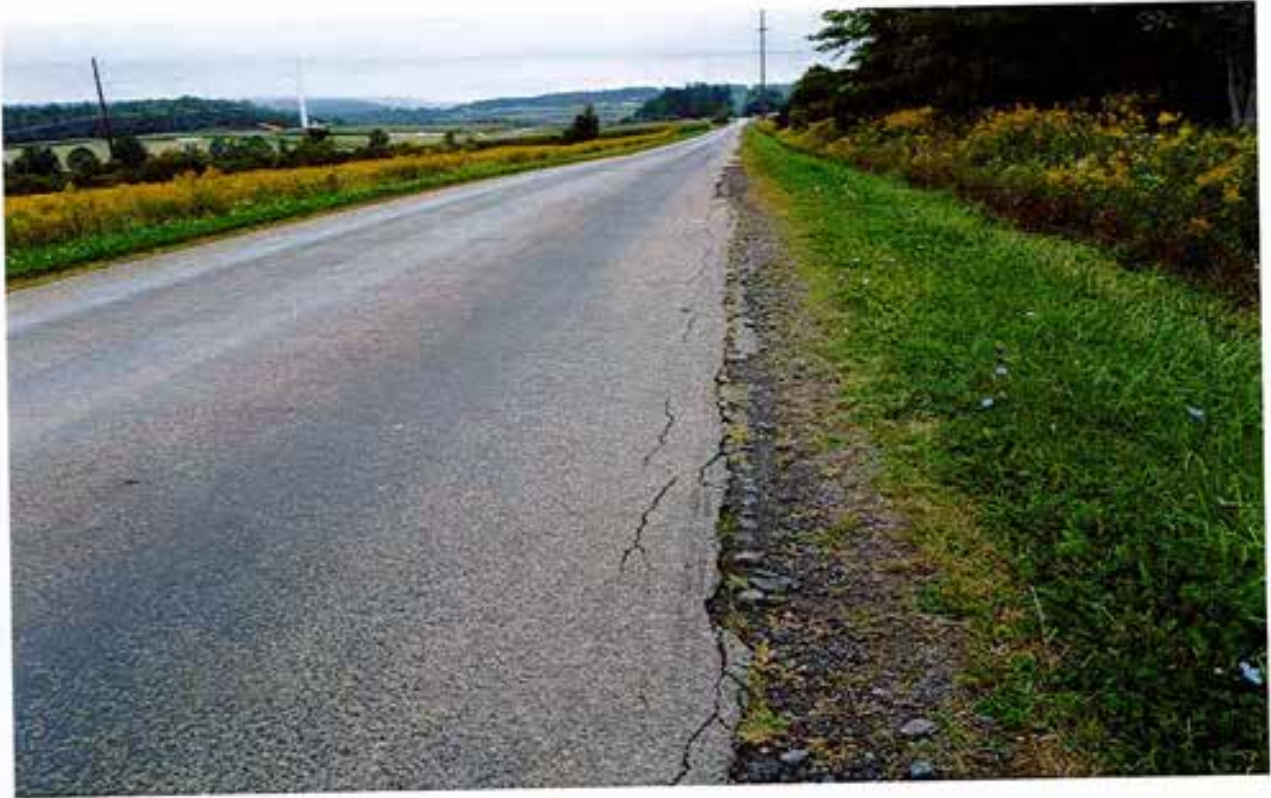
Sandbank Rd East and West edge deterioration North and South of 10157 to +/- 10220

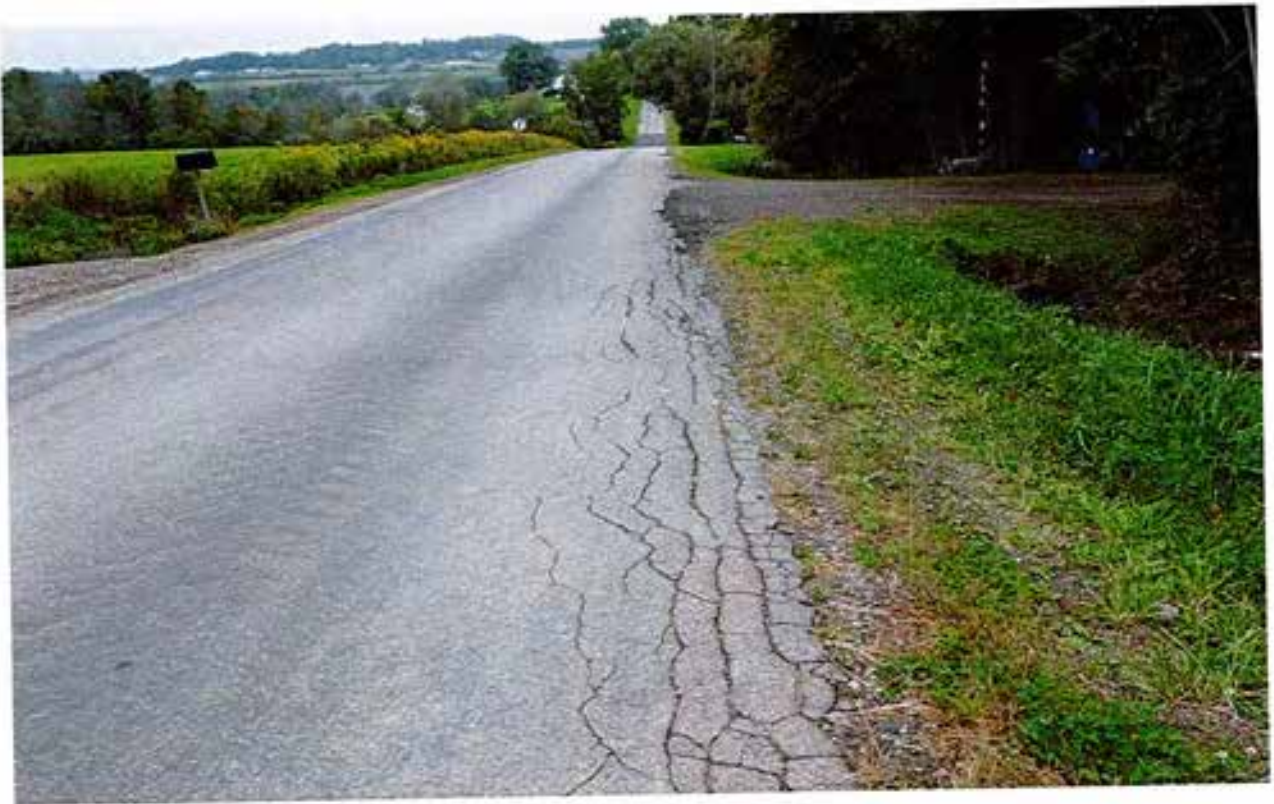
Sandbank Road East and West edge / shoulder deterioration near 10238

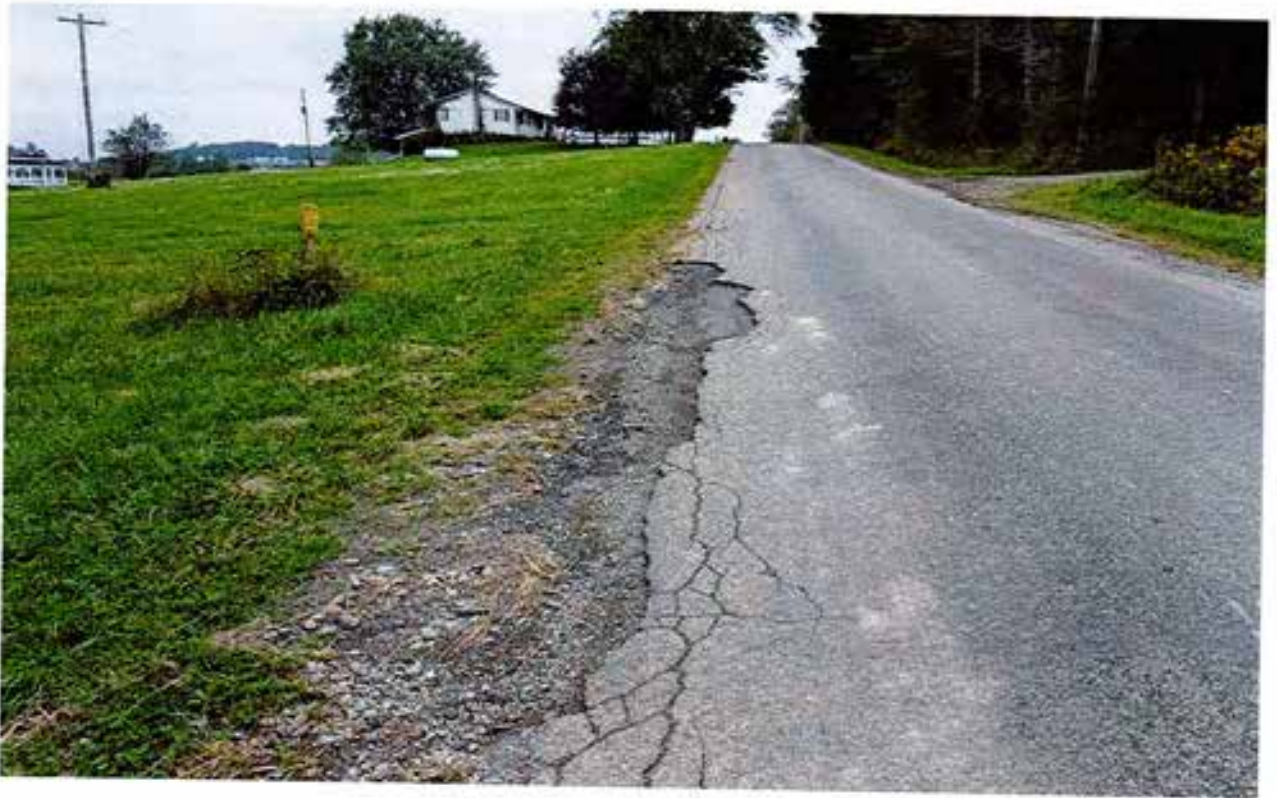
Sandbank Rd West lane and edge deterioration South of 10317
