## Road Condition & Vehicle Compliance Report

| Report # | 58 |
| Project Name | Alle-Catt Wind |
| Location | Town of Freedom |

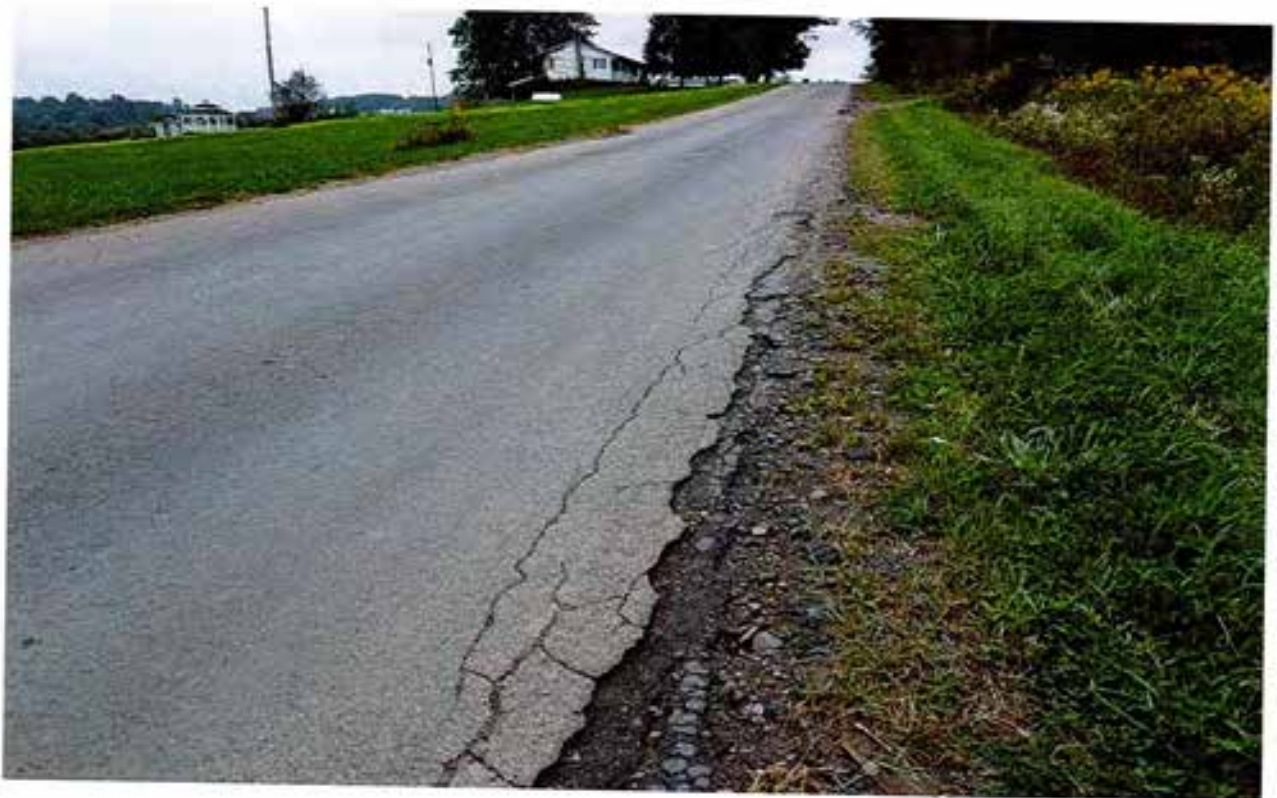
Sandbank Rd East lane and edge deterioration South of 10317

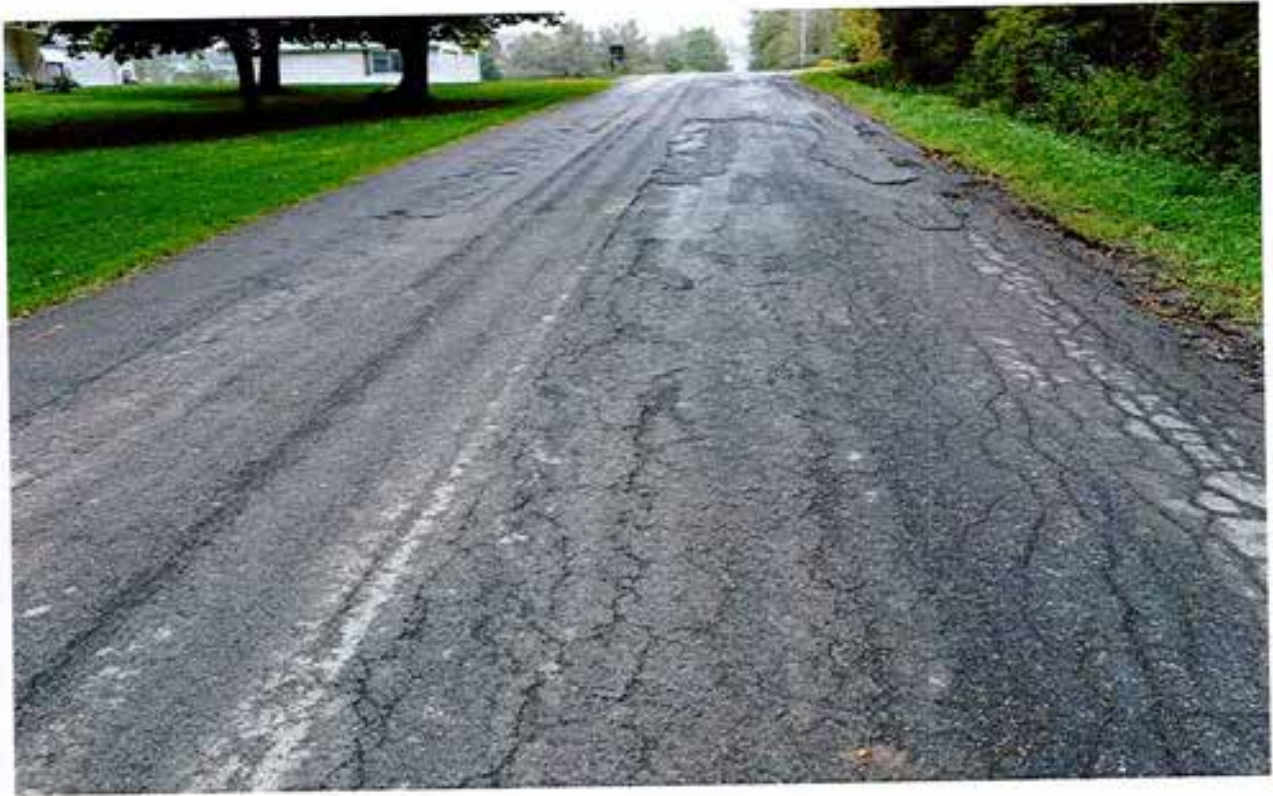
Sandbank Rd lane deterioration near 10317

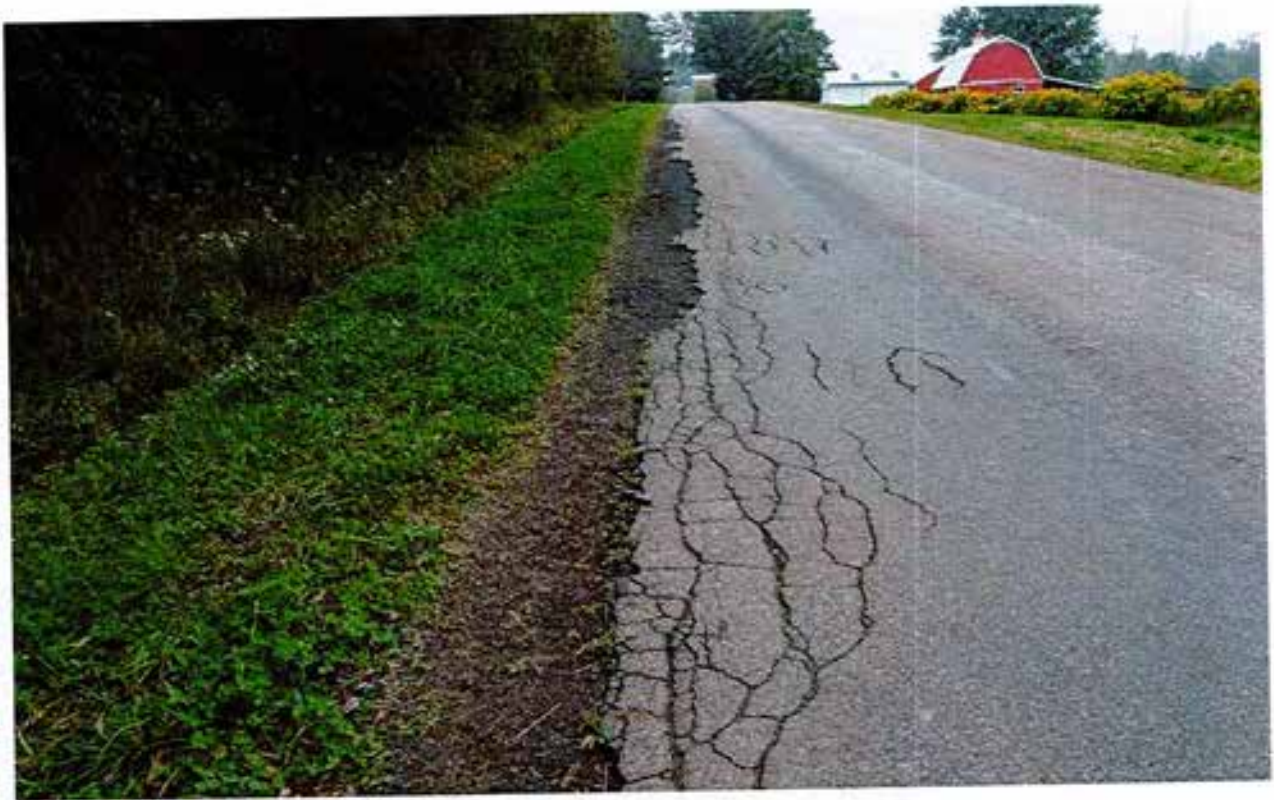
Sandbank Road East edge deterioration South of 10368

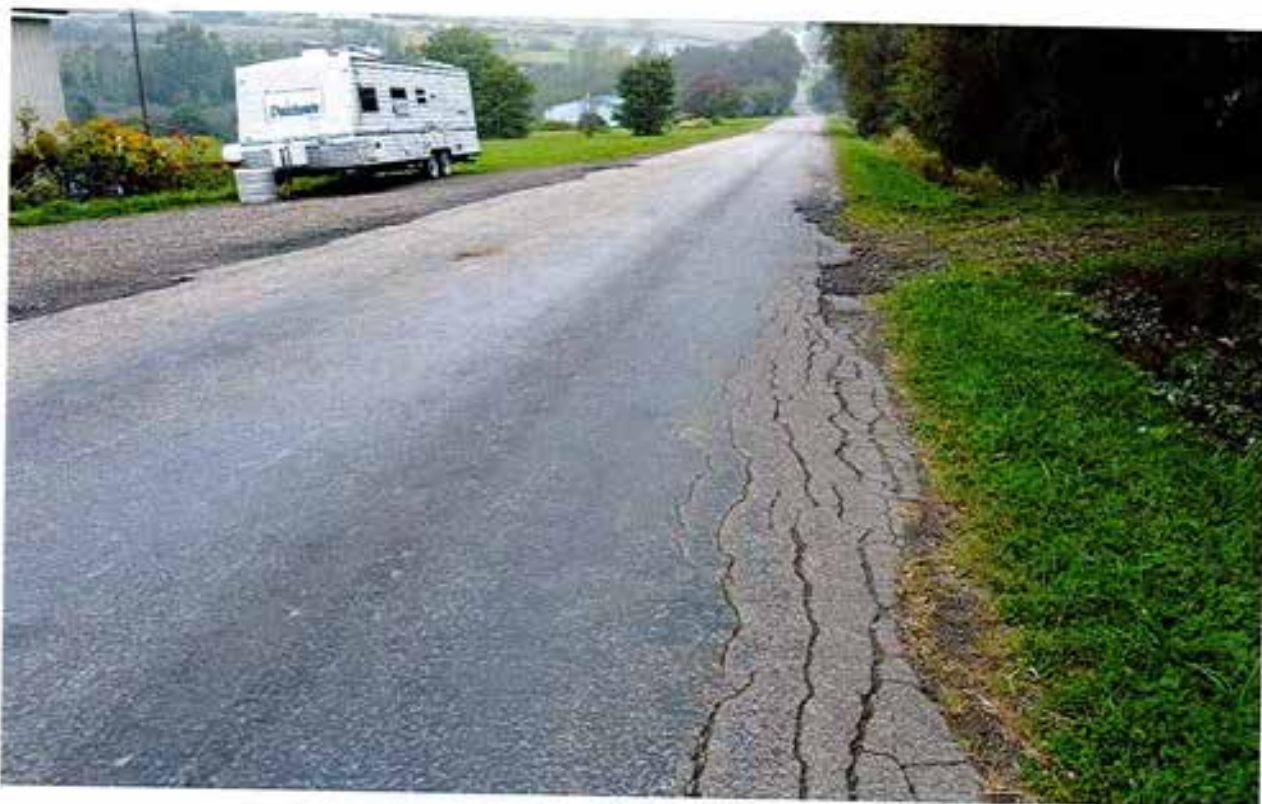
Sandbank Rd East and West side shoulder deterioration near 10442

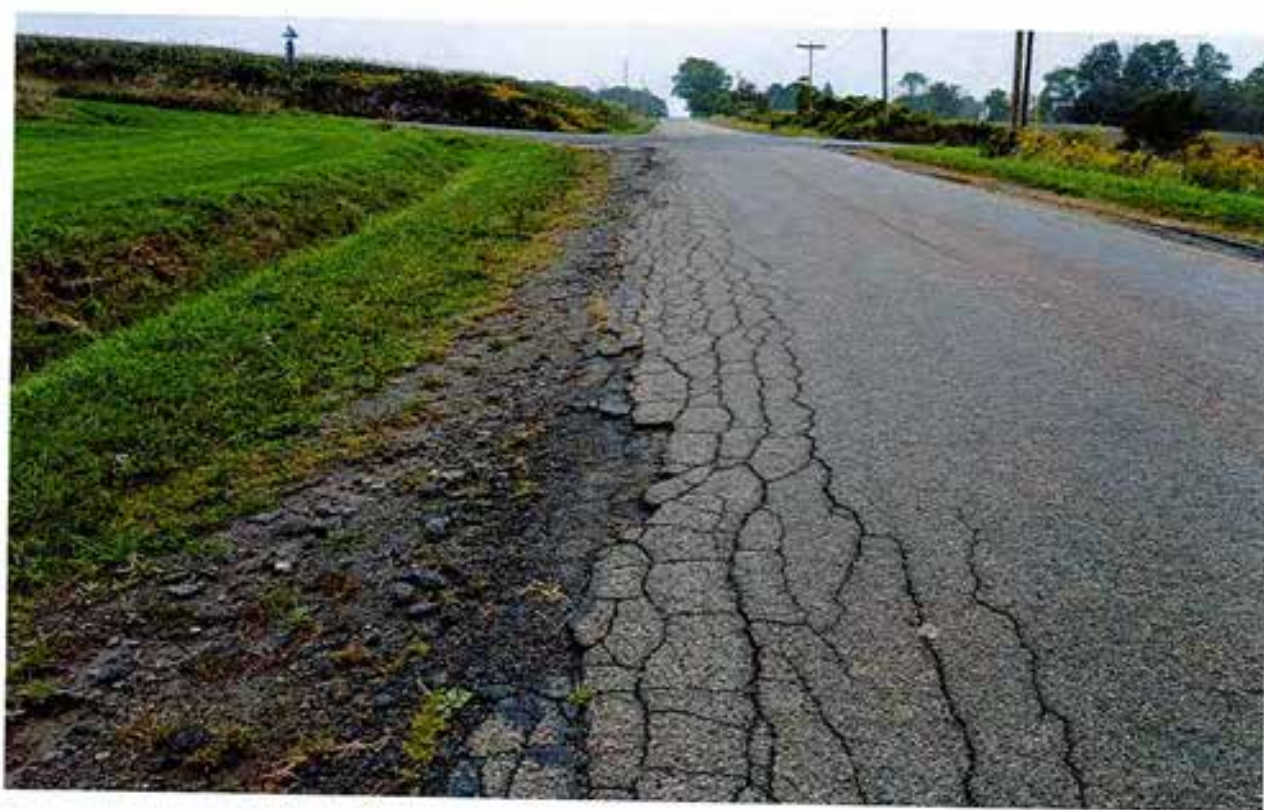
Sandbank Road (East and West) edge and shoulder deteriorating near intersection with Cross Road

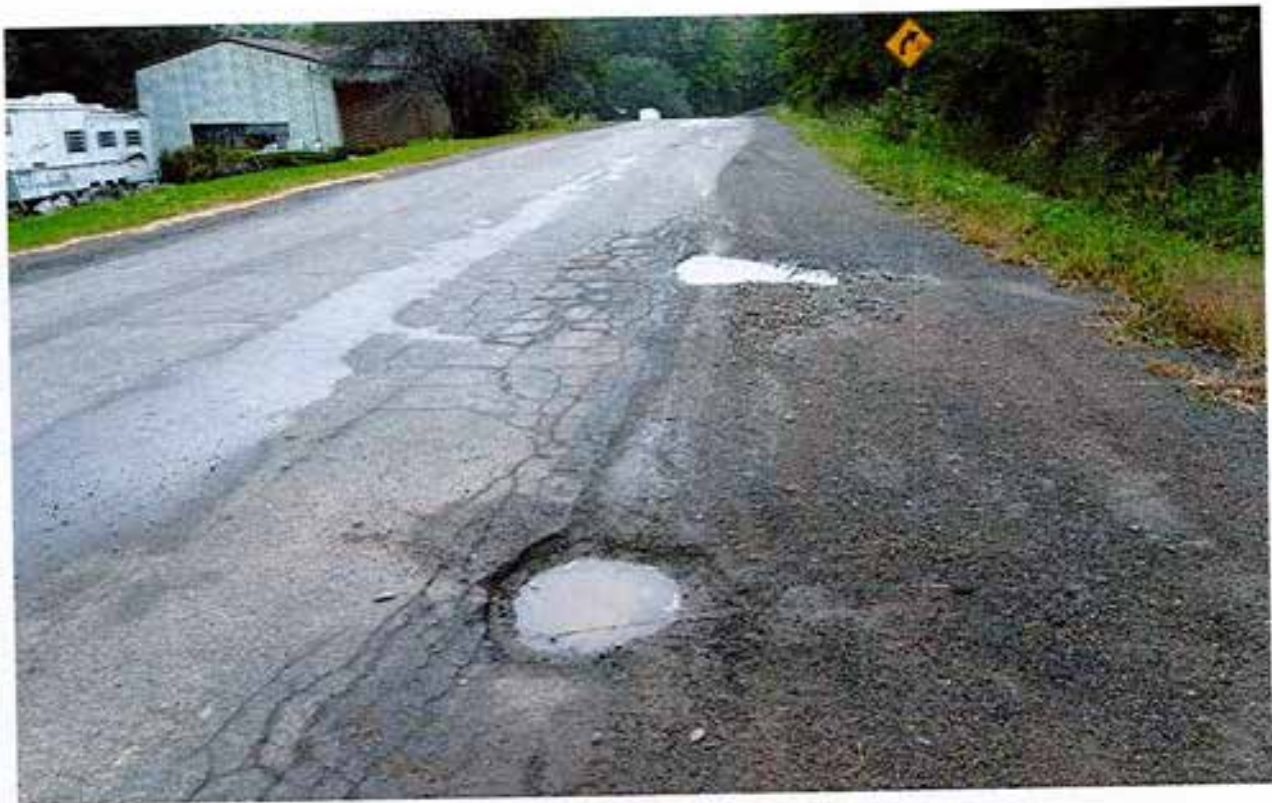
Osmun Rd Edge and shoulder deterioration near Zimmer

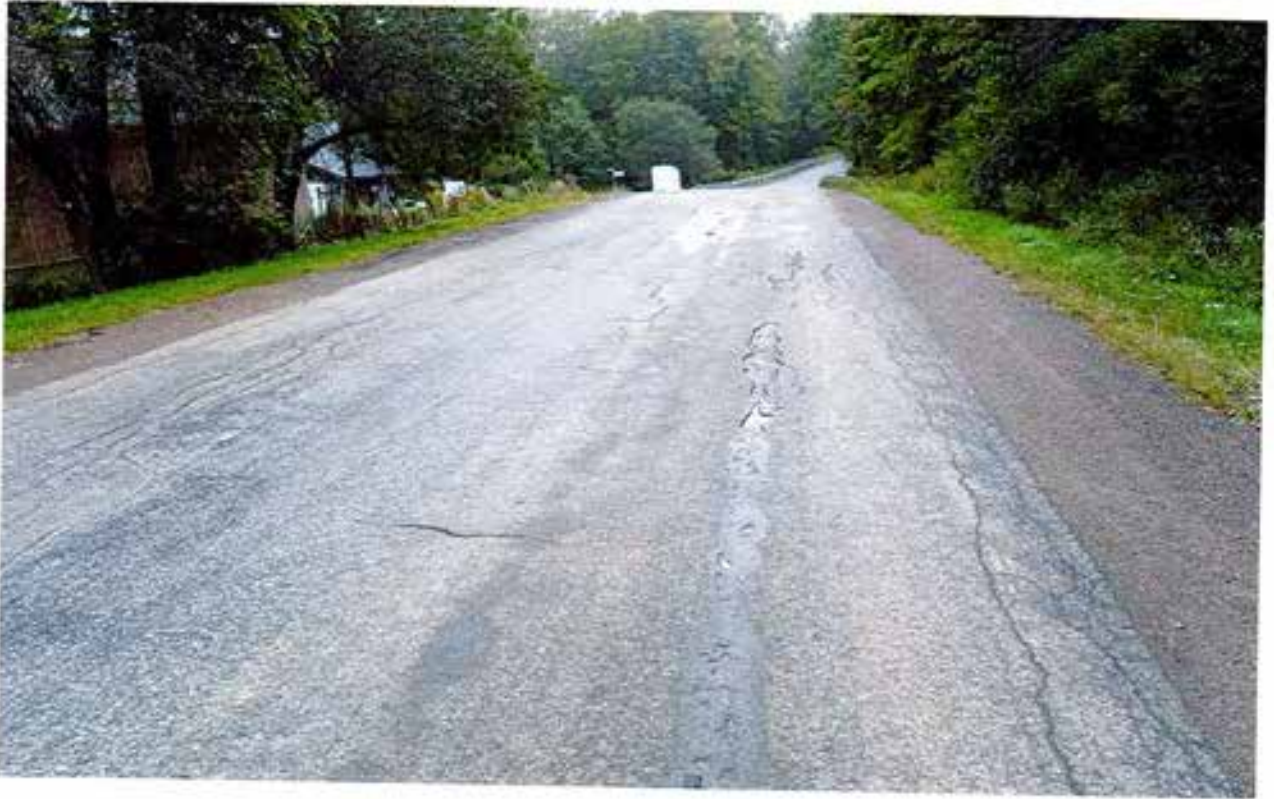
Osmun Rd lane deterioration near Zimmer

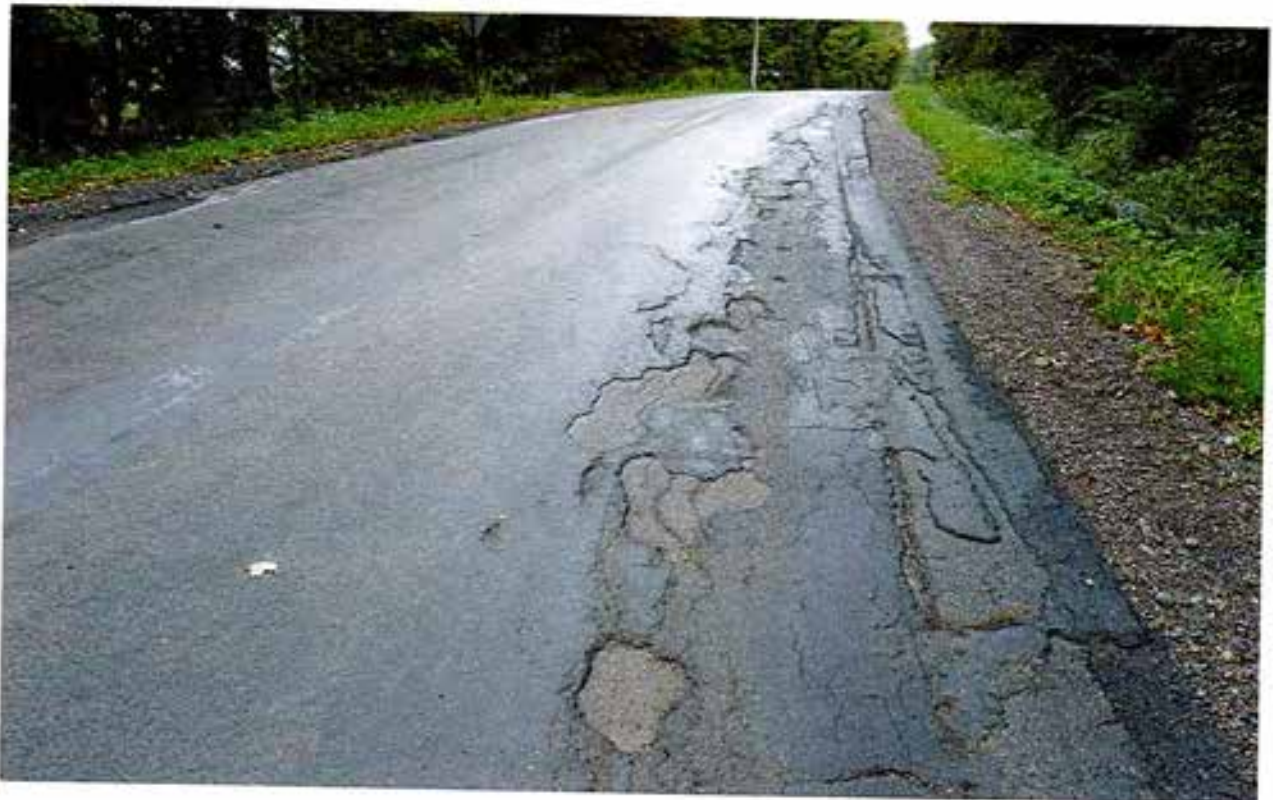
Osmun Road lane deterioration South of 10200

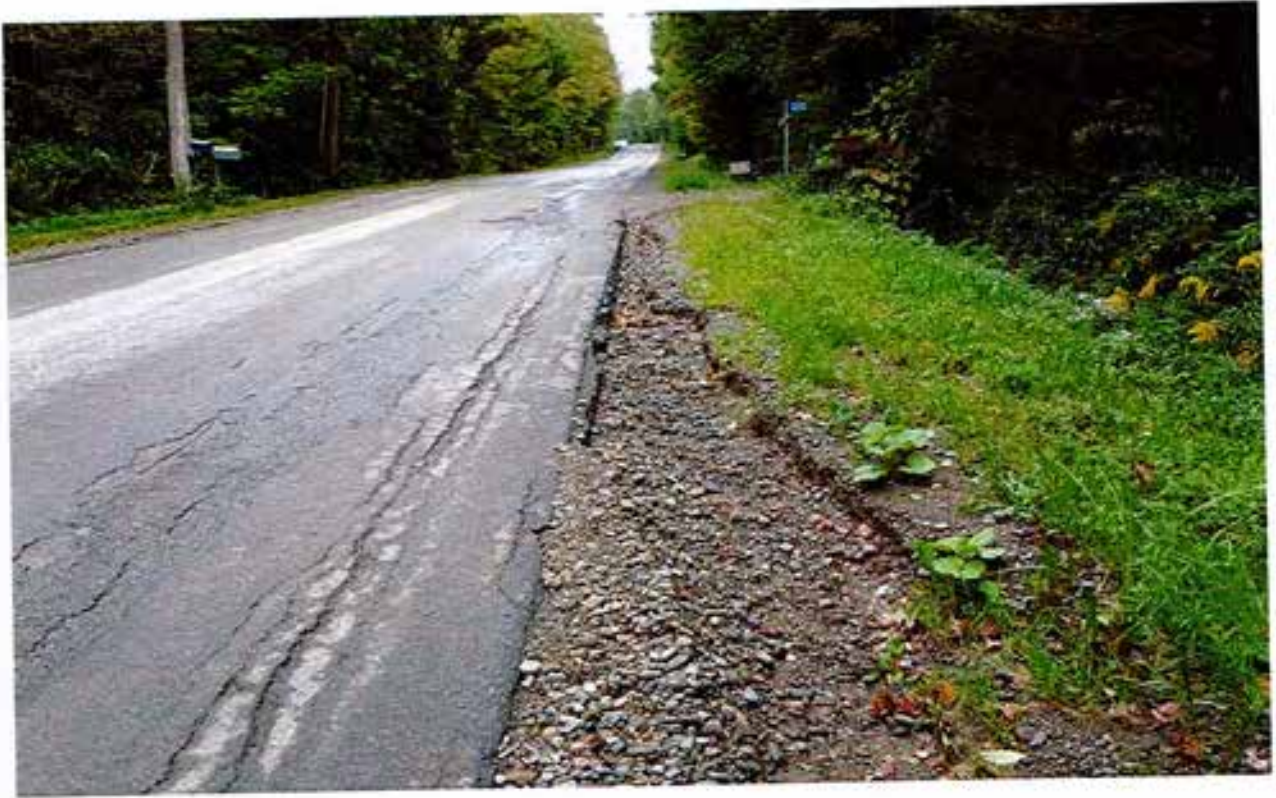
Osmun Road East lane and shoulder deterioration near 10200

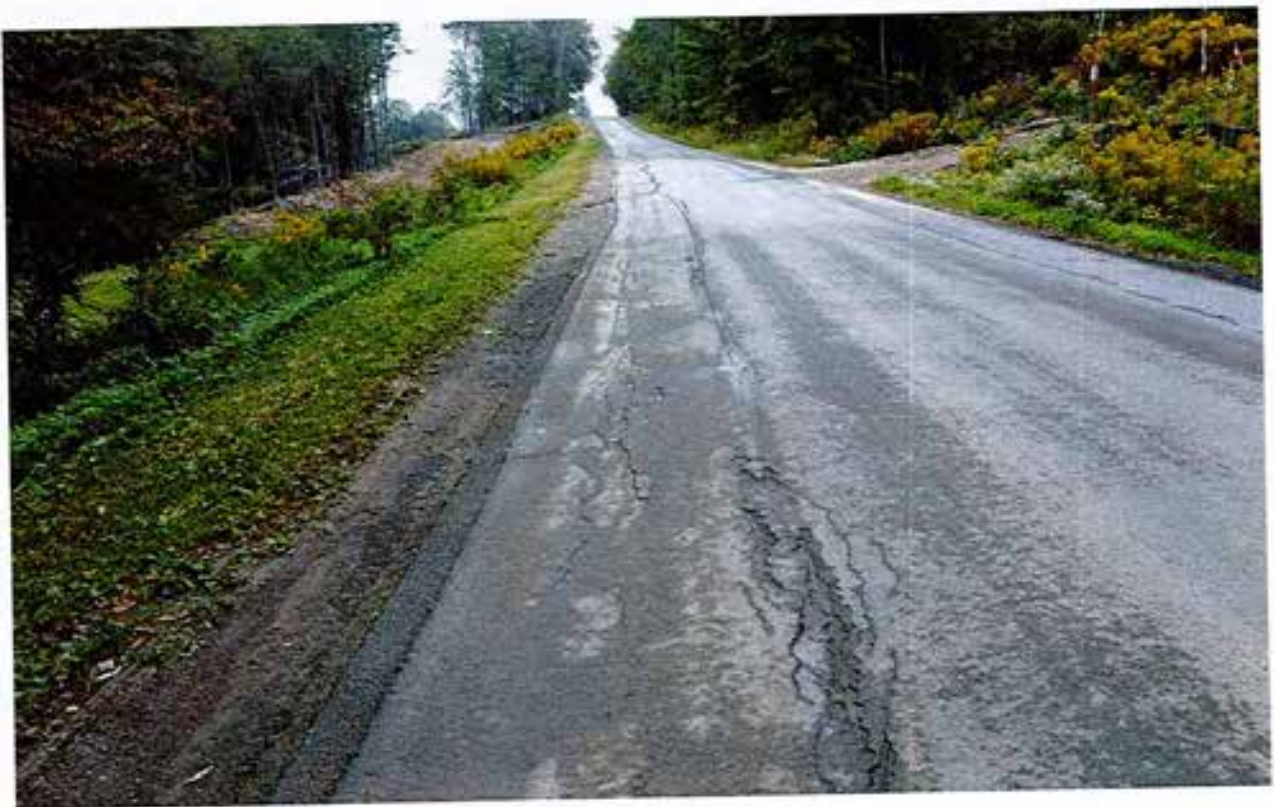
Osmun Rd lane deterioration North of 10220 near construction entrance

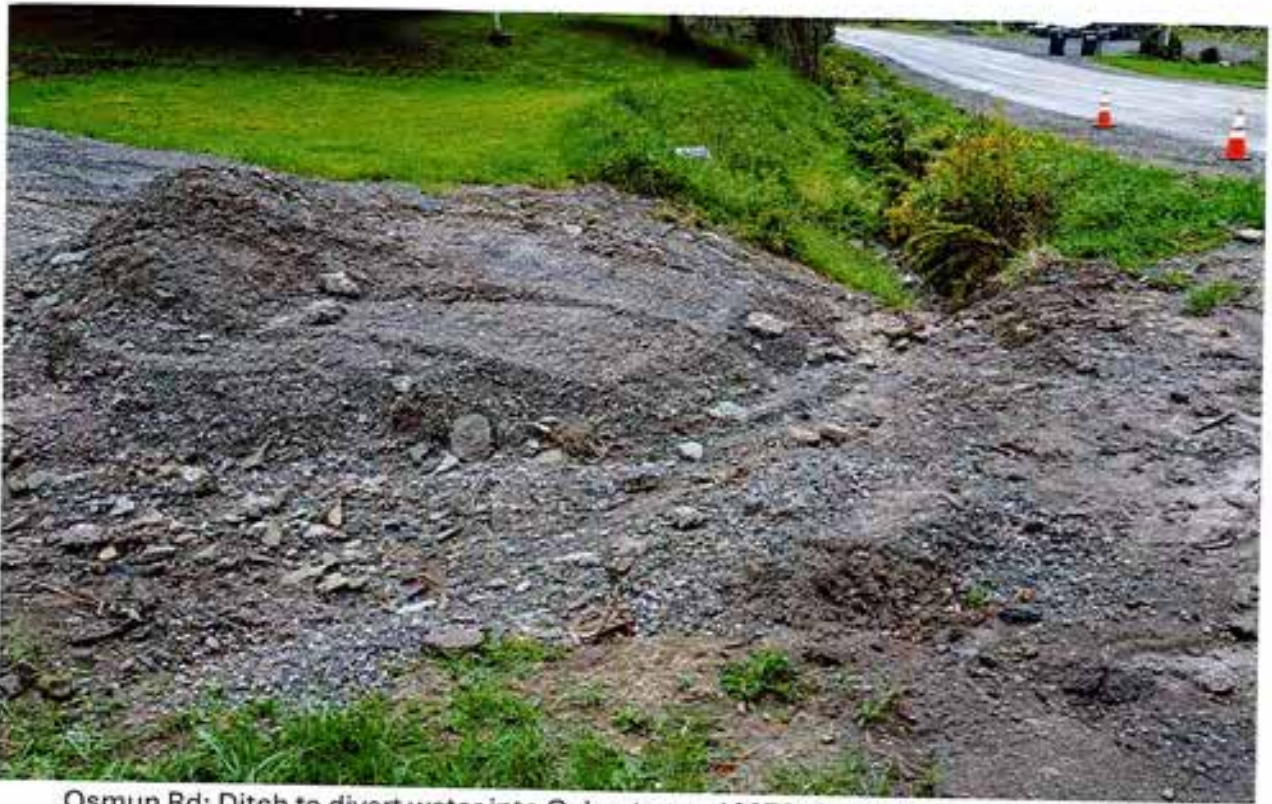
Osmun Rd: Ditch to divert water into Culvert near 10379. According to Town Highway Superintendent, the diversion ditch is helping prevent erosion. Ditch to be maintained as needed.

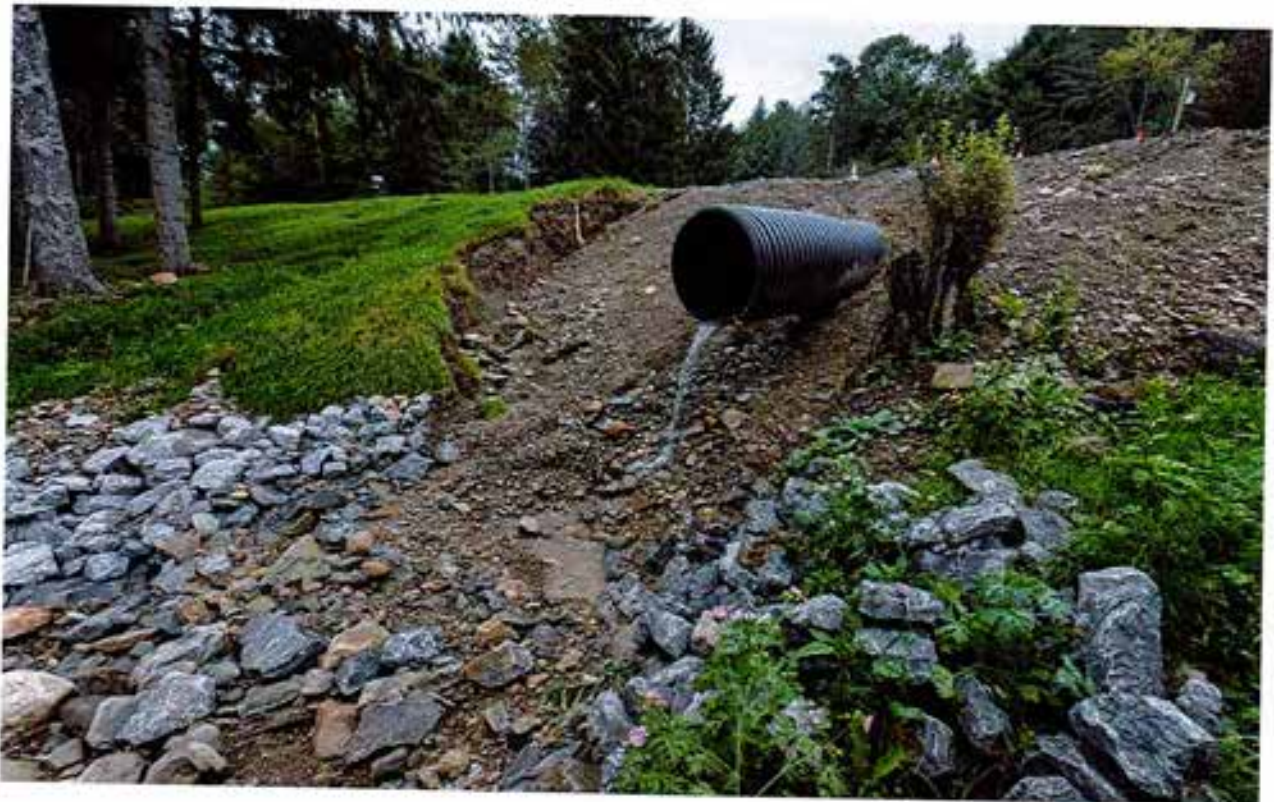
Osmun Rd: West end of Culvert near 10379. Recommend cutting pipe back to daylight grade and installing rock outlet protection to prevent further erosion of outlet area.

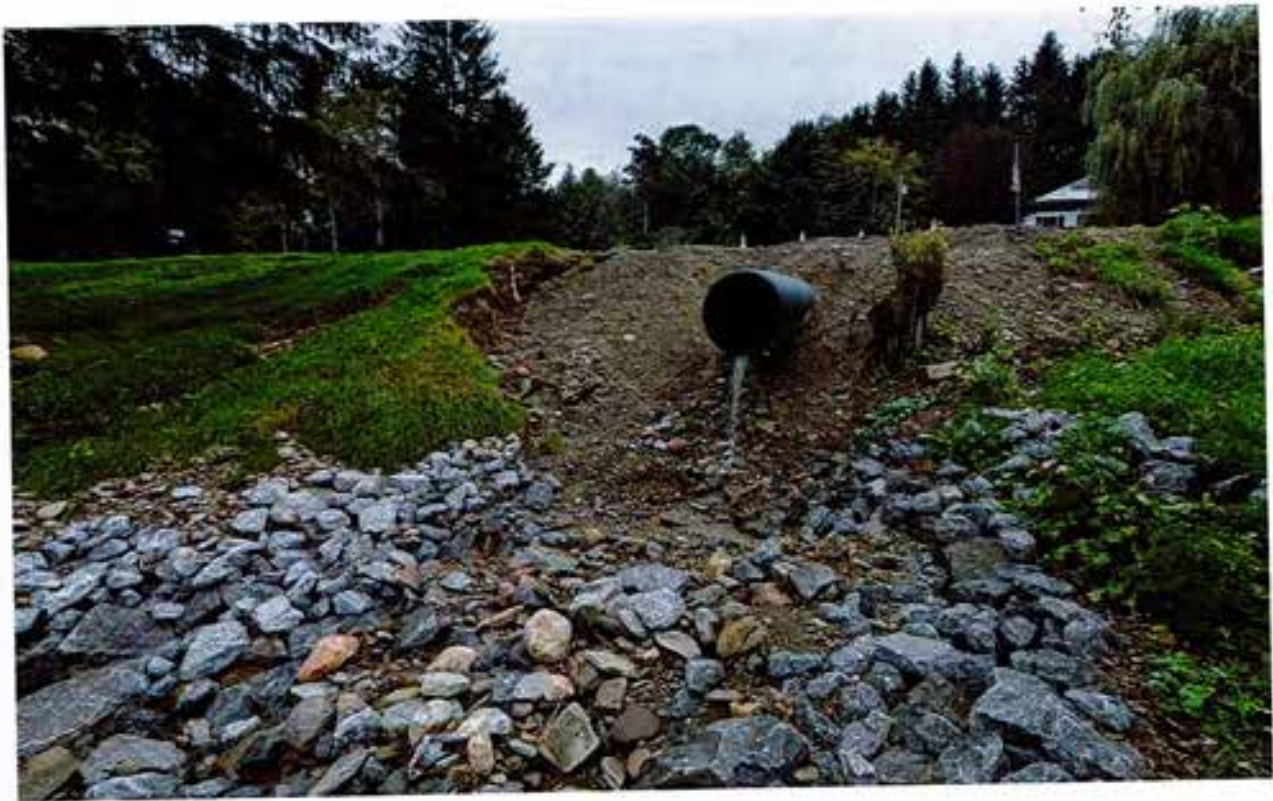
Osmun Rd: West end of Culvert near 10379. Consider rock revetment (rock lining) alongside slope from the road to prevent further washout of this slope.

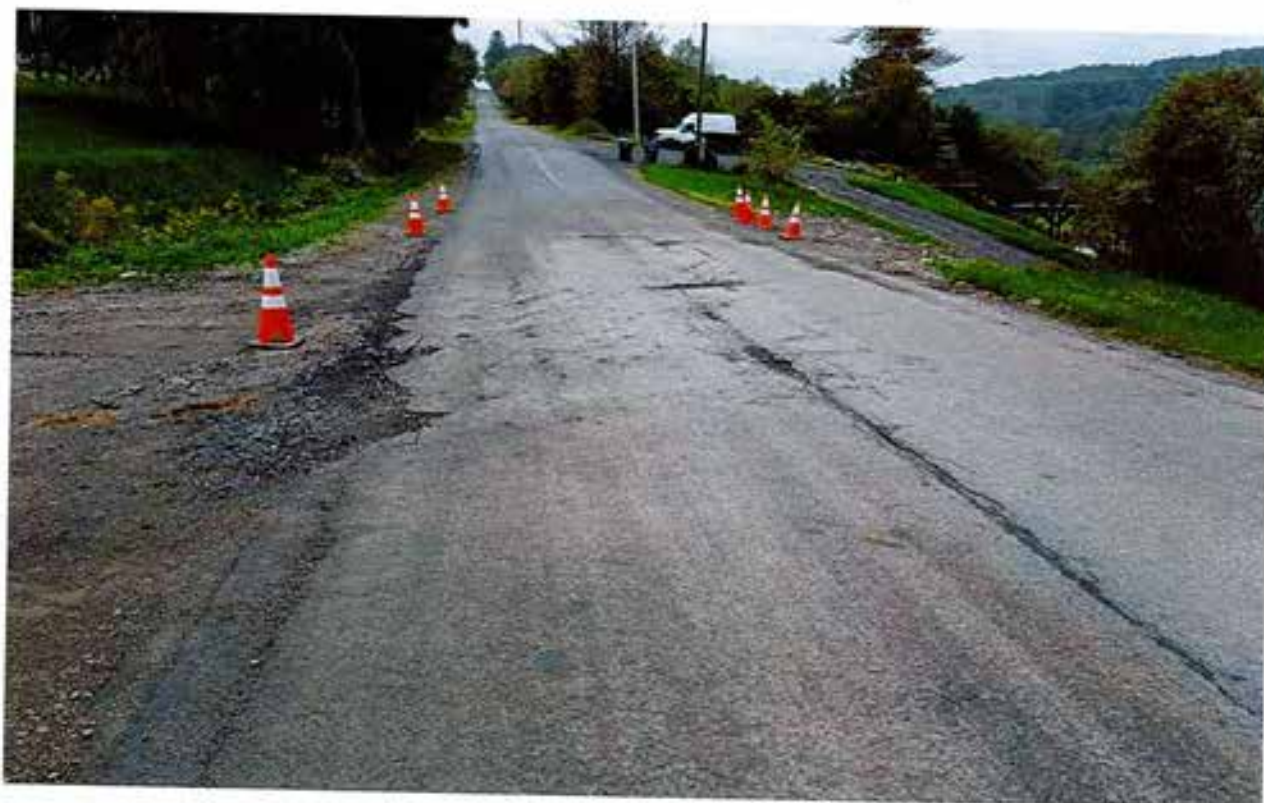
Osmun Rd: Road over Culvert near 10379 facing South. Road edge deterioration is evident.

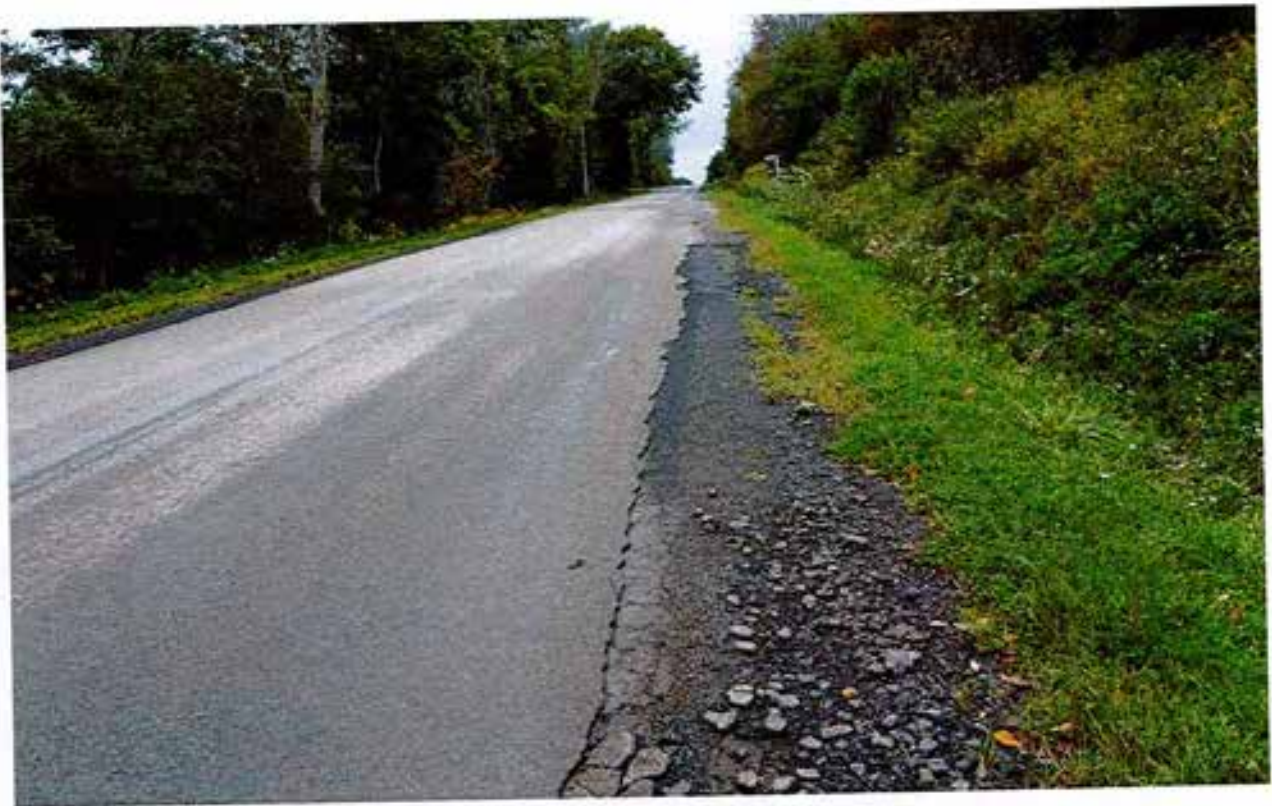
Osmun Rd East side lane, edge, and shoulder deterioration North and South of 10410

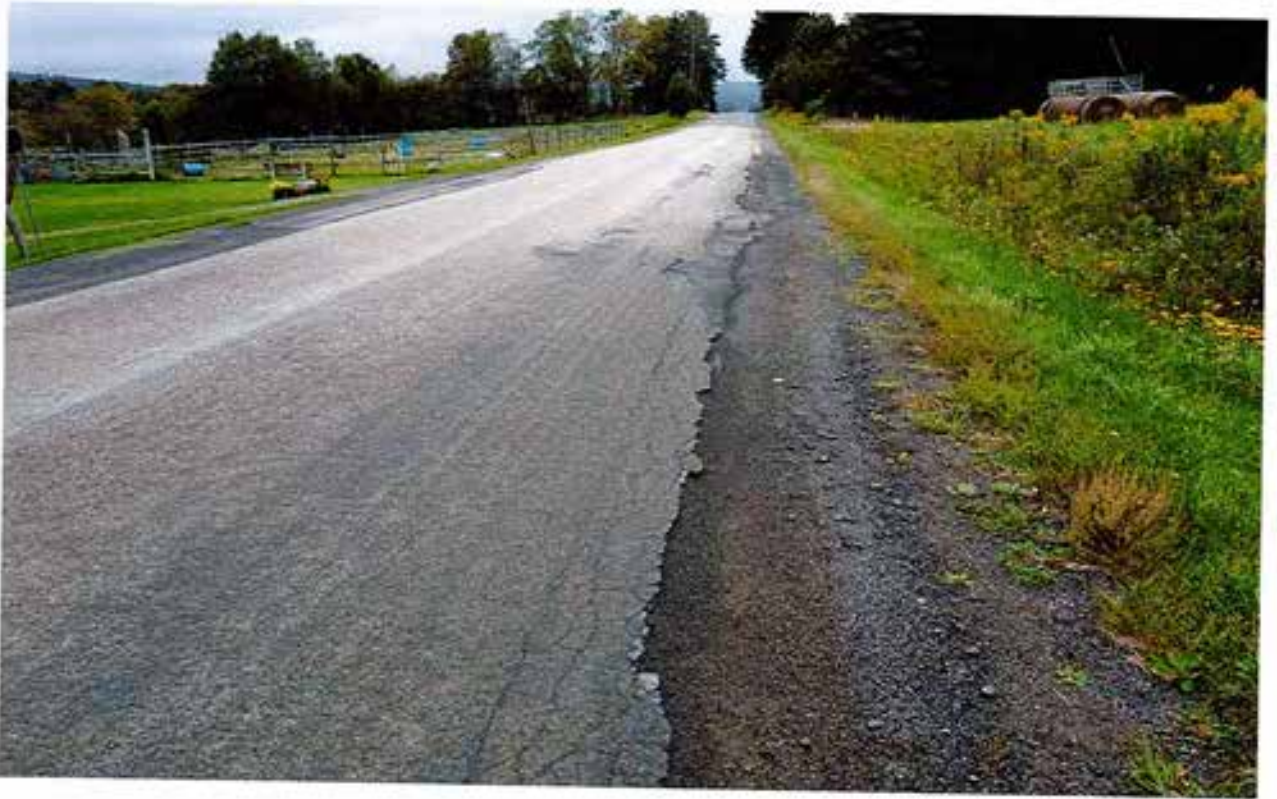
Osmun Road East edge and shoulder deterioration near 10571

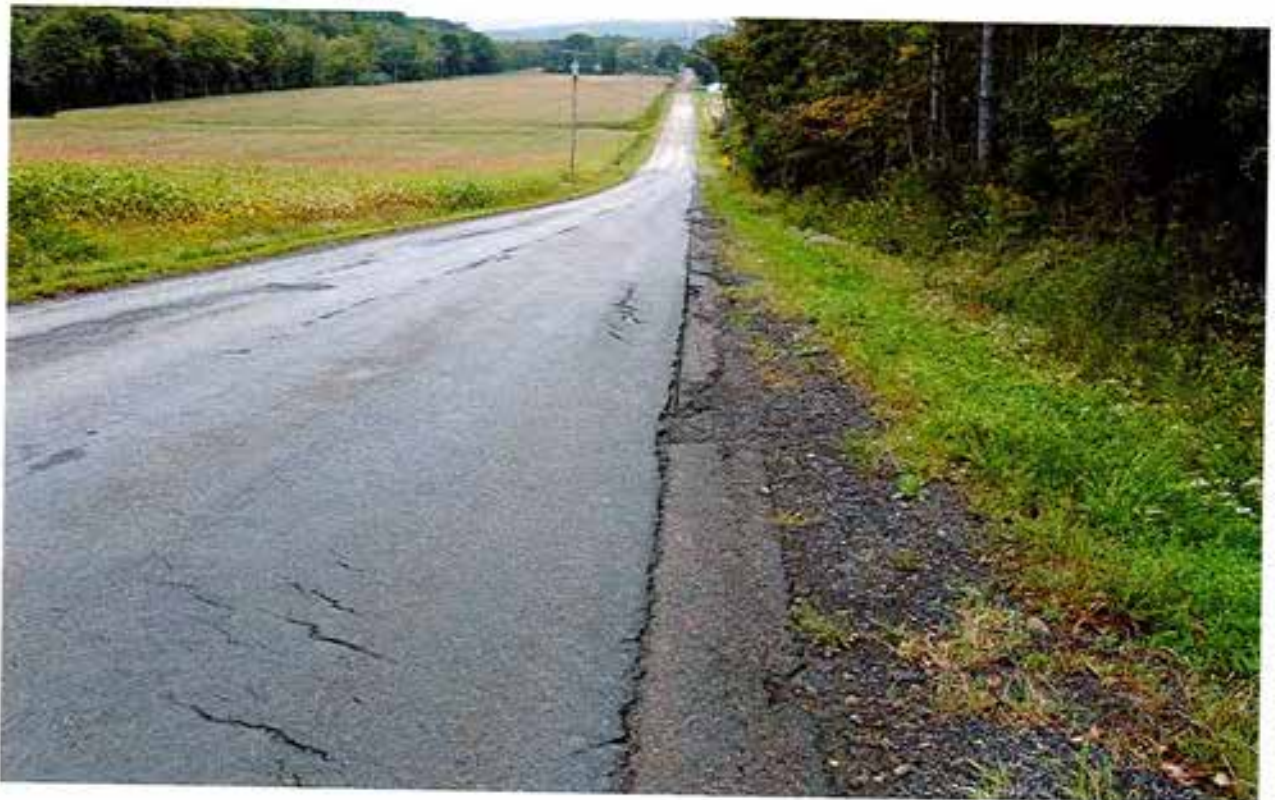
Osmun Rd edge deterioration South of 10674

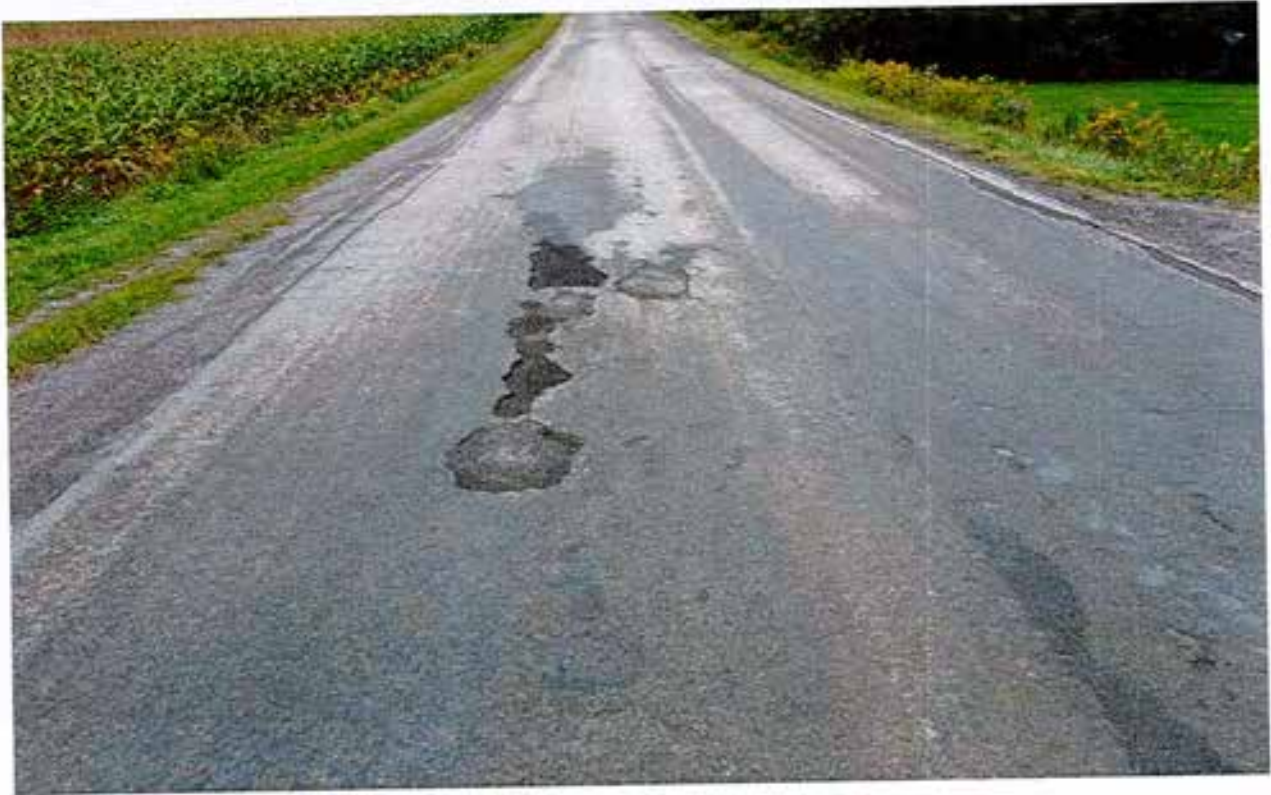
Osmun Road lane deterioration near 10674

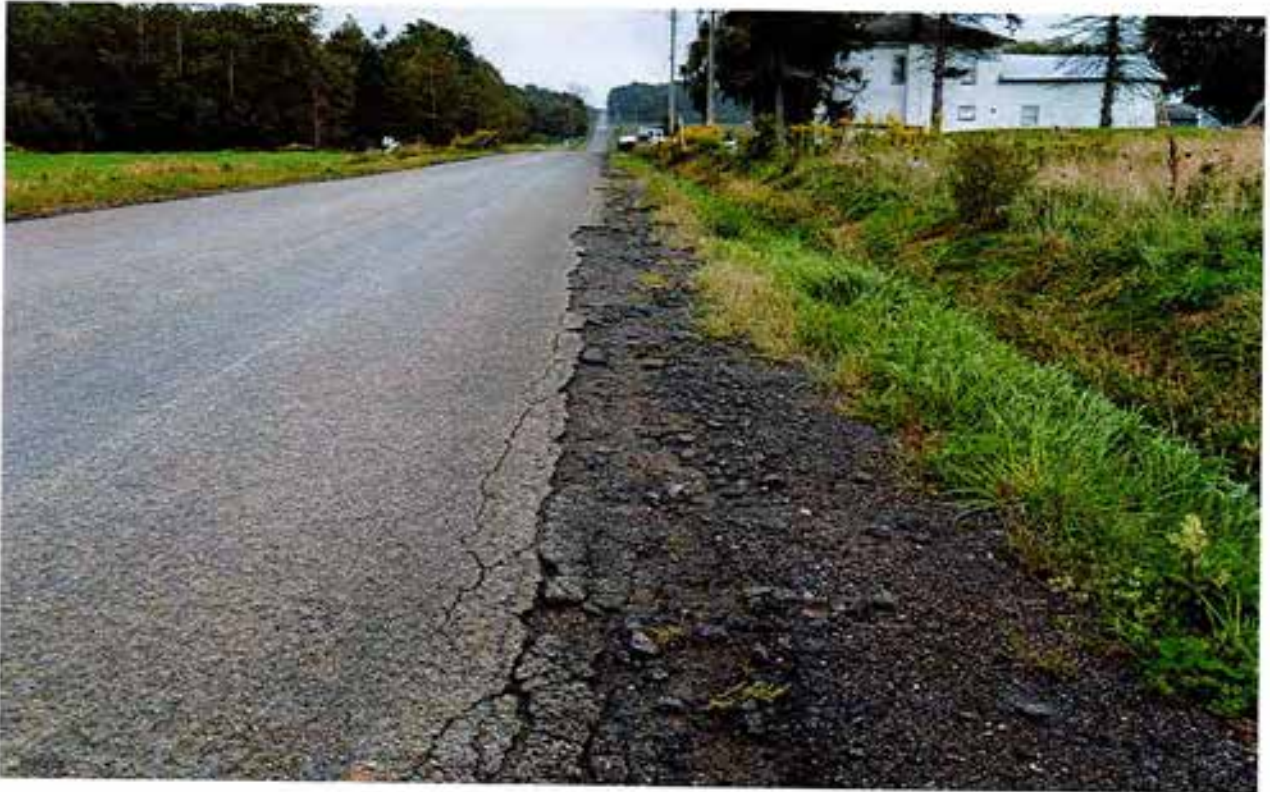
Baird Rd South shoulder deterioration East and West of 379

| Maintenance Needed: | - Repair shoulder |

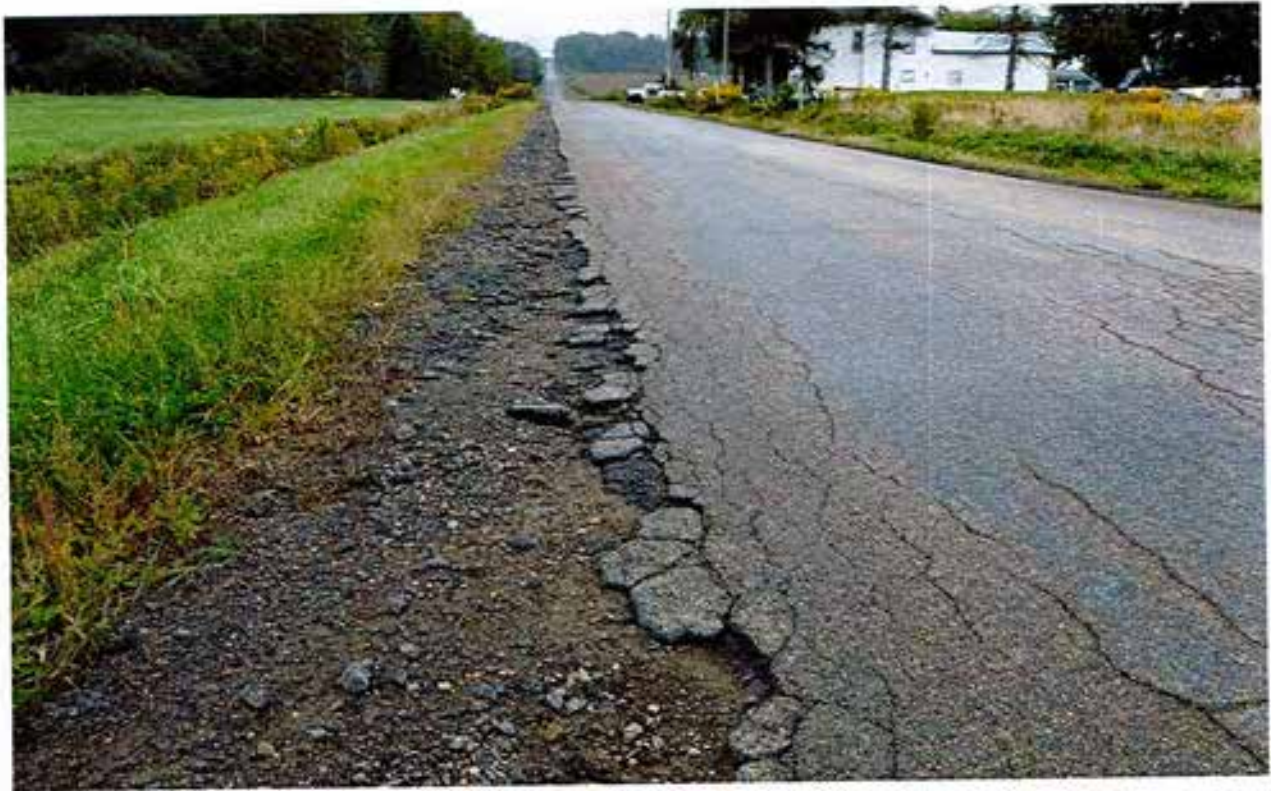
Baird Rd North shoulder deterioration East and West of 379

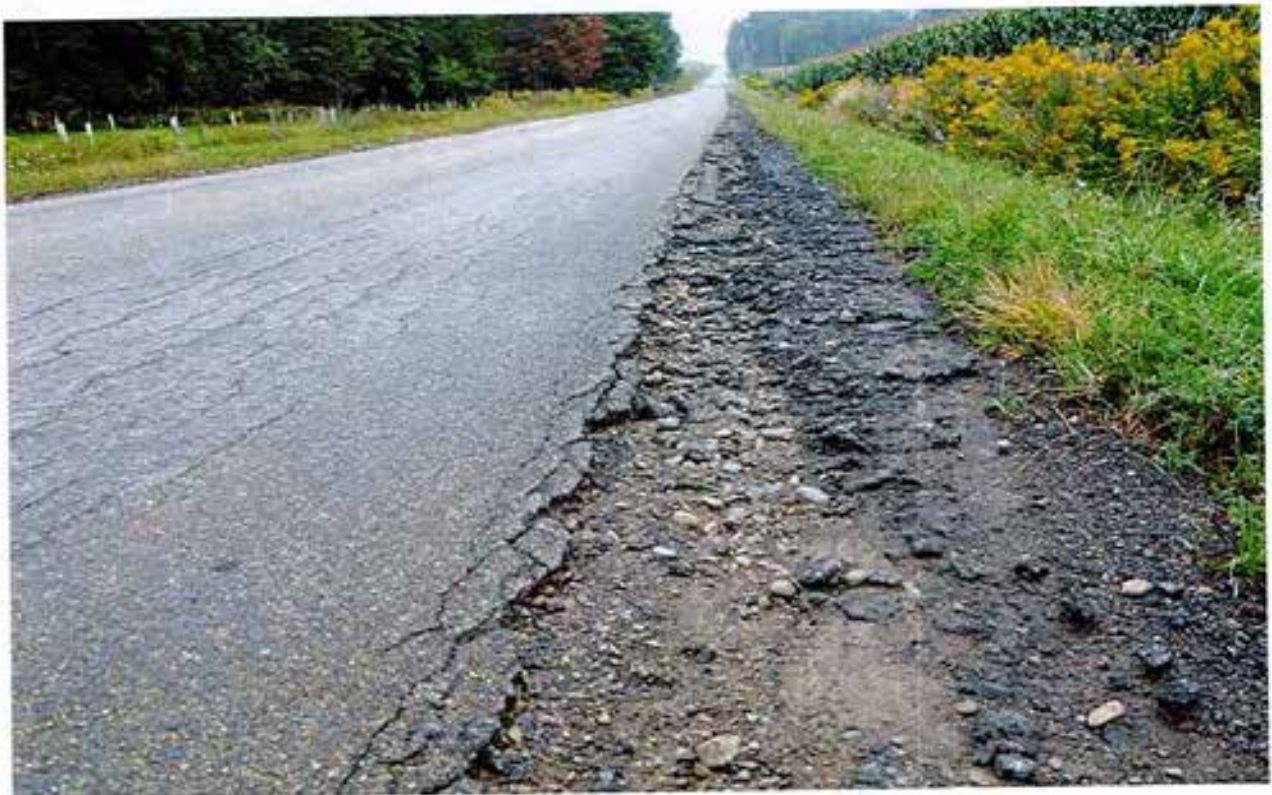
Baird Road South edge deterioration from +/- 379 to +/- 253

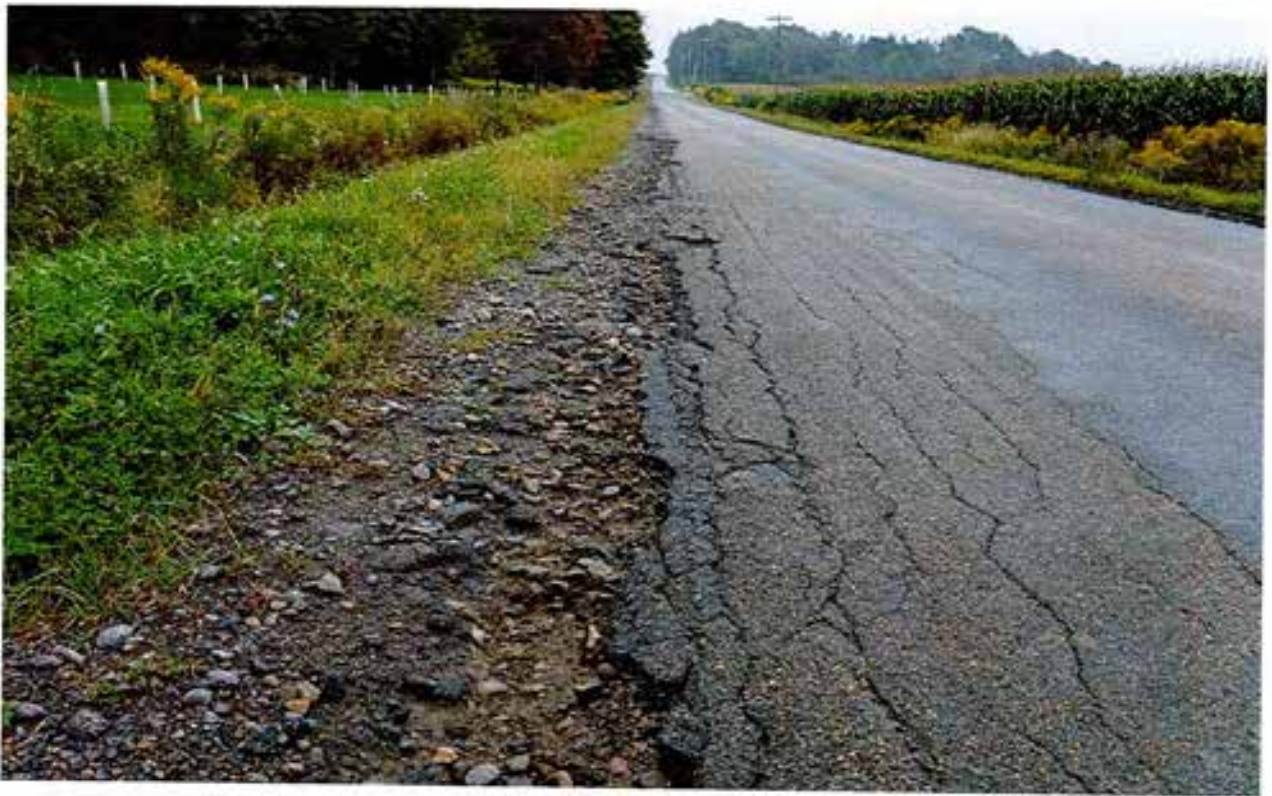
Baird Road North edge deterioration from +/- 379 to +/- 253
