## Road Condition & Vehicle Compliance Report

| Report # | 58 |
| Project Name | Alle-Catt Wind |
| Location | Town of Freedom |

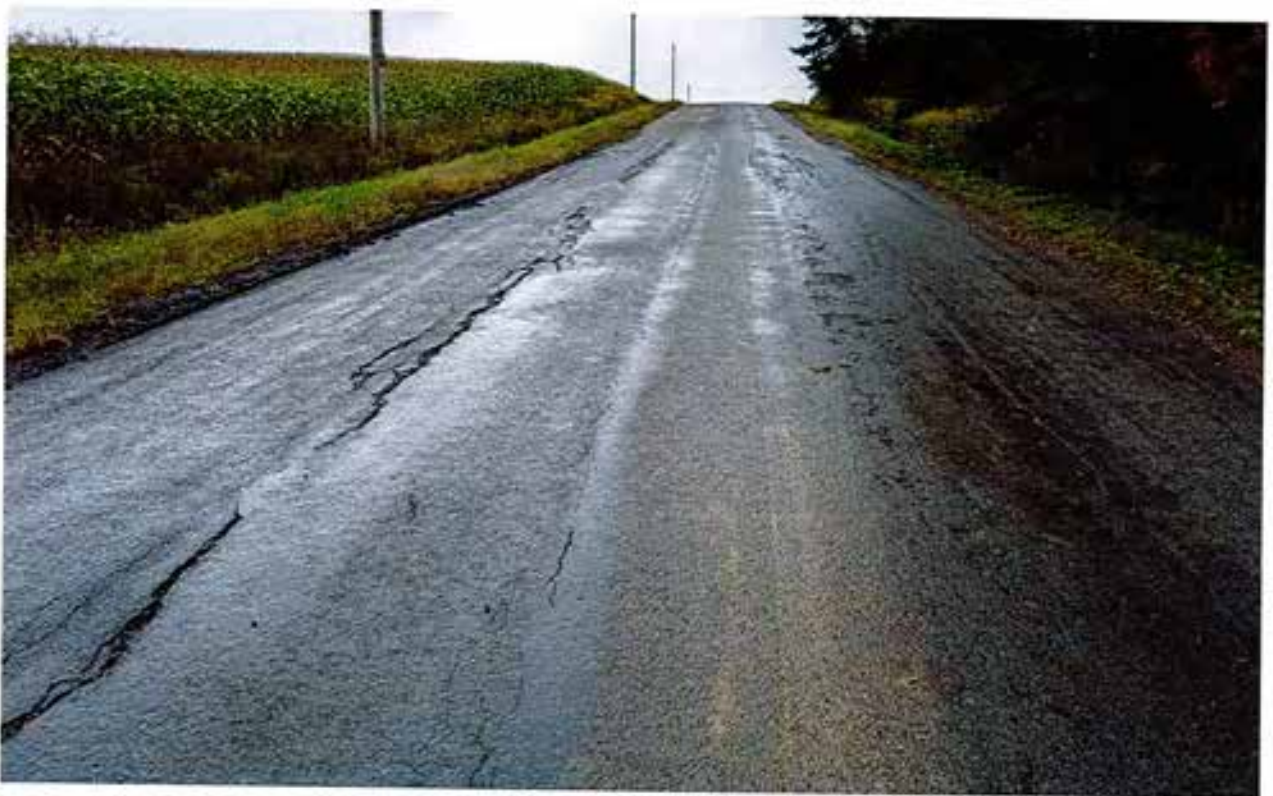
Baird Road lane deterioration from 253 to 187

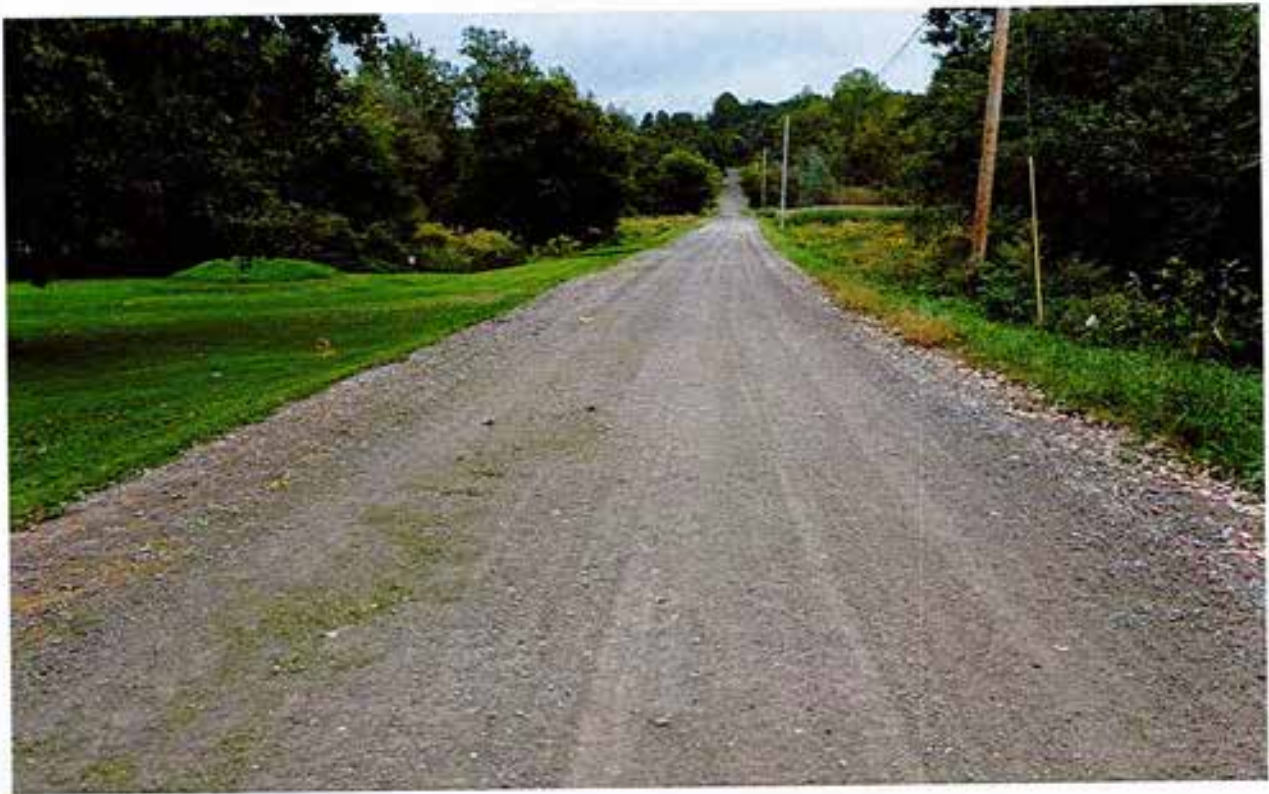
Jones Rd

| Non-Hazard Items for Continued Observation: | - Jones Rd. should be paved from Route 98 to the bridge, see this page for photo. |

| Maintenance Needed: | - Repair this spring. |
