## Road Condition & Vehicle Compliance Report

| Report # | 59 |
| Project Name | Alle-Catt Wind |
| Location | Town of Freedom |

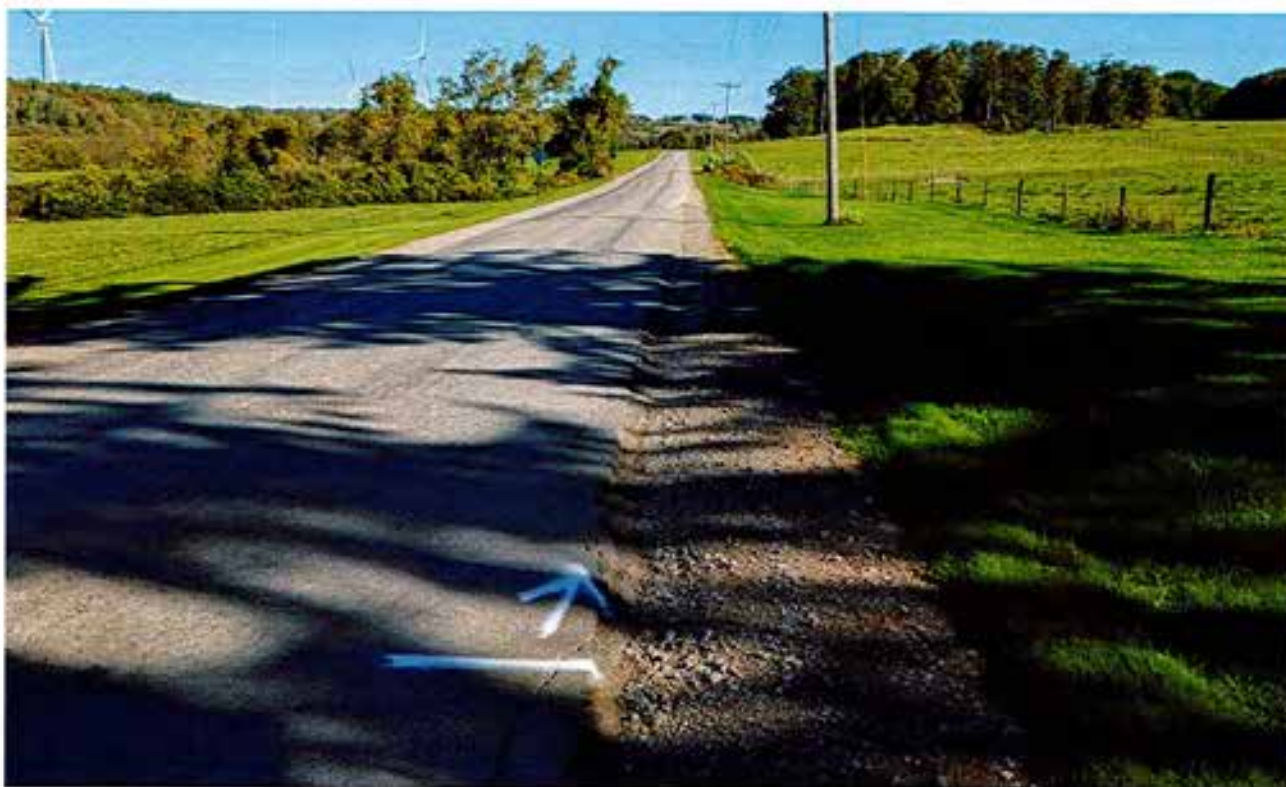
East edge of North Road

| Maintenance Needed: | <ul style="list-style-type: none"> <li>- Apply QPR to significant potholes</li> <li>- Repair shoulders</li> </ul> |

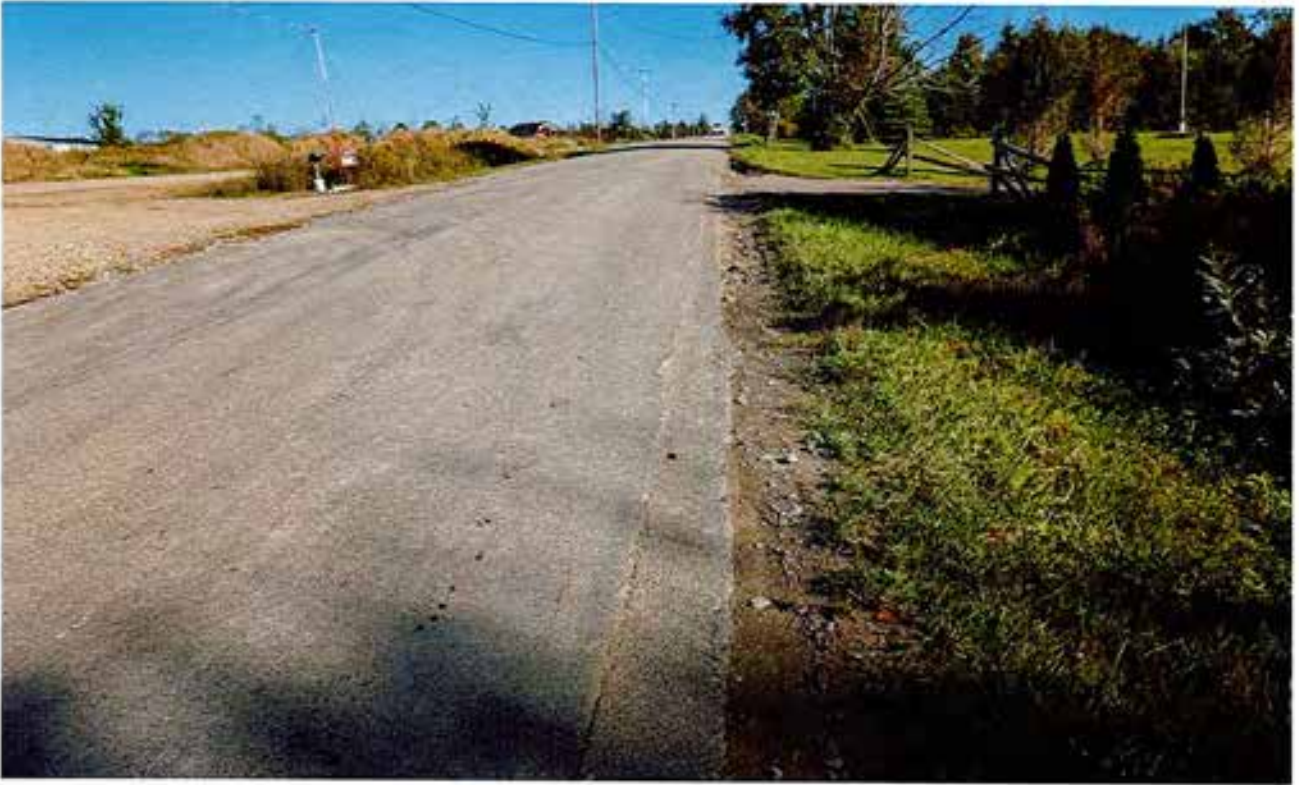
North Road North edge and shoulder deterioration near 11614

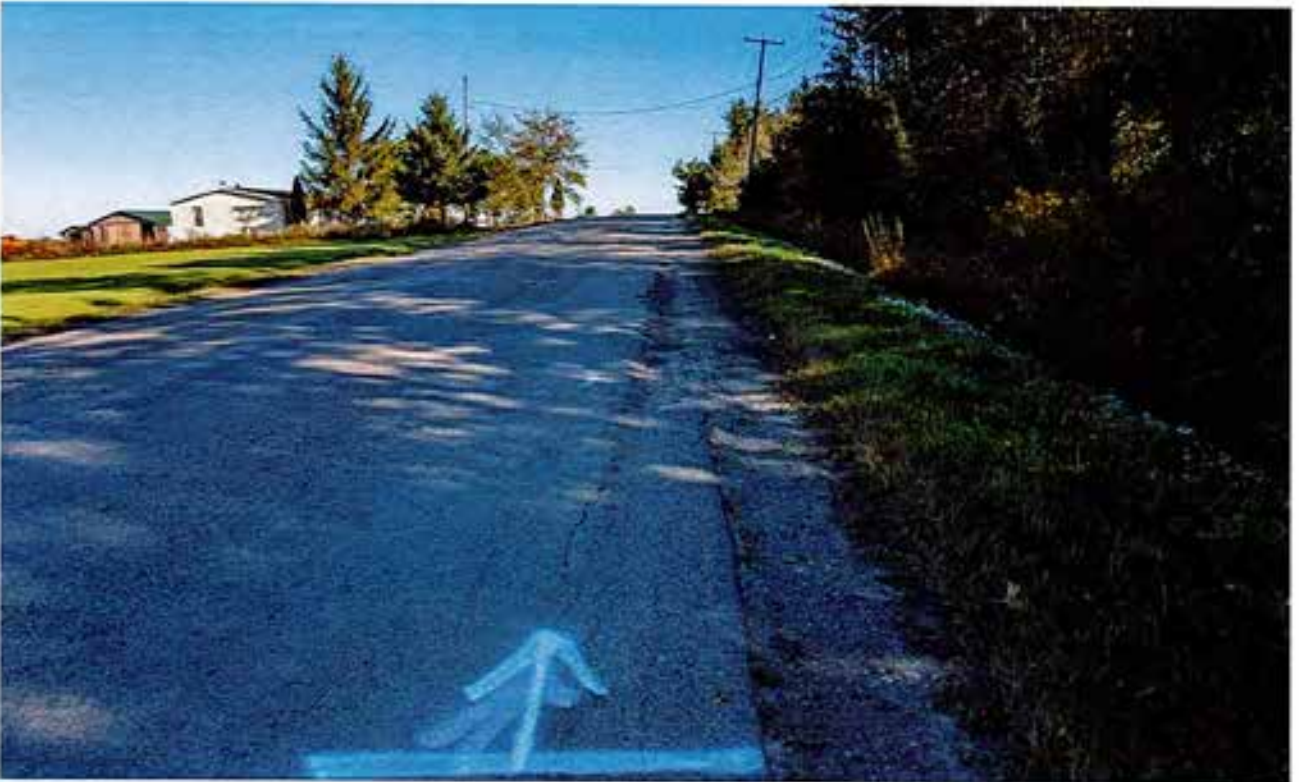
North Road lane and edge deteriorating with South of 11875

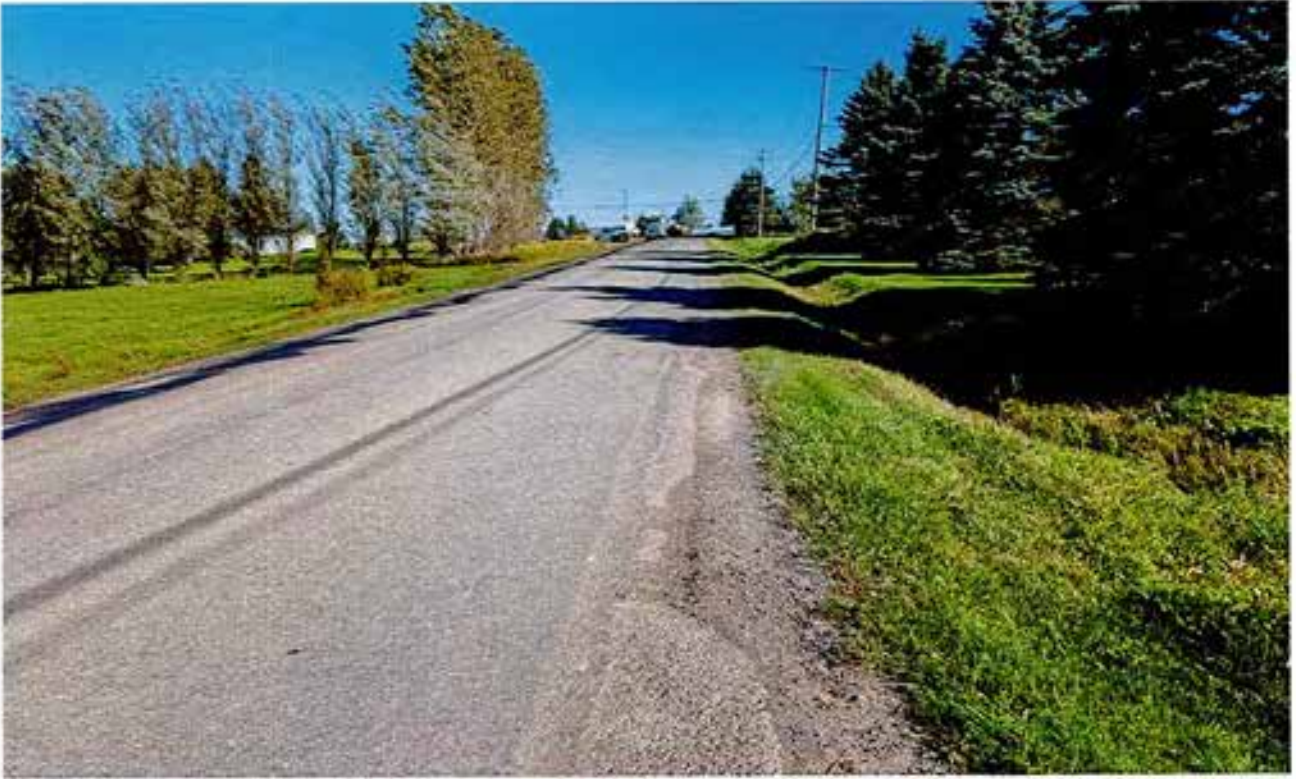
North Road lane, edge, and shoulder deterioration near 11980

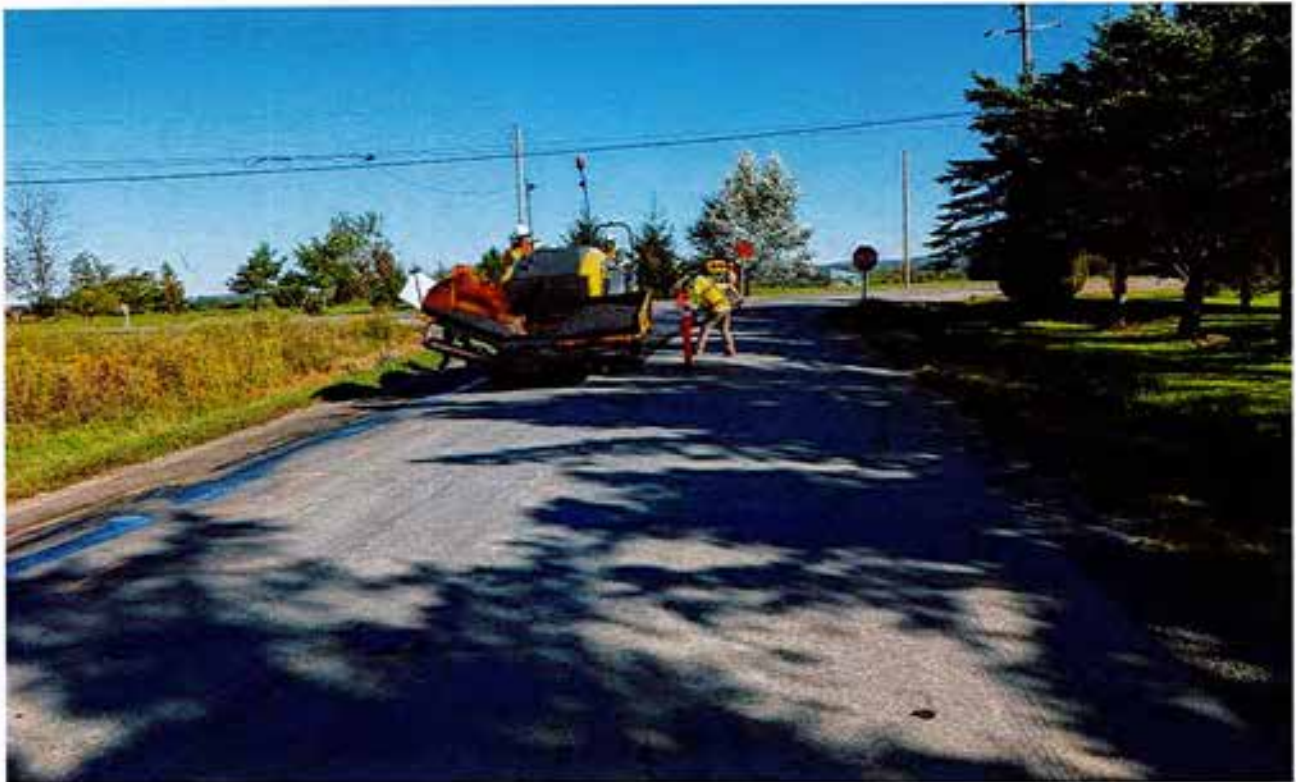
Lane deterioration North Rd near intersection with Bray Rd (REPAIRS IN PROGRESS)

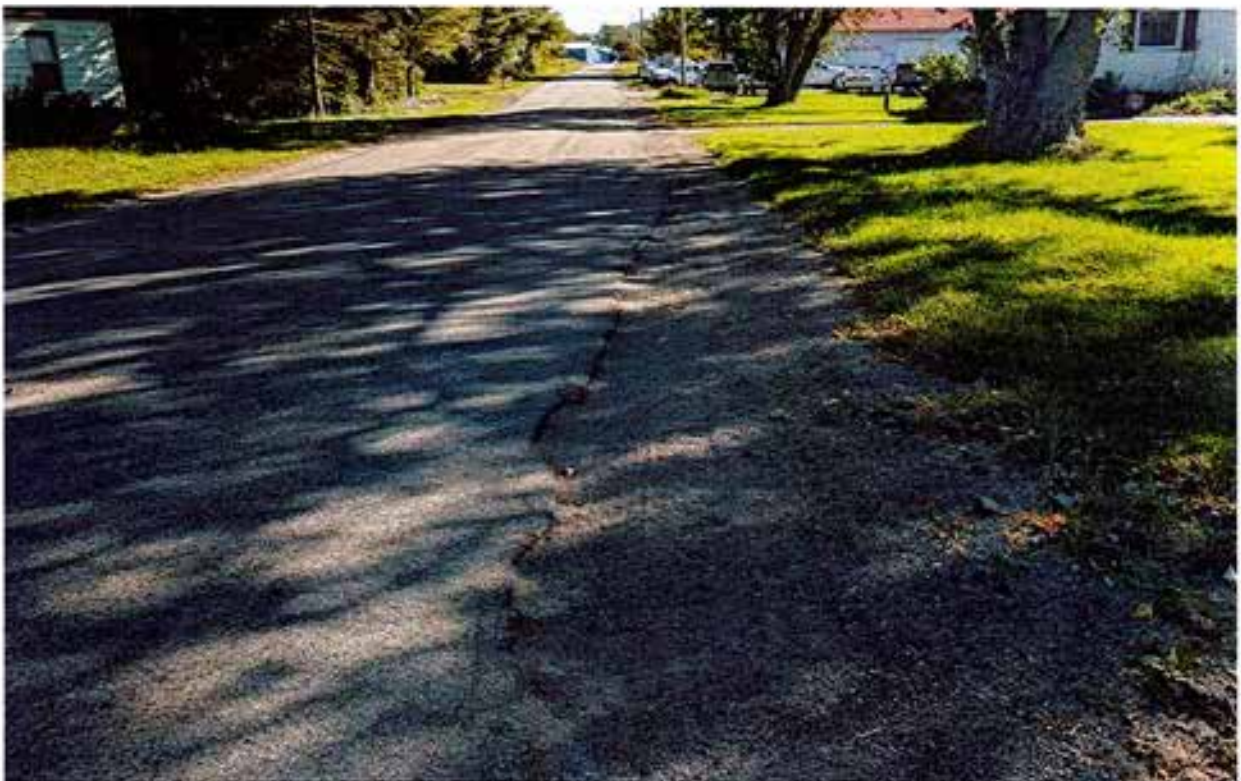
Eagle Street lane and edge deterioration near 1253

| Maintenance Needed: | <ul style="list-style-type: none"> <li>- Repair lanes and shoulders.</li> </ul> |

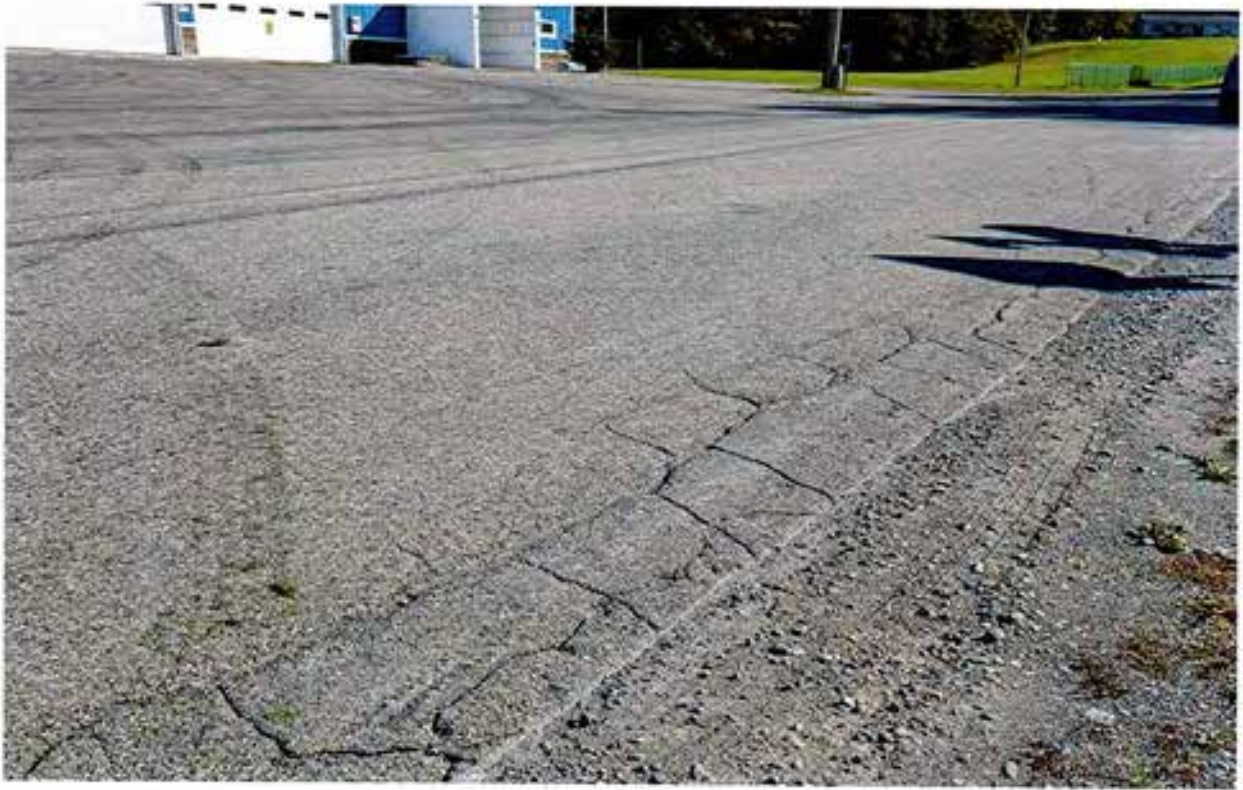
Eagle Street South side lane and edge deterioration near 11405

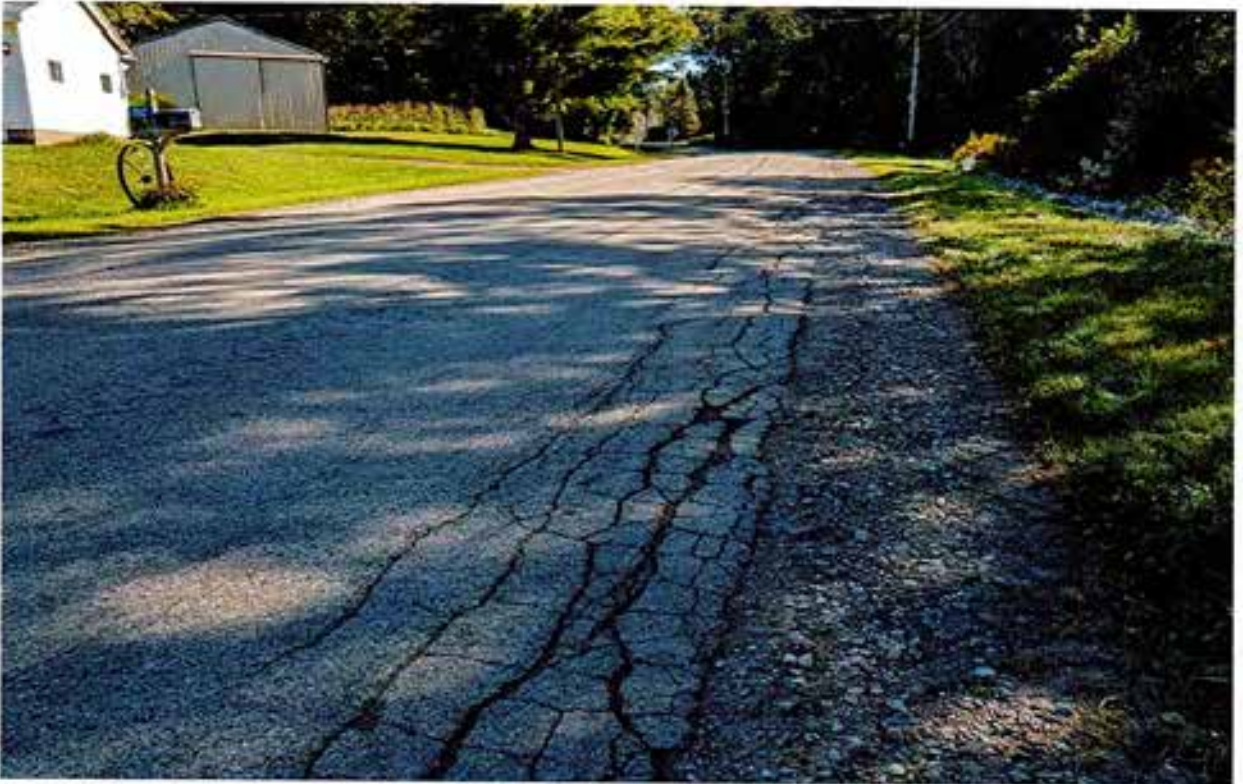
Eagle Street lane and edge deterioration near 1152

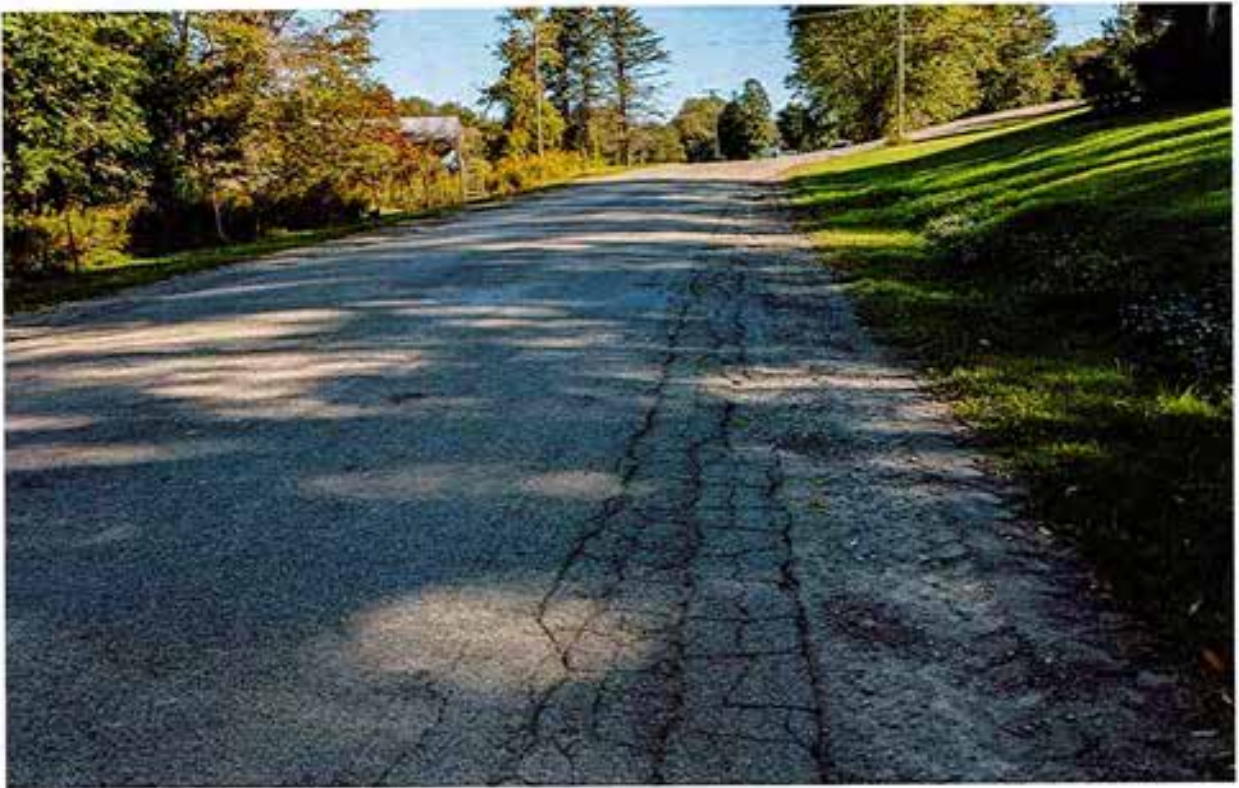
Eagle Street East edge deterioration near Hughes

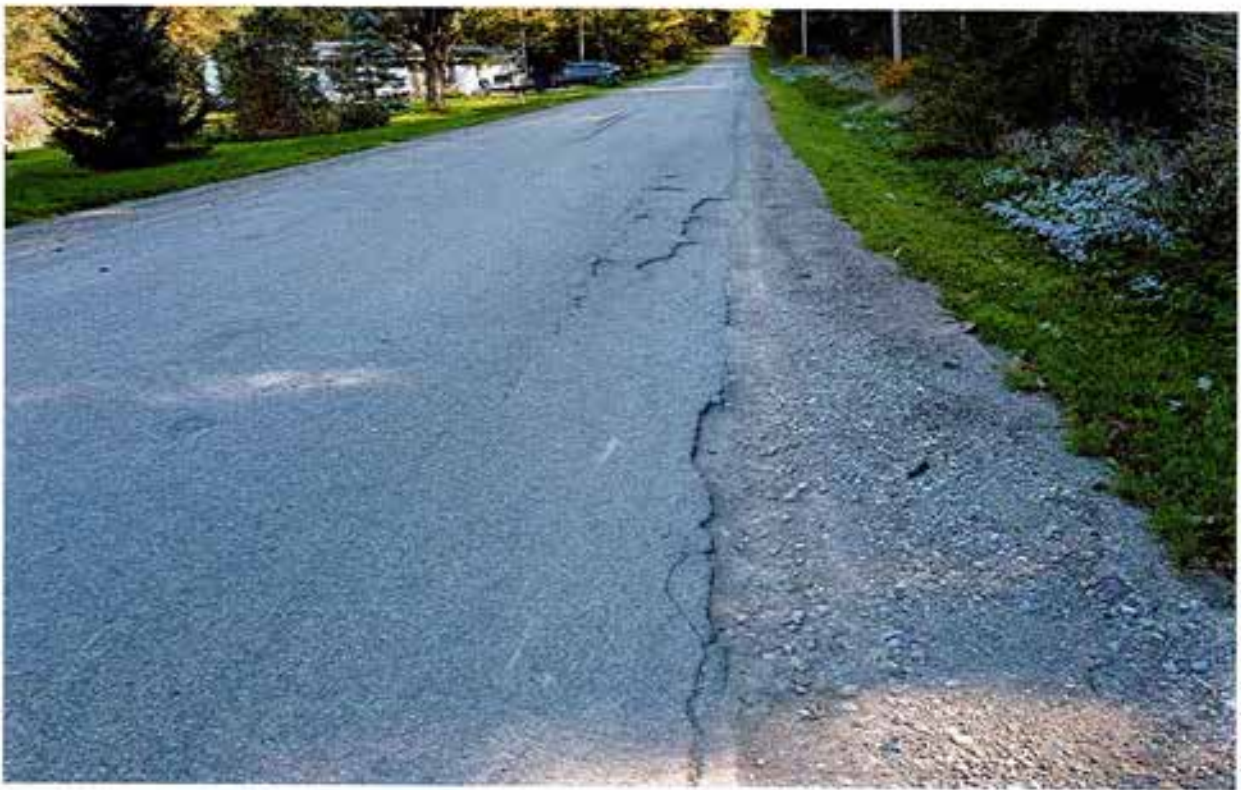
Eagle Street lane and East edge deterioration near 994

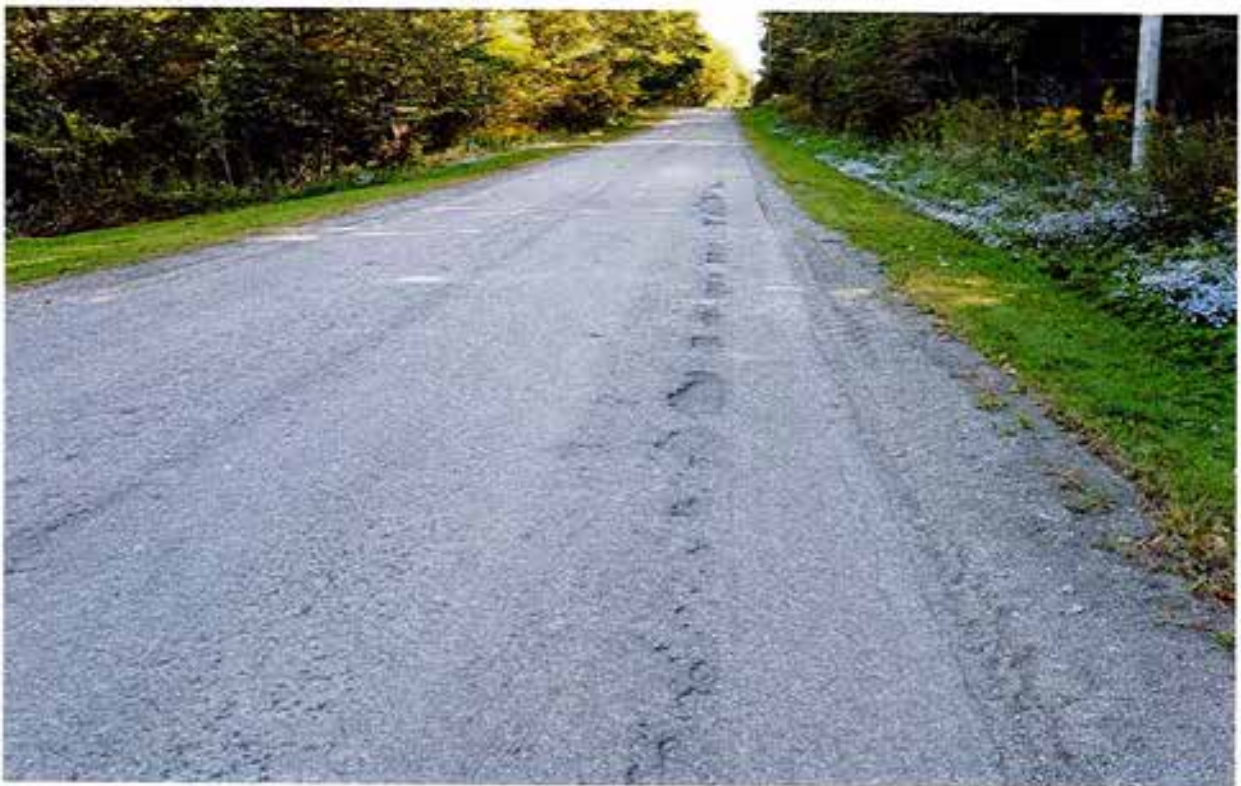
Eagle Street lane deterioration near 1000

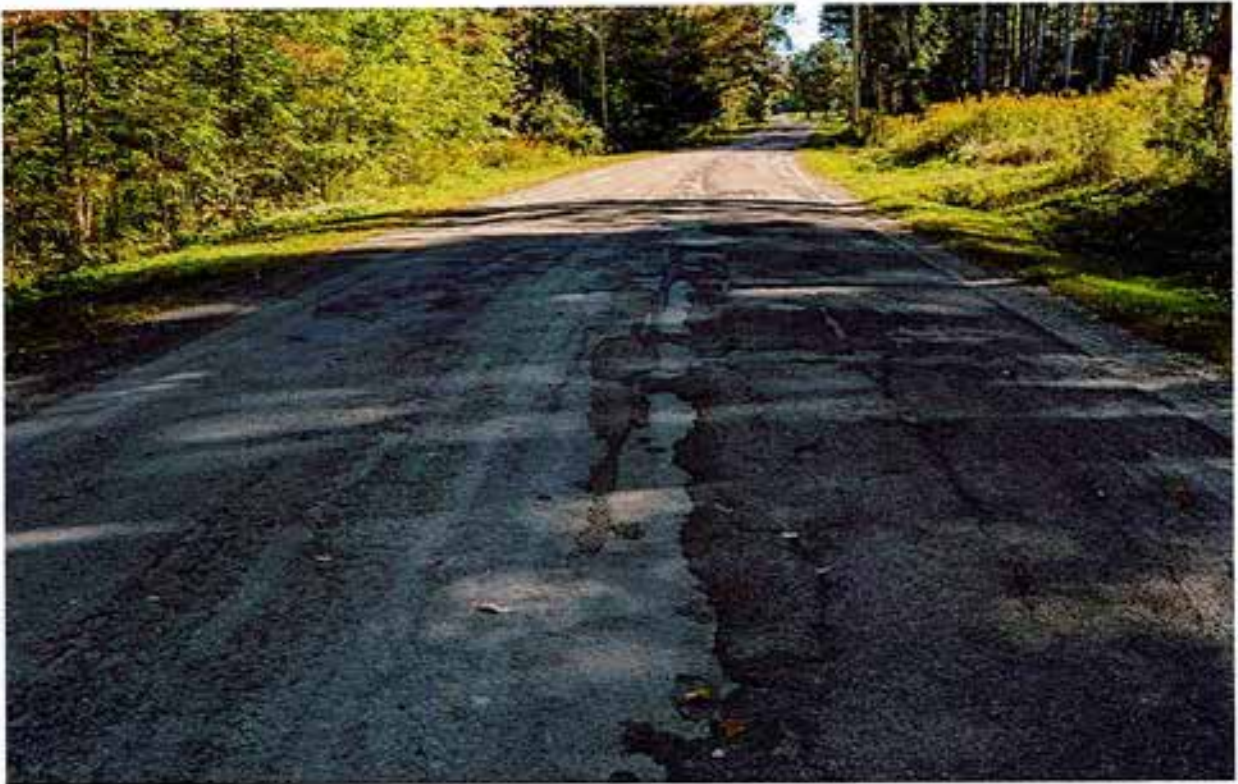
Eagle Street lane deterioration near 915

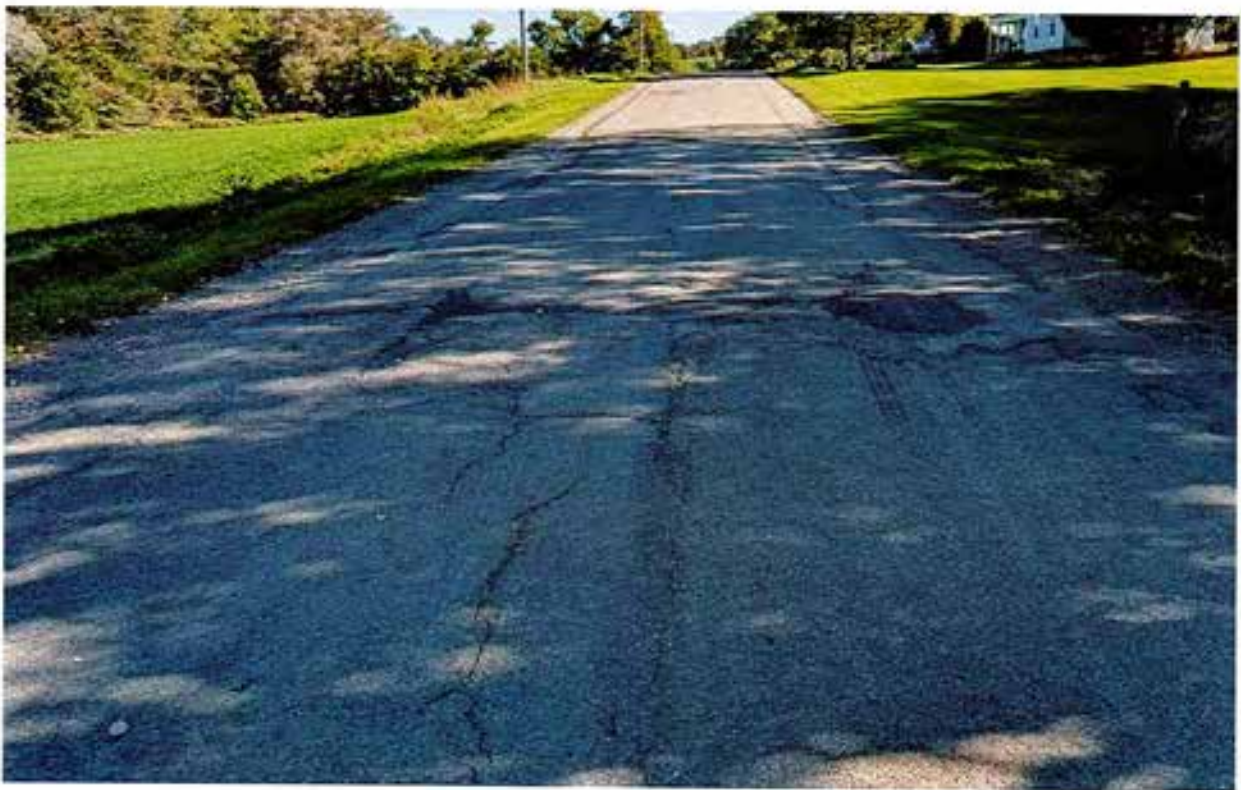
Eagle Street lane deterioration South of 849

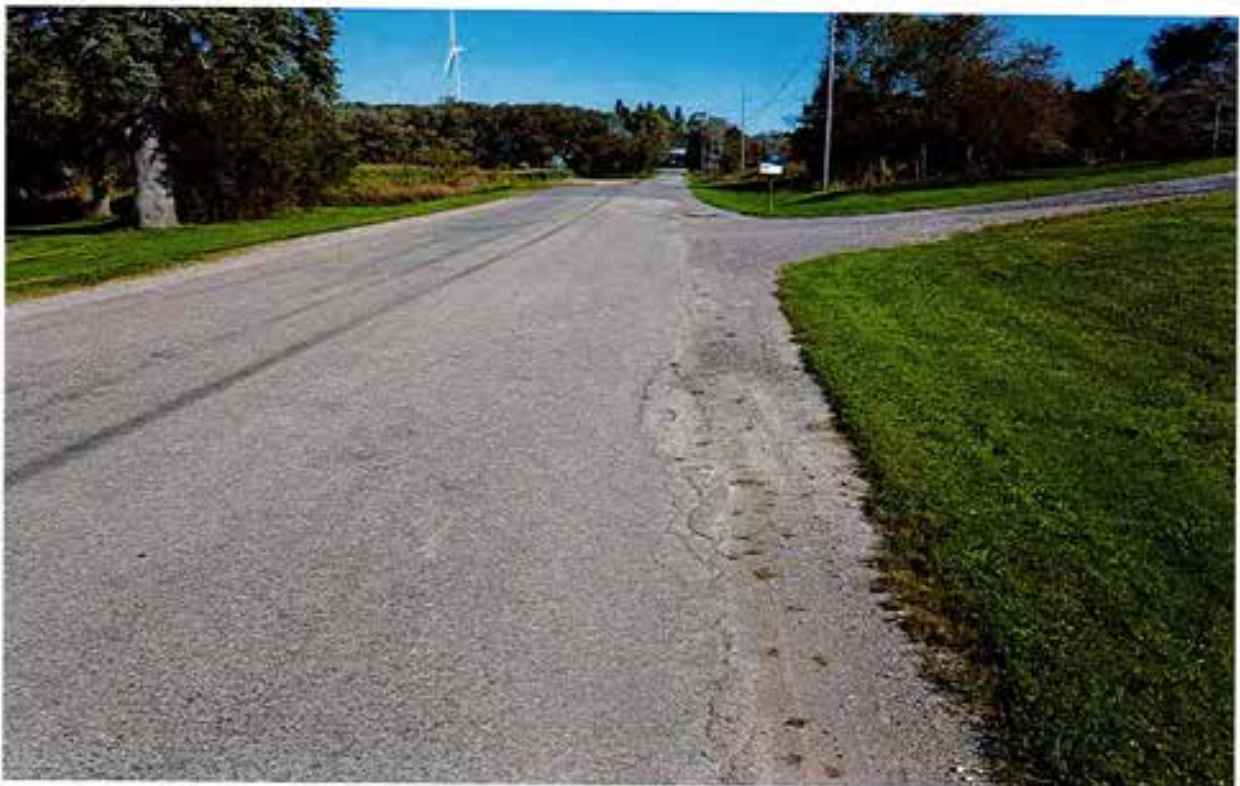
Eagle Street East edge and shoulder deterioration near 757

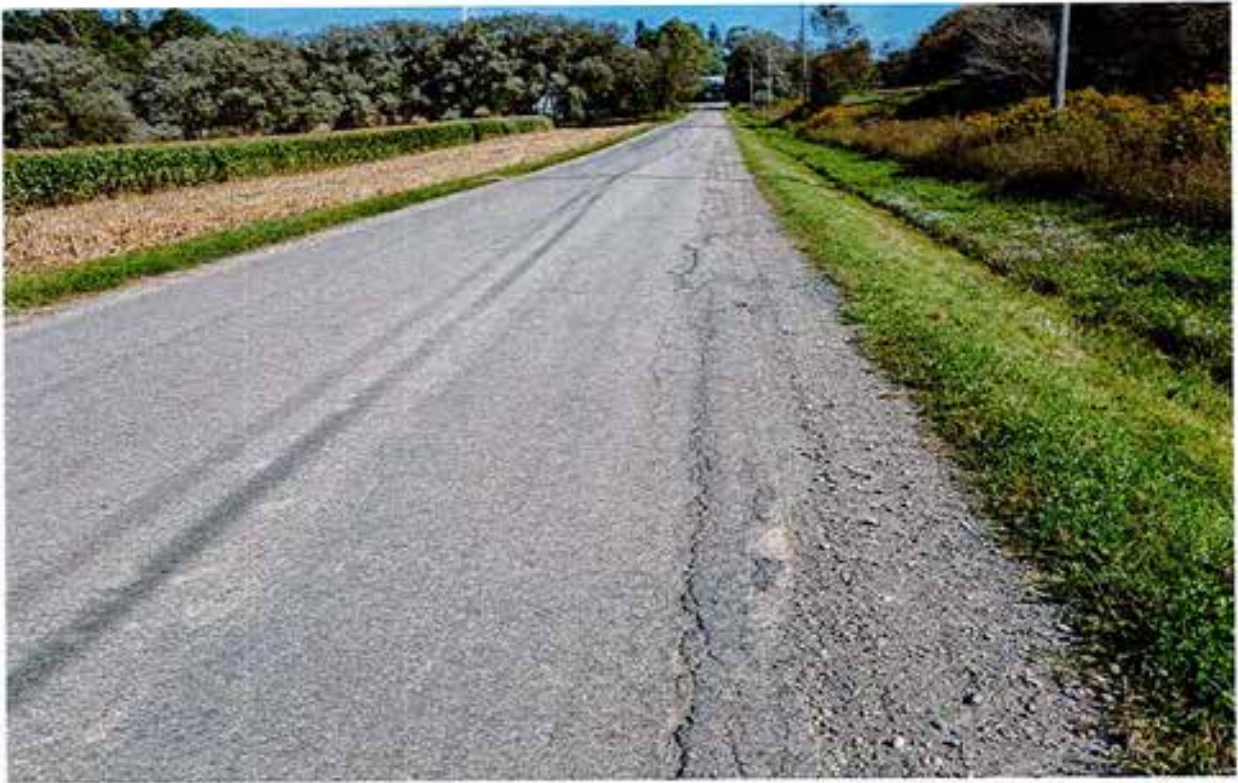
Eagle Street lane and edge deterioration North of 757

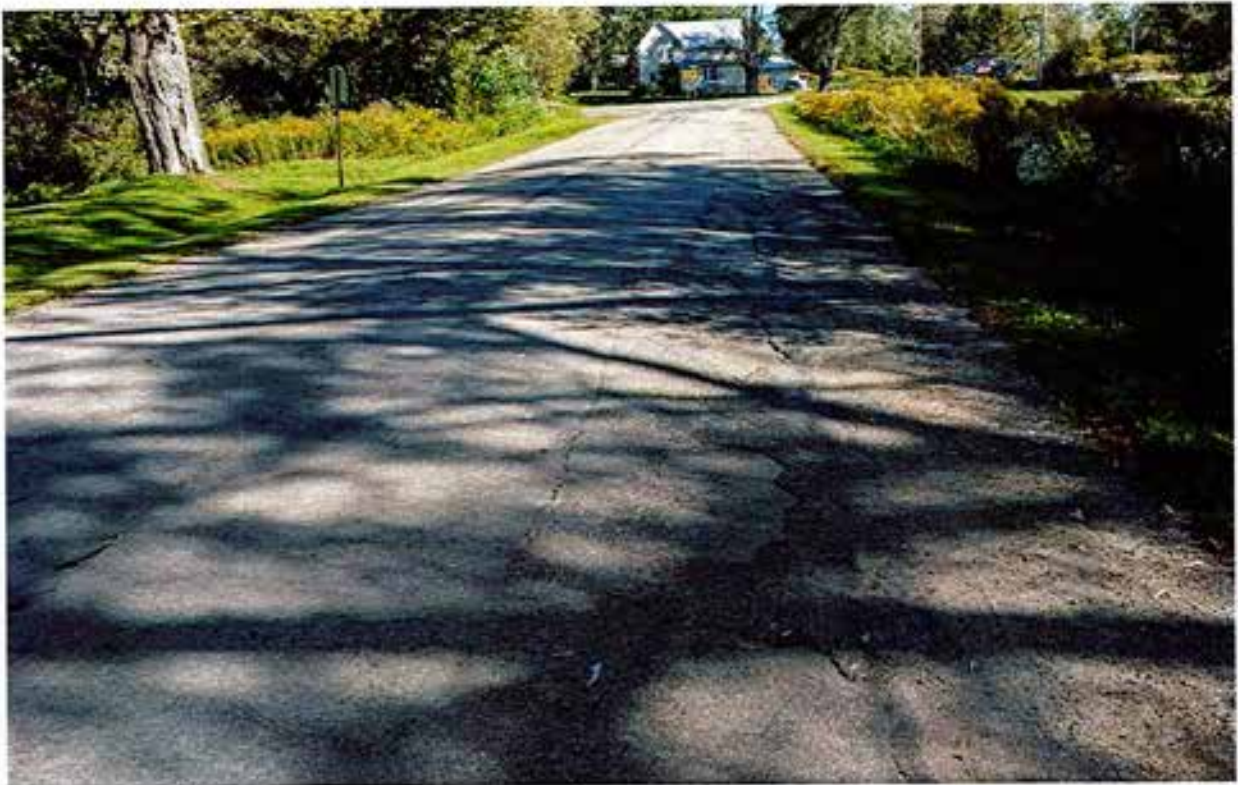
Eagle Street East lane deterioration near 708

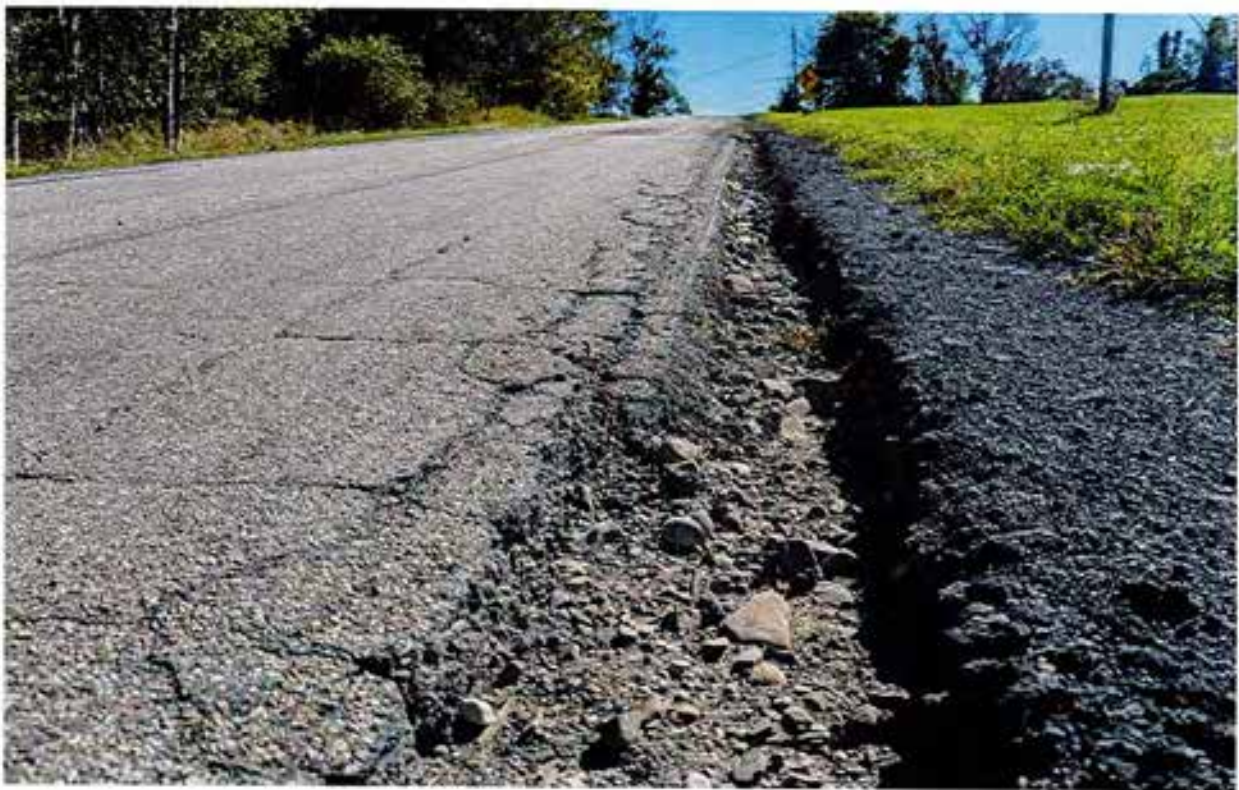
Hughes Road edge and shoulder deterioration on North and South sides East of 951

| Maintenance Needed: | - Repair shoulder |

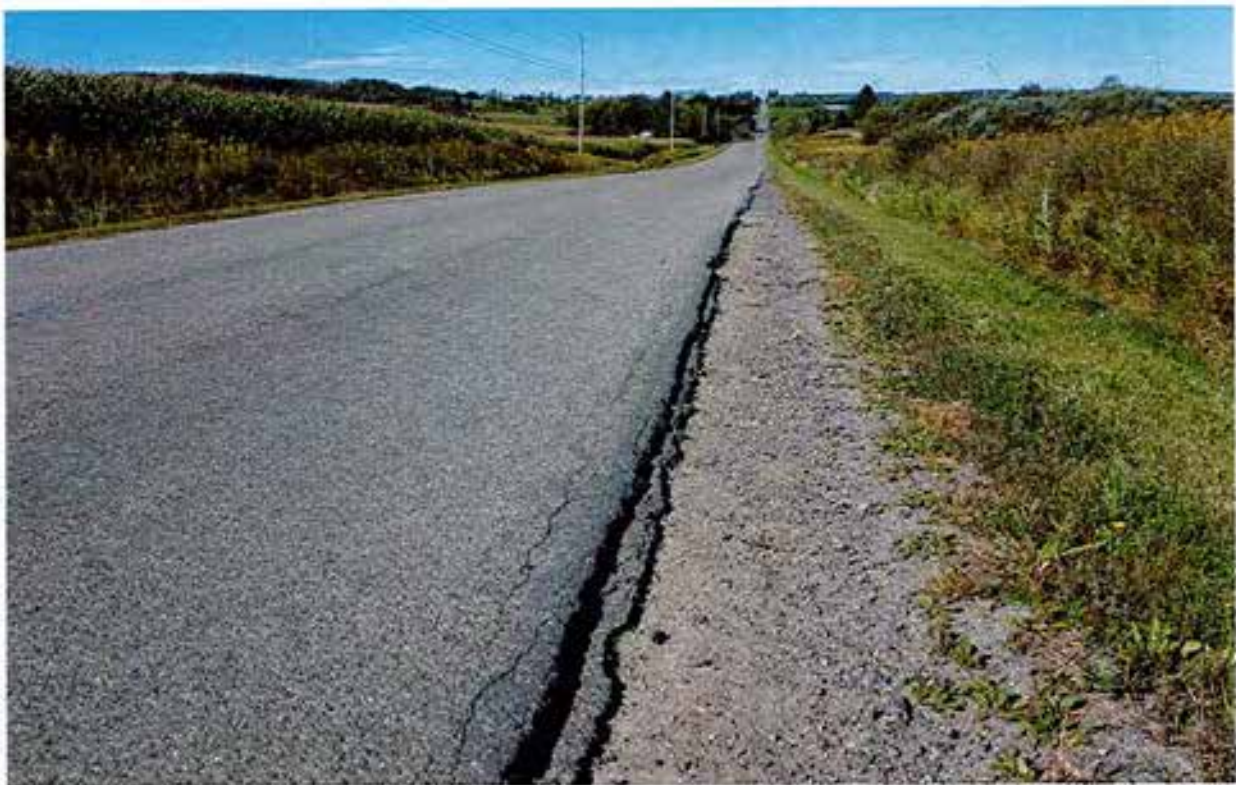
Bray Road North edge and shoulder deteriorating from gas pipeline #57 to +/- House 113

| Maintenance Needed: | <ul style="list-style-type: none"> <li>- Repairs should be made for lane and shoulder deterioration.</li> </ul> |

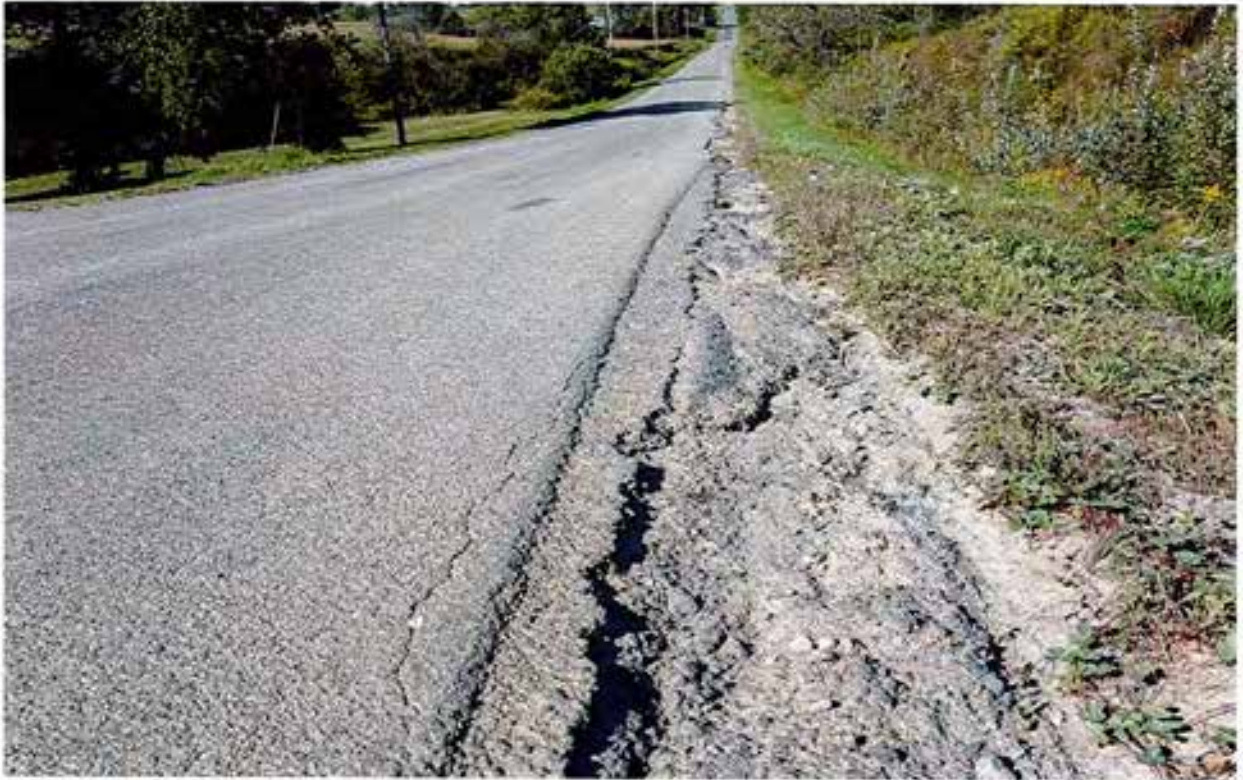
Bray Road North edge and shoulder deteriorating from +/-113 to +/-2473

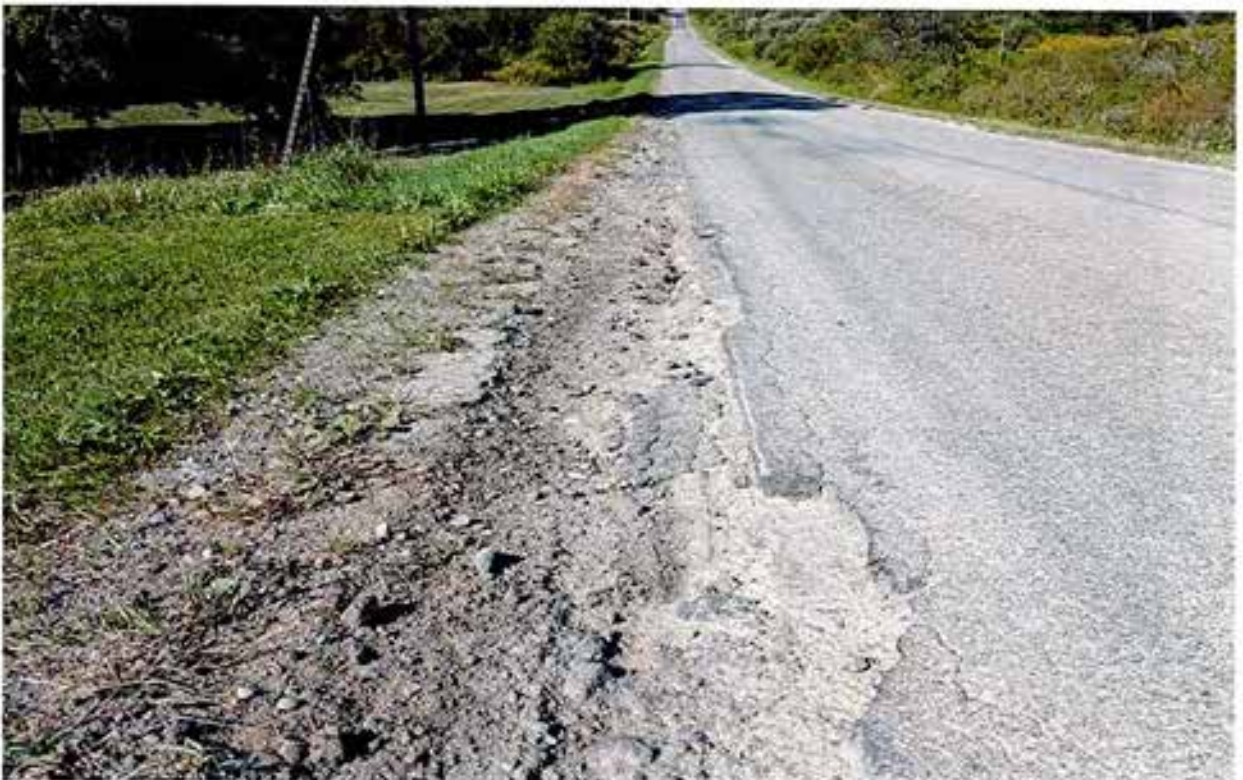
Bray Road South edge and shoulder West of 113

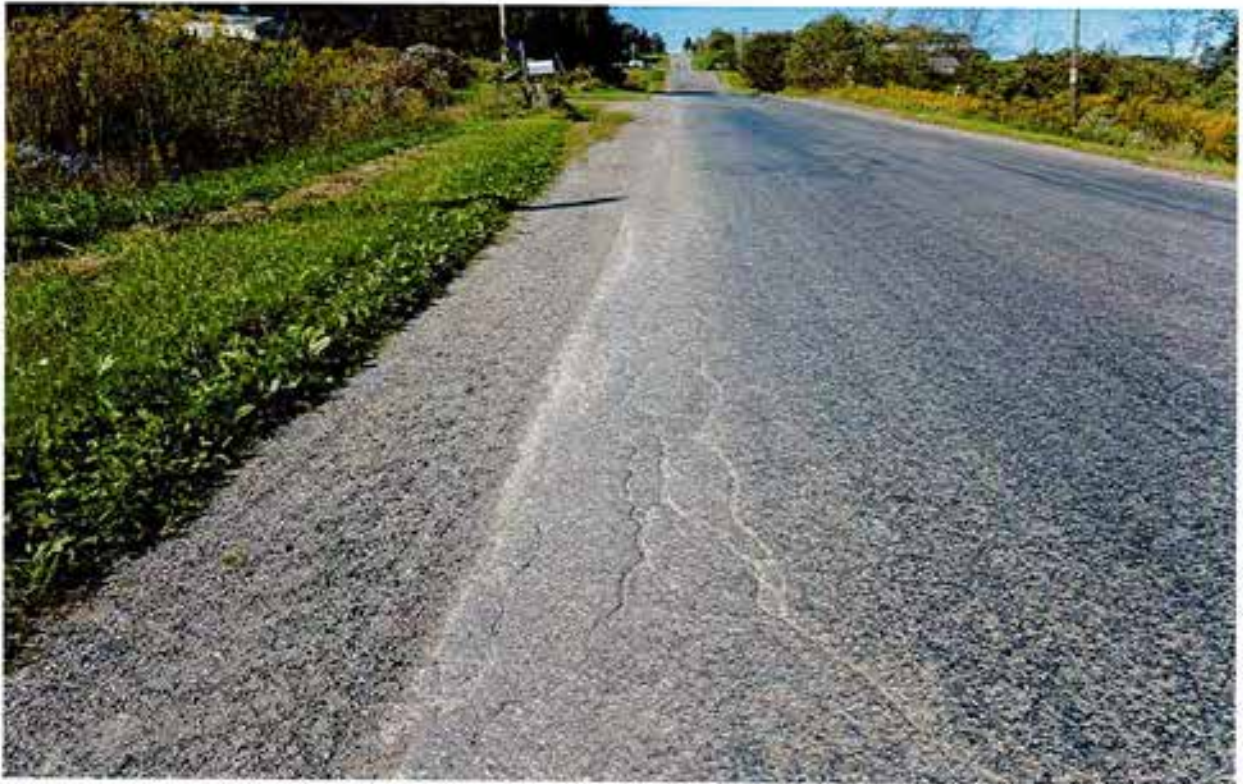
Bray Road South edge and shoulder deteriorating near 223

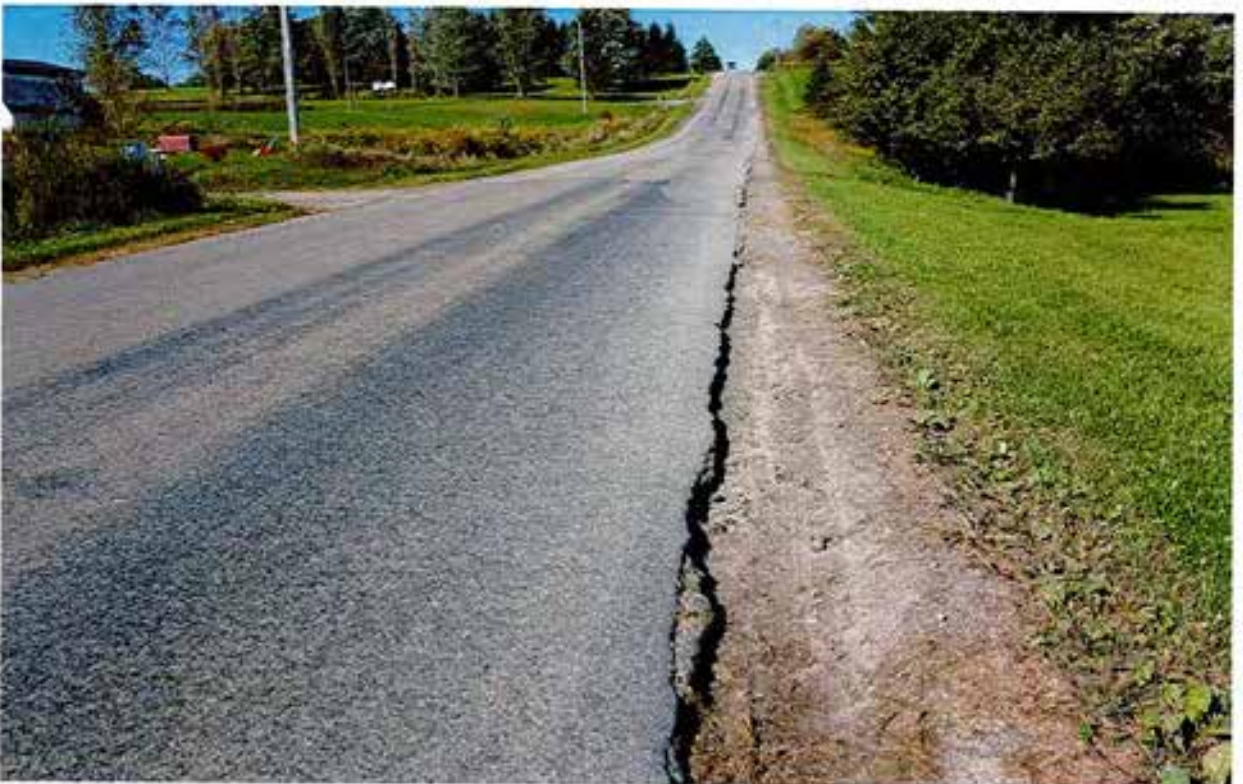
Bray Road North edge and shoulder deteriorating near 245

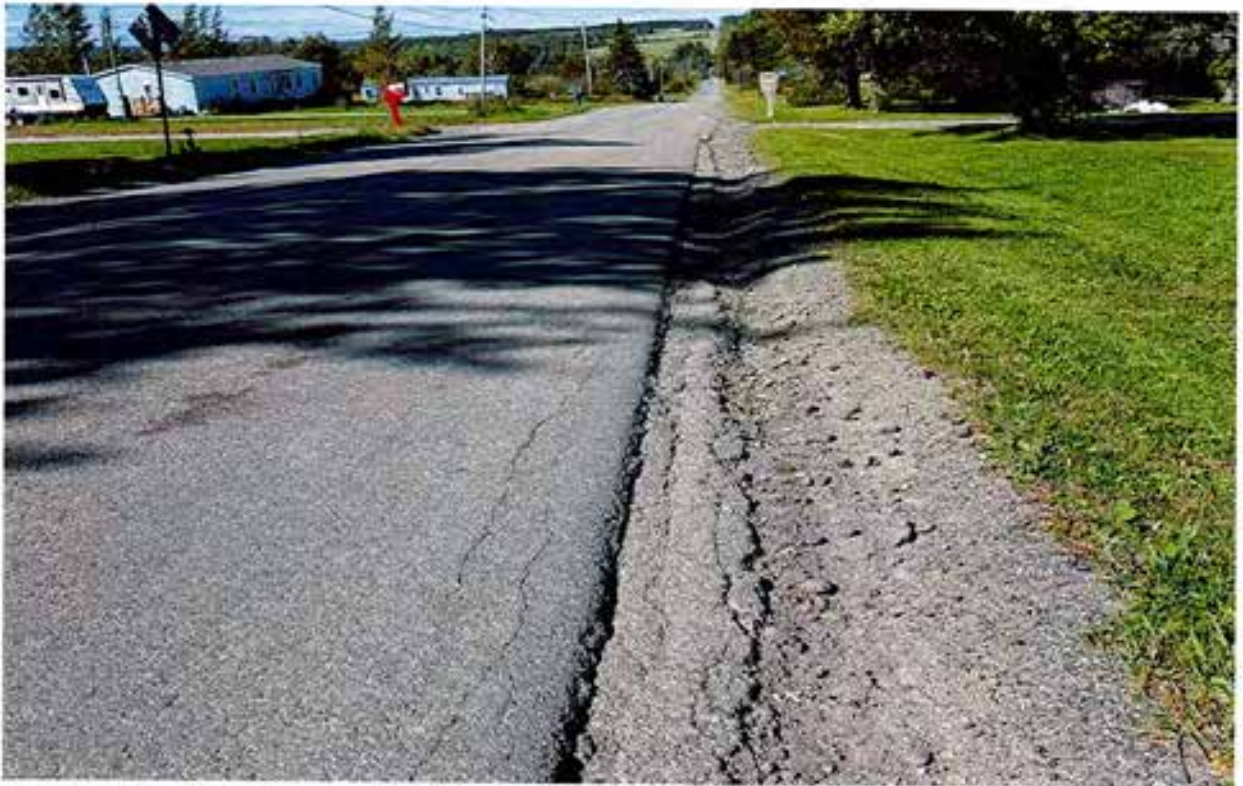
Bray Road North edge and shoulder deteriorating near 2231
