## Road Condition & Vehicle Compliance Report

| Report # | 59 |
| Project Name | Alle-Catt Wind |
| Location | Town of Freedom |

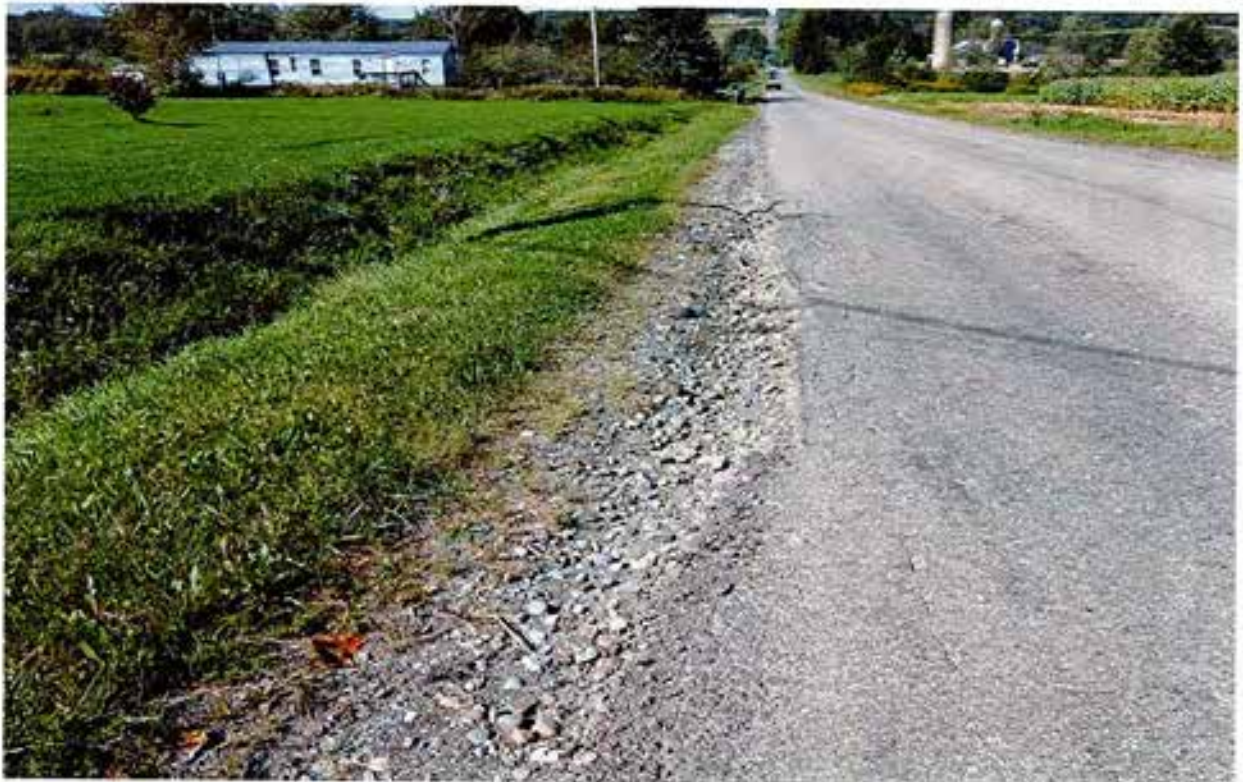
Bray Road South edge and shoulder deteriorating near 409

| Maintenance Needed: | <ul style="list-style-type: none"> <li>- Repairs should be made for lane and shoulder deterioration.</li> </ul> |

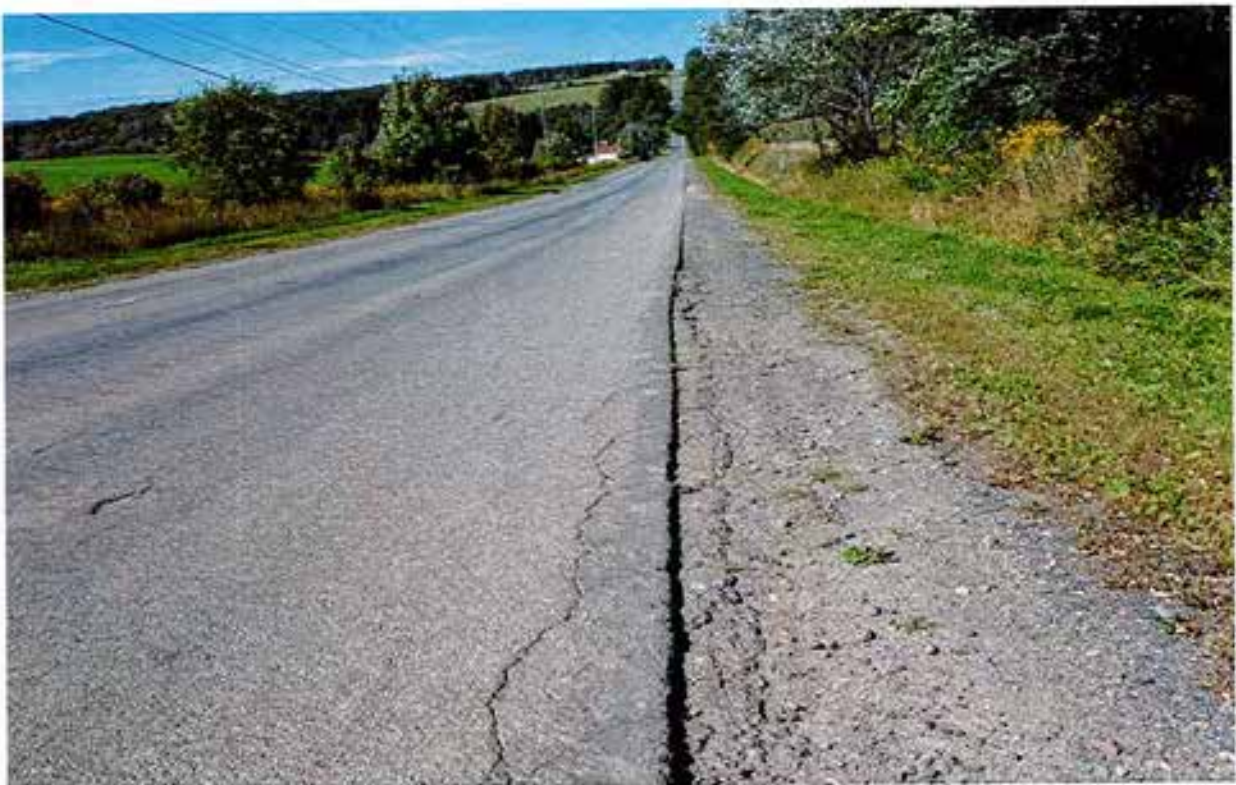
Bray Road North edge and shoulder deteriorating from 475 to Eagle Street

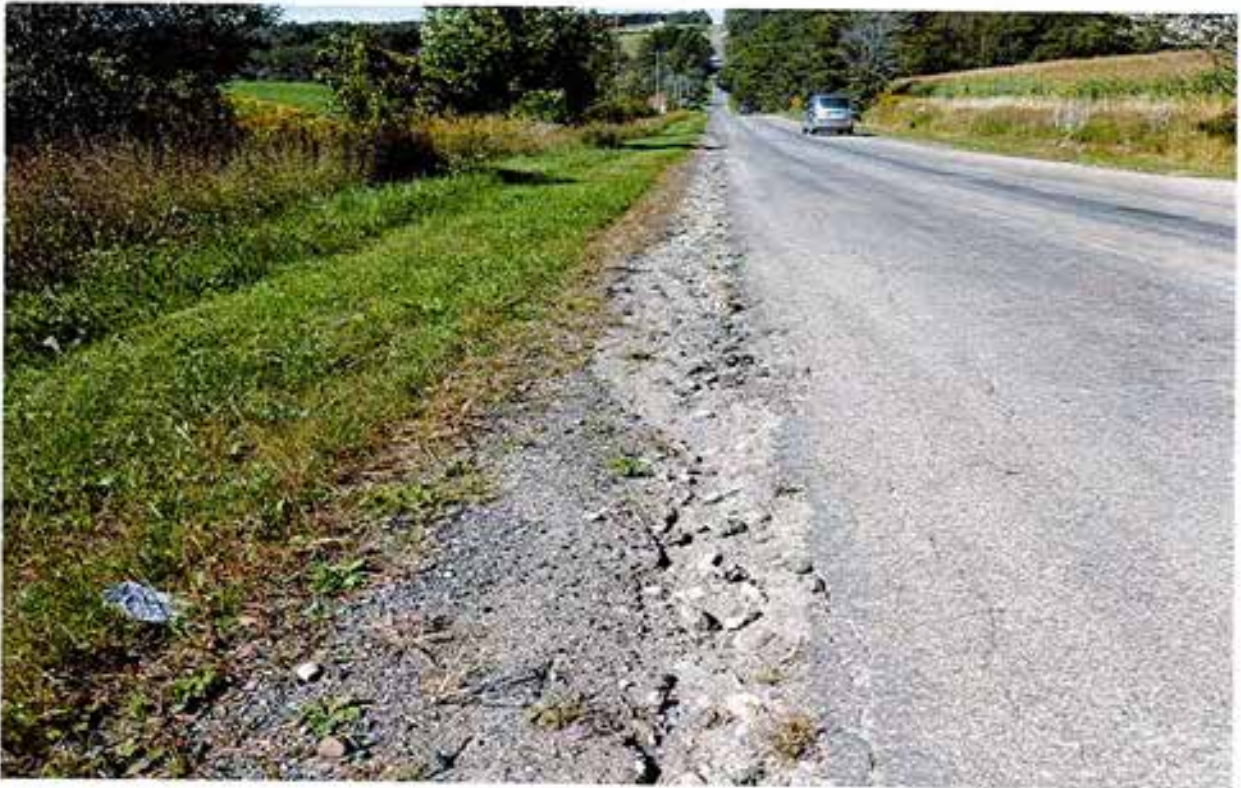
Bray Road South edge and shoulder deteriorating from 475 to Eagle Street

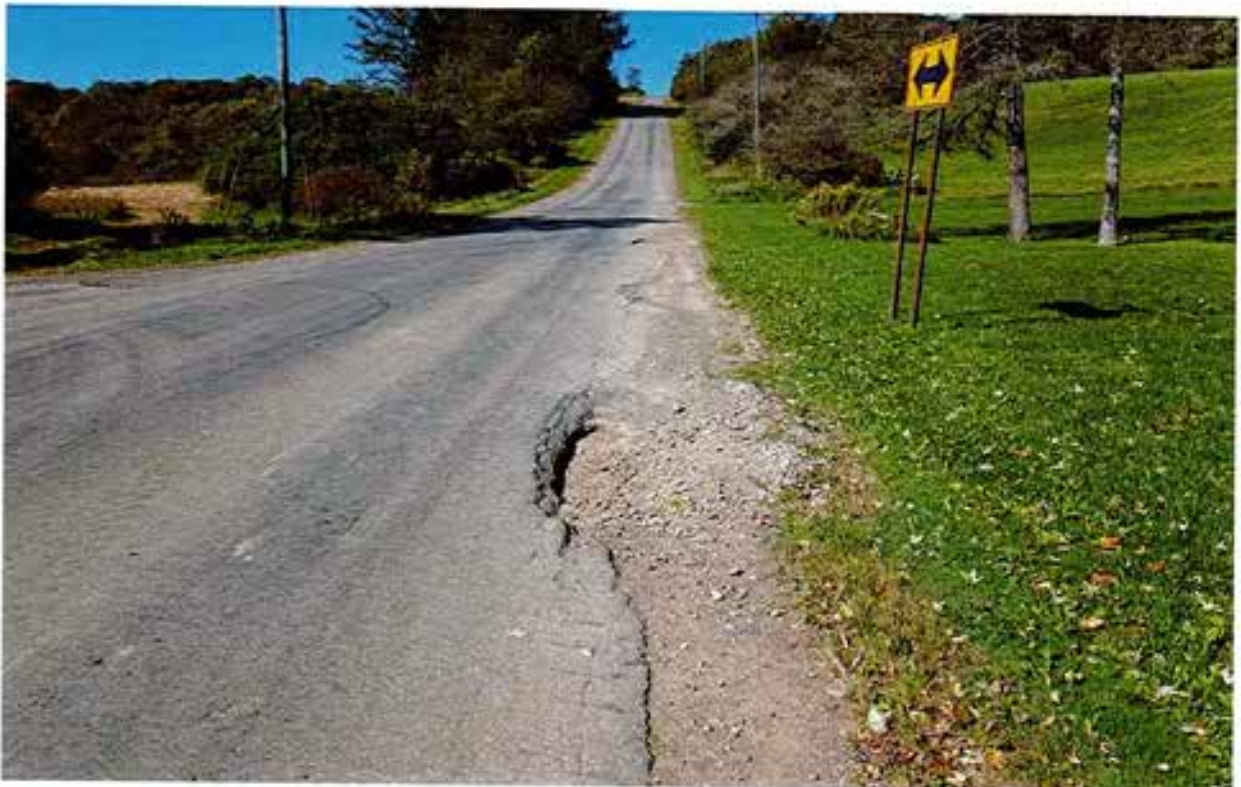
Bray Road Edge Deterioration at Eagle Street Intersection

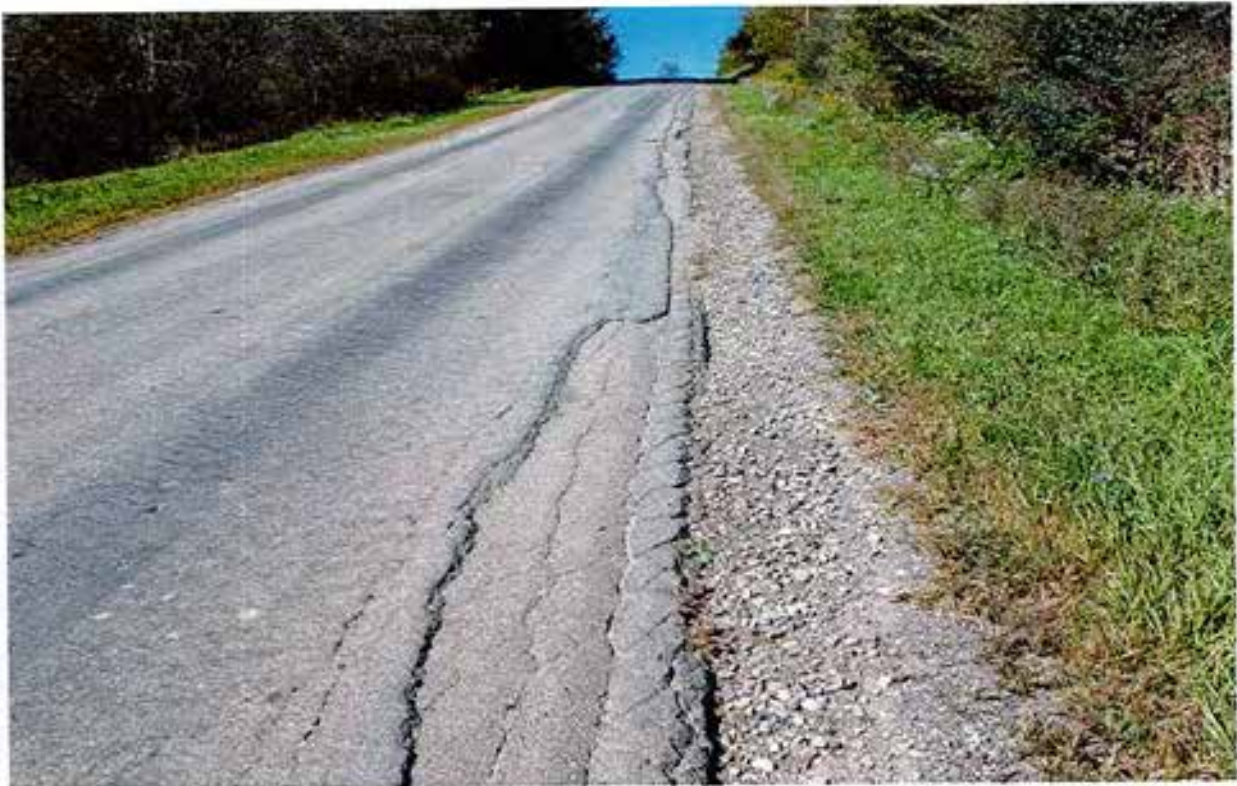
Bray Road North edge and shoulder deteriorating from Eagle Street to +/- 2801

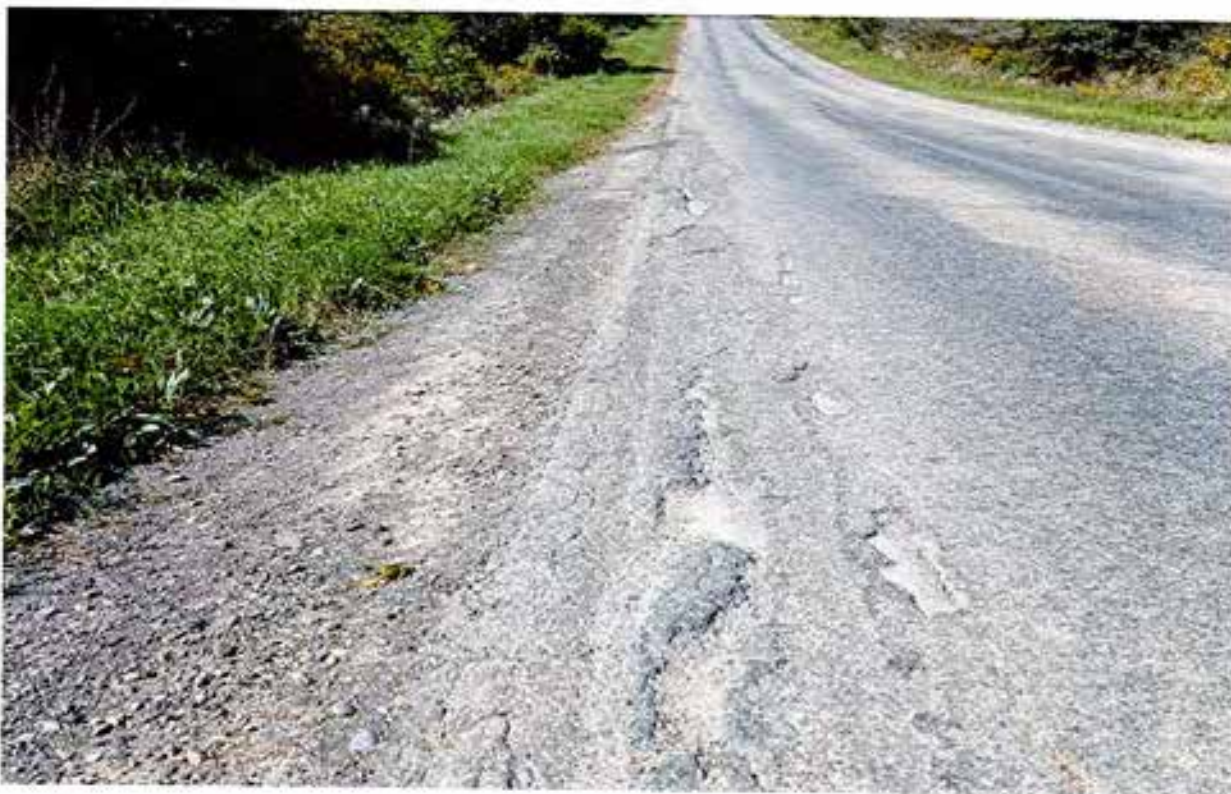
Bray Road South edge and shoulder deteriorating from Eagle Street to +/- 2801

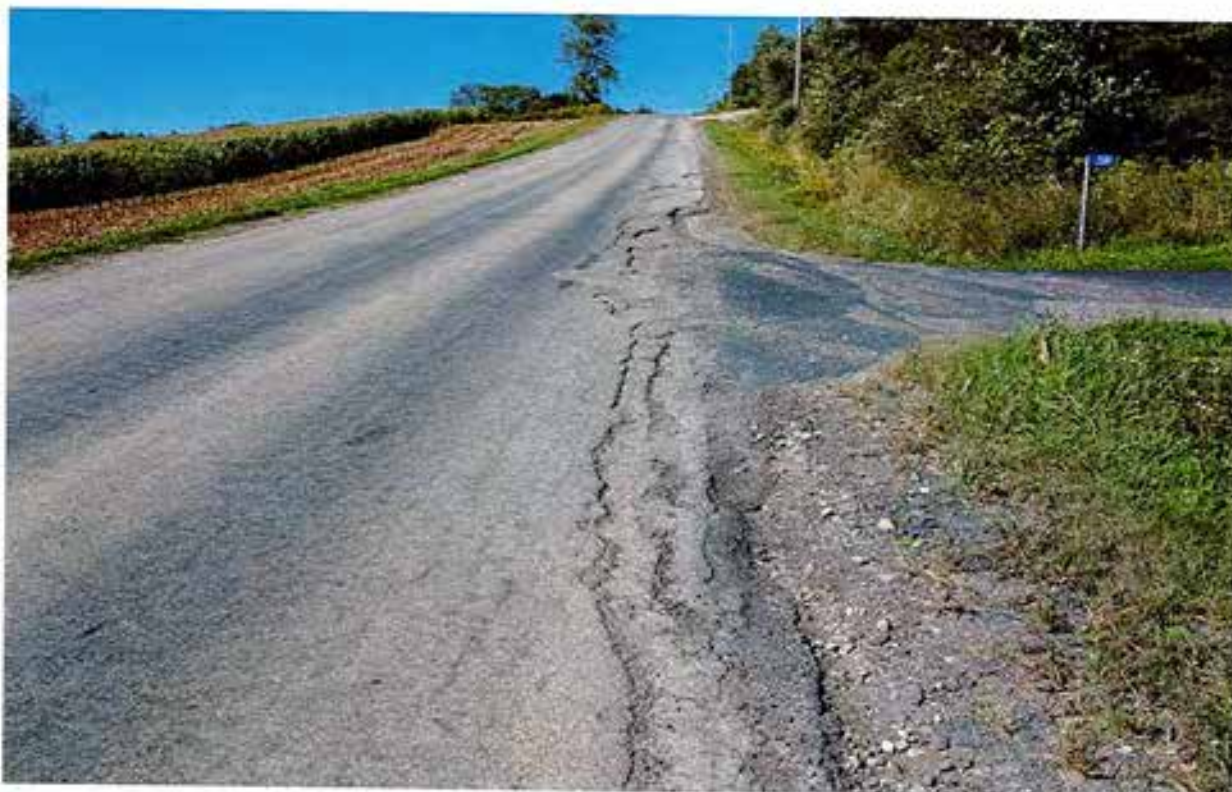
Bray Road North edge and lane deterioration near 2801 (#1)

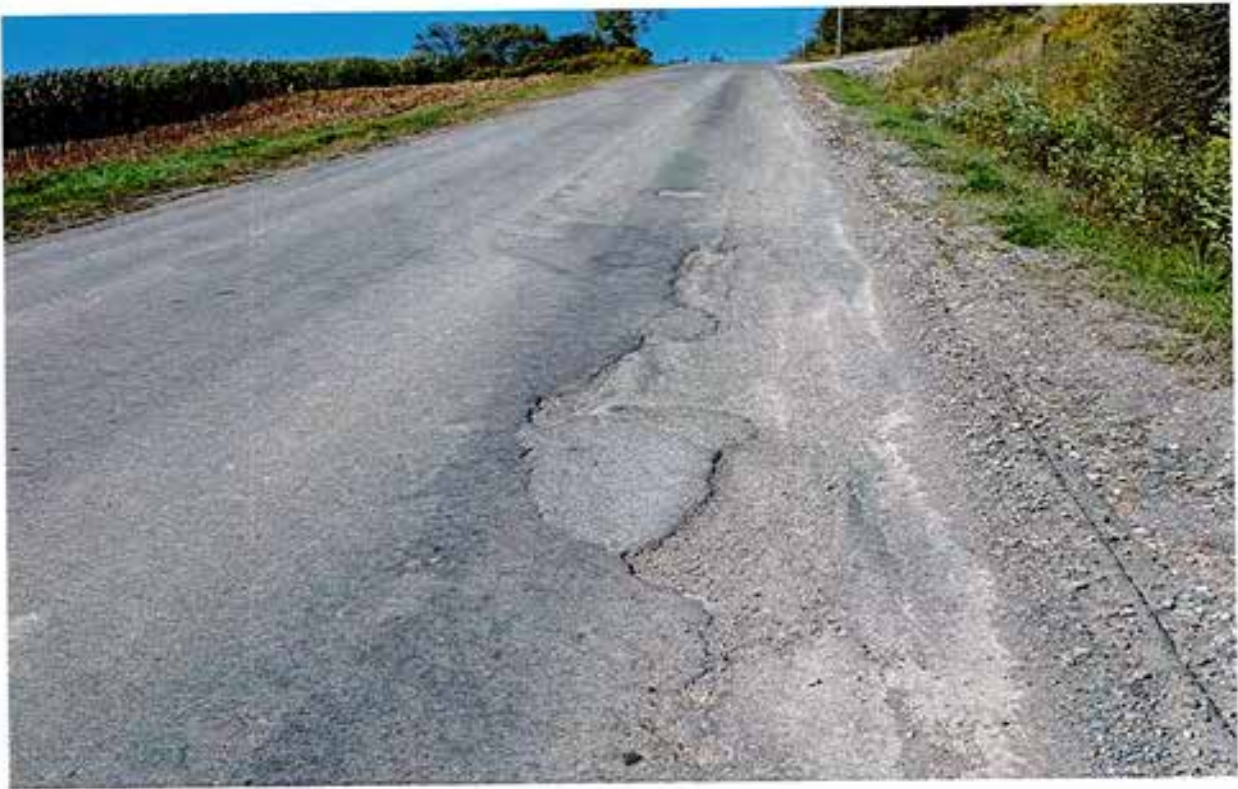
Bray Road lane deterioration near 2801 (#2)

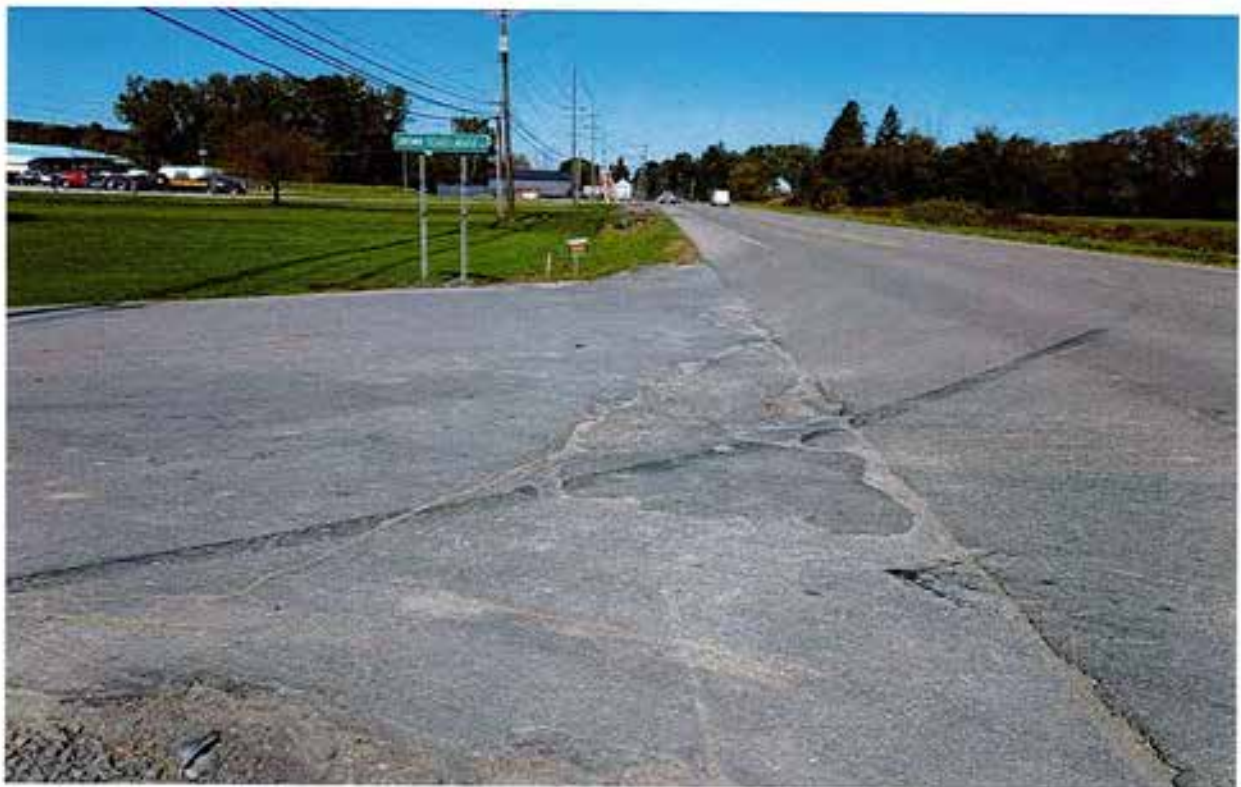
Brown Schoolhouse Road lane deterioration near intersection with Route 98

| Maintenance Needed: | <ul style="list-style-type: none"> <li>- Repair shoulders</li> <li>- Repair intersection</li> </ul> |

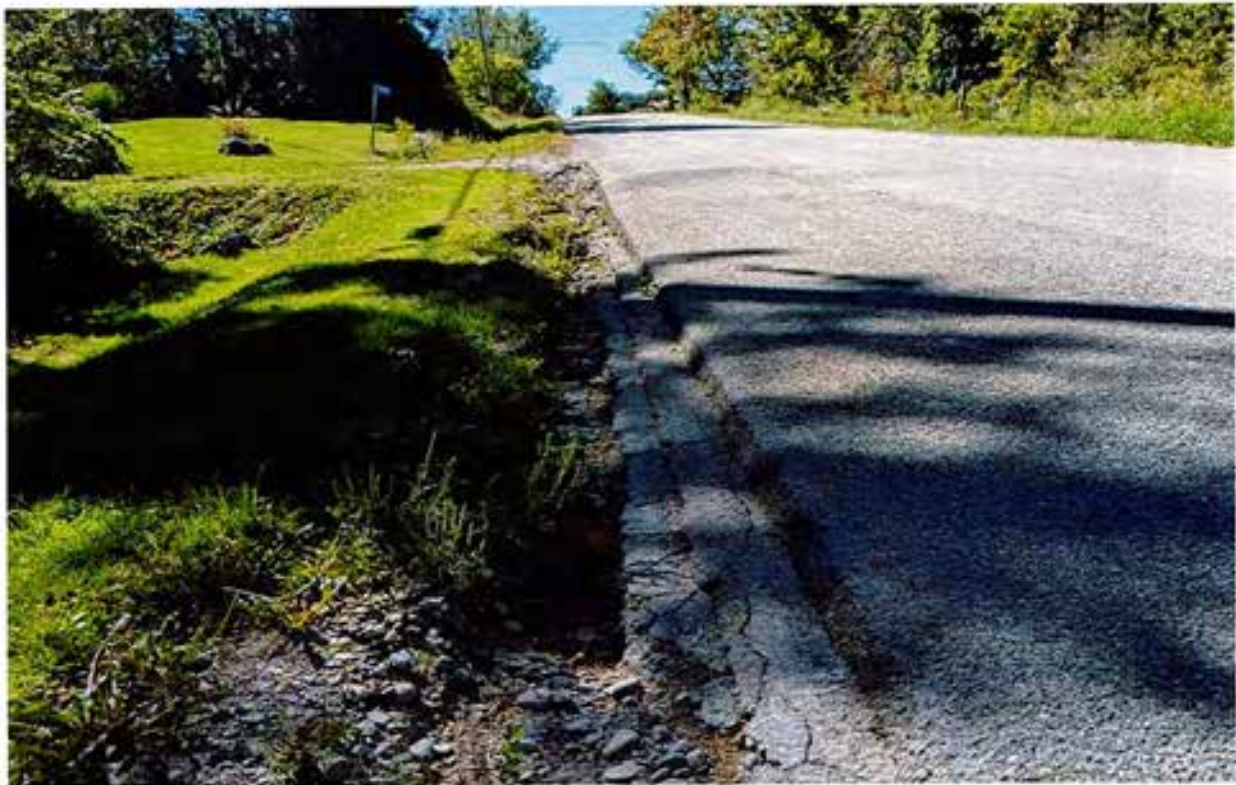
Brown Schoolhouse Road East edge and shoulder deterioration from 11754 to 11740

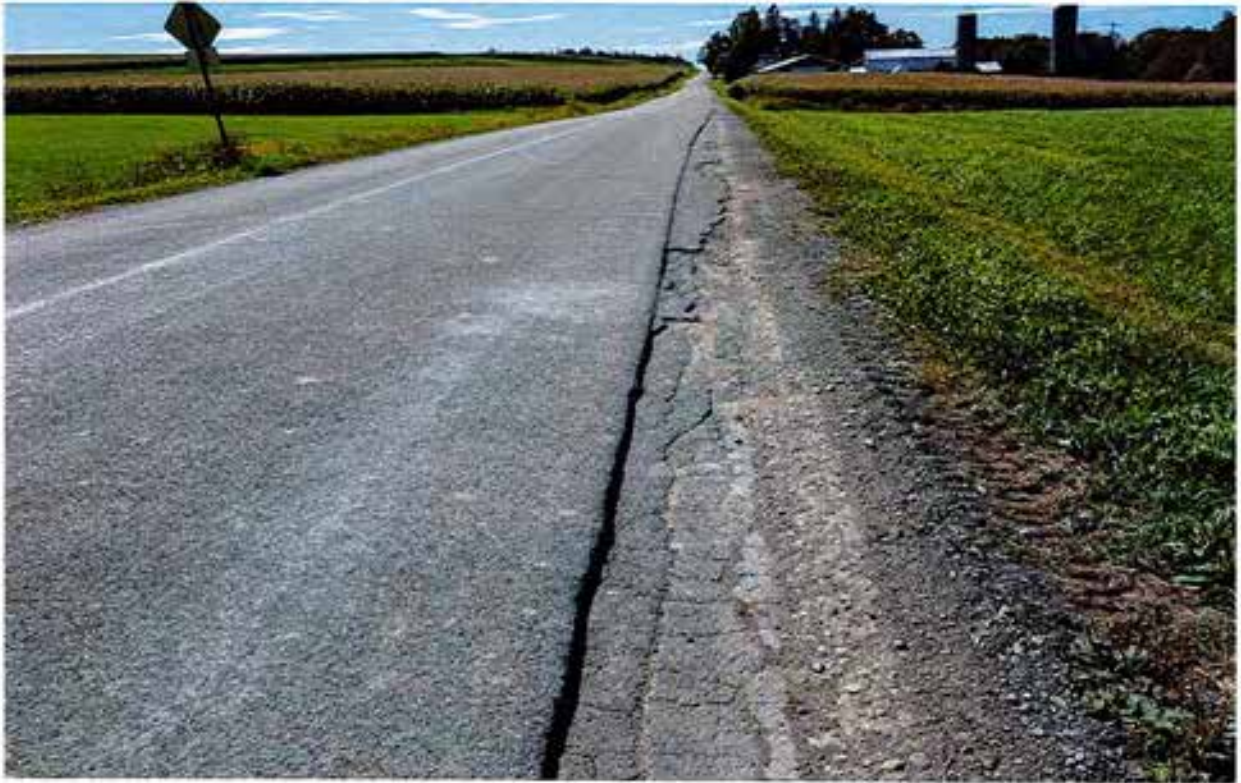
Brown Schoolhouse Road West shoulder deterioration from 11214 to 11123

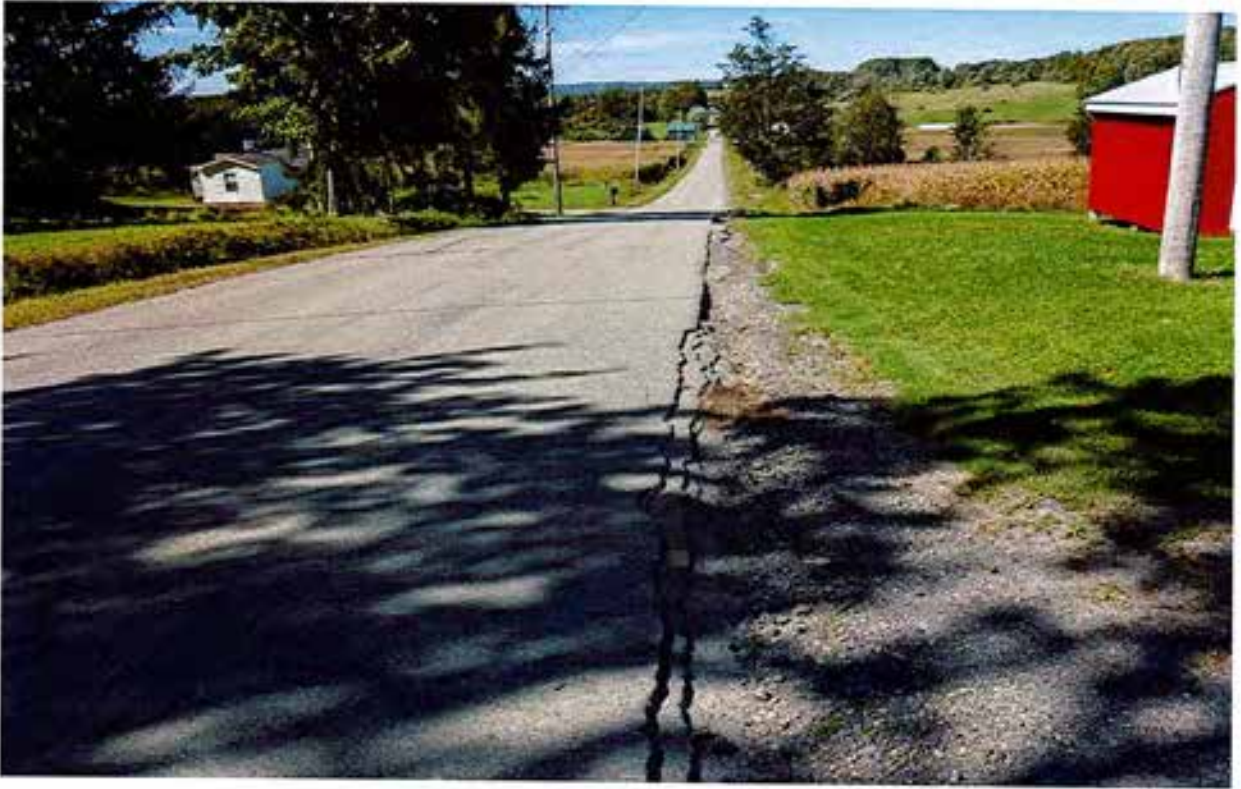
Fisher Blake Road edge and shoulder deterioration near 2177

| Maintenance Needed: | <ul style="list-style-type: none"> <li>- Repair shoulders</li> </ul> |

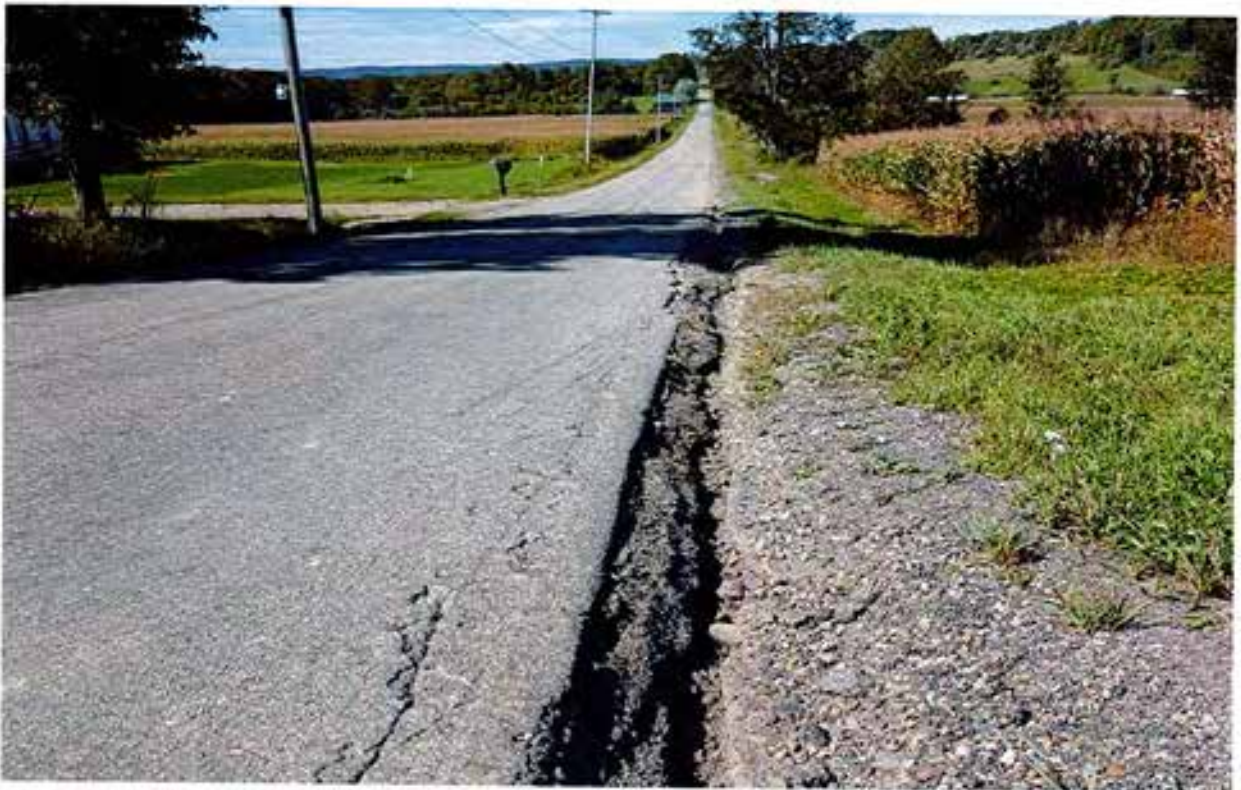
Fisher Blake Road North edge and shoulder deterioration near 2195

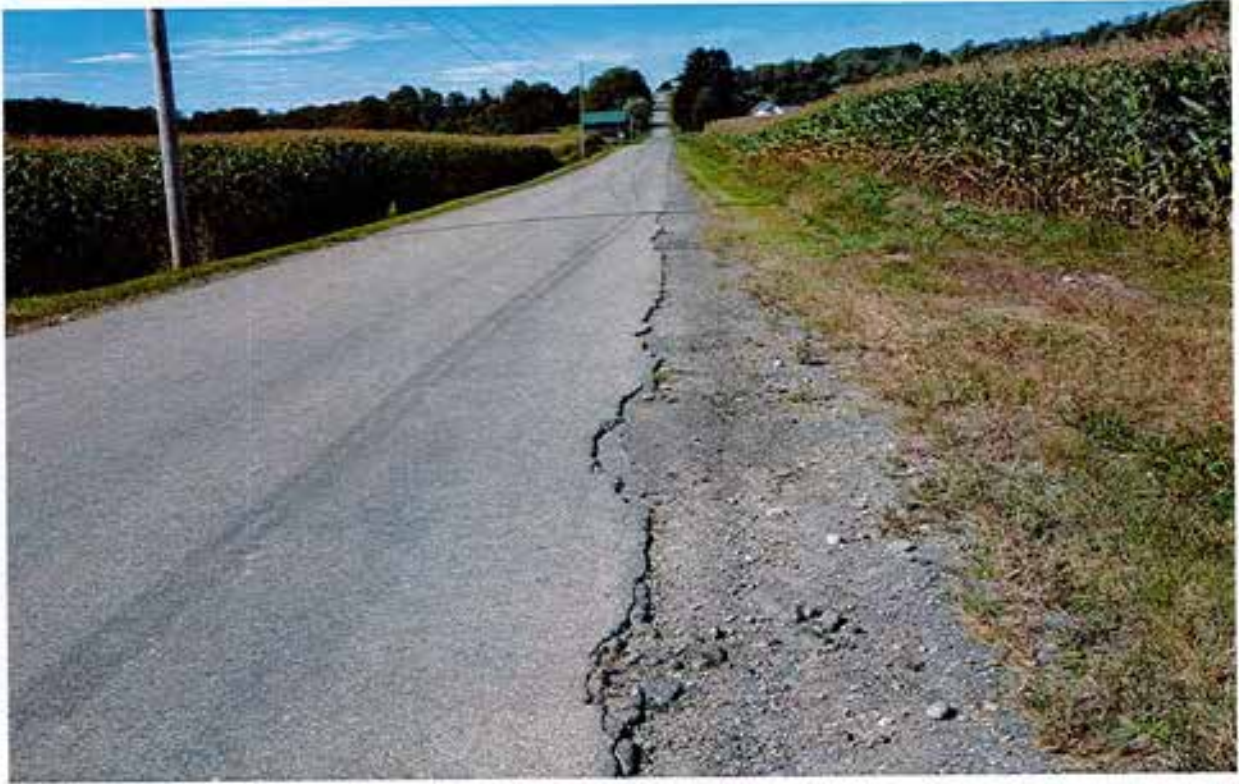
Fisher Blake Road North edge and shoulder deterioration from 2195 to +/- 2272

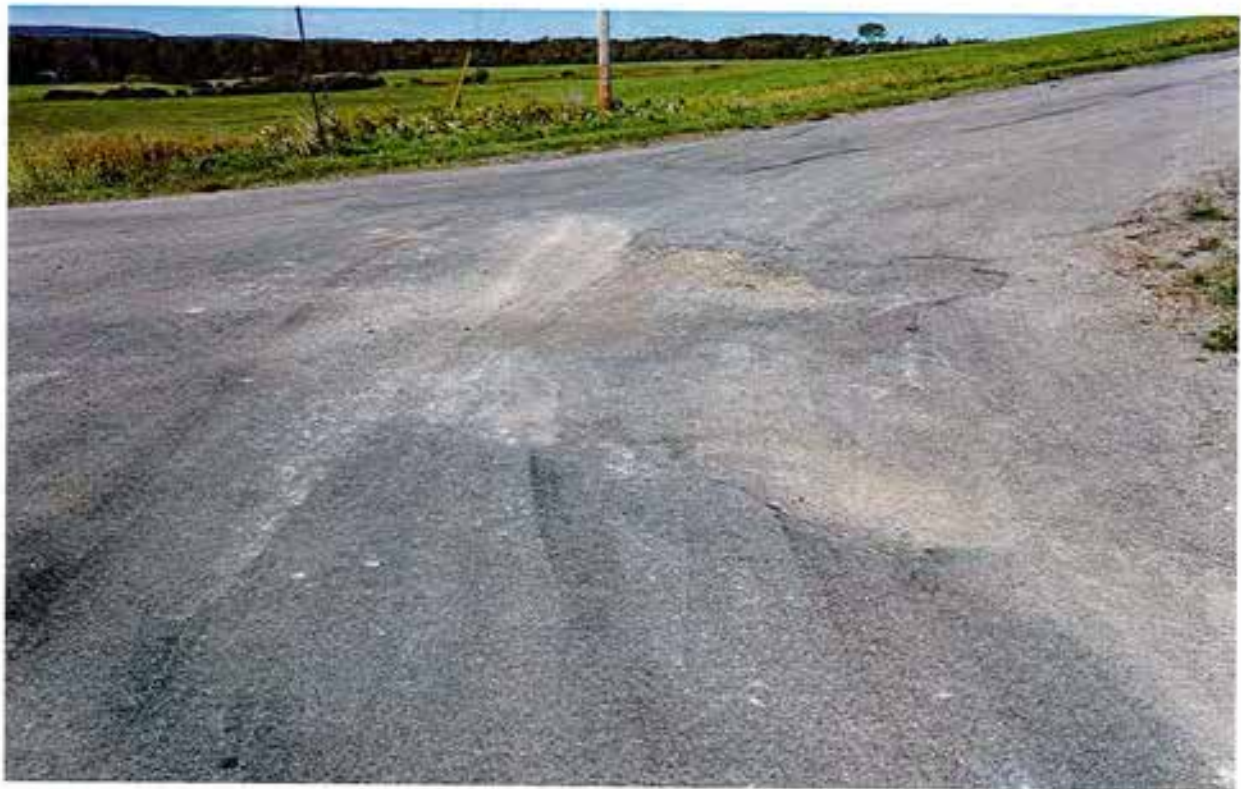
| Hazards Identified: | <ul style="list-style-type: none"> <li>- Potholing and lane deterioration forming at intersection with Brown Schoolhouse Rd. This item will be removed from report if confirmed that project does not use this road, see this page for photo.</li> <li>- Edge of road deteriorating near 1812</li> </ul> |

Edmunds Road intersection of Brown School House

| Maintenance Needed: | <ul style="list-style-type: none"> <li>- Repair intersection</li> <li>- Repair shoulder</li> </ul> |

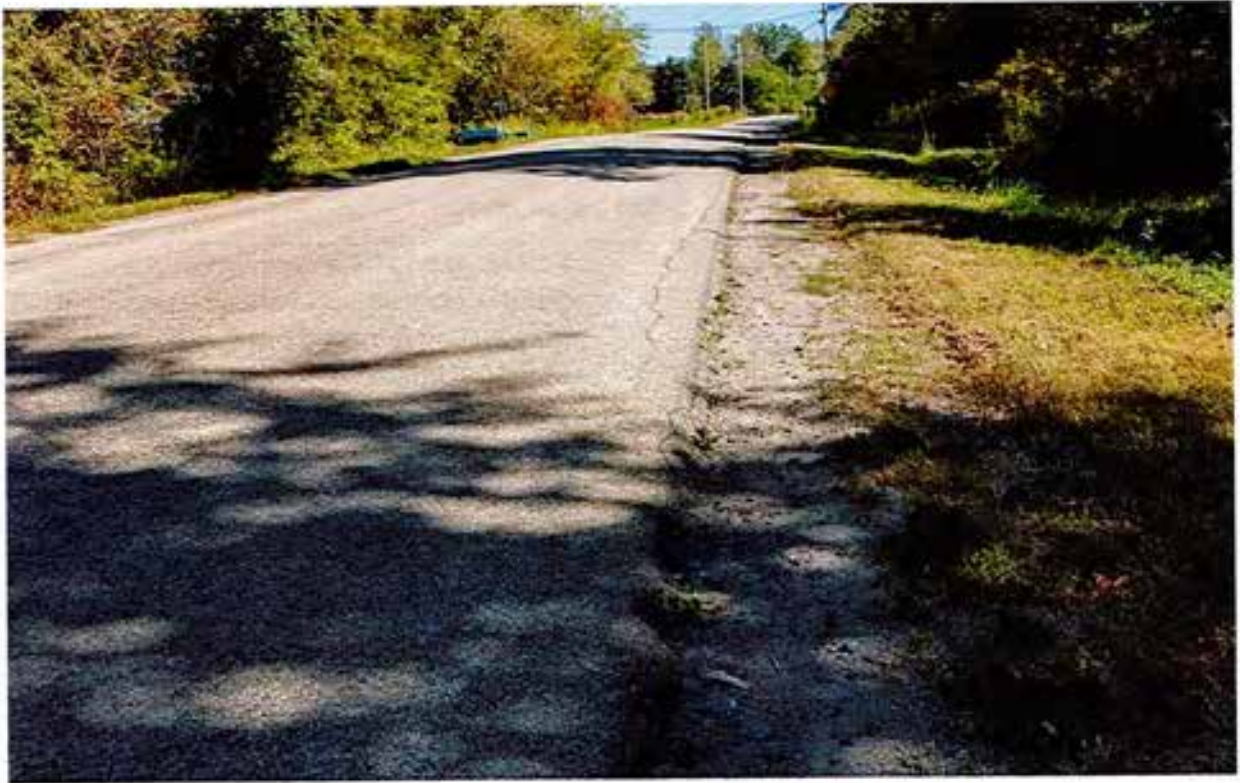
Edmunds Road South edge and shoulder deterioration 1940 to 1850

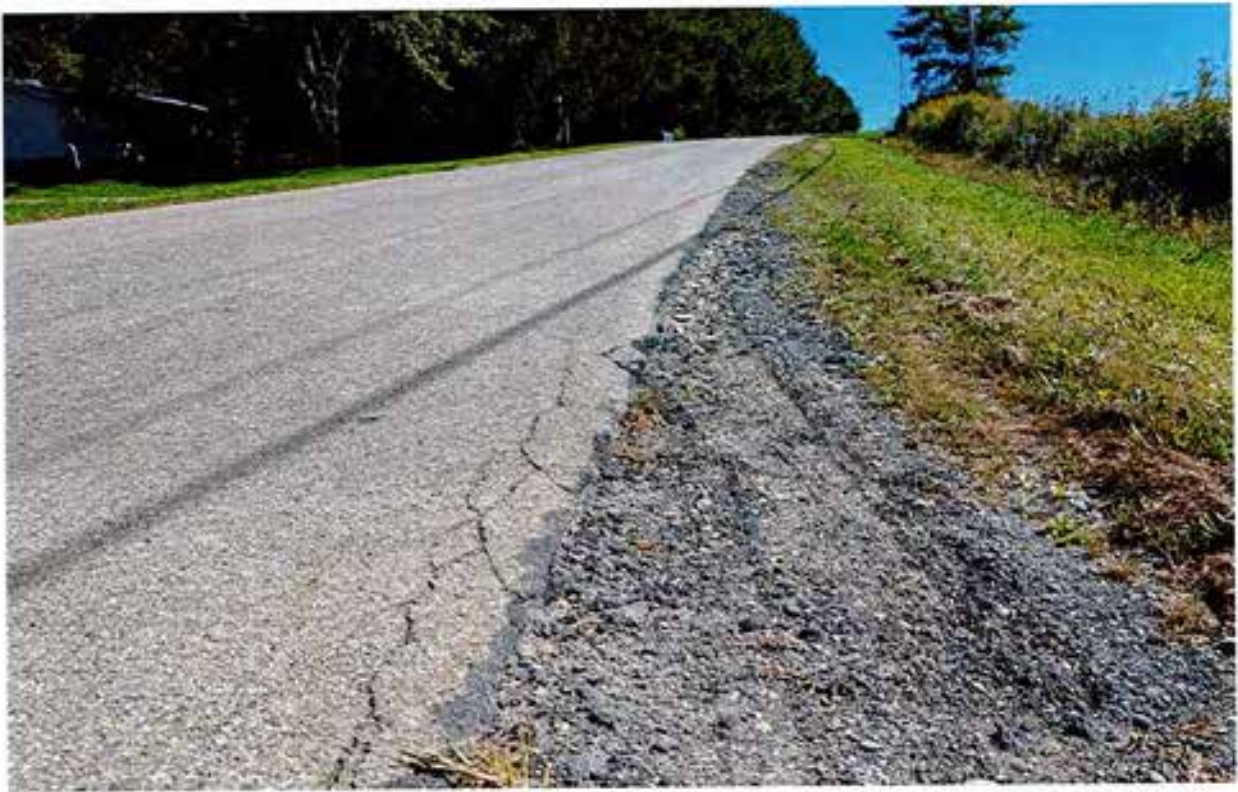
Edmunds Rd Southeast edge and shoulder deteriorating near 1812

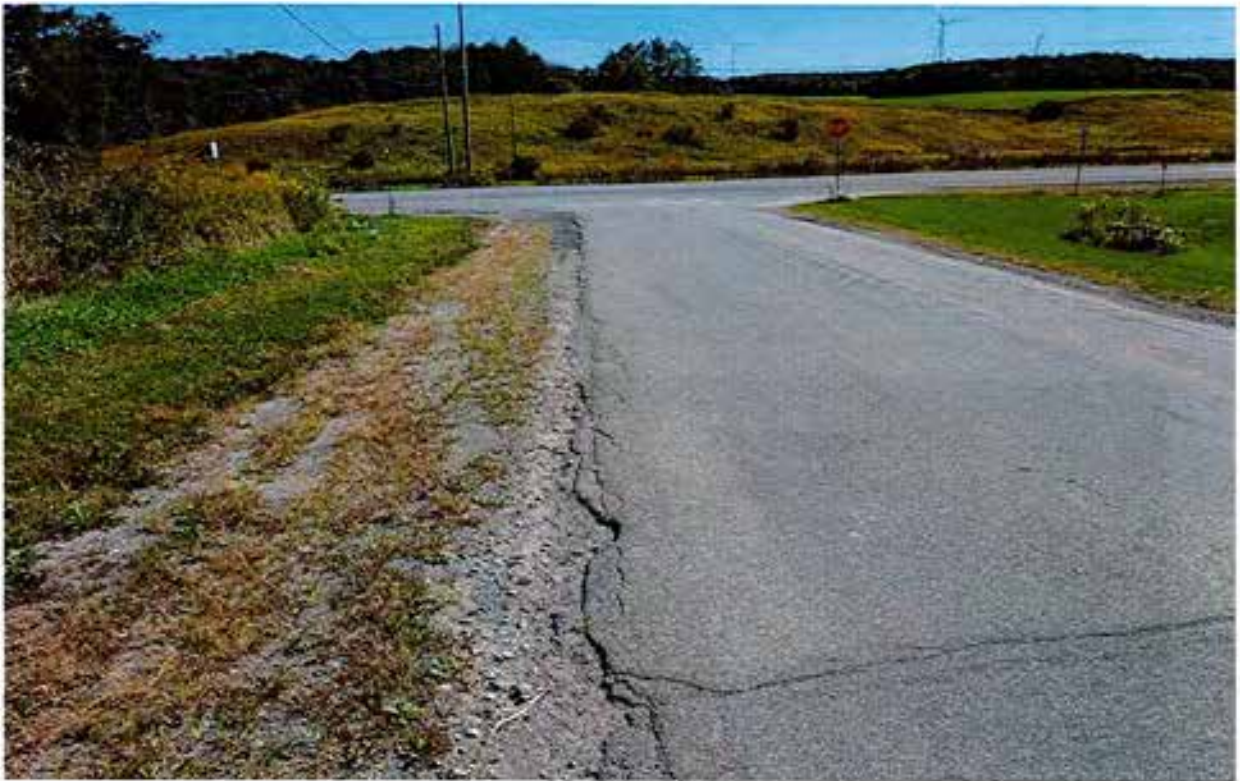
Edmunds Rd lane and shoulder deterioration on North and South sides of Rd near intersection with Maple Grove

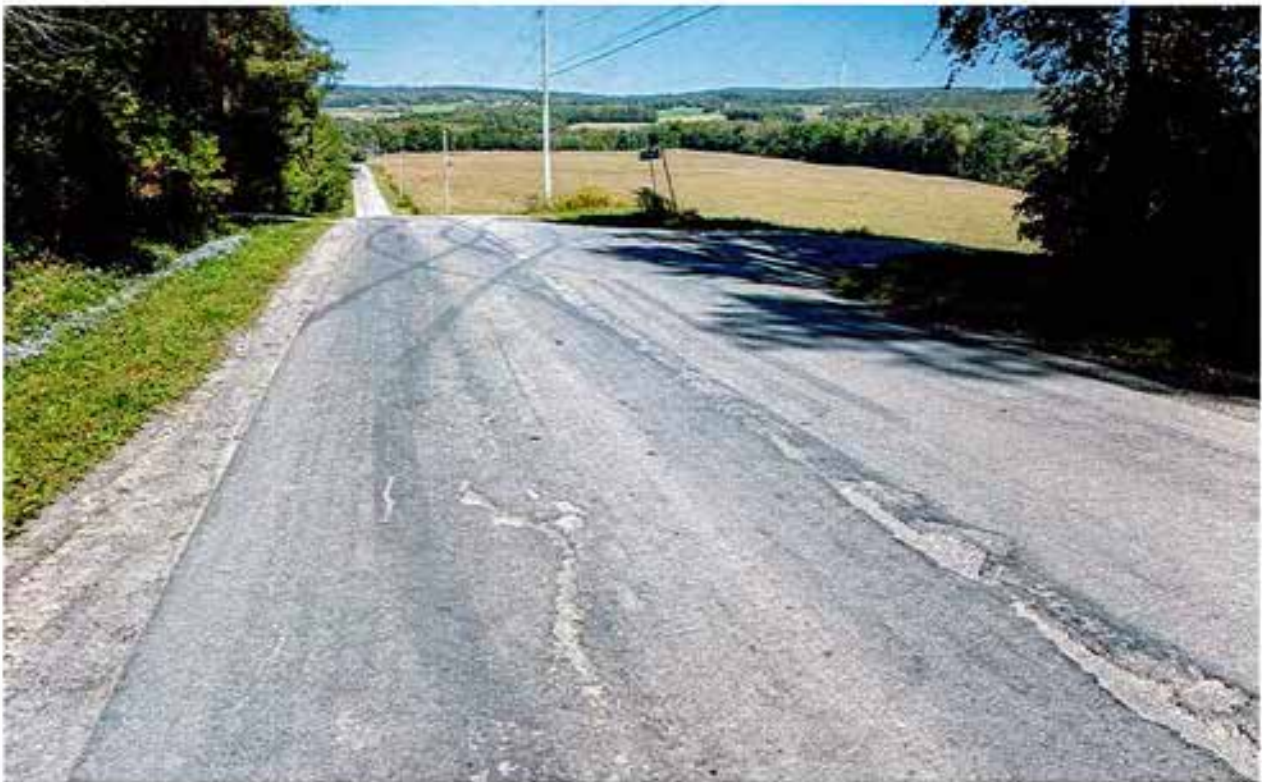
Galen Hill Road intersection with Phillippi Rd lane deterioration

| Maintenance Needed: | <ul style="list-style-type: none"> <li>- Large pothole and deterioration at Galen Hill Rd and 98 intersection, repairs needed.</li> <li>- Repair lane from Phillippi Rd to 10553 Galen Hill</li> </ul> |

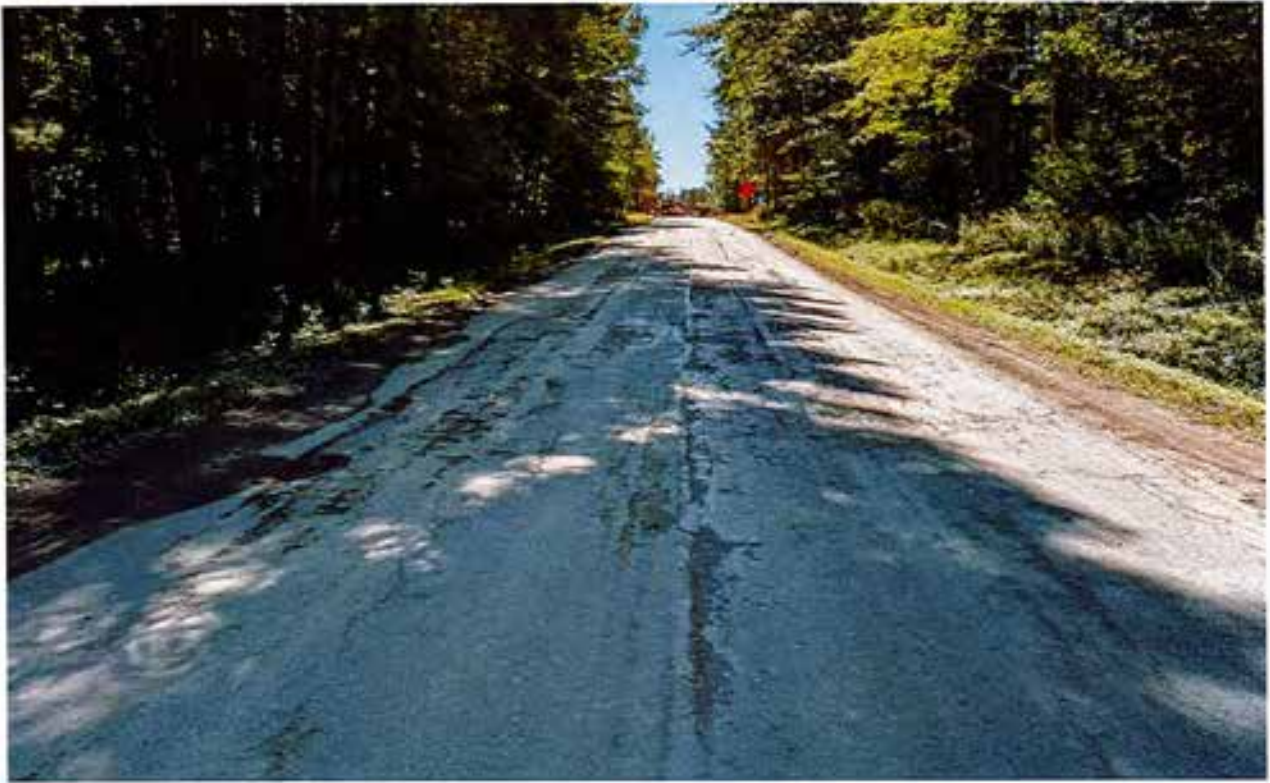
Galen Hill Road lane deterioration from Phillippi Rd to 10553

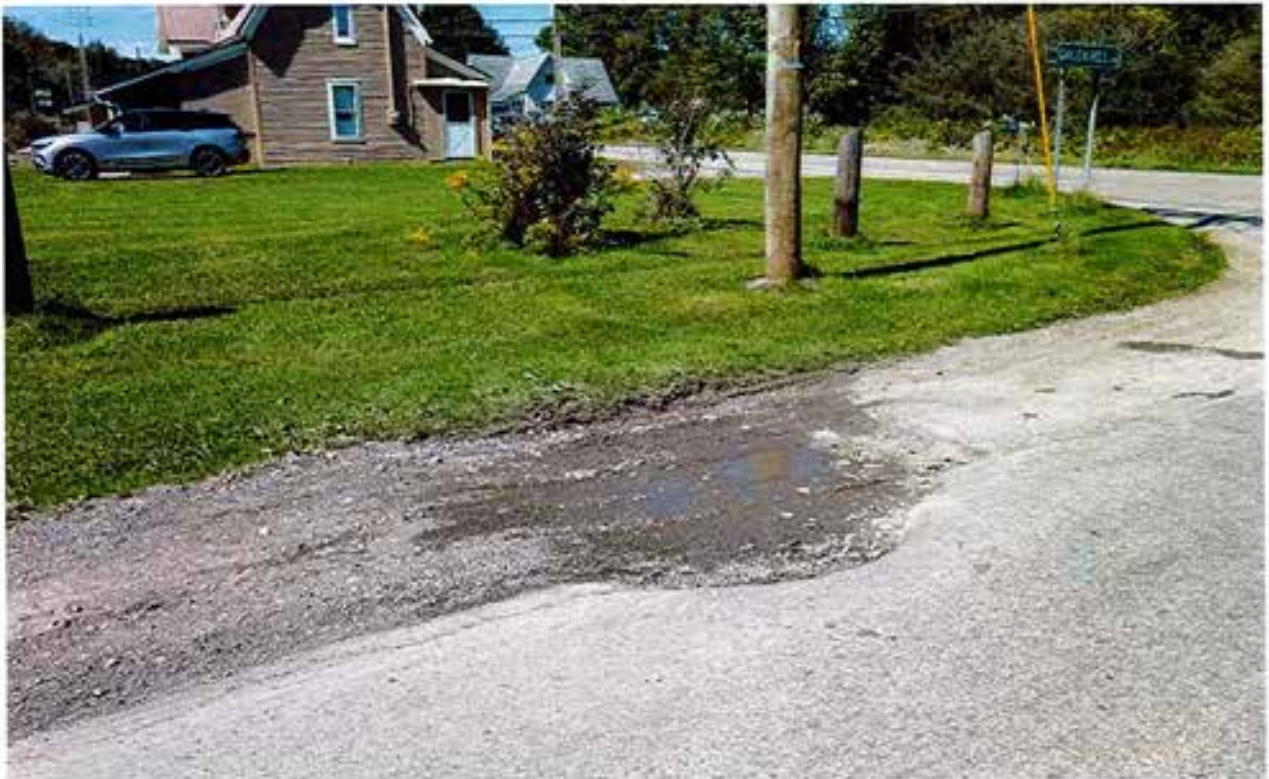
Galen Hill Rd pothole at intersection of Route 98

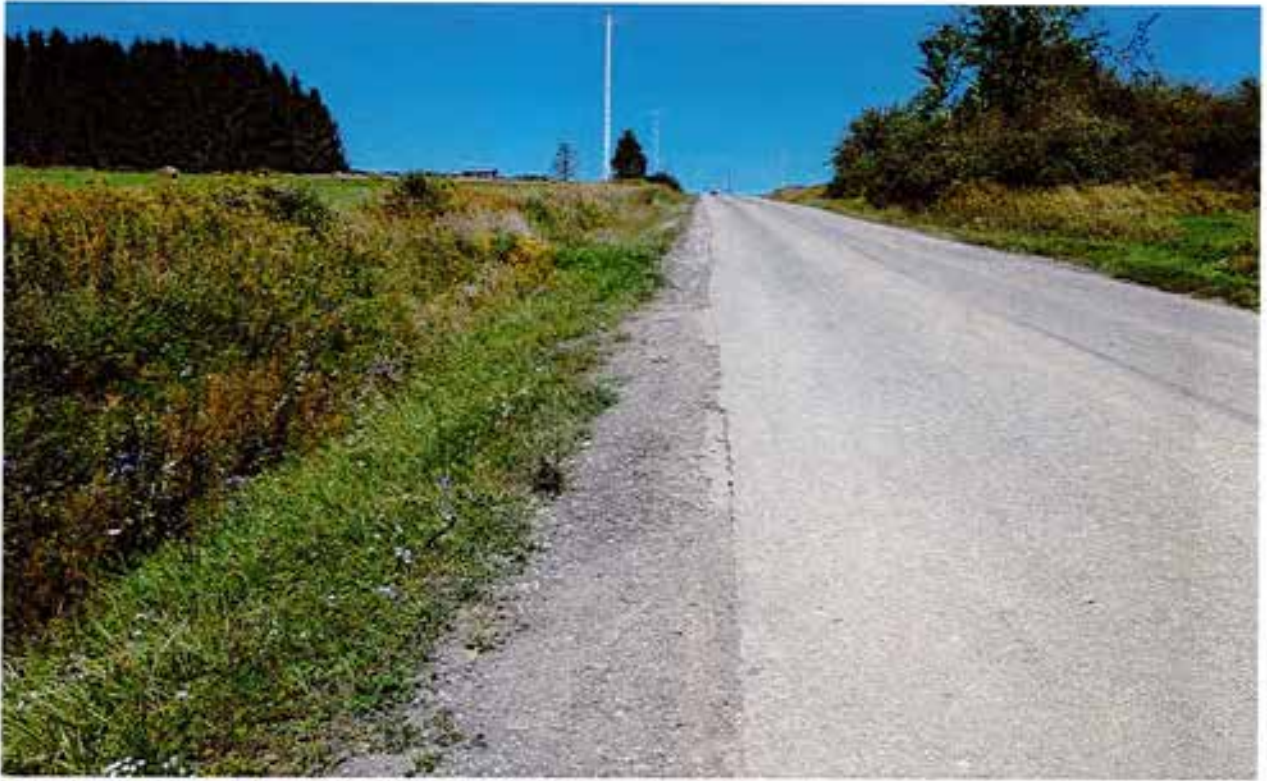
Galen Hill West edge and shoulder deterioration North of 10075

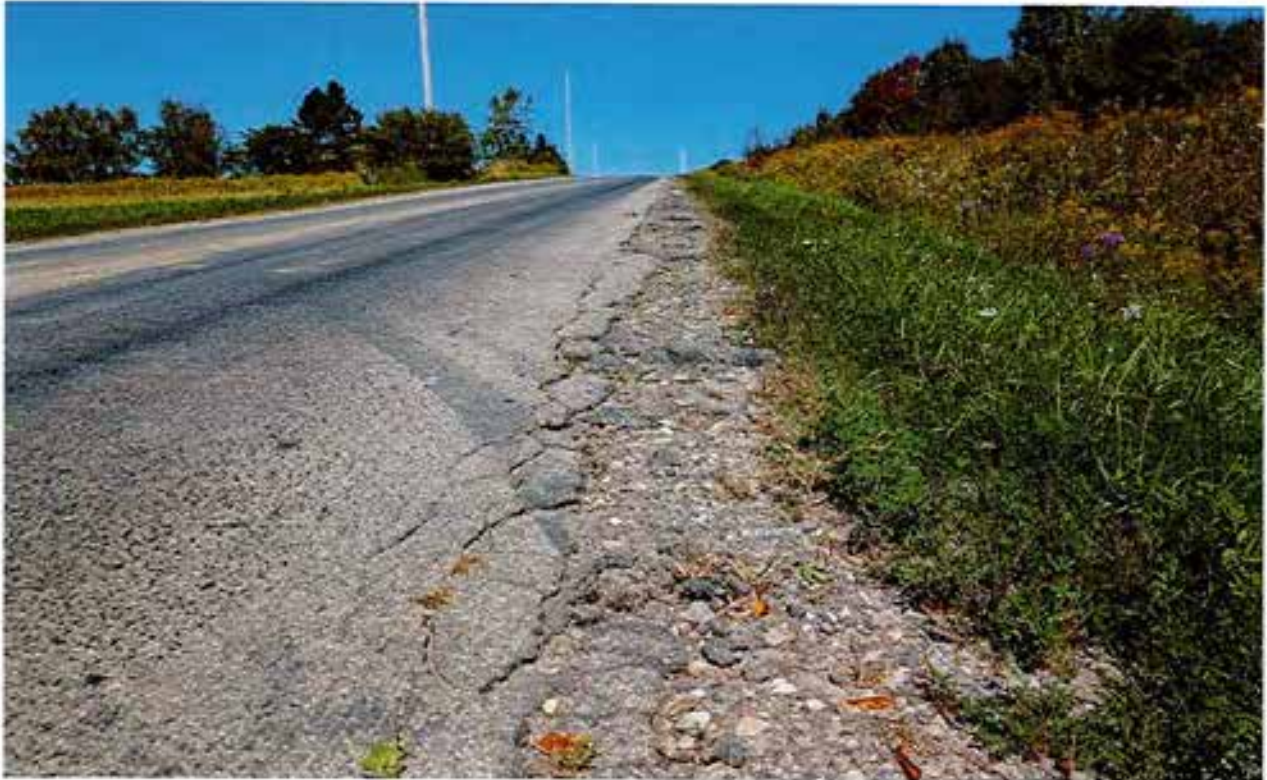
Sandbank Road East edge and shoulder deterioration near 9999
