## Road Condition & Vehicle Compliance Report

| Report # | 59 |
| Project Name | Alle-Catt Wind |
| Location | Town of Freedom |

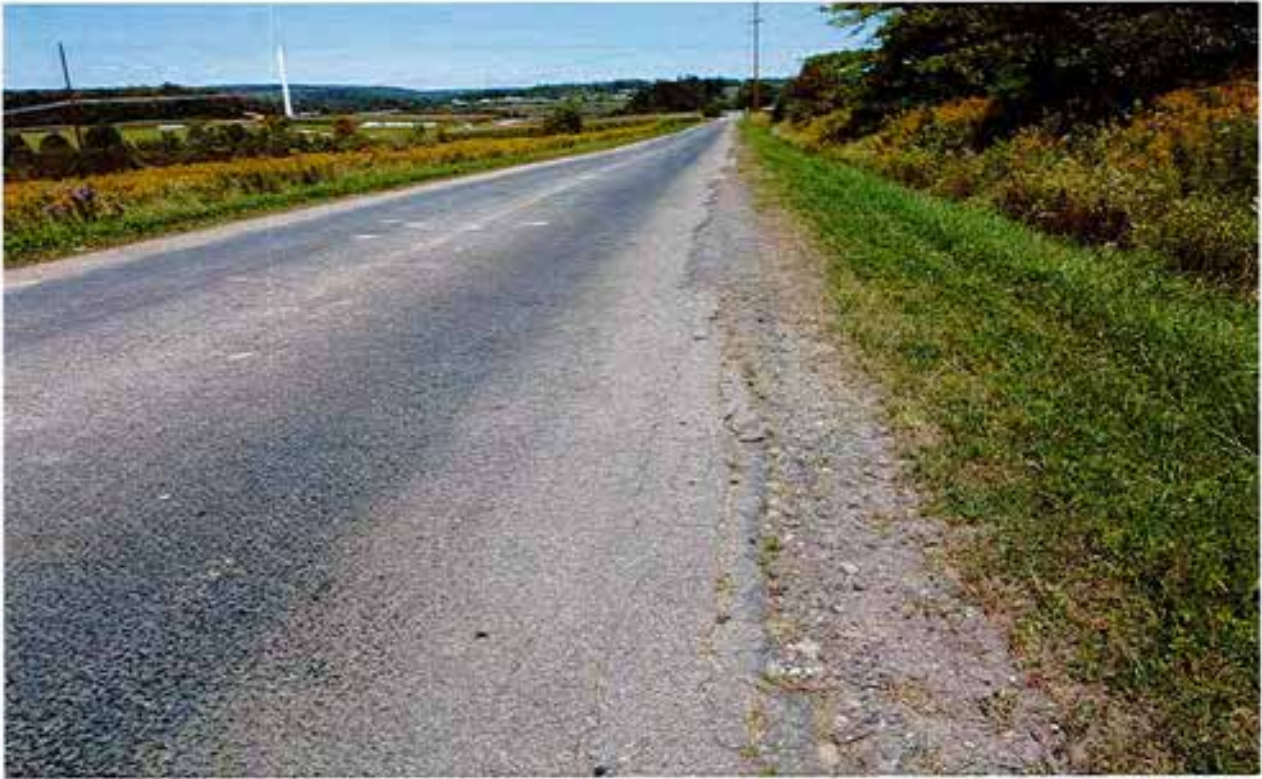
Sandbank Rd East and West edge deterioration North and South of 10157 to +/- 10220

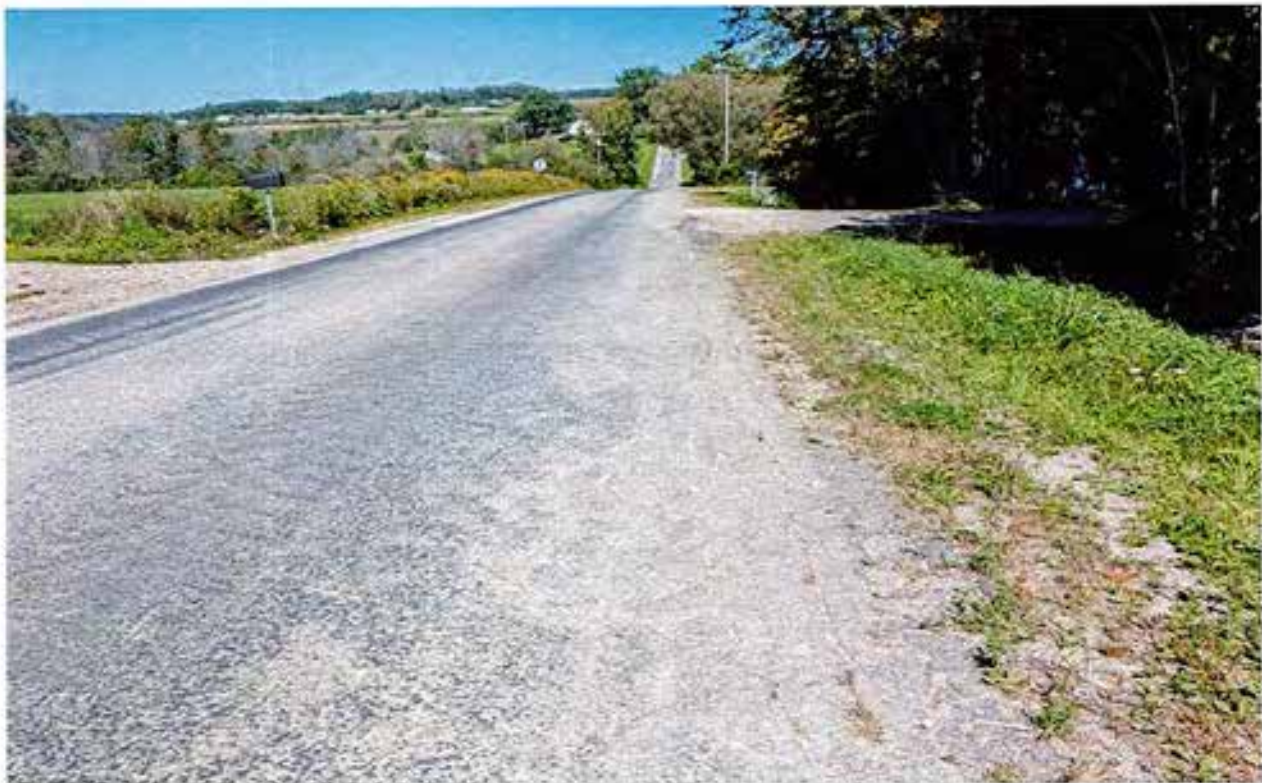
Sandbank Road East and West edge / shoulder deterioration near 10238

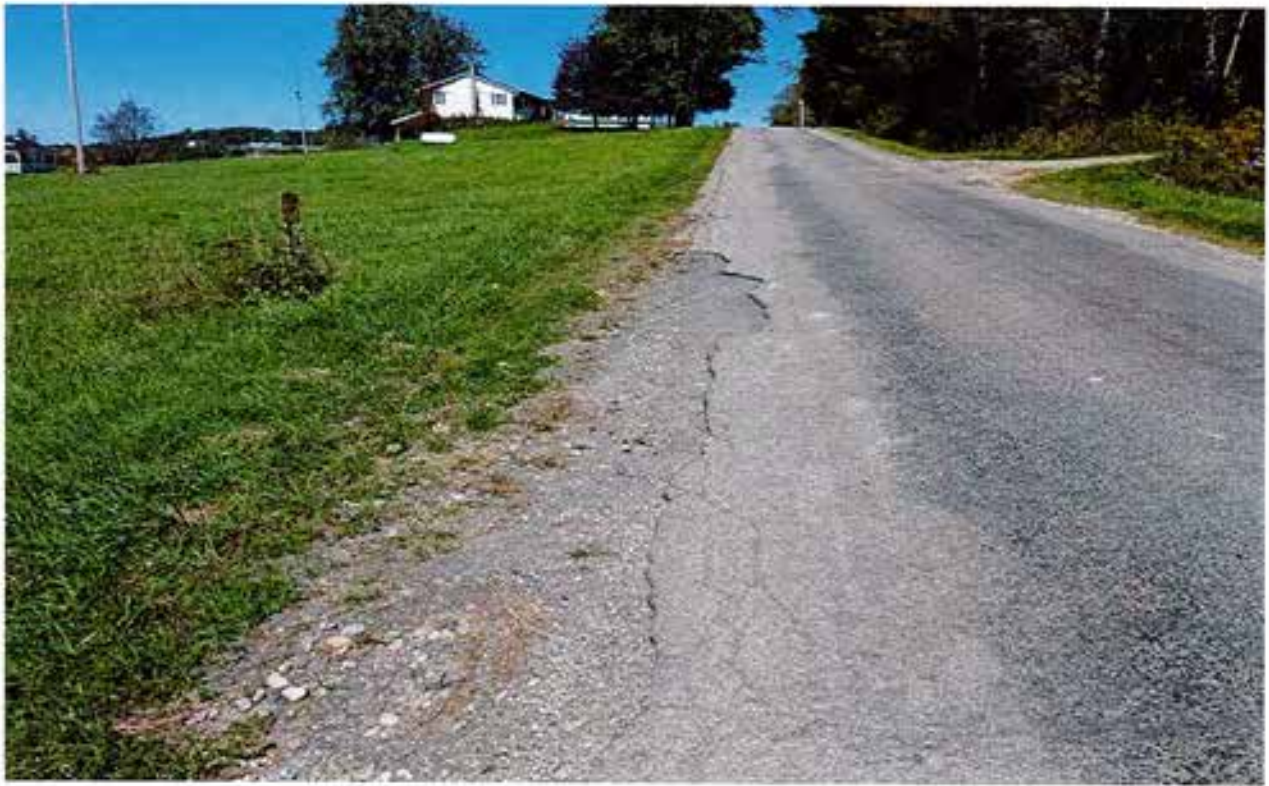
Sandbank Rd West lane and edge deterioration South of 10317

| Maintenance Needed: | - Discuss repair with Highway Supervisor |

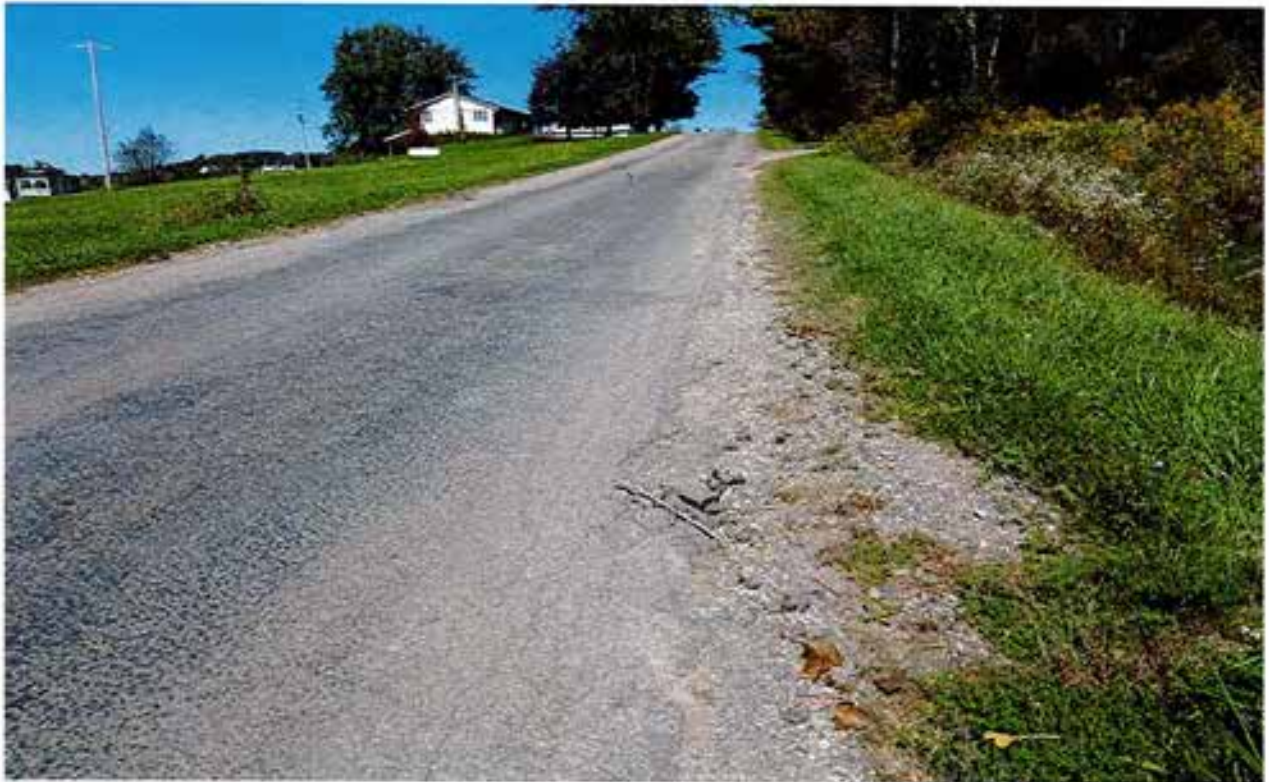
Sandbank Rd East lane and edge deterioration South of 10317

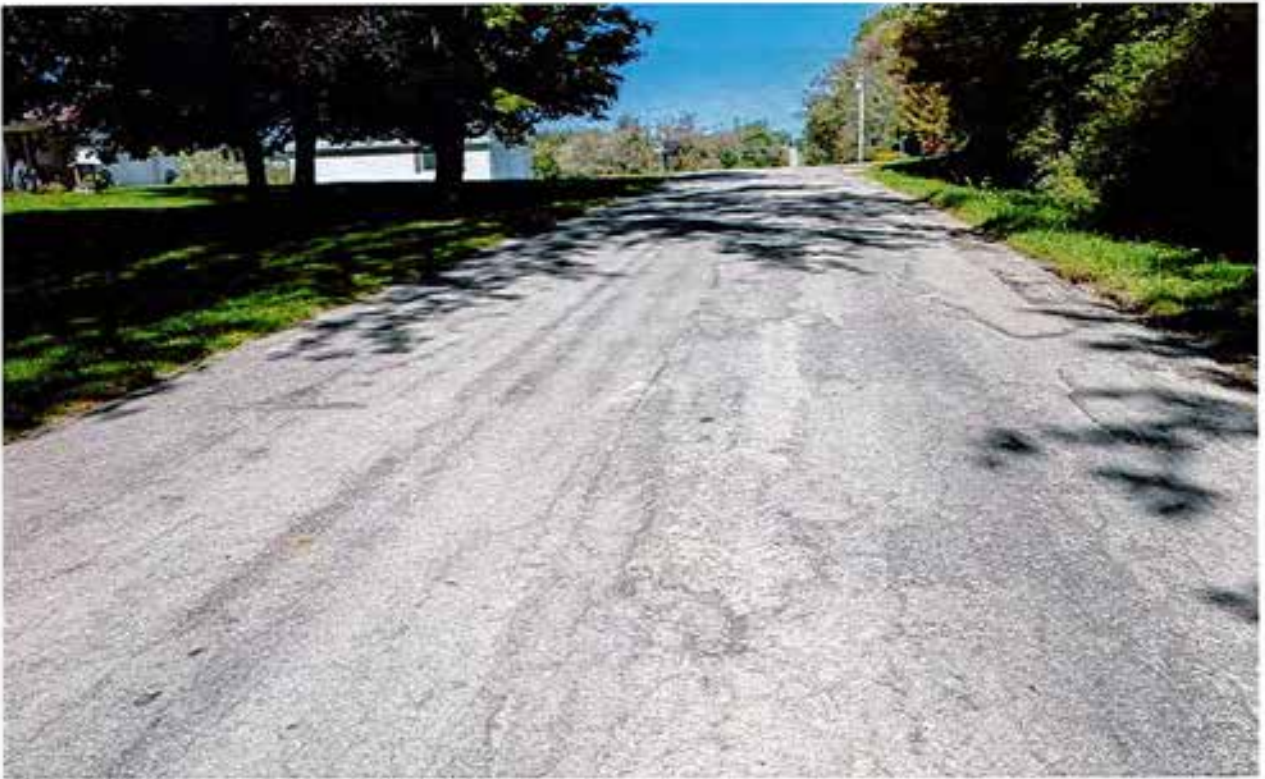
Sandbank Rd lane deterioration near 10317

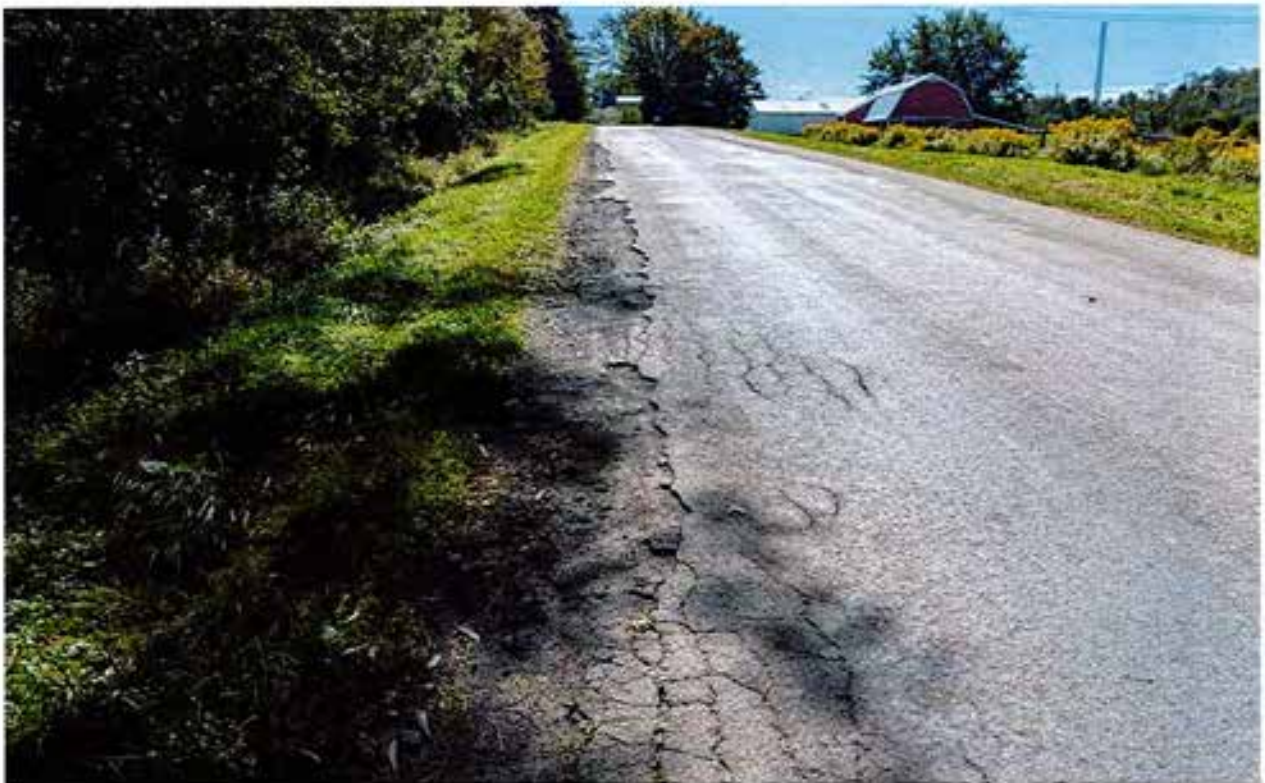
Sandbank Road East edge deterioration South of 10368

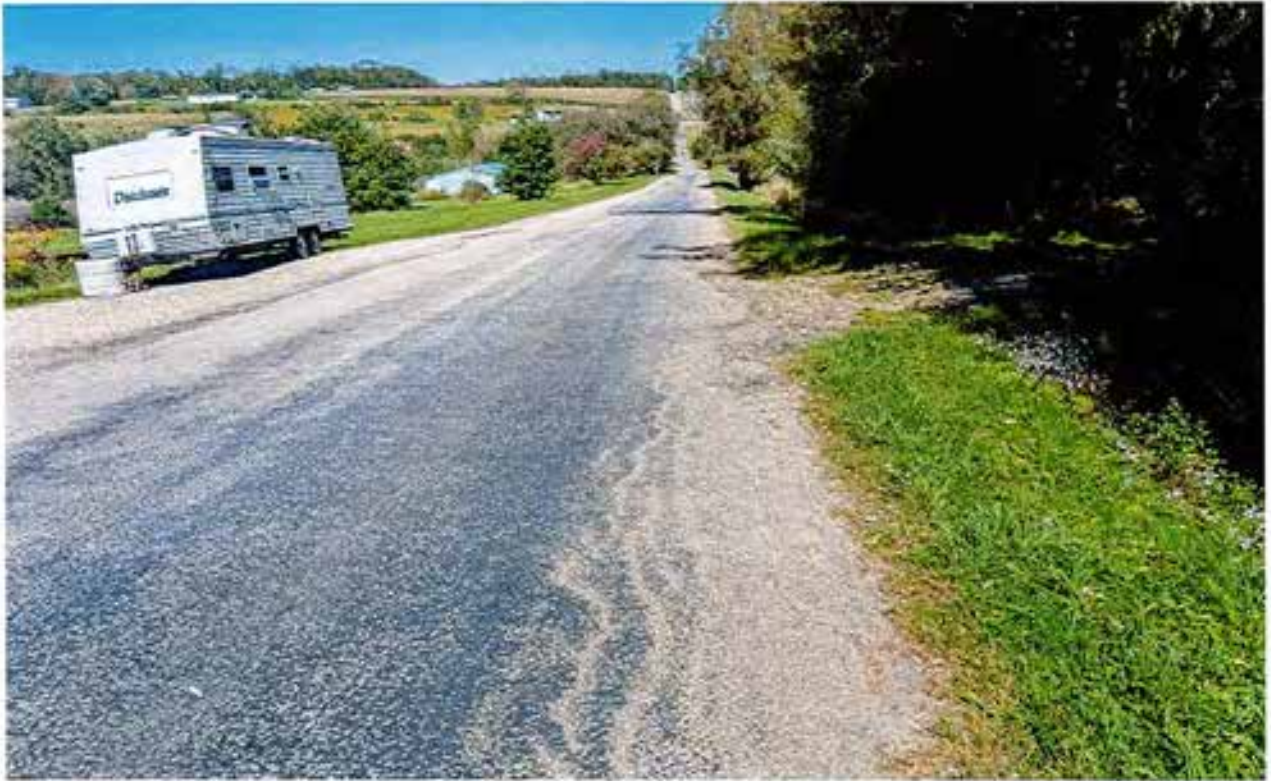
Sandbank Rd East and West side shoulder deterioration near 10442

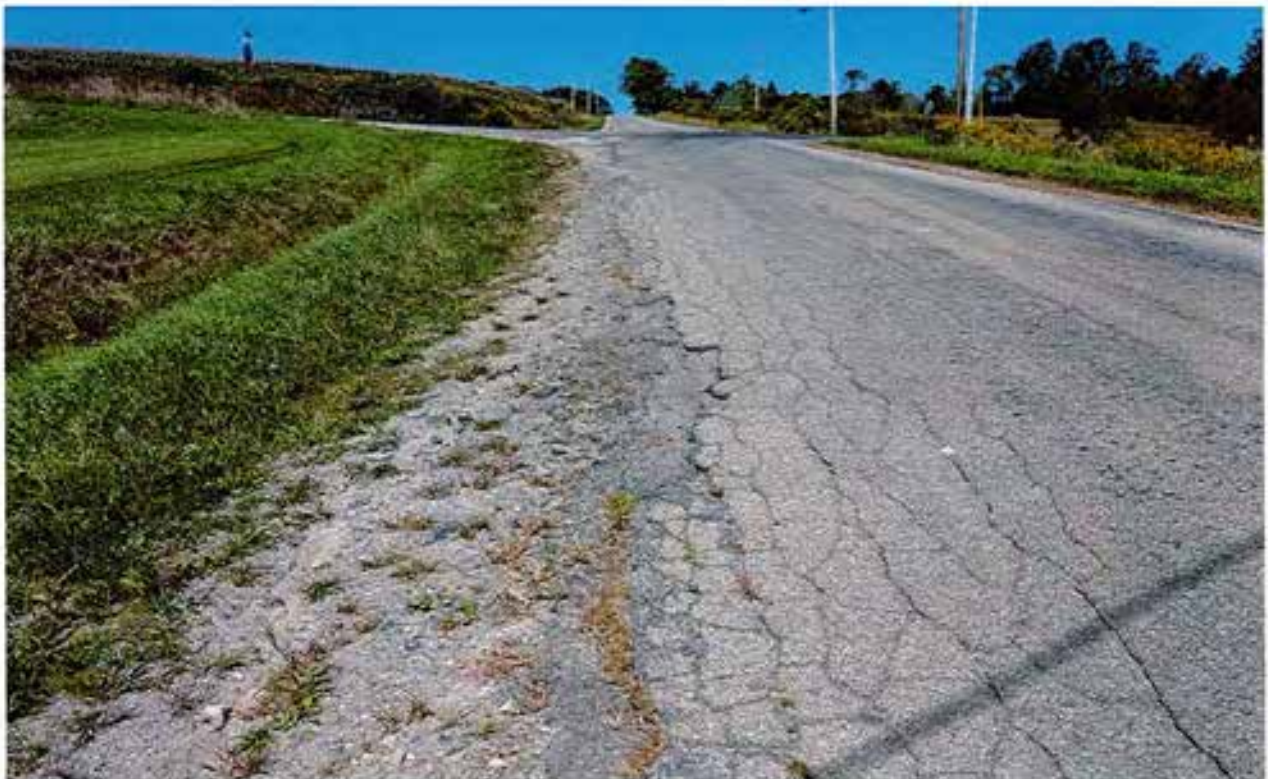
Sandbank Road (East and West) edge and shoulder deteriorating near intersection with Cross Road

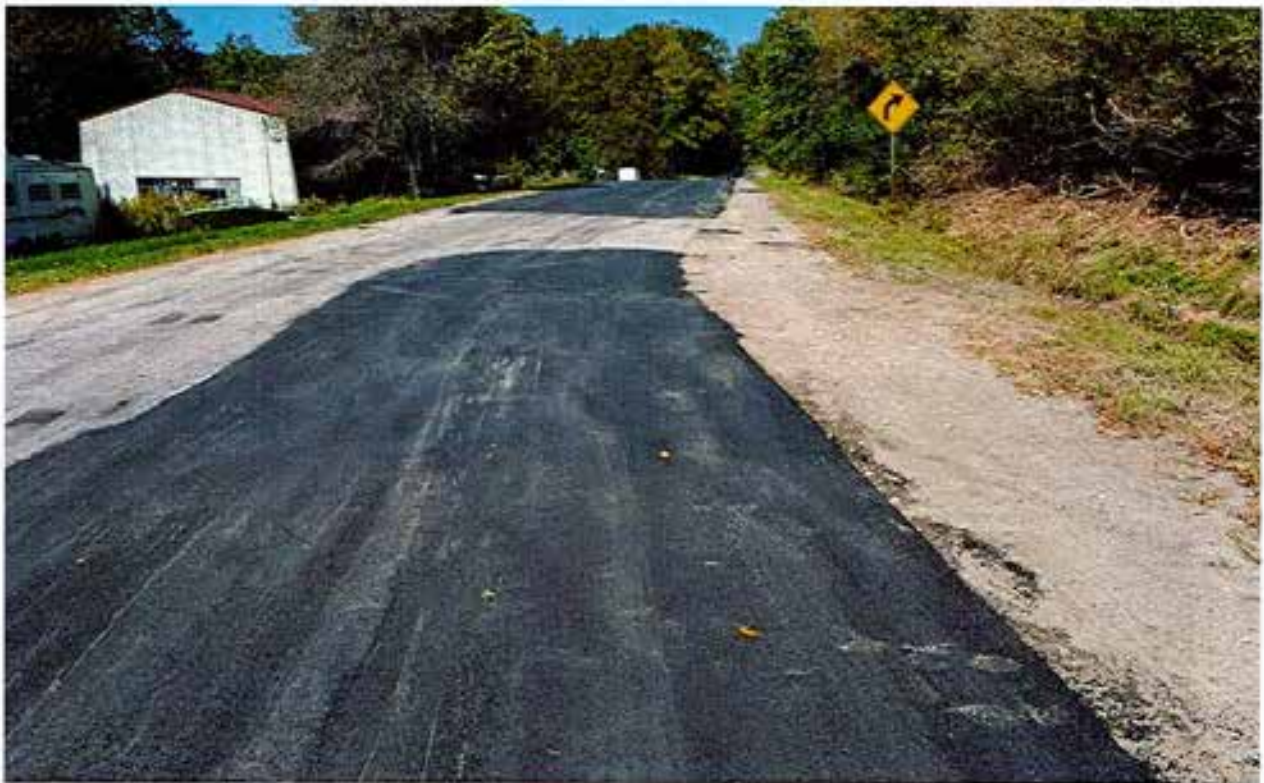
Osmun Rd Edge and shoulder deterioration near Zimmer (REPAIRED)

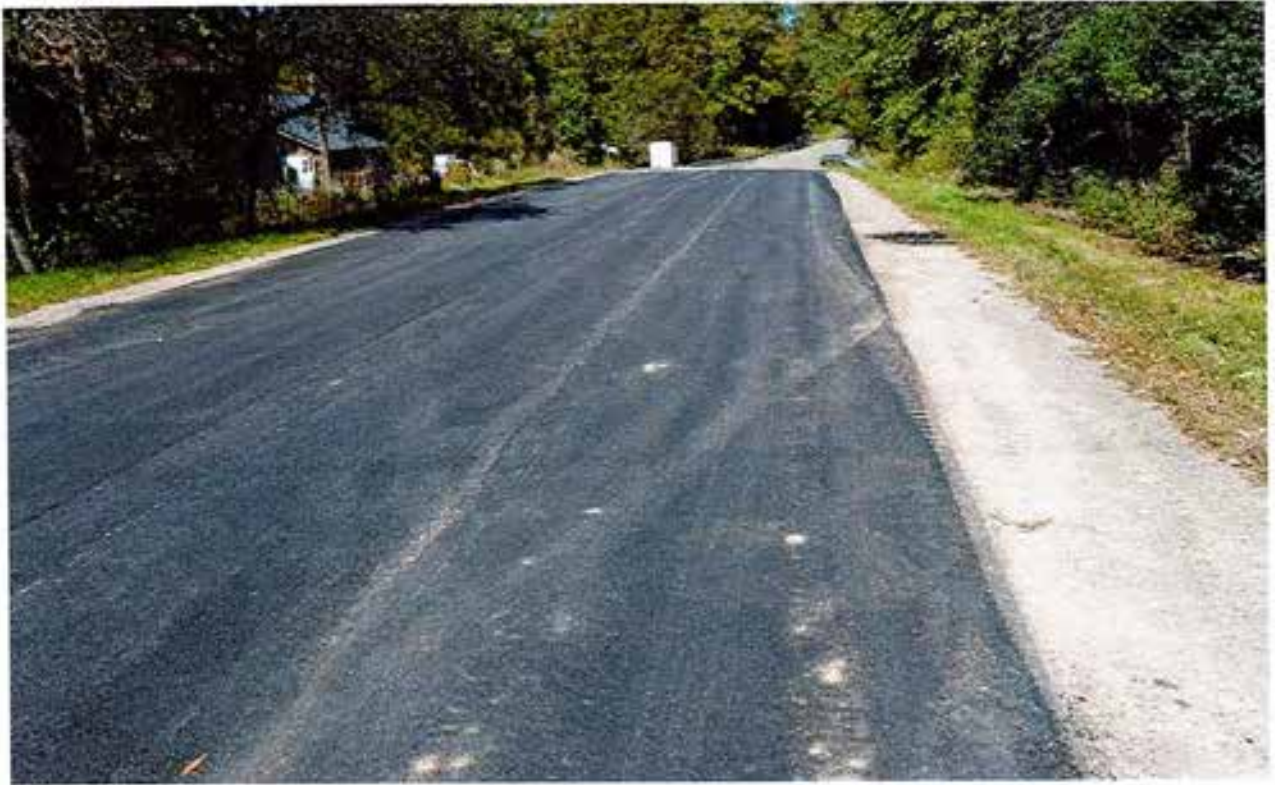
Osmun Rd lane deterioration near Zimmer (REPAIRED)

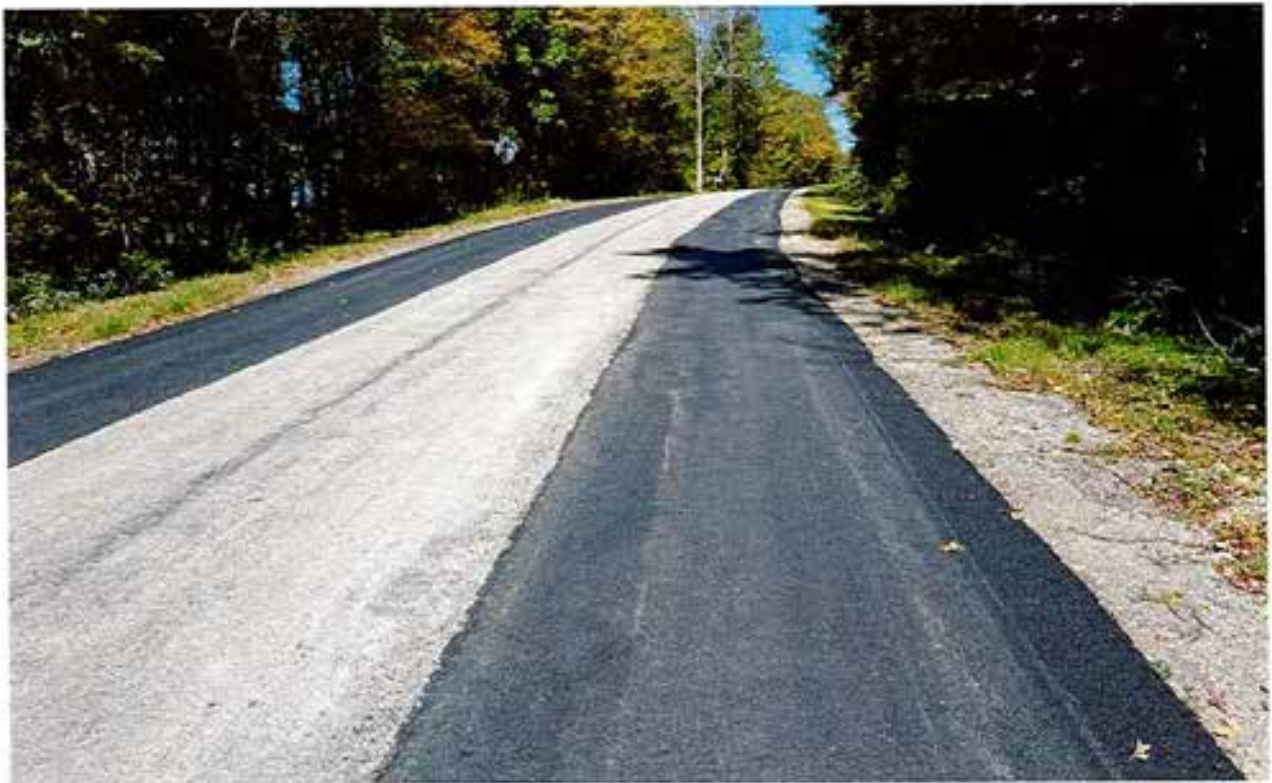
Osmun Road lane deterioration South of 10200 (REPAIRED)

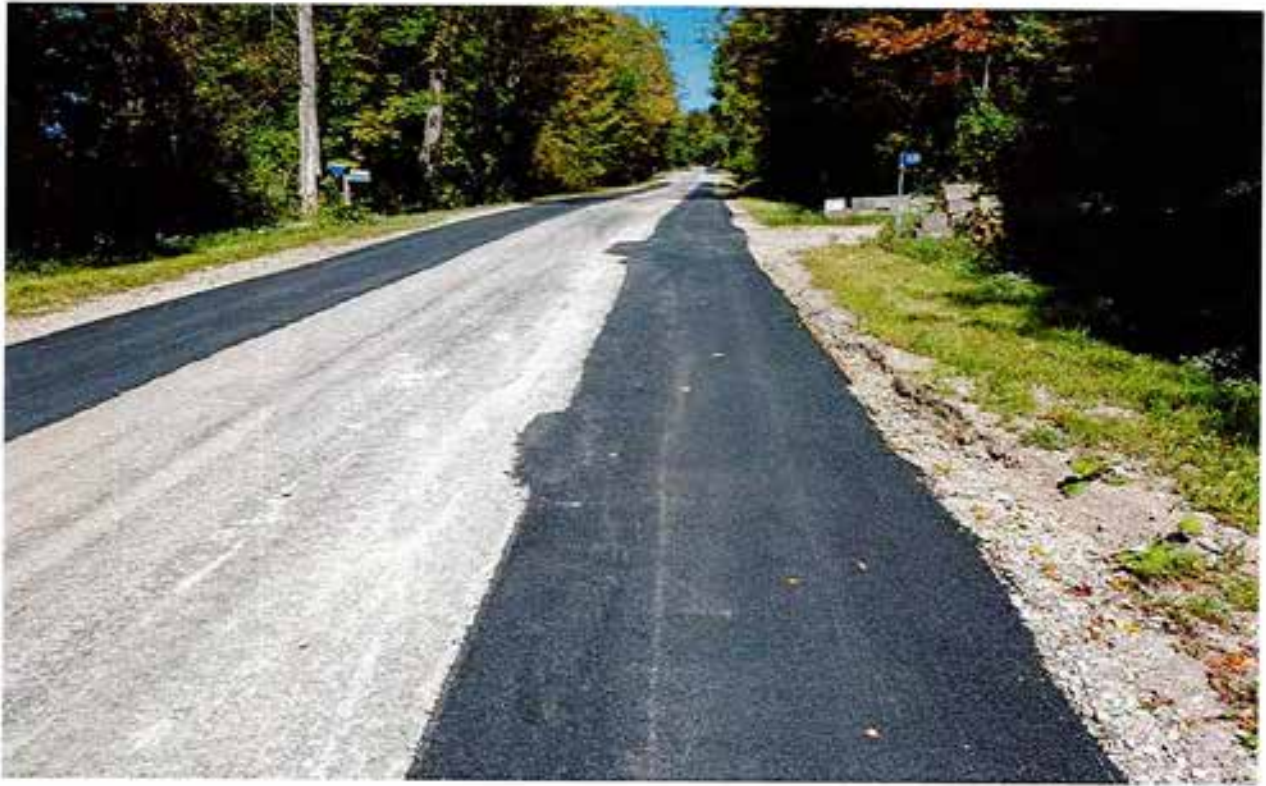
Osmun Road East lane and shoulder deterioration near 10200 (REPAIRED)

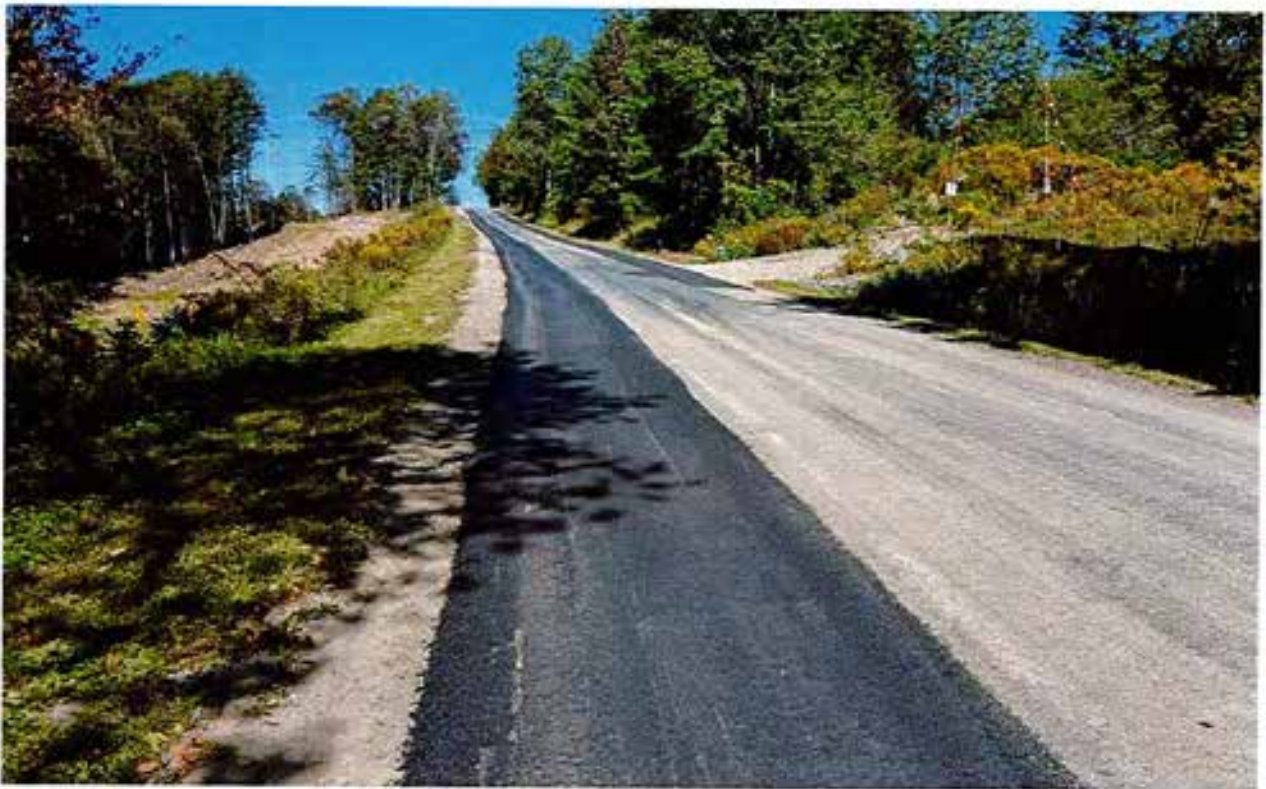
Osmun Rd lane deterioration North of 10220 near construction entrance (REPAIRED)

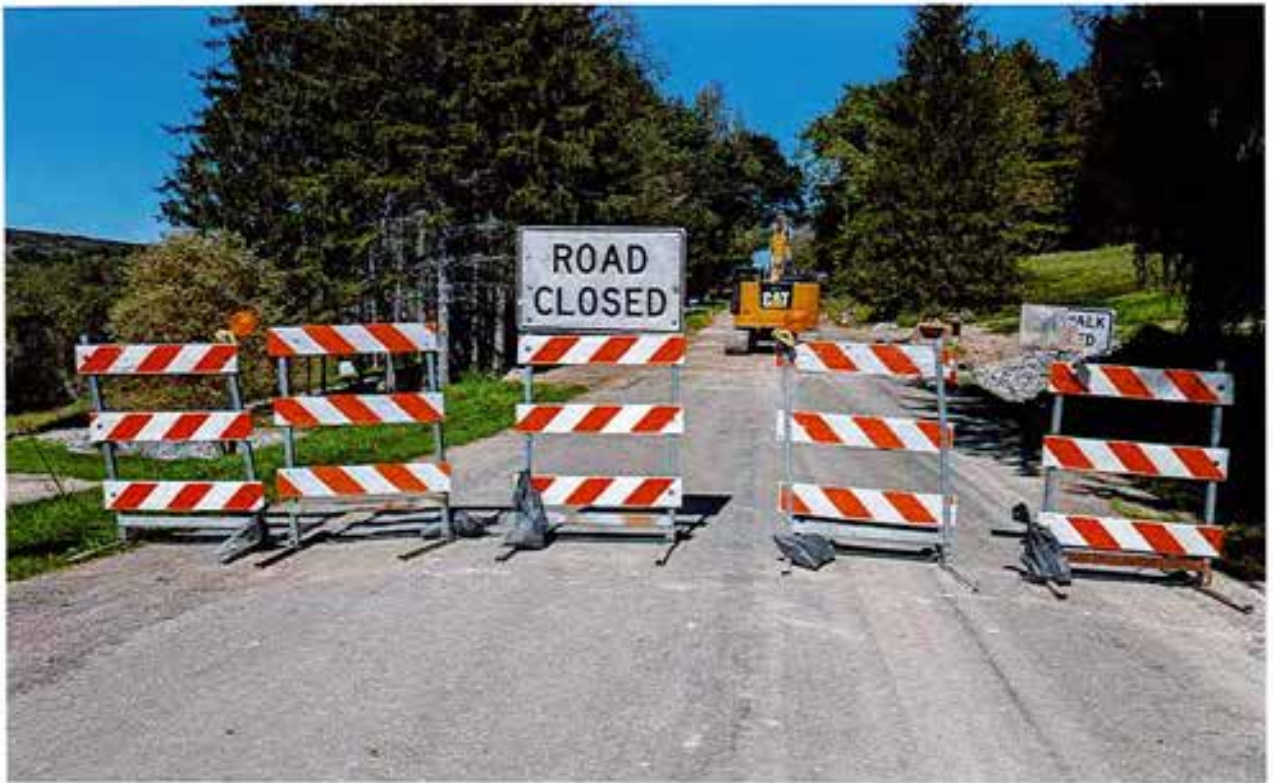
| Hazards Identified: | <ul style="list-style-type: none"> <li>- Curvert/road washout condition near 10379 Osmun Rd. (Repair in progress)</li> </ul> |

Osmun Rd: Road over Culvert near 10379 facing North (REPAIRS IN PROGRESS)

| Maintenance Needed: | <ul style="list-style-type: none"> <li>- Repair shoulder</li> <li>- Maintain diversion ditch and install additional erosion control measures near 10379 Osmun</li> </ul> |

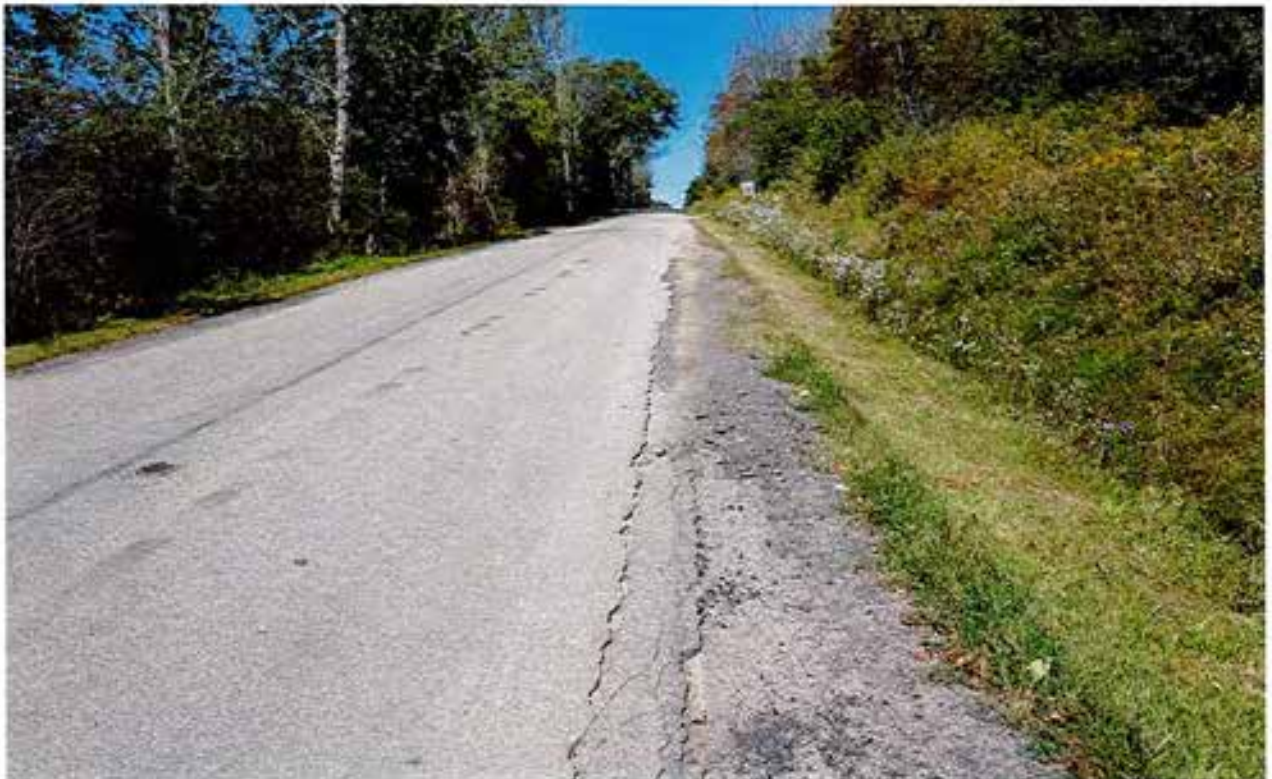
Osmun Rd East side lane, edge, and shoulder deterioration North and South of 10410

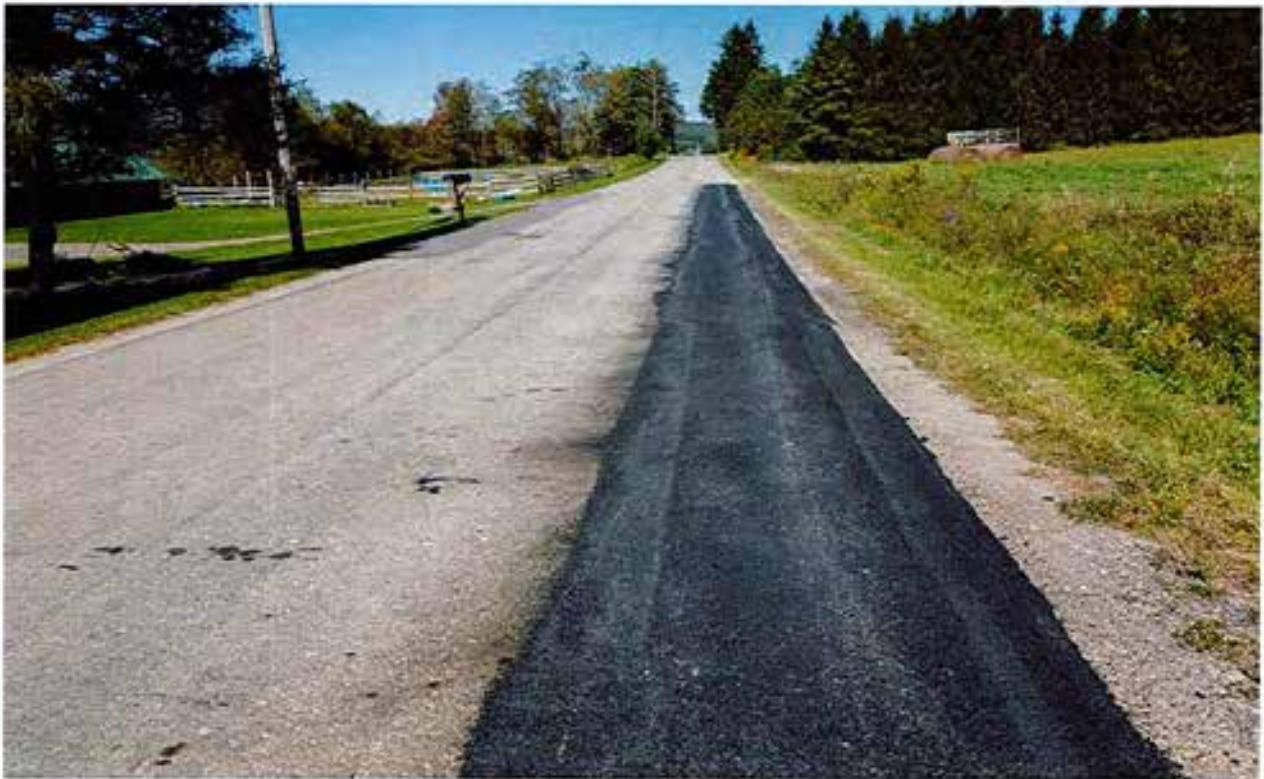
Osmun Road East edge and shoulder deterioration near 10571 (REPAIRED)

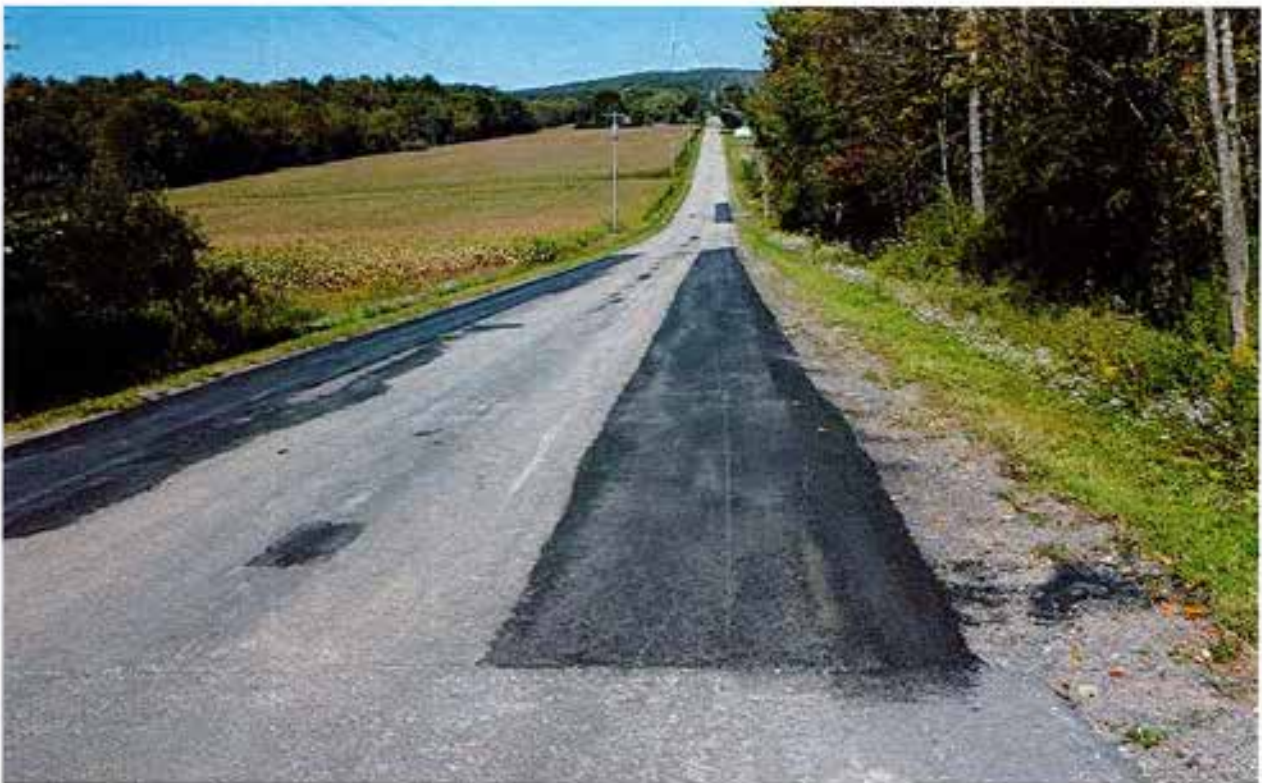
Osmun Rd edge deterioration South of 10674 (REPAIRED)

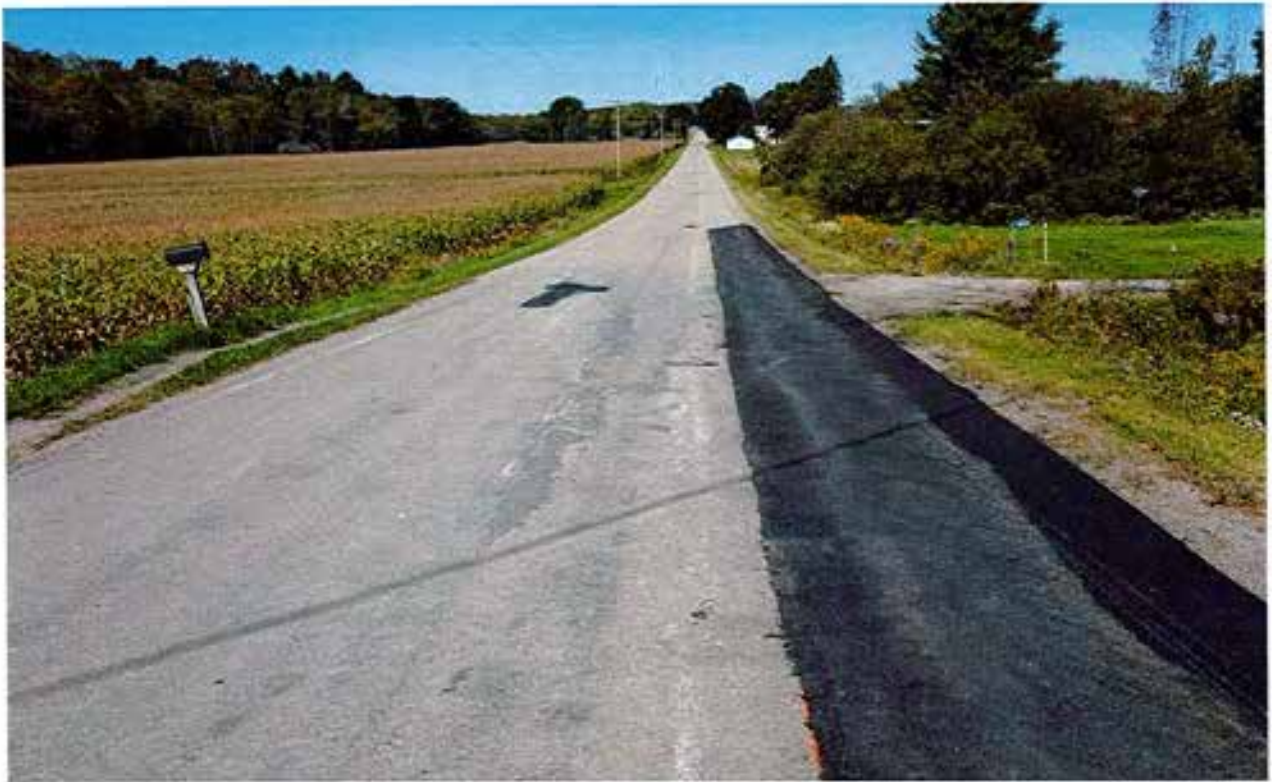
Osmun Road lane deterioration near 10674

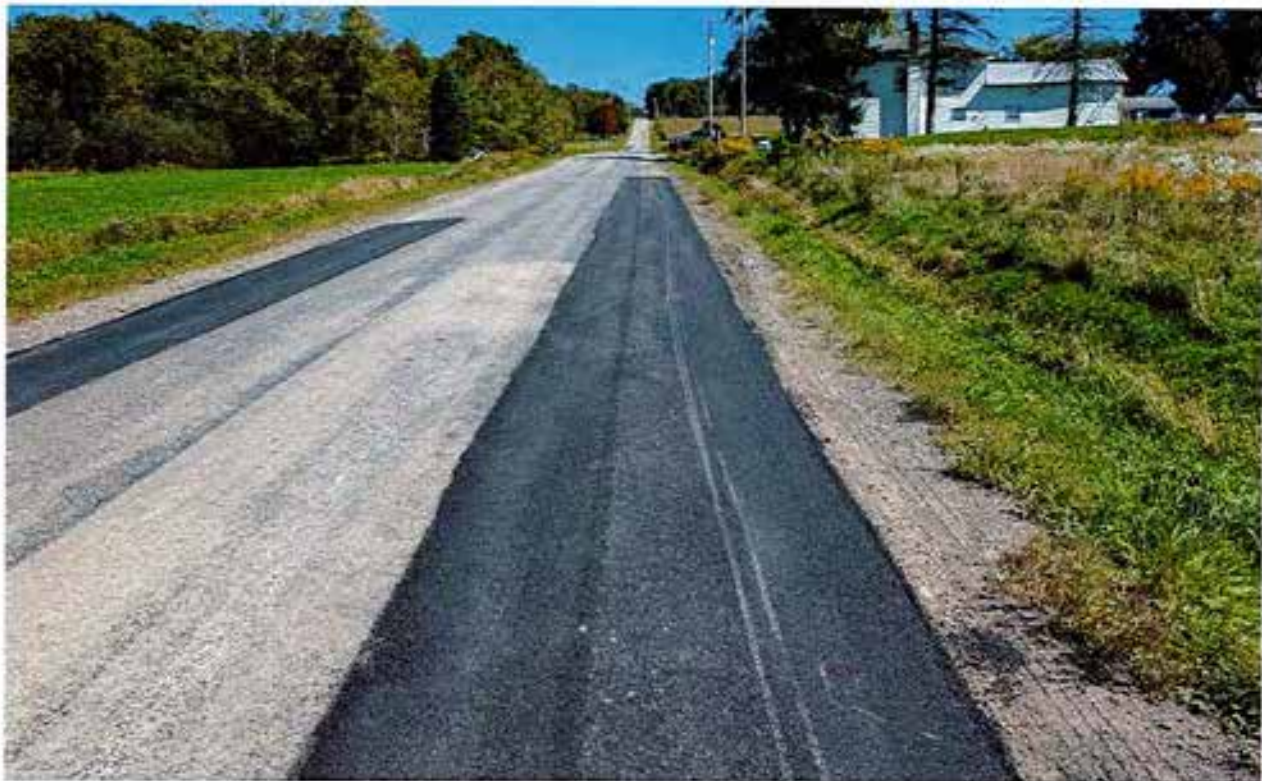
Baird Rd South shoulder deterioration East and West of 379 (REPAIRED)

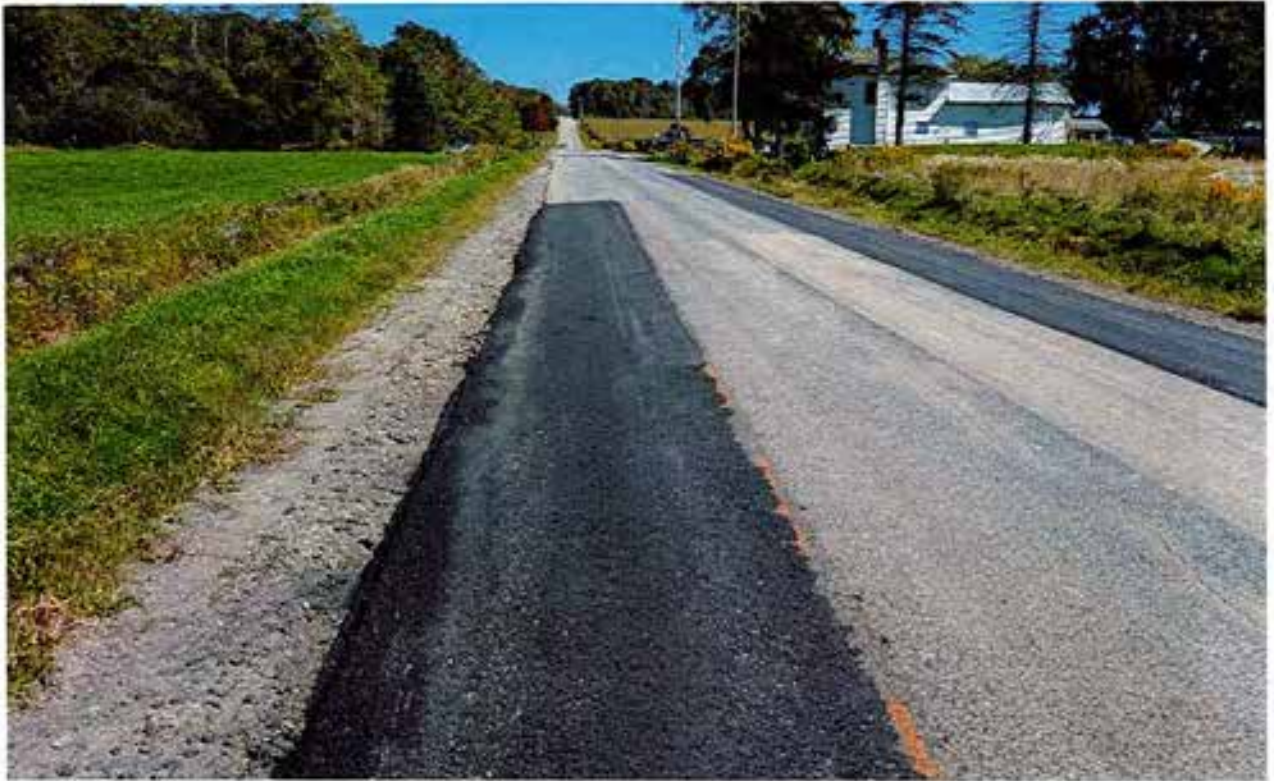
Baird Rd North shoulder deterioration East and West of 379 (REPAIRED)

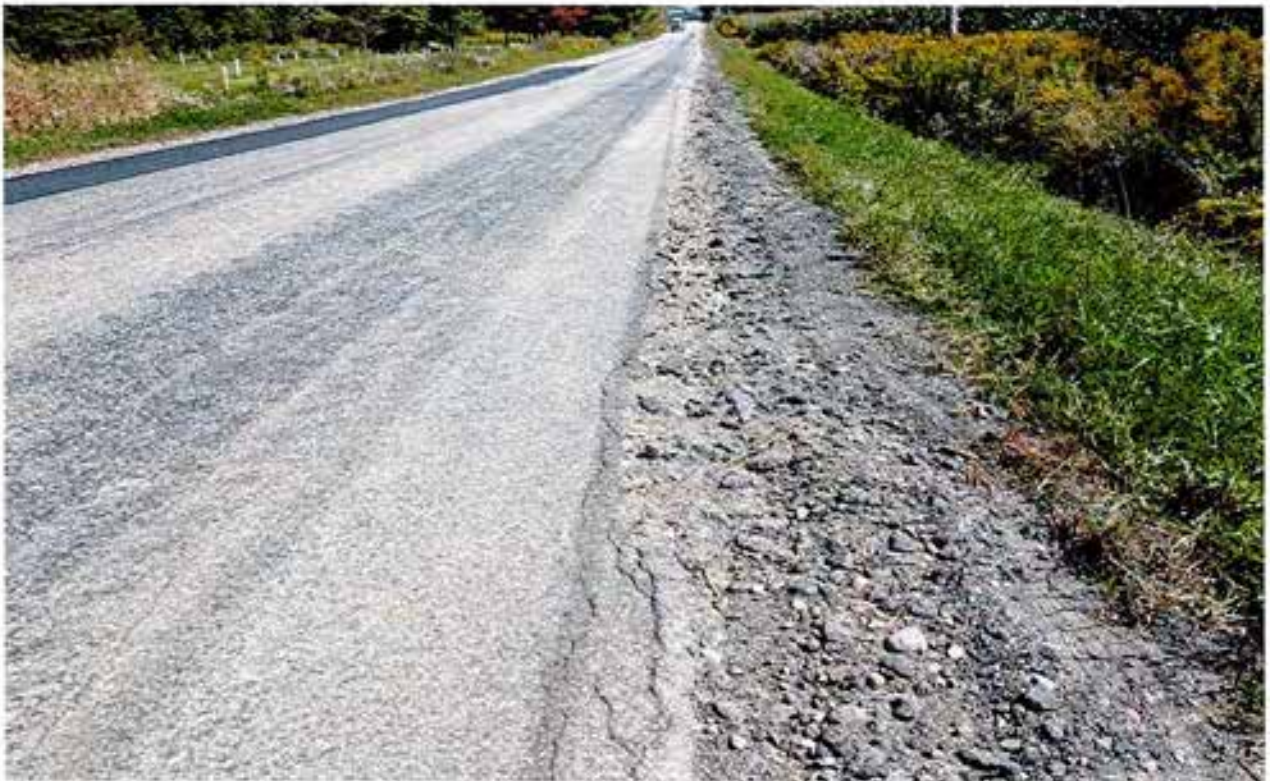
| Hazards Identified: | - Deterioration of shoulder South edge from +/- 379 to +/- 253 |

Baird Road South edge deterioration from +/- 379 to +/- 253

| Maintenance Needed: | - Repair shoulder |

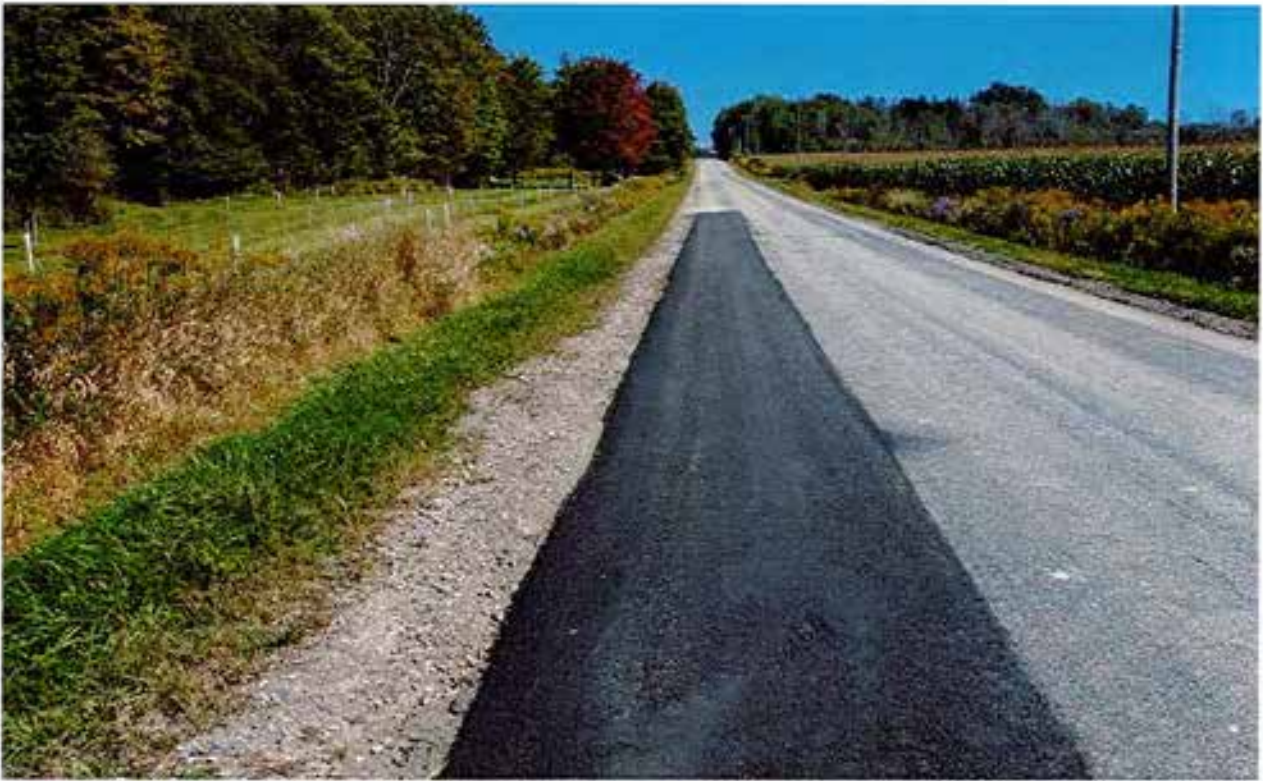
Baird Road North edge deterioration from +/- 379 to +/- 253 (REPAIRED)

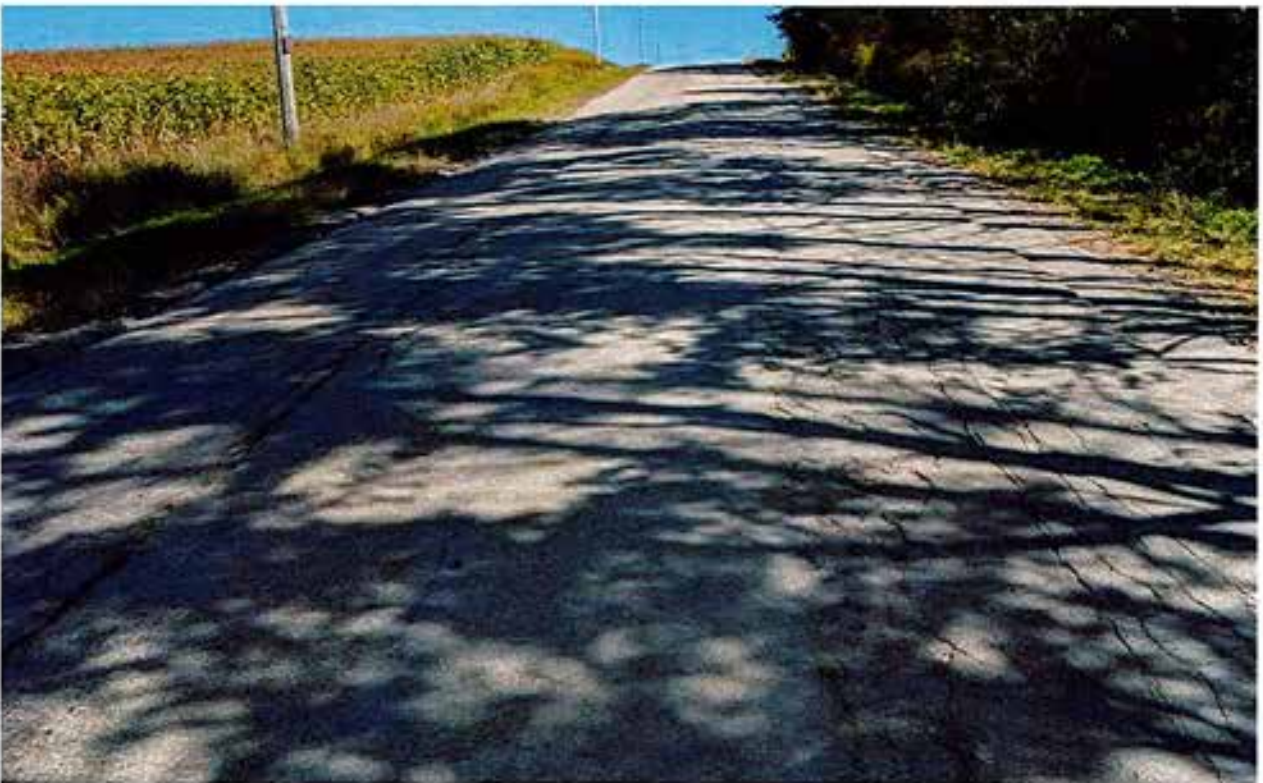
Baird Road lane deterioration from 253 to 187
