## Road Condition & Vehicle Compliance Report

| Report # | 59 |
| Project Name | Alle-Catt Wind |
| Location | Town of Freedom |

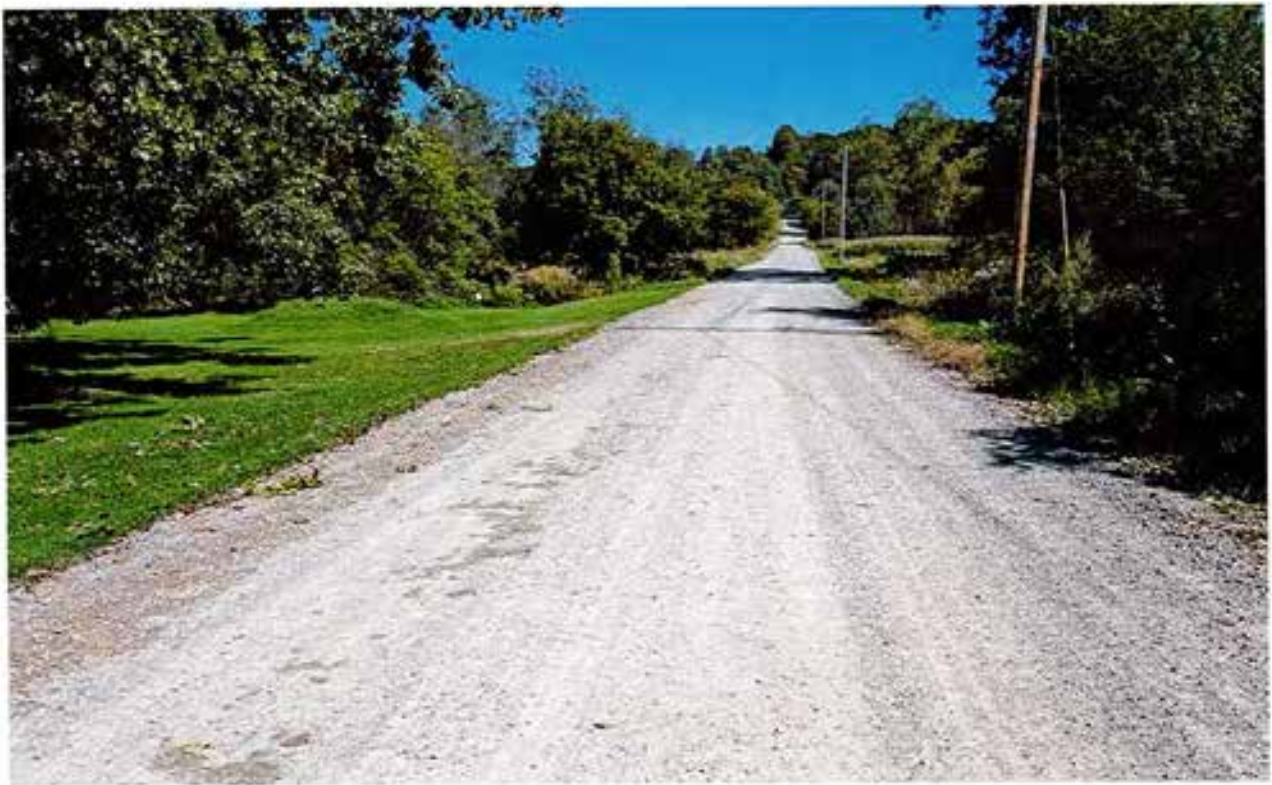
Jones Rd

| Non-Hazard Items for Continued Observation: | - Jones Rd. should be paved from Route 98 to the bridge, see this page for photo. |

| Maintenance Needed: | - Repair this spring. |
