## Road Condition & Vehicle Compliance Report

| Report # | 60 |
| Project Name | Alle-Catt Wind |
| Location | Town of Freedom |

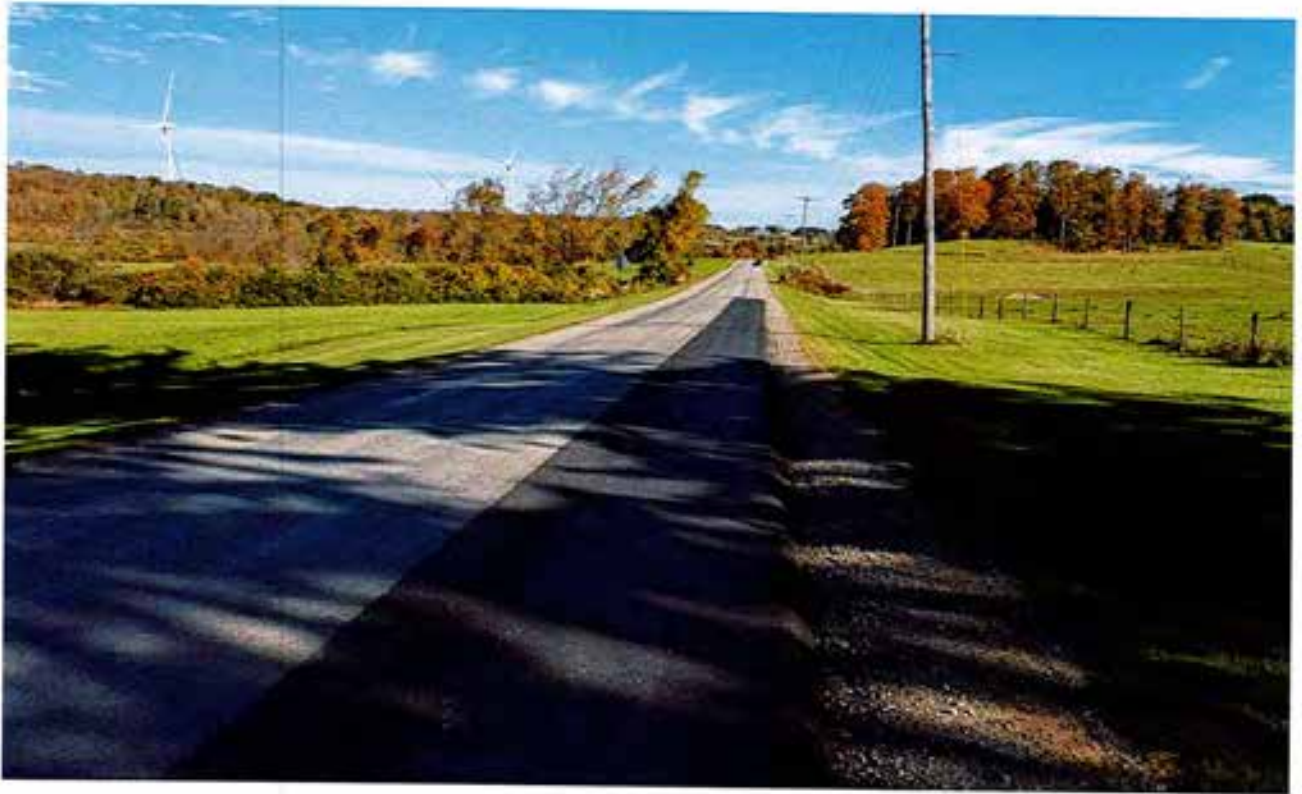
East edge of North Road (REPAIRED)

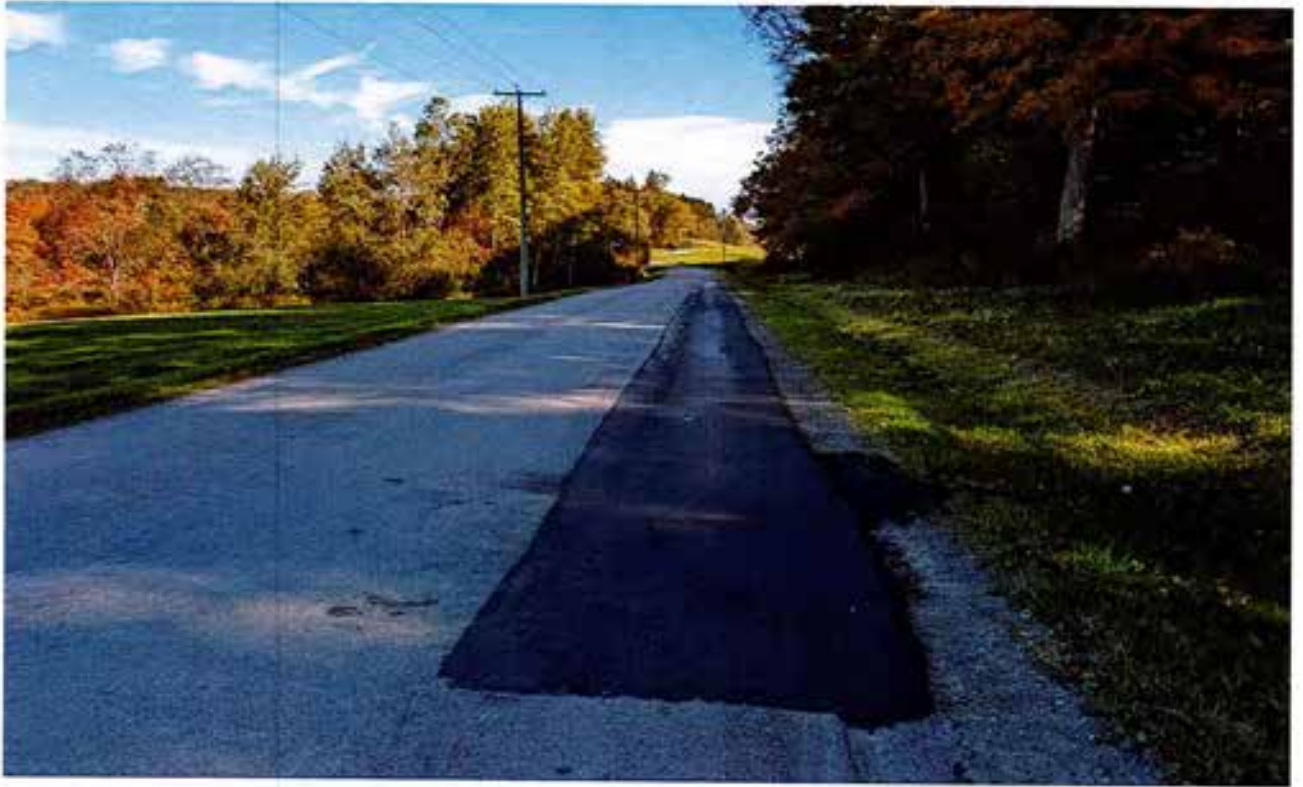
East edge of North Road (REPAIRED)

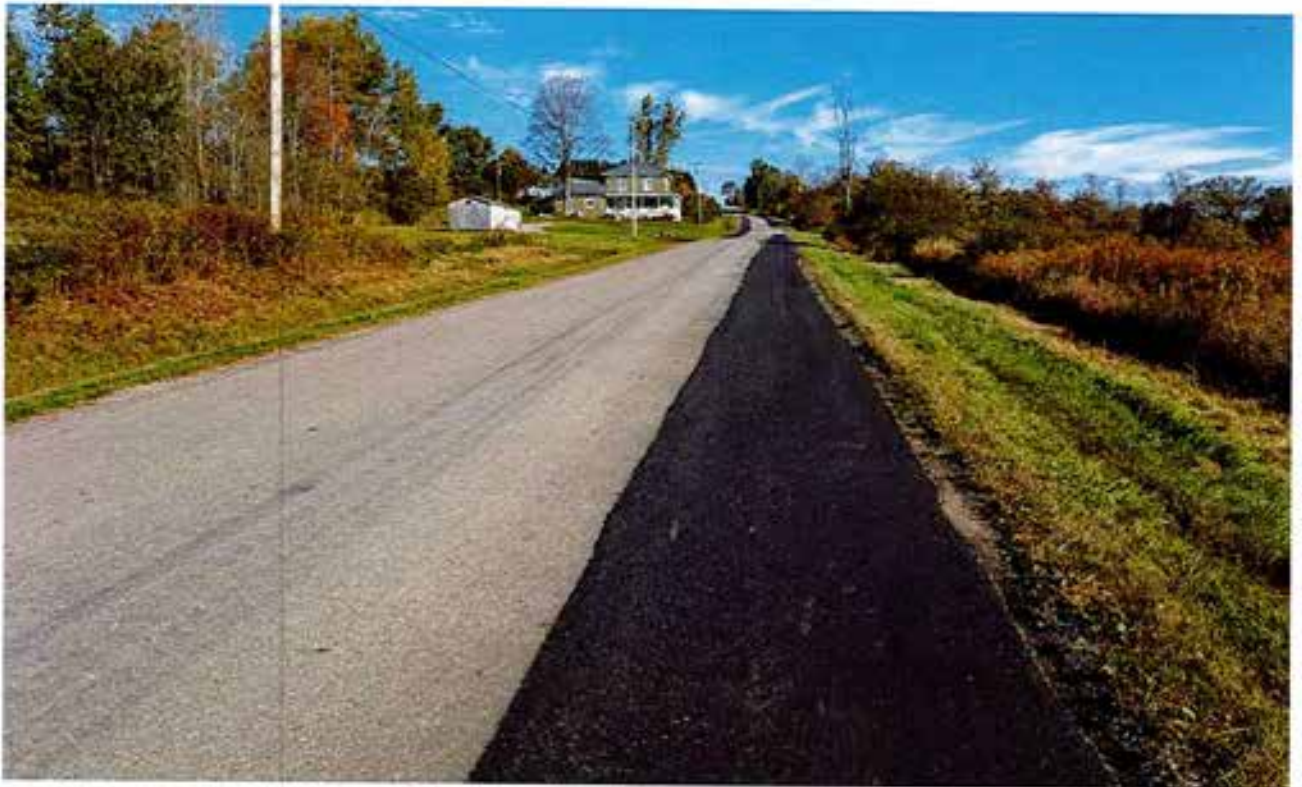
East edge of North Road (REPAIRED)

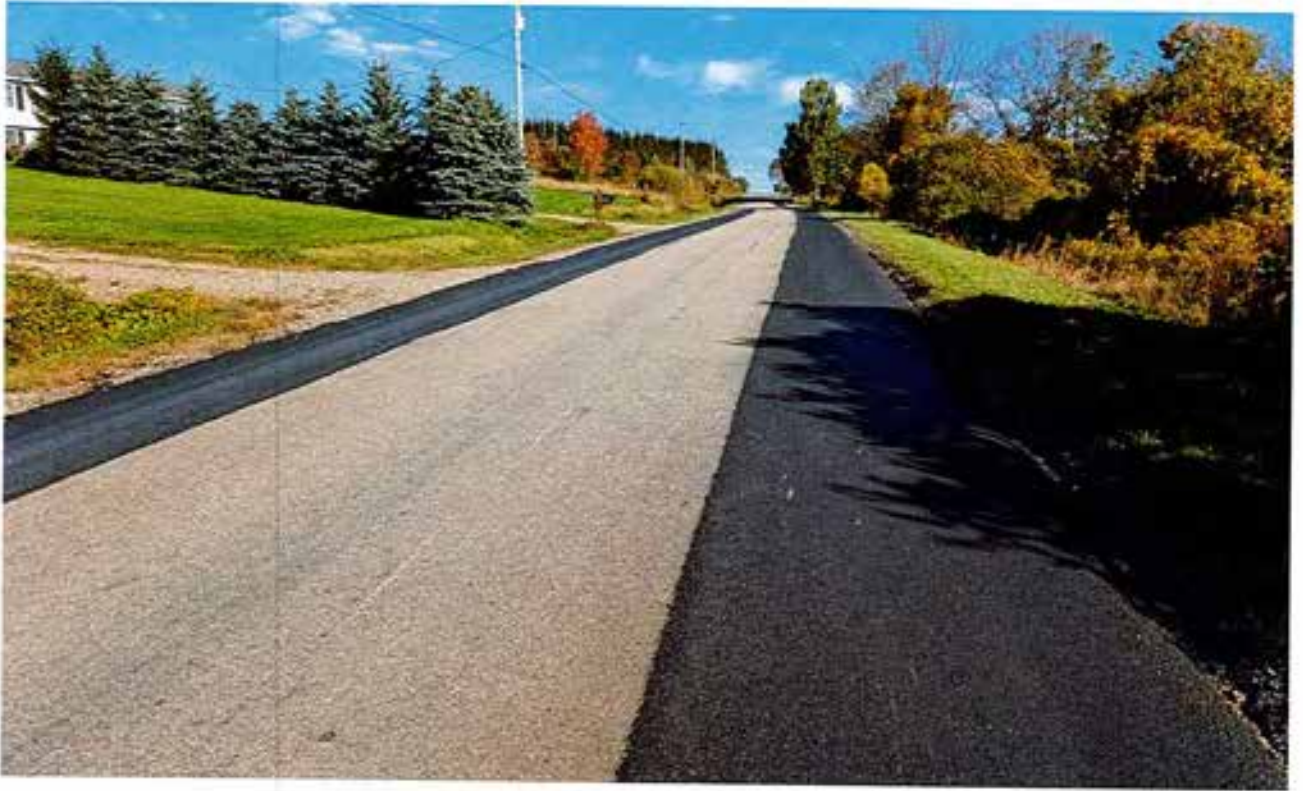
North Road East edge and shoulder near 11509 (REPAIRED)

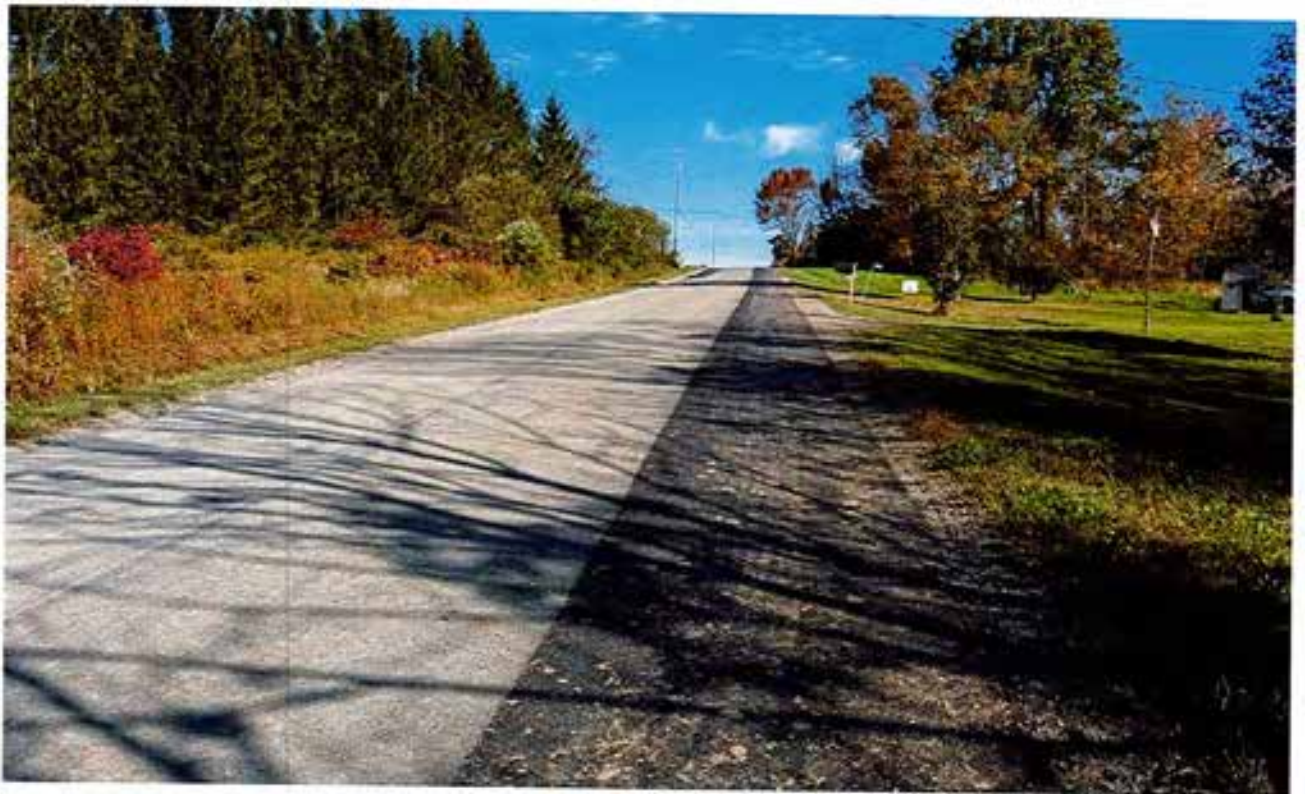
North Road East edge near 11582 (REPAIRED)

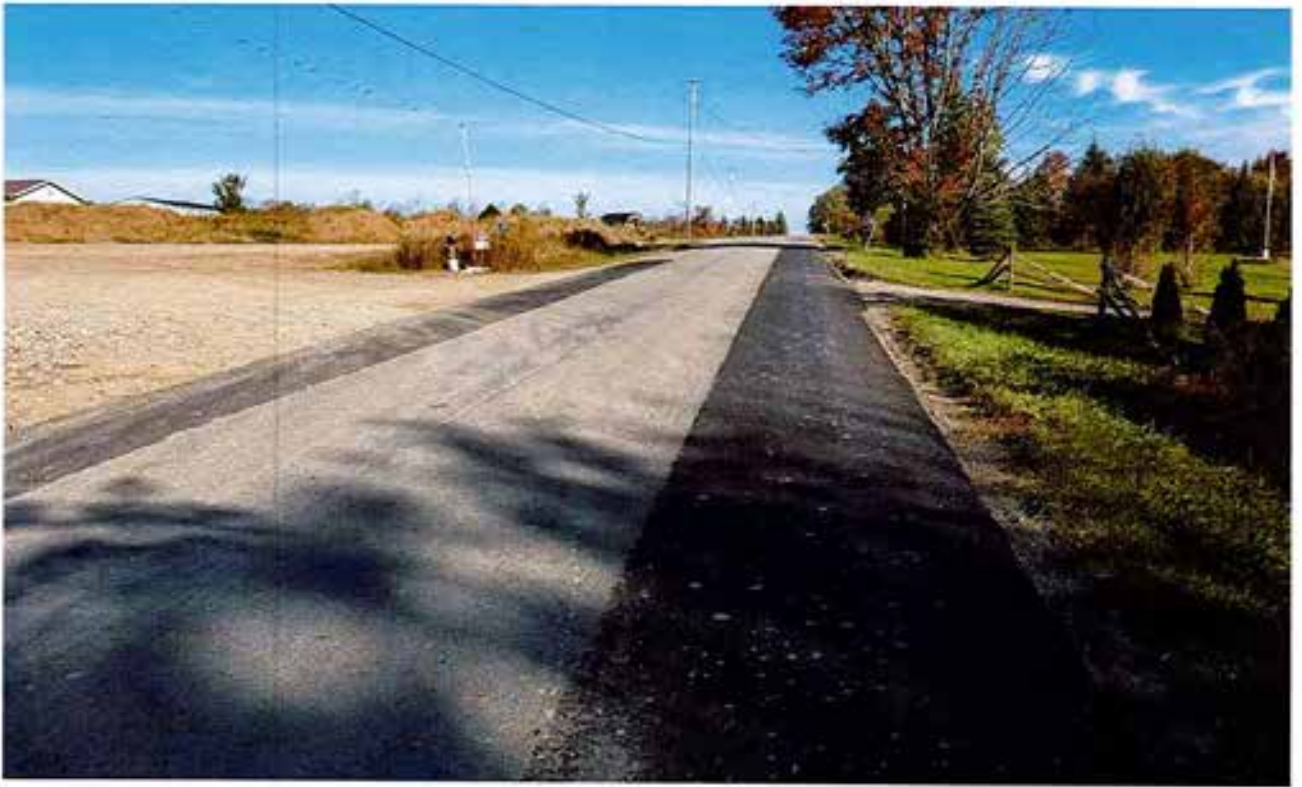
North Road North edge and shoulder near 11614 (REPAIRED)

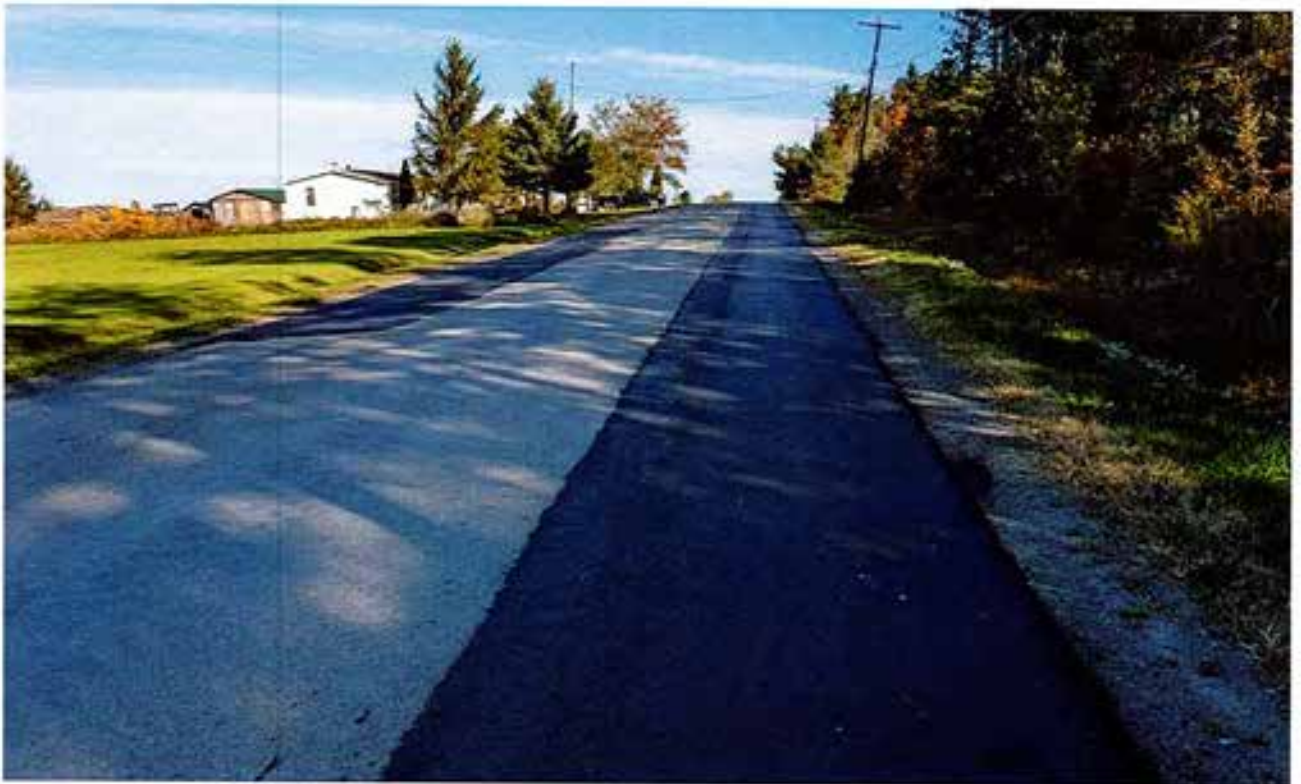
North Road lane and edge South of 11875 (REPAIRED)

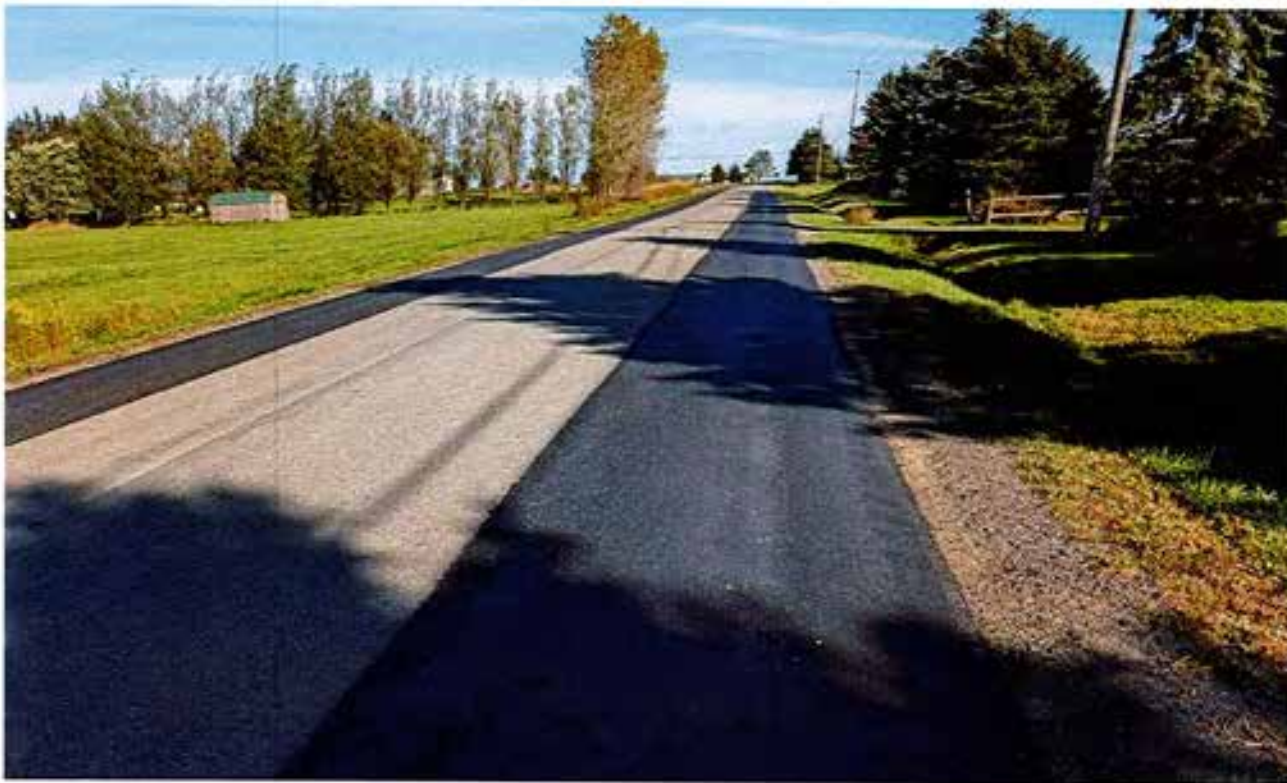
North Road lane, edge, and shoulder near 11980 (REPAIRED)

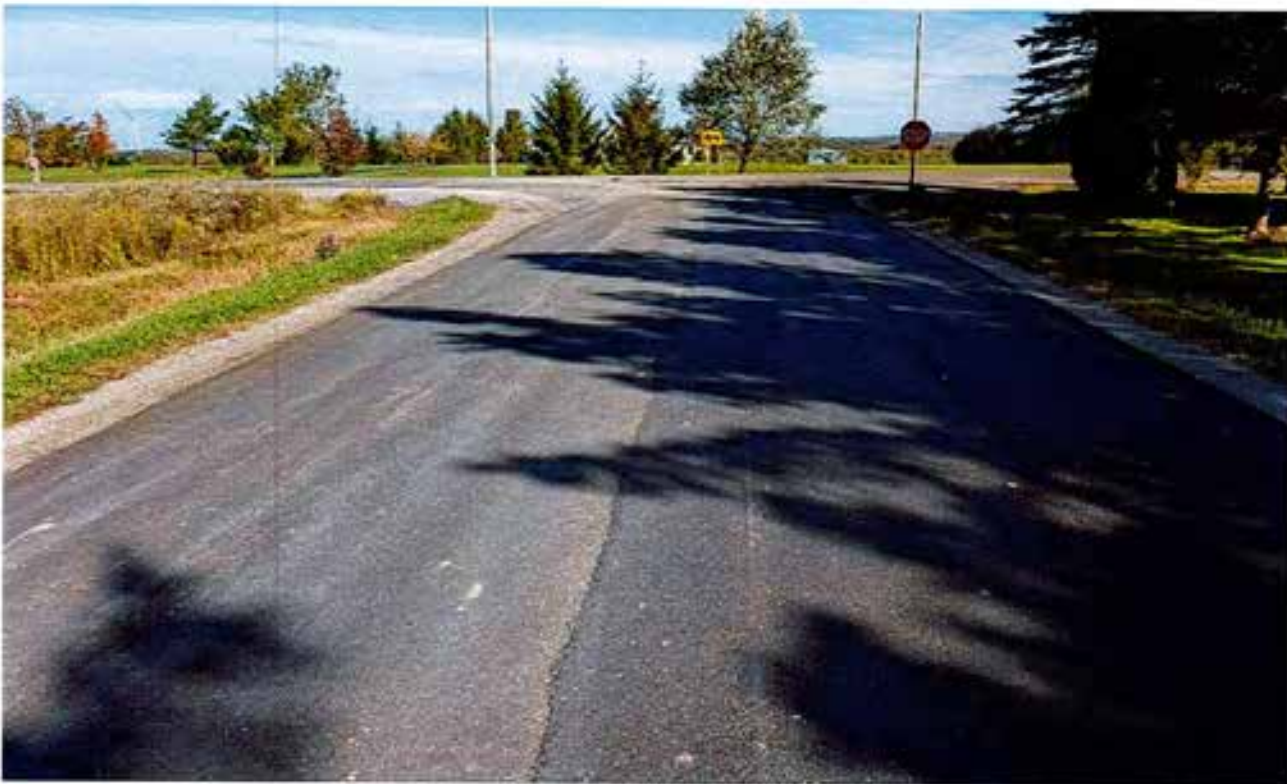
North Rd near intersection with Bray Rd (REPAIRED)

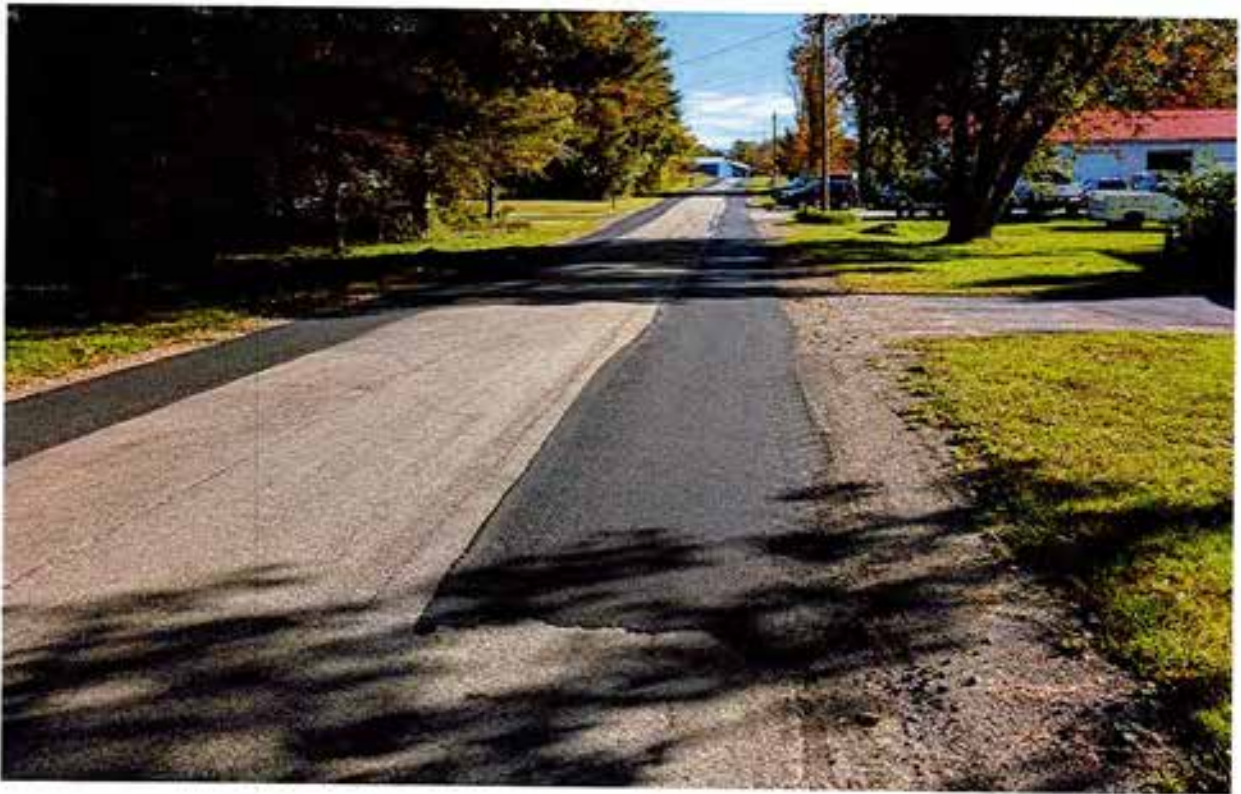
Eagle Street lane and edge near 1253 (REPAIRED)

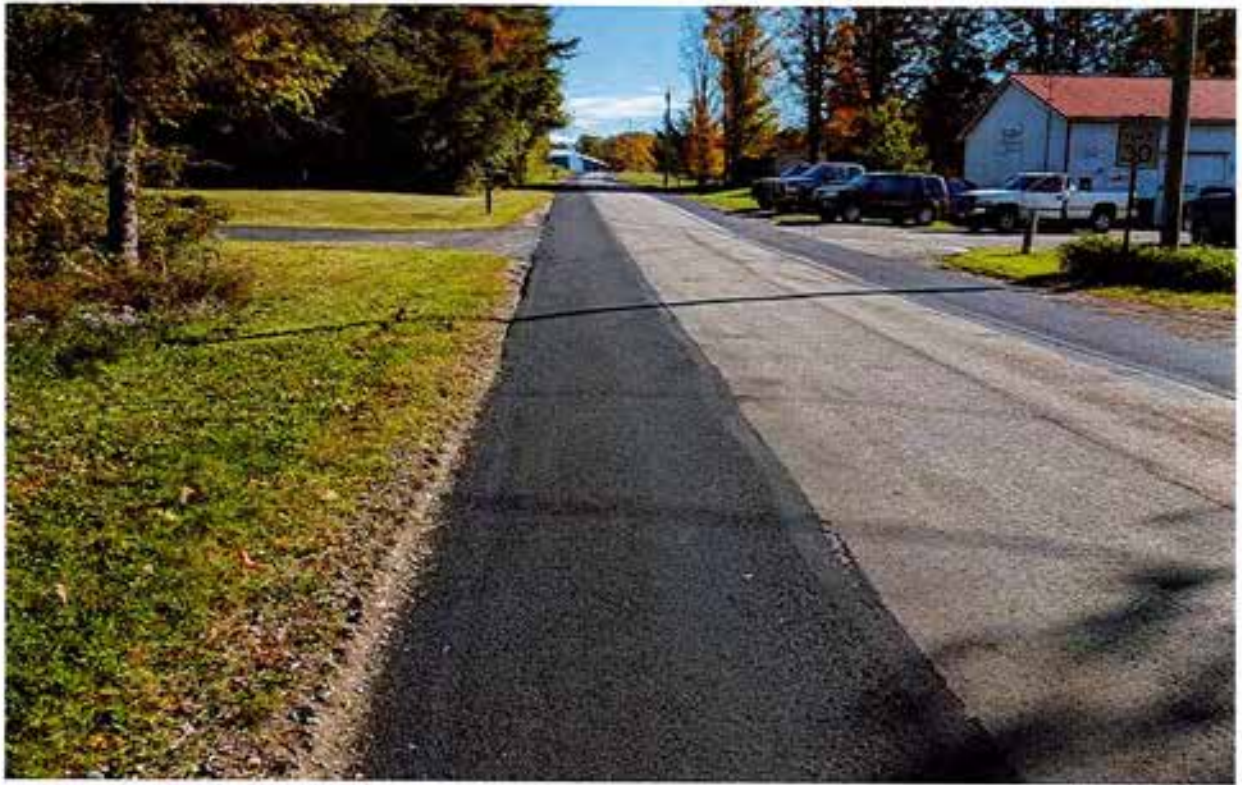
Eagle Street East and West side lane and edge near 1244 (REPAIRED)

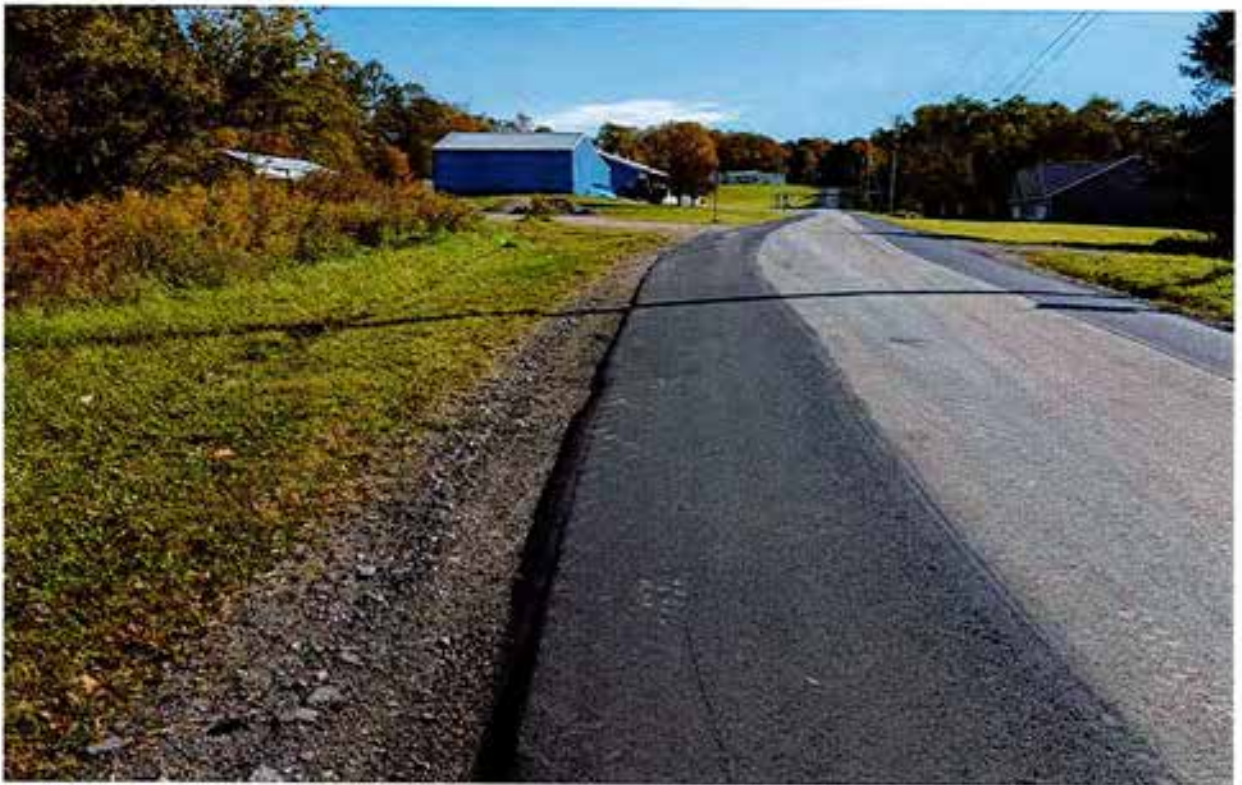
Eagle Street North and South side lane and edge near 1219 (REPAIRED)

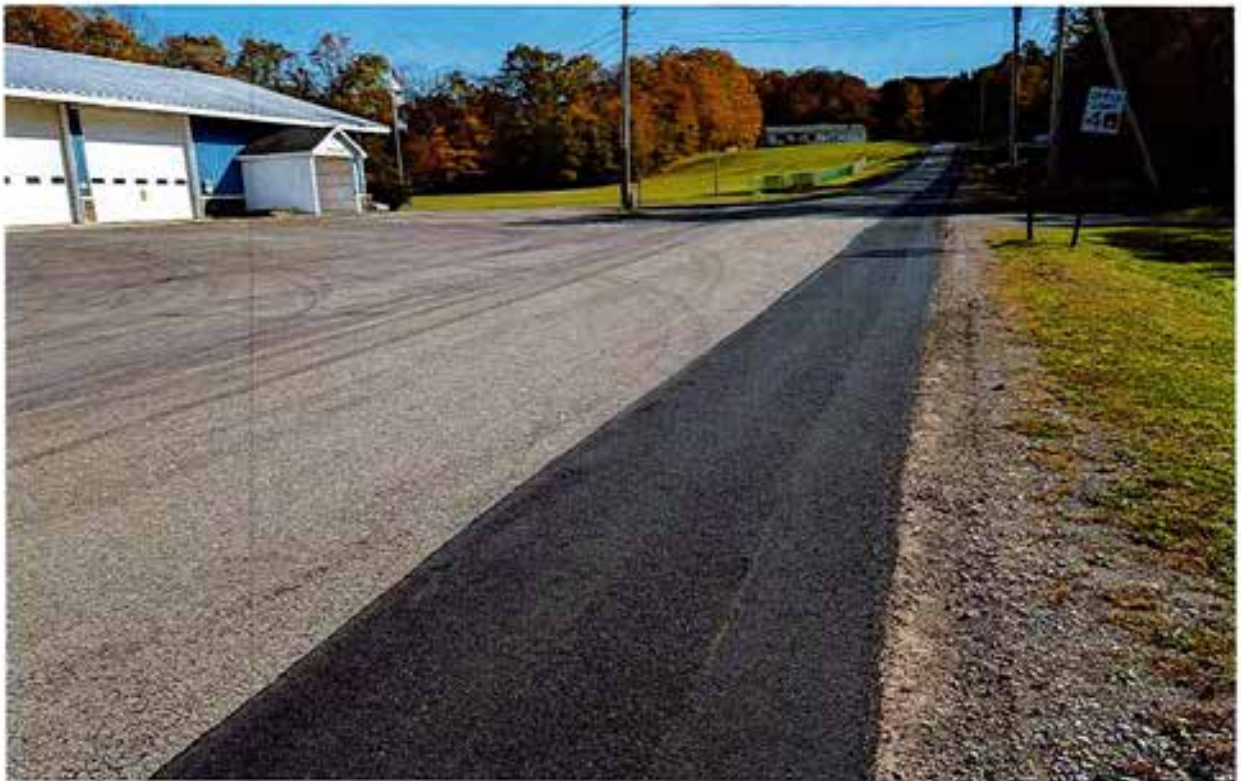
Eagle Street South side lane and edge near 11405 (REPAIRED)

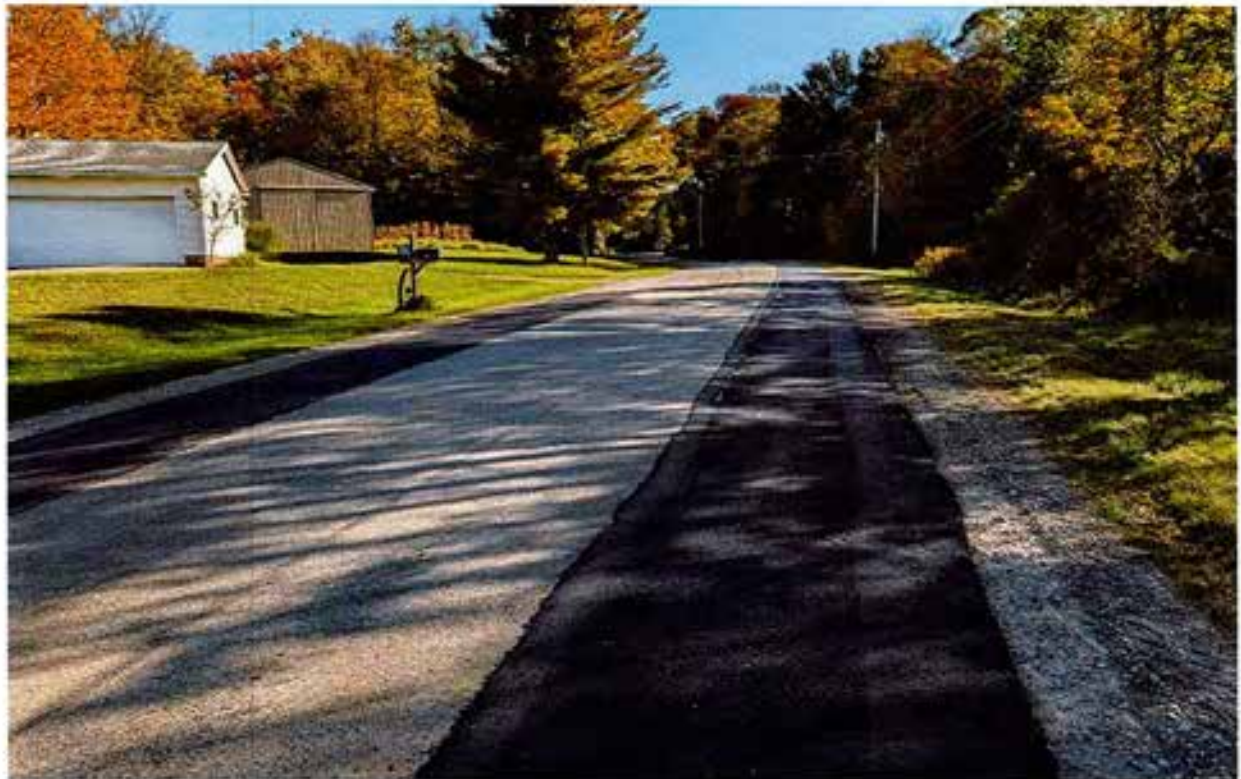
Eagle Street lane and edge near 1152 (REPAIRED)

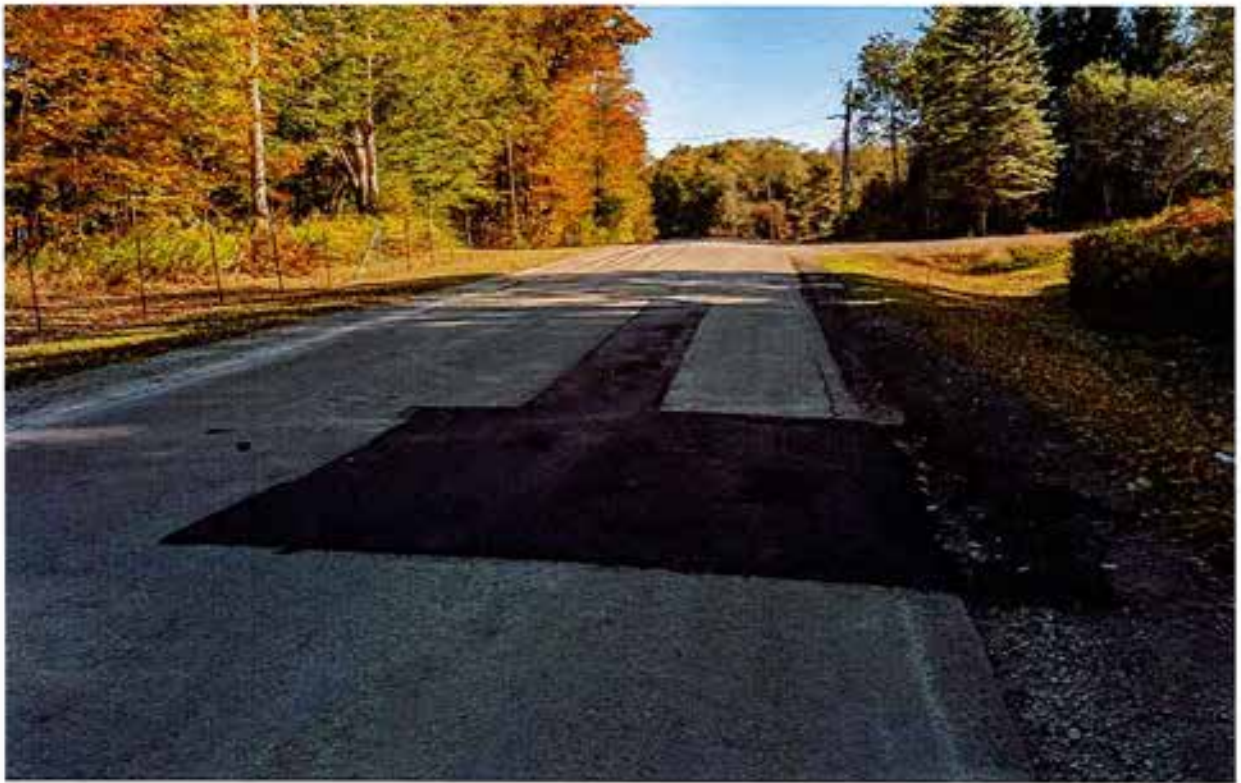
Eagle Street lane and shoulder near 1111 (REPAIRED)

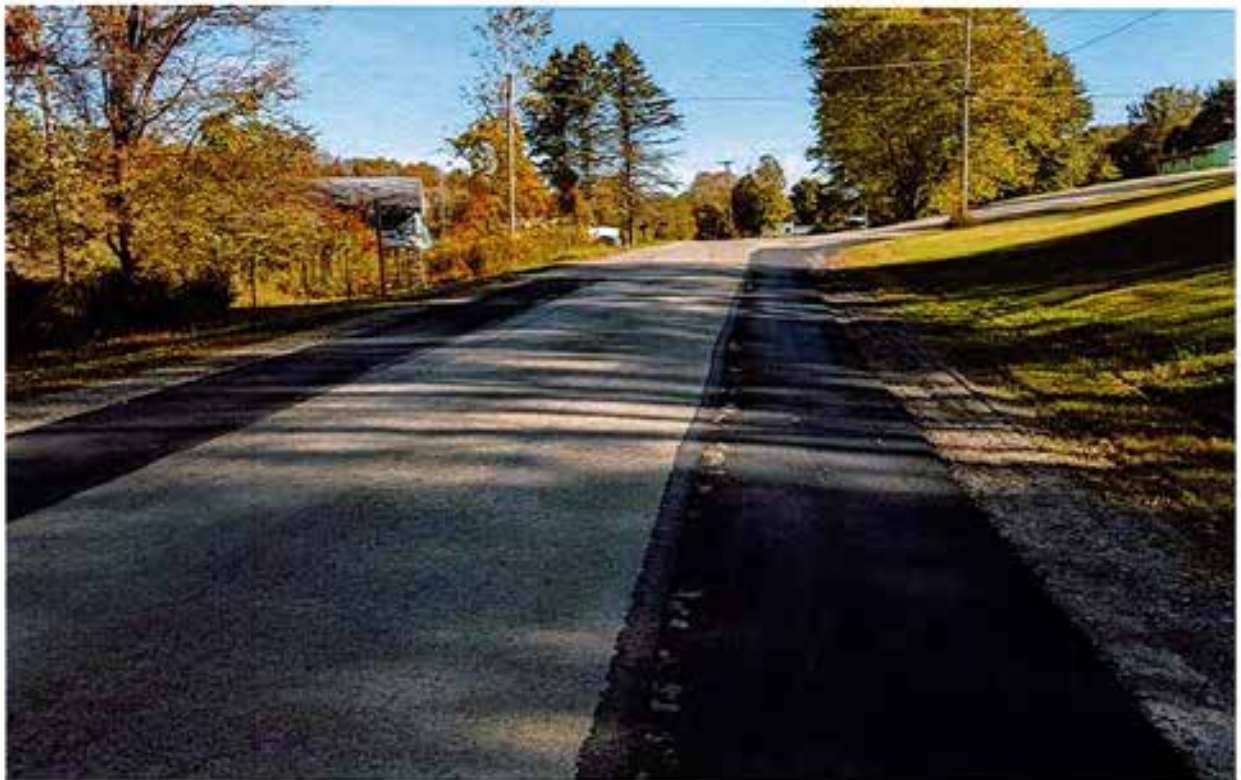
Eagle Street East edge near Hughes (REPAIRED)

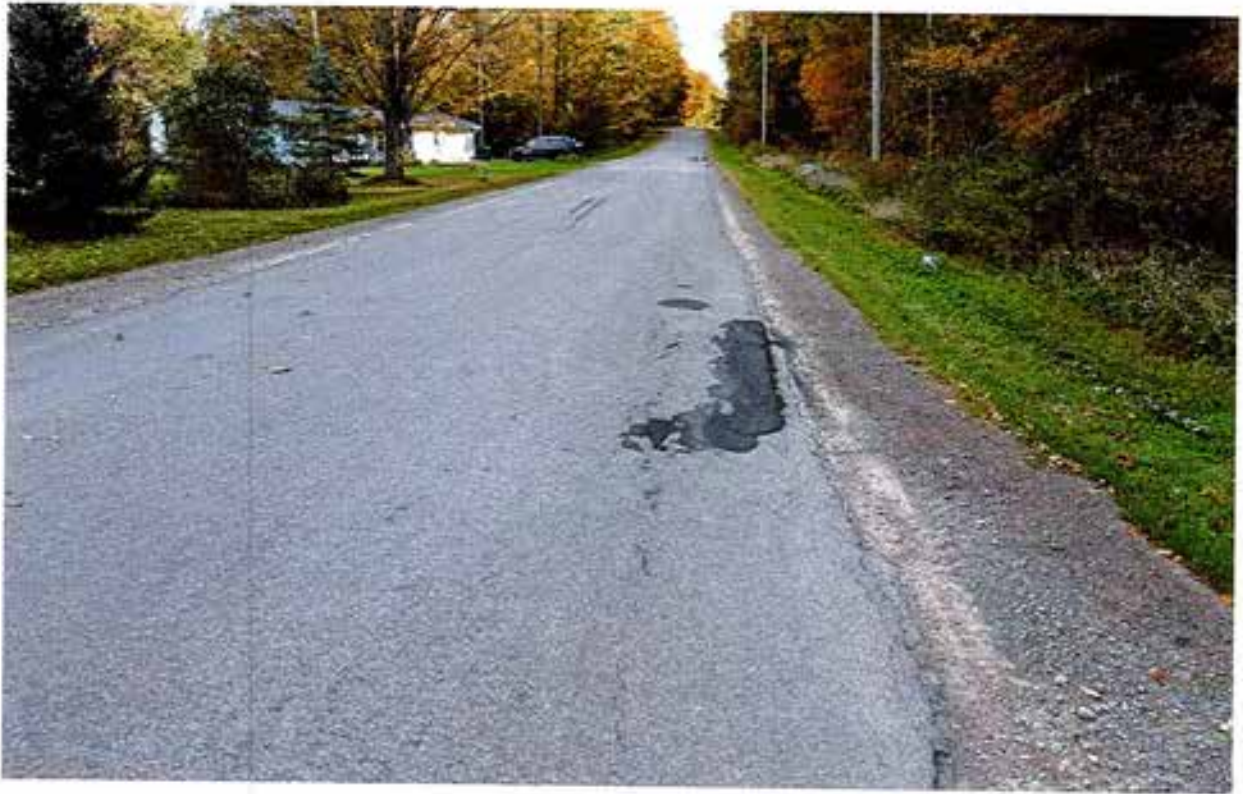
Eagle Street lane and East edge near 994 (REPAIRED)

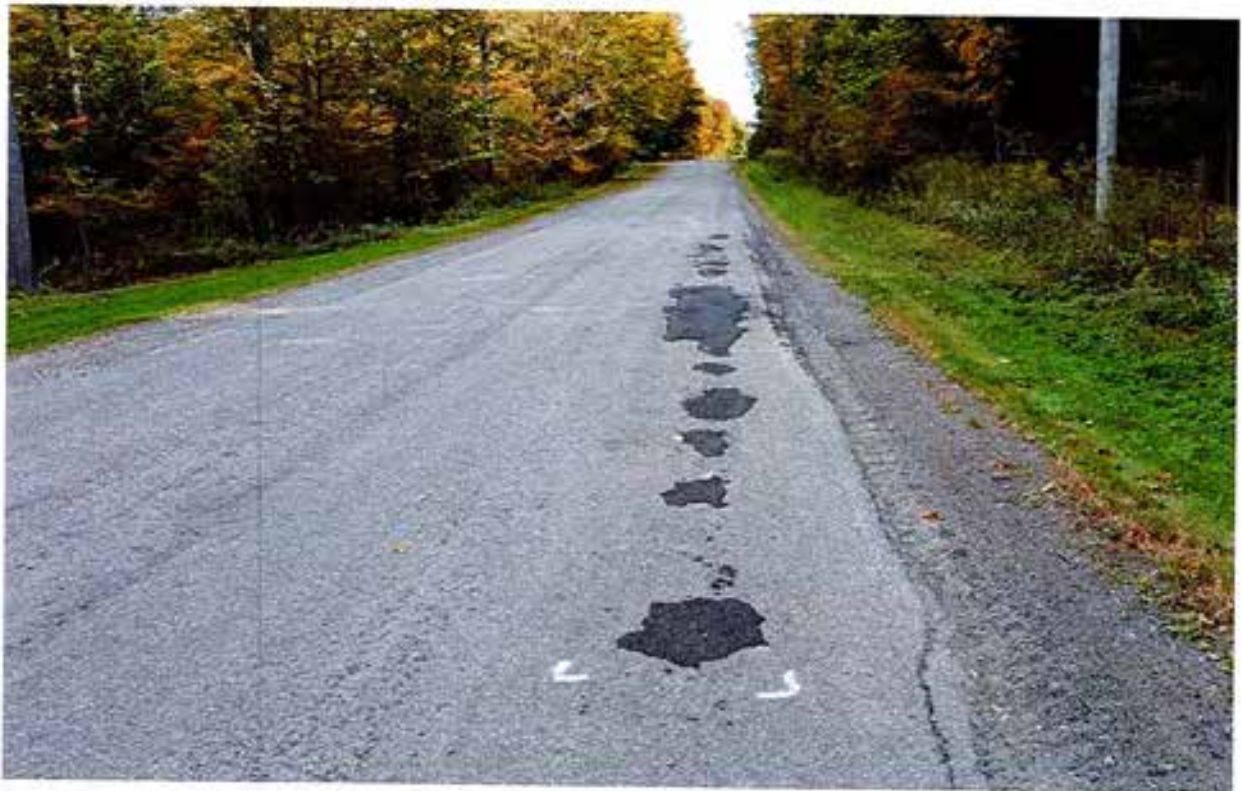
Eagle Street lane near 1000 (REPAIRED)

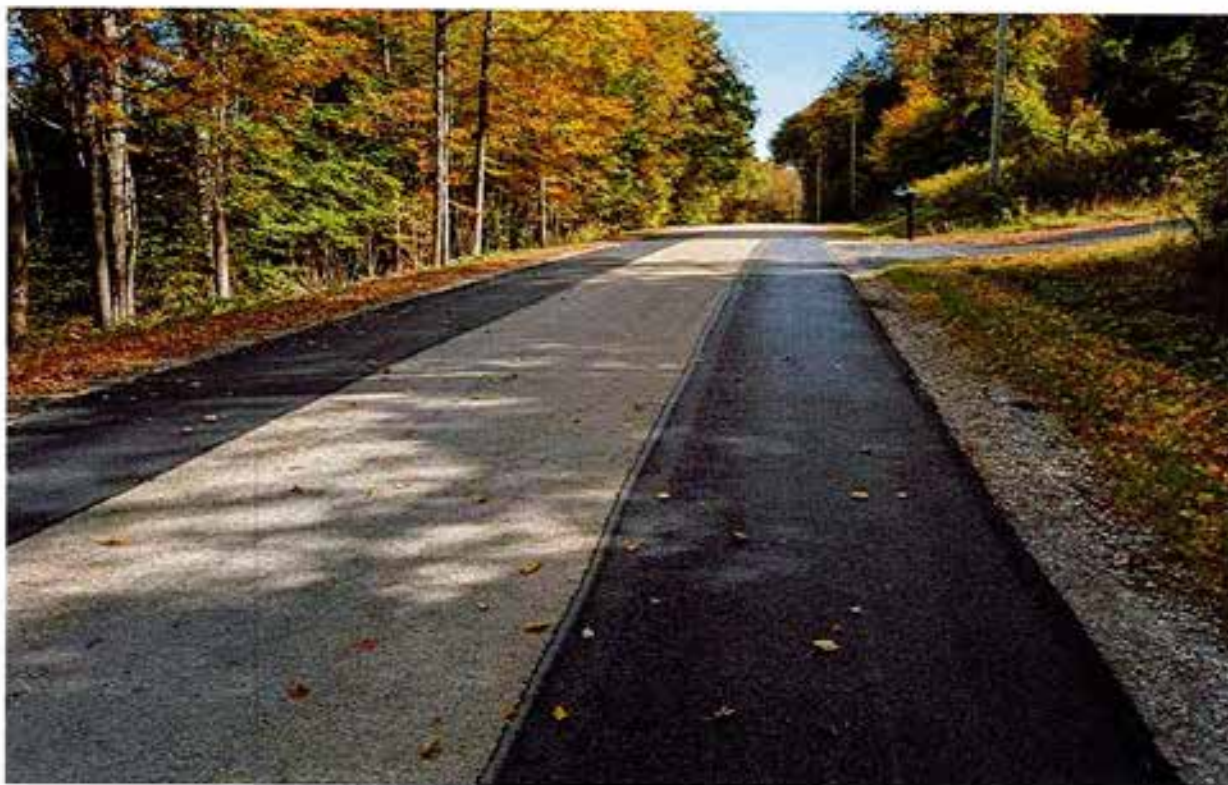
Eagle Street lane and edge near 931 (REPAIRED)

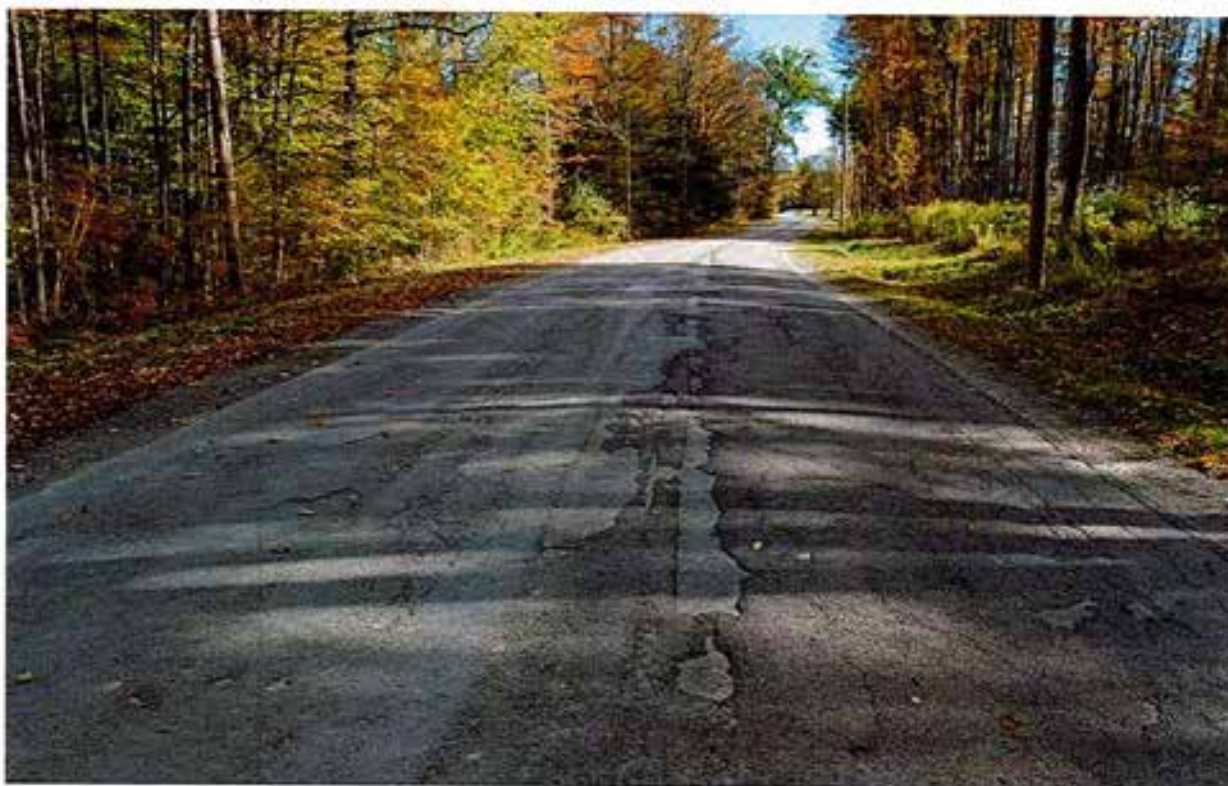
| Non-Hazards Identified: | - Eagle Street lane deficiency near 915 |

Eagle Street lane near 915

| Maintenance Needed: | - Repair lane |

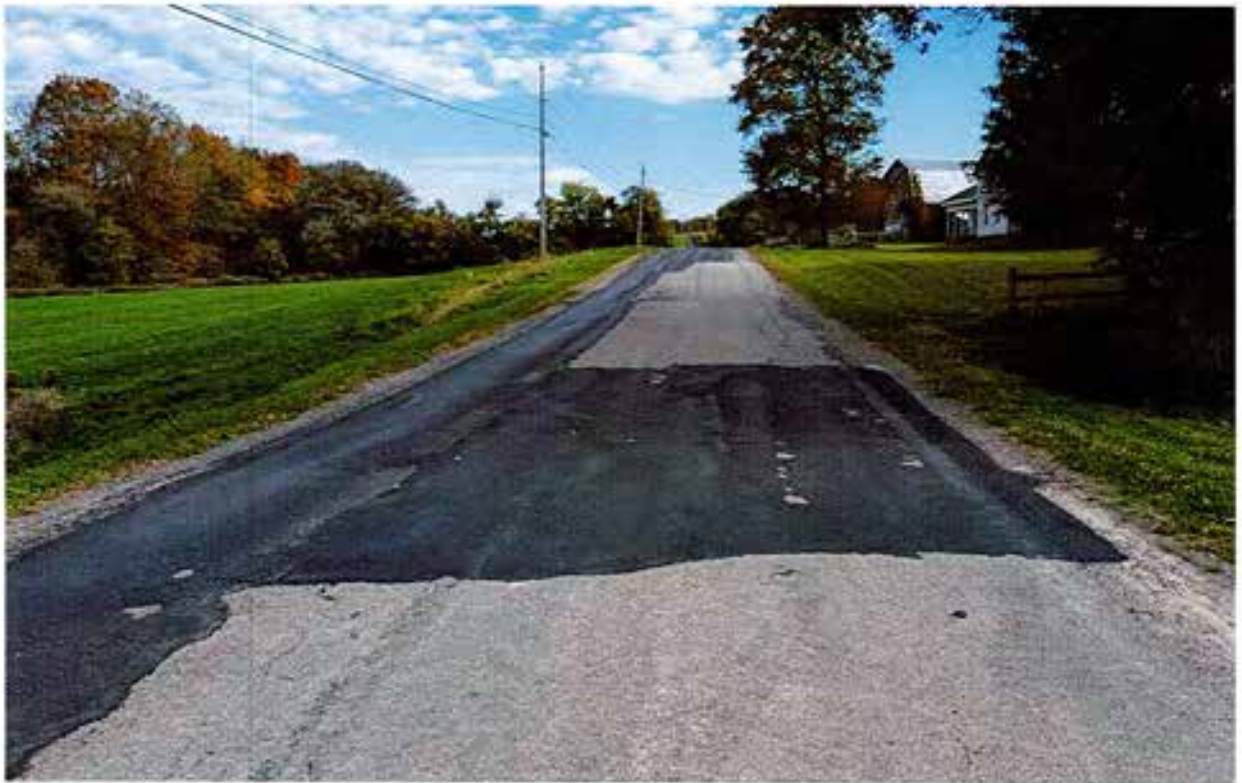
Eagle Street lane South of 849 (REPAIRED)

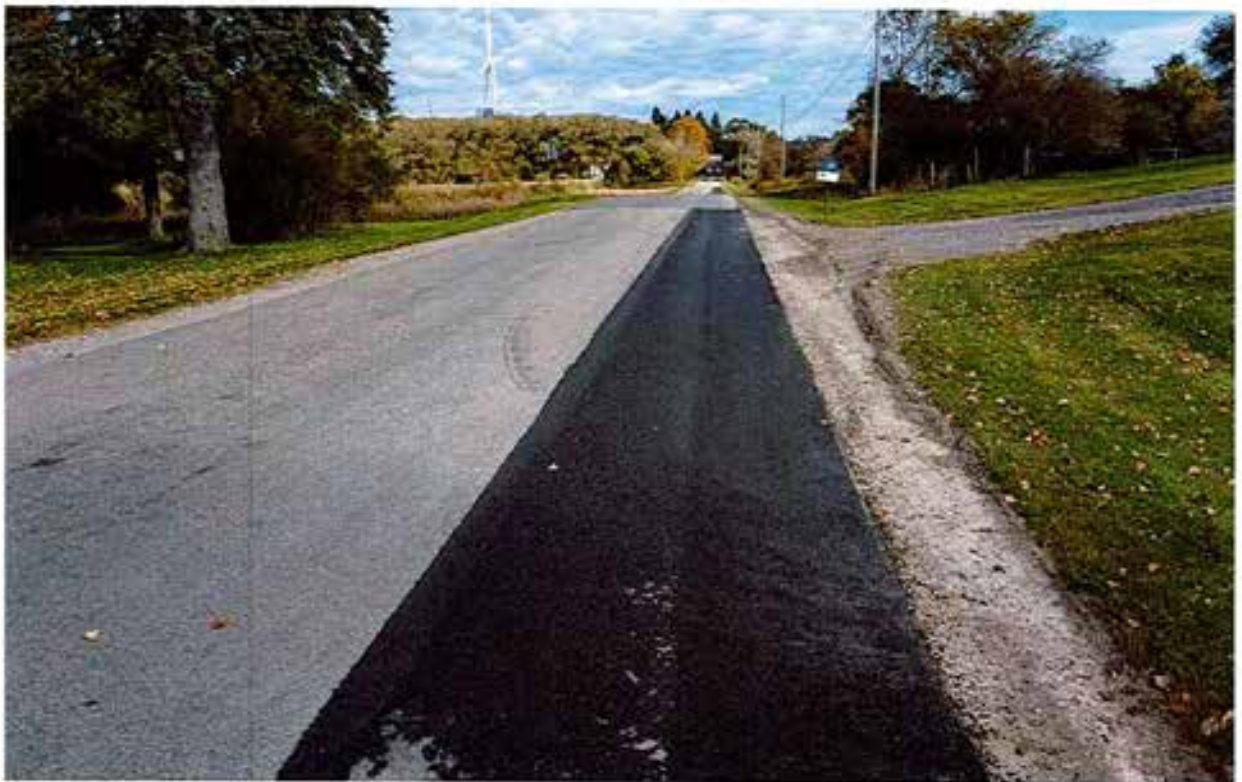
Eagle Street East edge and shoulder near 757 (REPAIRED)

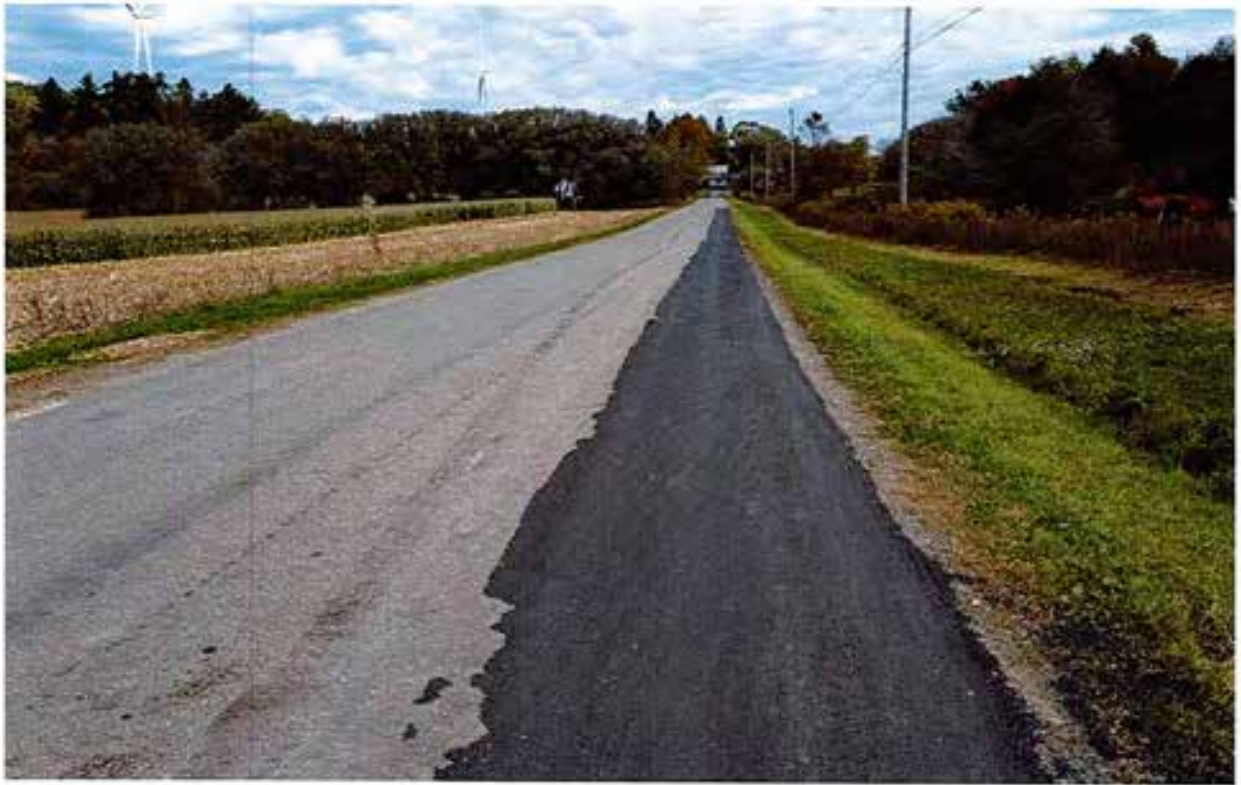
Eagle Street lane and edge North of 757 (REPAIRED)
