## Road Condition & Vehicle Compliance Report

| Report # | 60 |
| Project Name | Alle-Catt Wind |
| Location | Town of Freedom |

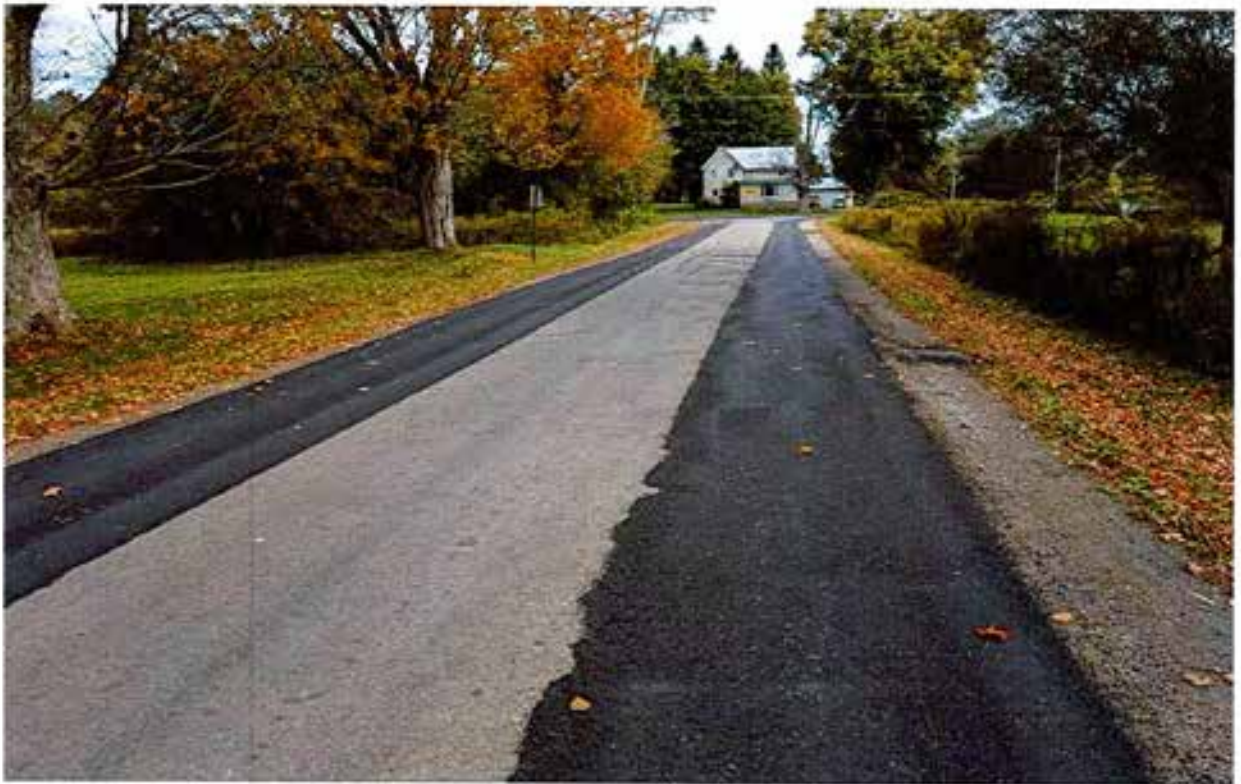
Eagle Street East lane near 708 (REPAIRED)

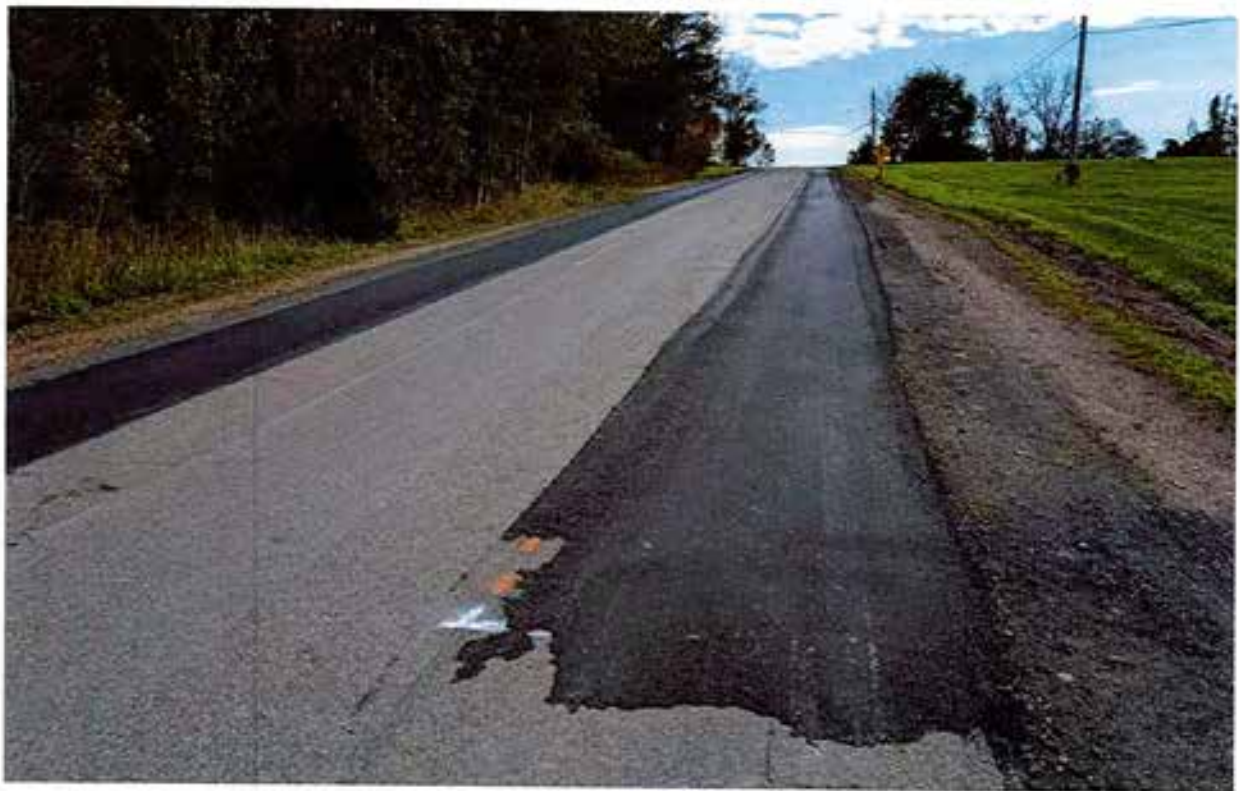
Hughes Road edge and shoulder on North and South sides East of 951 (REPAIRED)

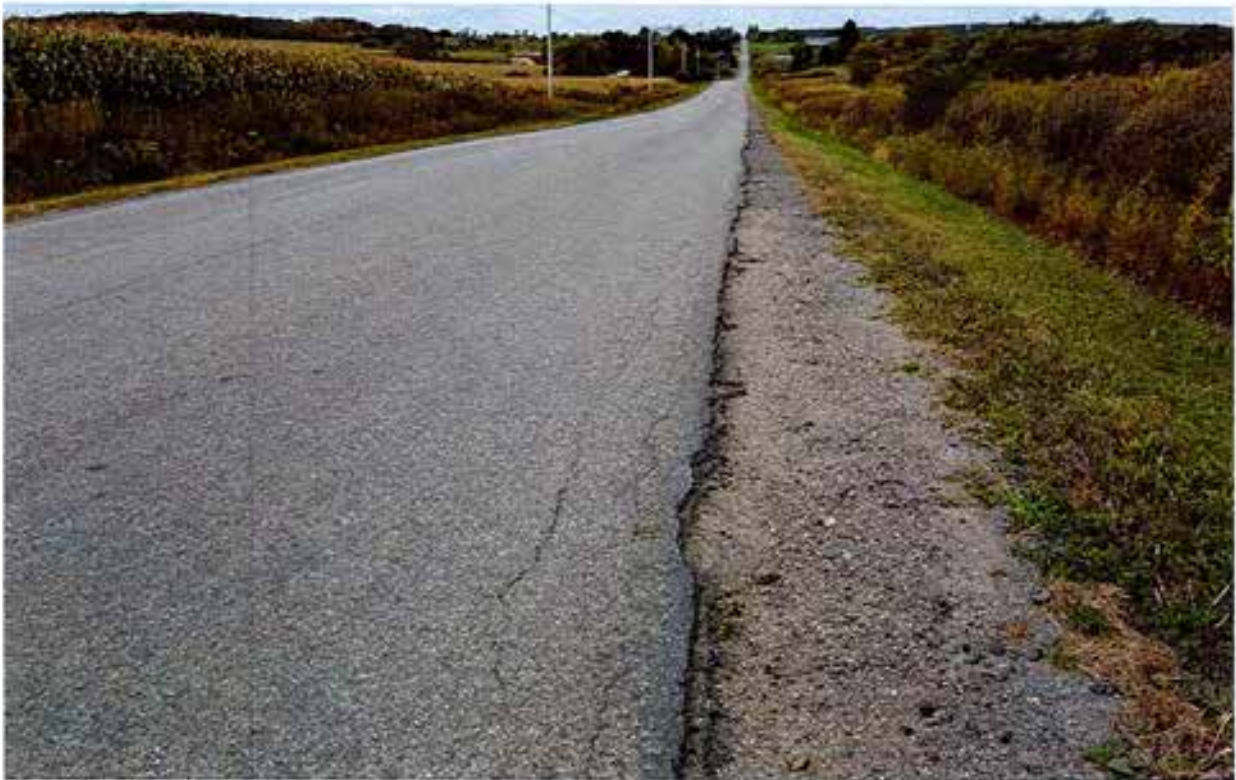
| Hazards Identified: | <ul style="list-style-type: none"> <li>- Edge/shoulder deficiency at various locations.</li> </ul> |

Bray Road North edge and shoulder from gas pipeline #57 to +/- House 113

| Maintenance Needed: | <ul style="list-style-type: none"> <li>- Repairs should be made to lane and shoulder.</li> </ul> |

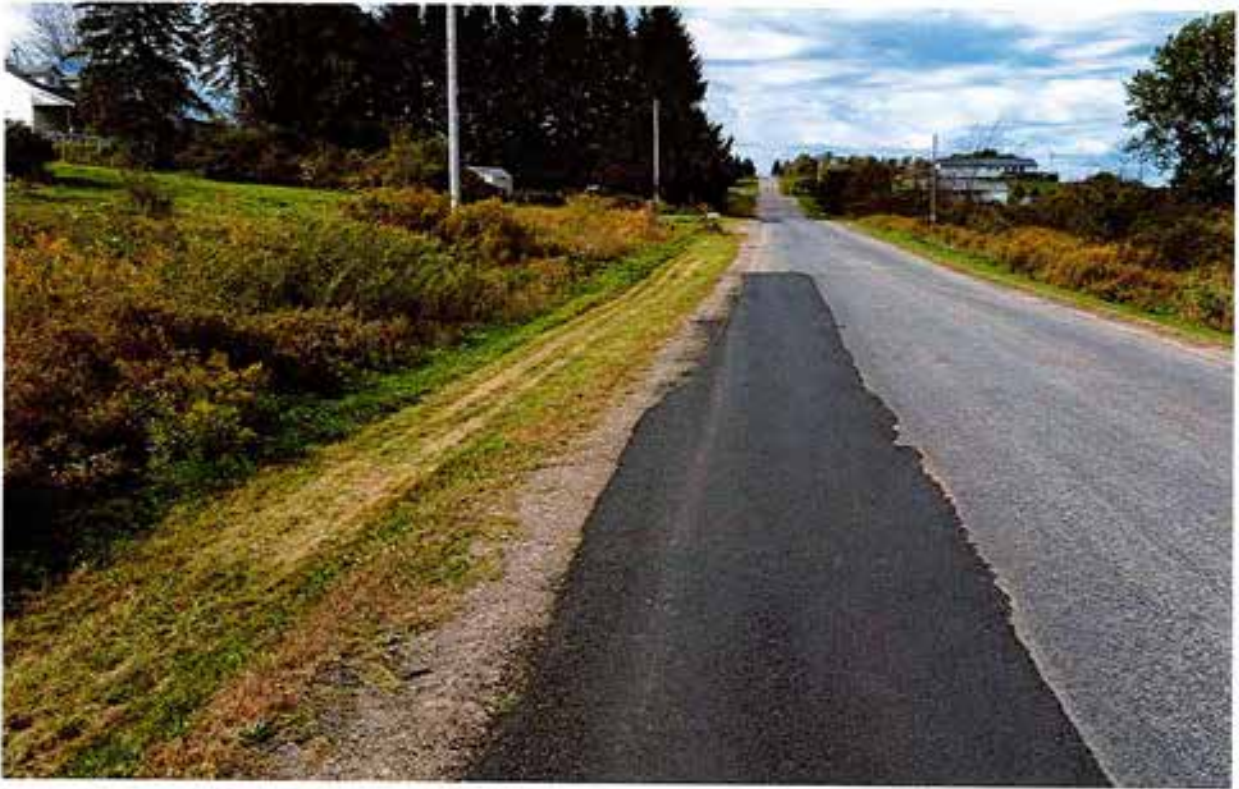
Bray Road South edge and shoulder near 223 (REPAIRED)

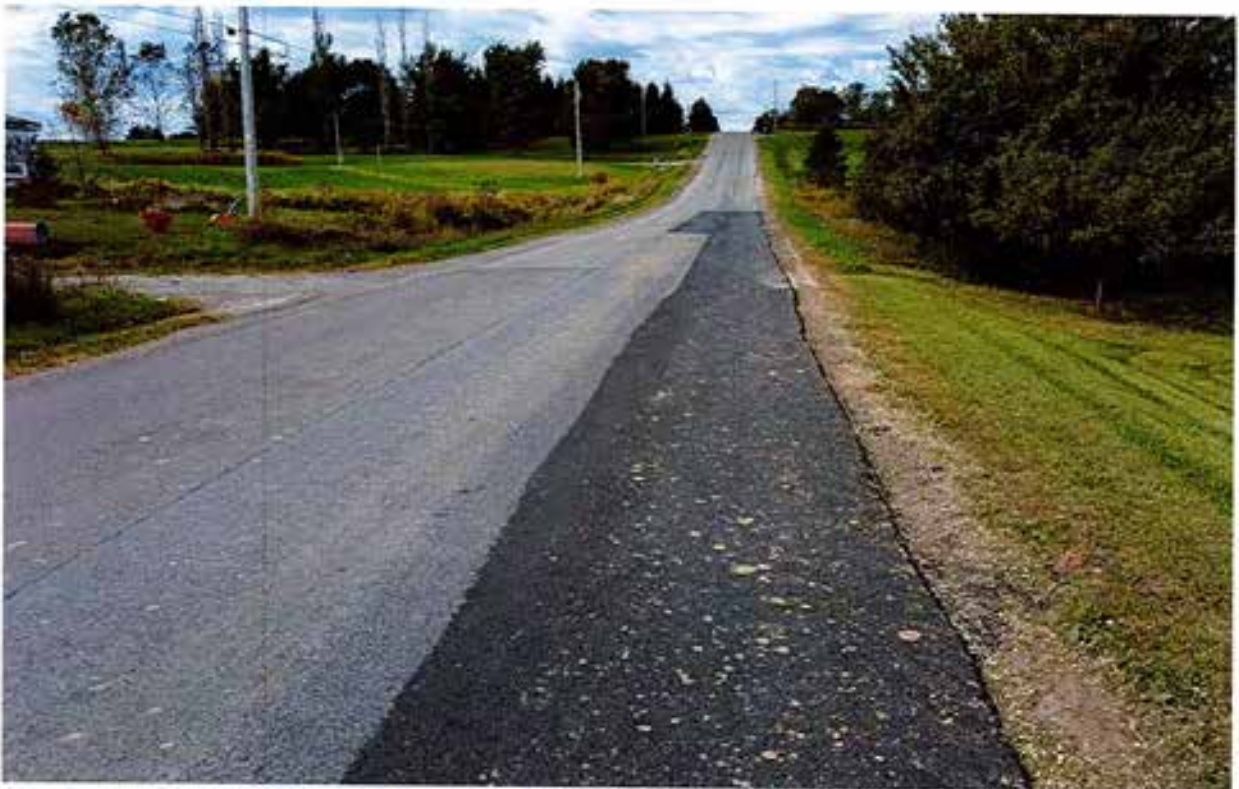
Bray Road North edge and shoulder near 245 (REPAIRED)

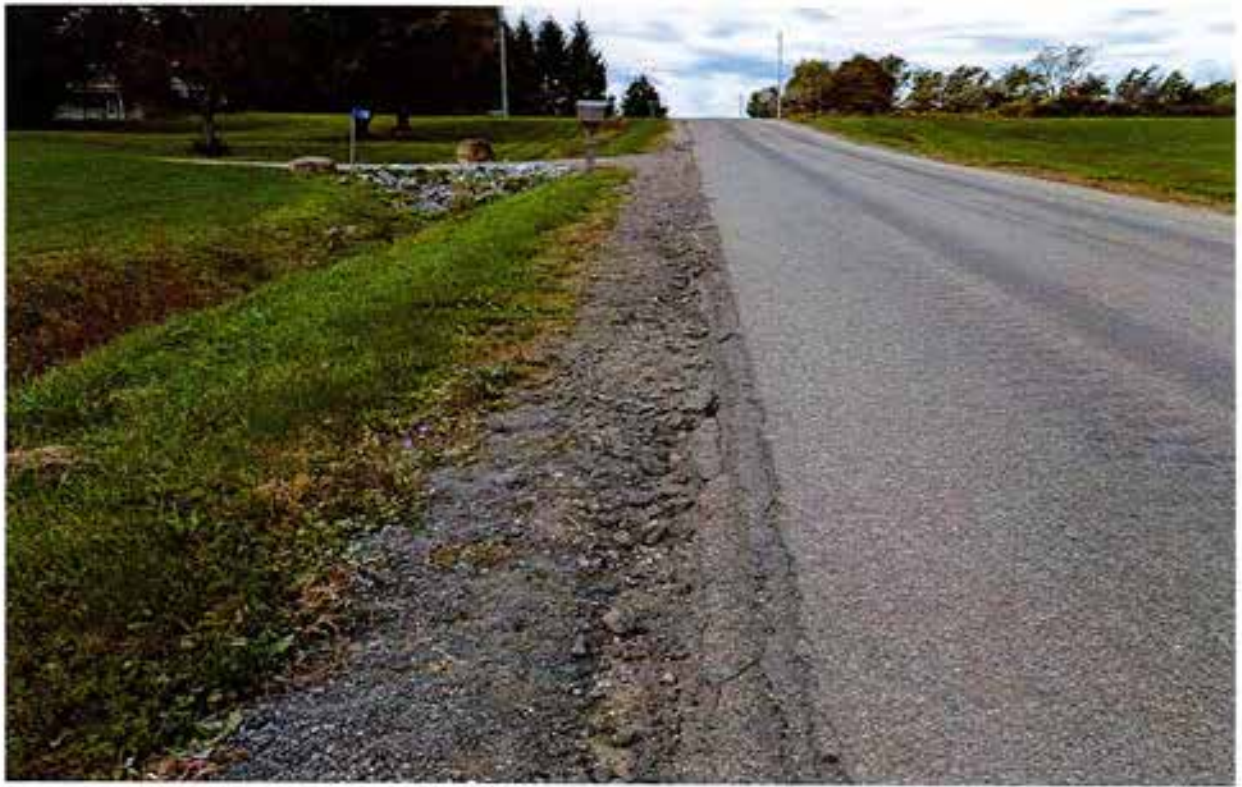
Bray Road South edge and shoulder near 259

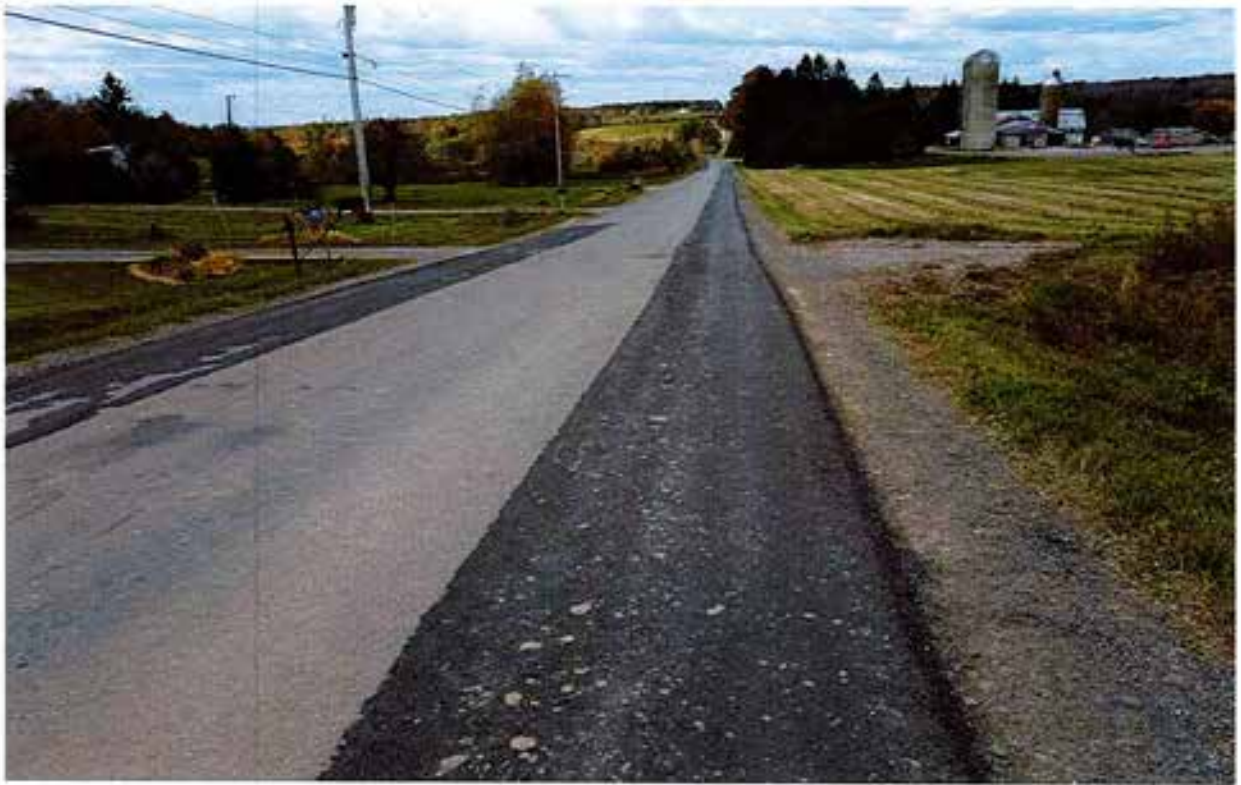
Bray Road North edge and shoulder from 409 to 475 (REPAIRED)

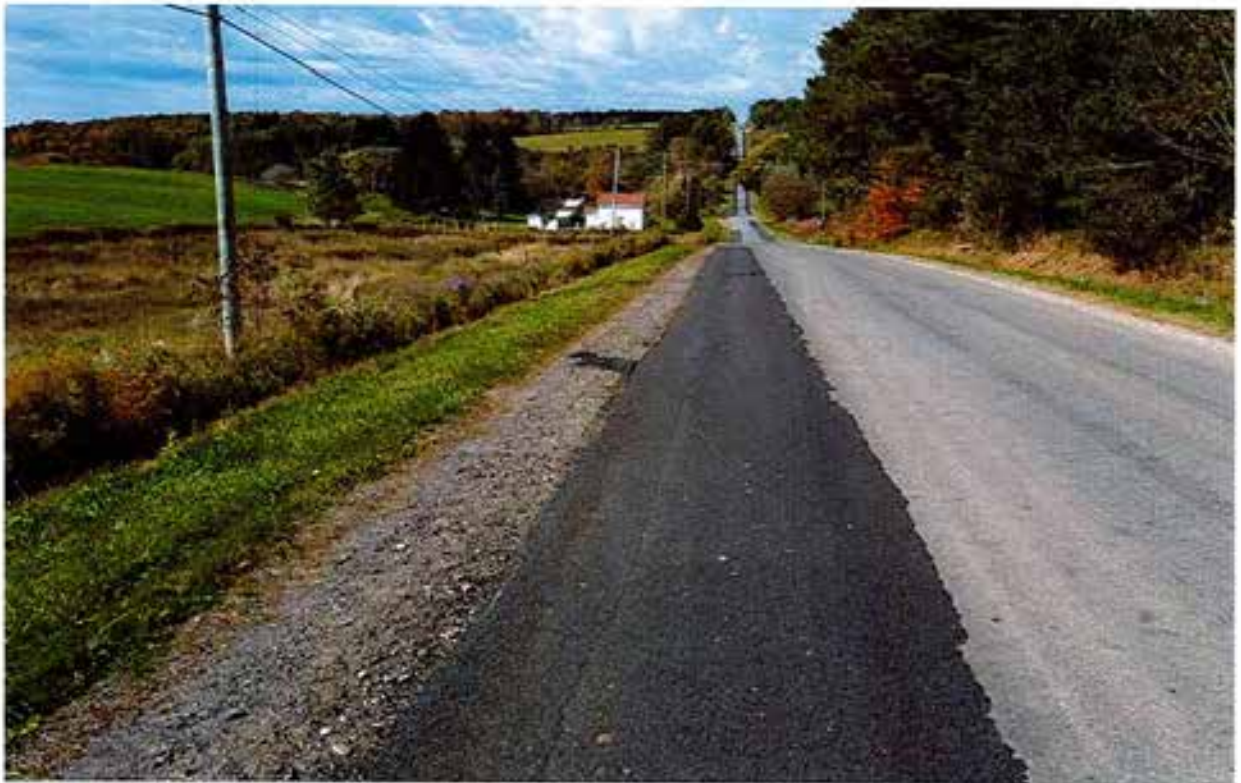
Bray Road South edge and shoulder from 475 to Eagle Street (REPAIRED)

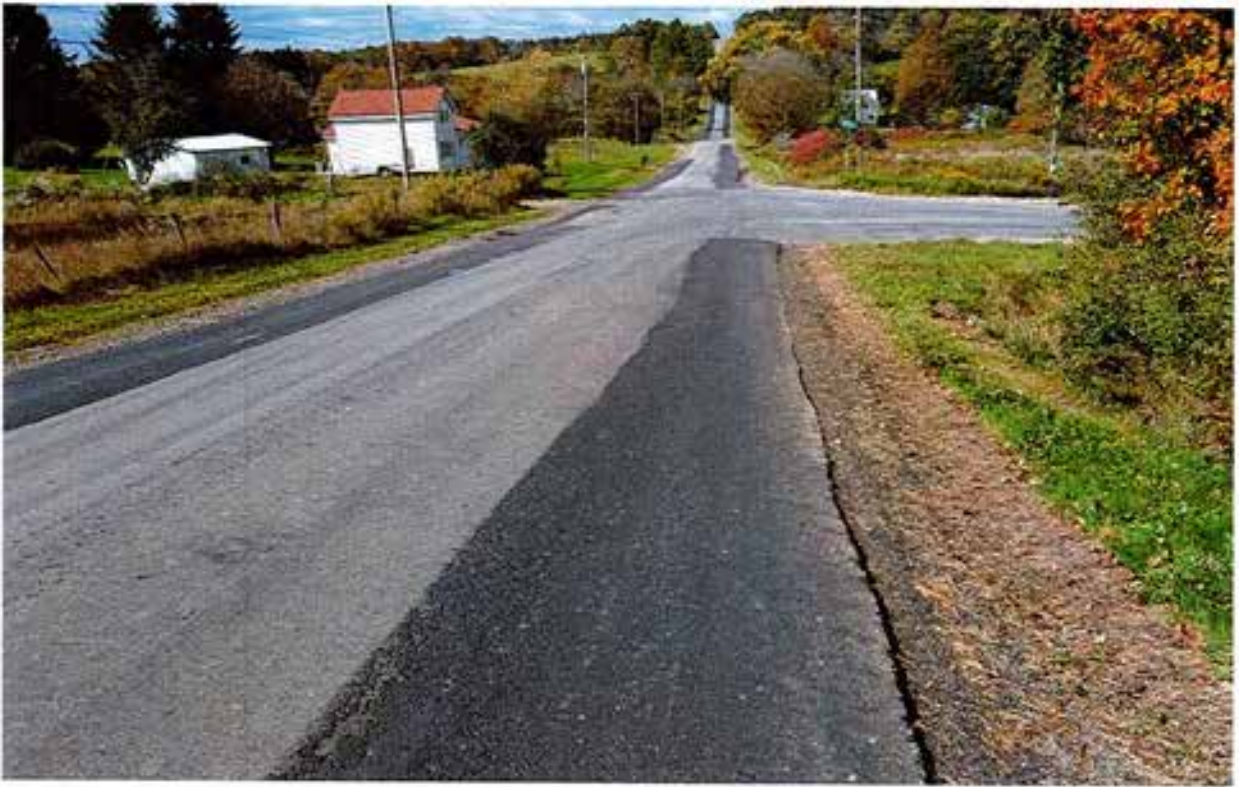
Bray Road North edge West of Hiram (REPAIRED)

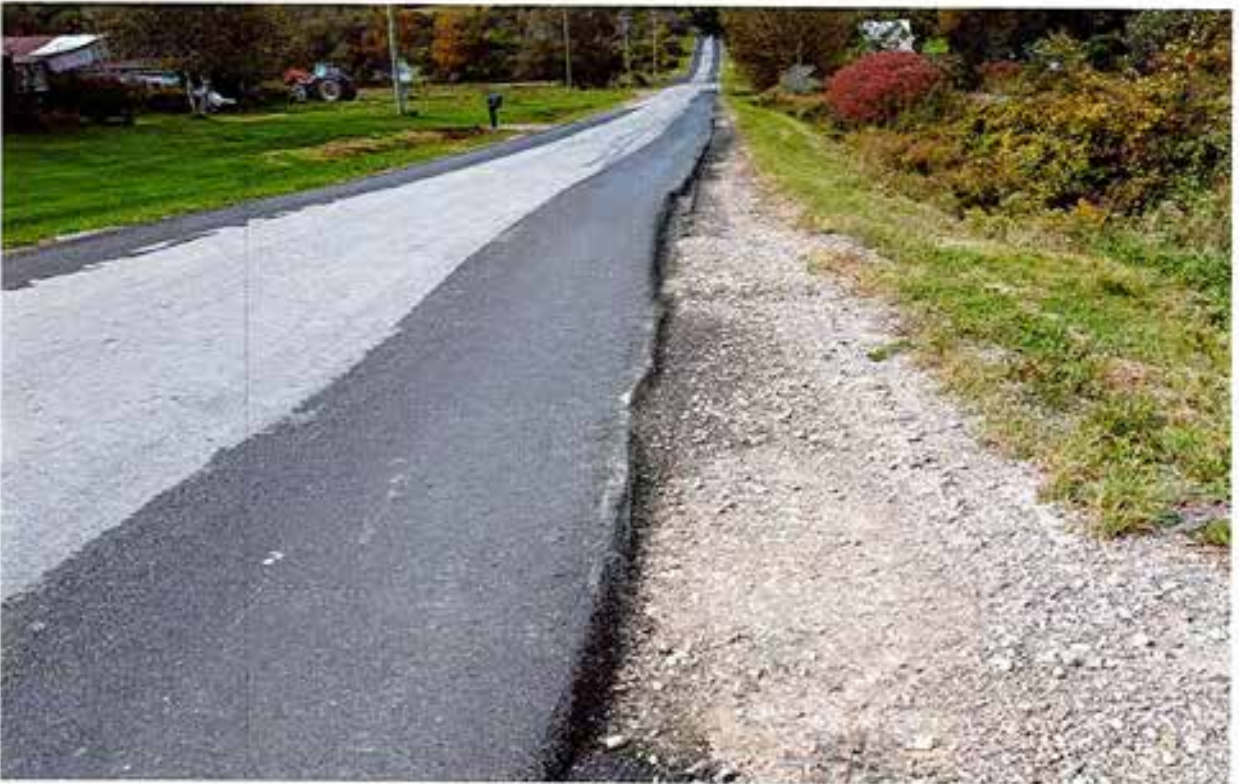
Bray Road North side from Hiram to +/- Eagle Street – No Shoulder

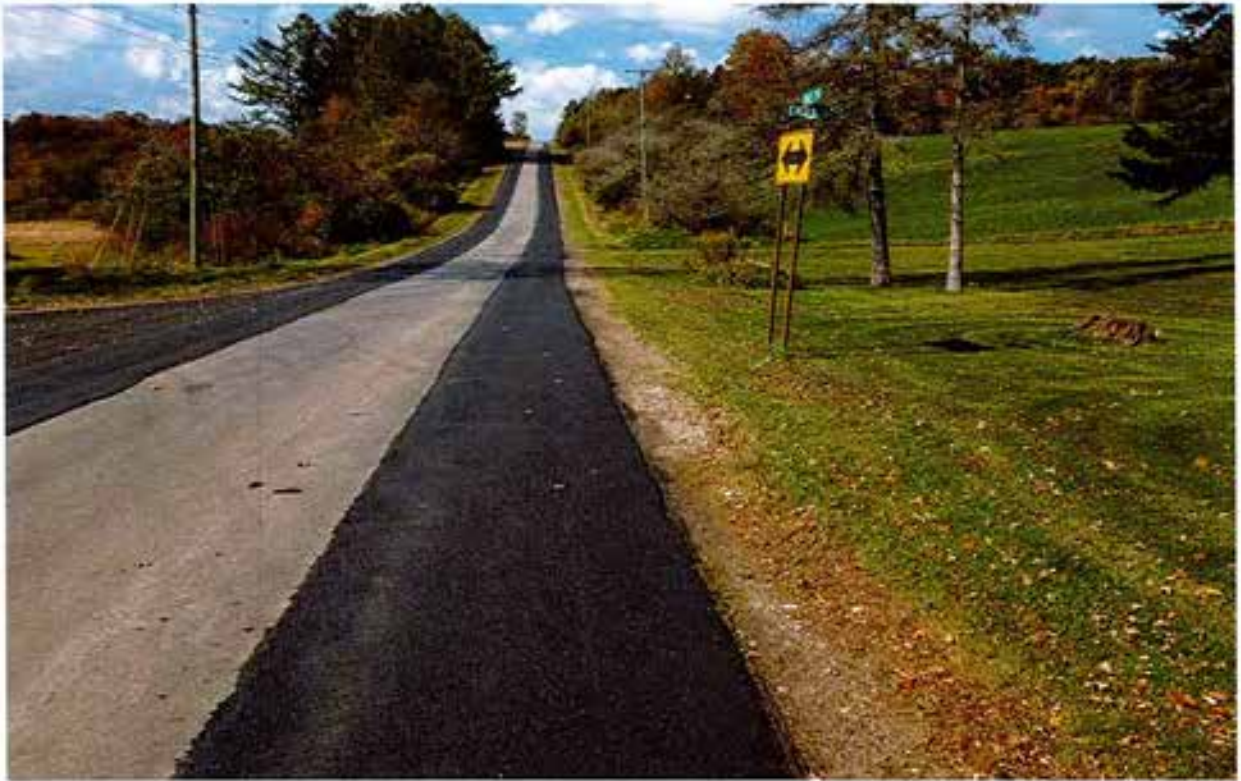
Bray Road Edge at Eagle Street Intersection (REPAIRED)

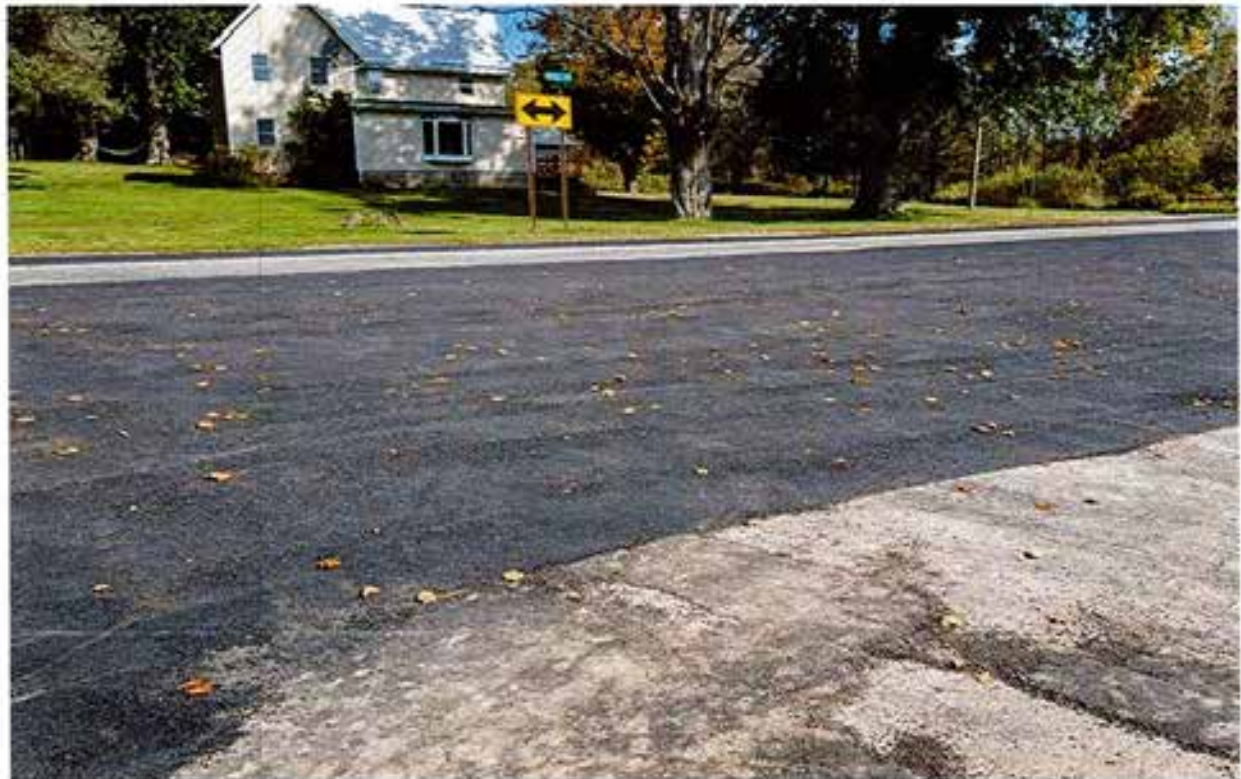
Bray Road lane near intersection with Eagle St (REPAIRED)

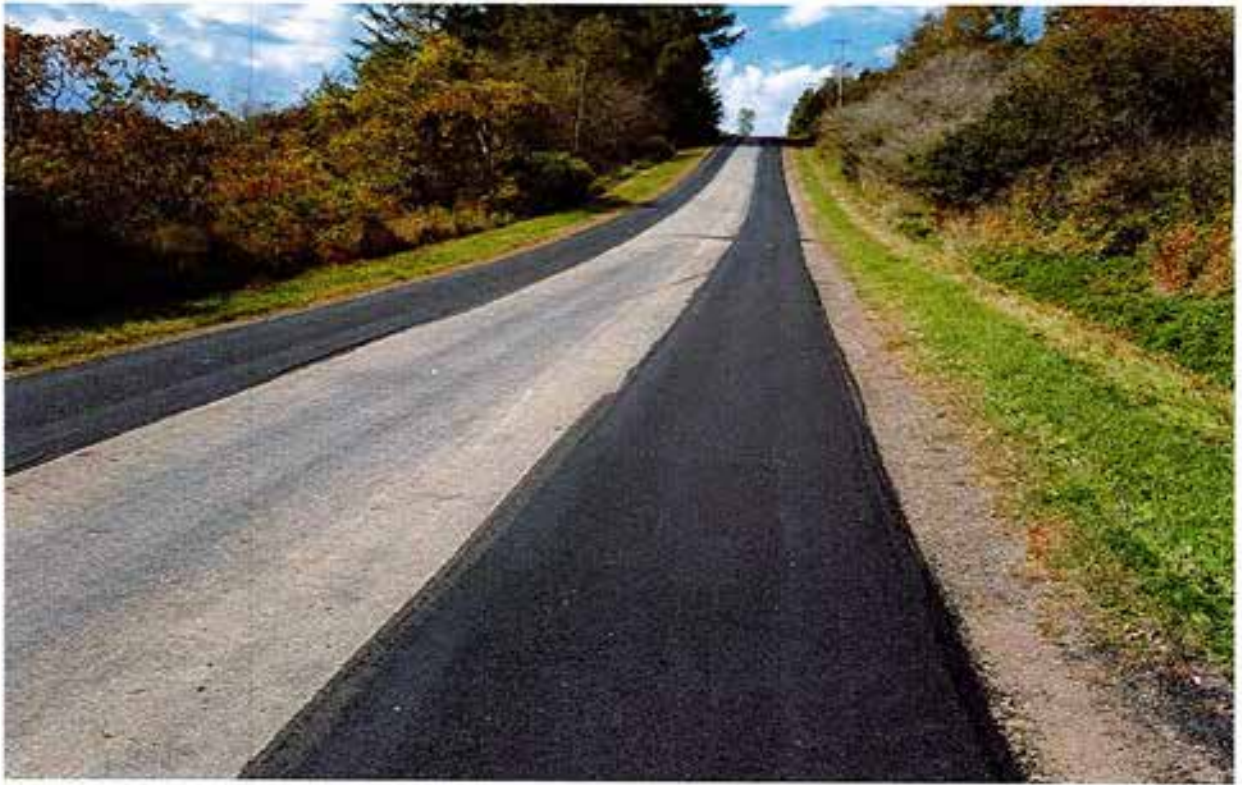
Bray Road North edge and shoulder from Eagle Street to +/- 2801 (REPAIRED)

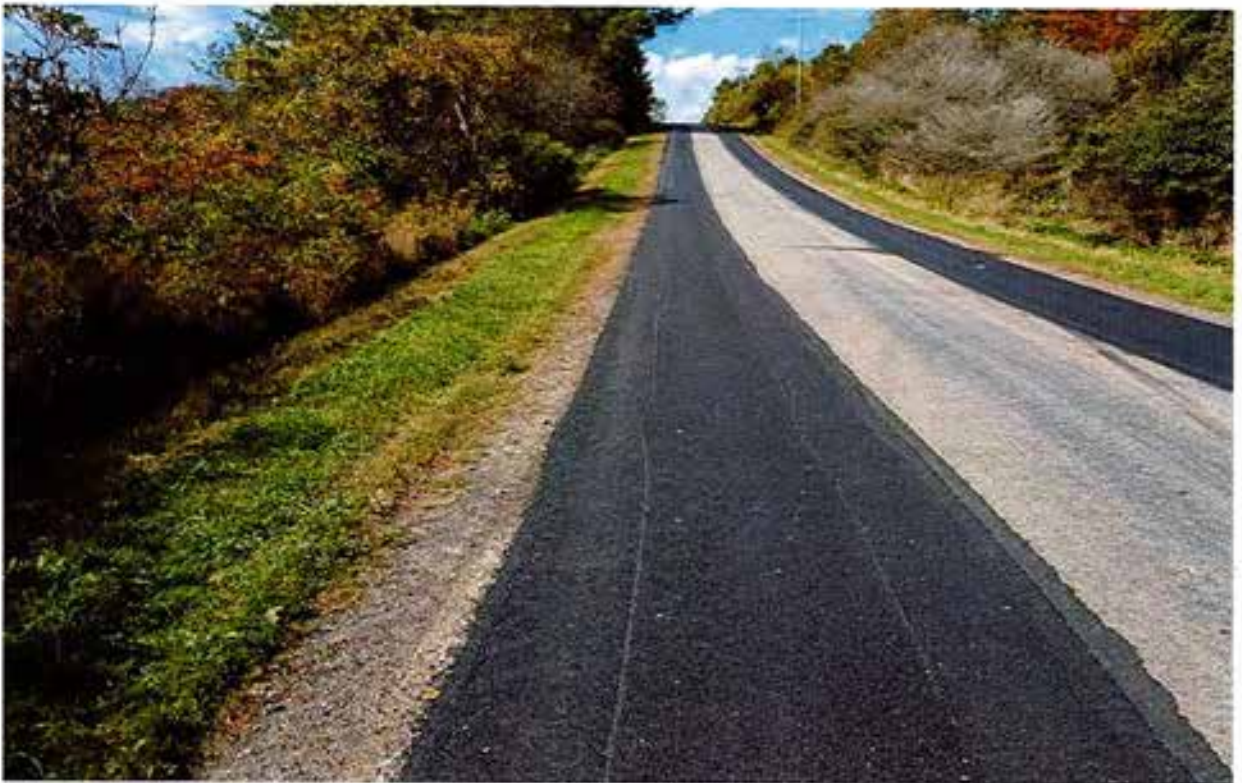
Bray Road South edge and shoulder from Eagle Street to +/- 2801 (REPAIRED)

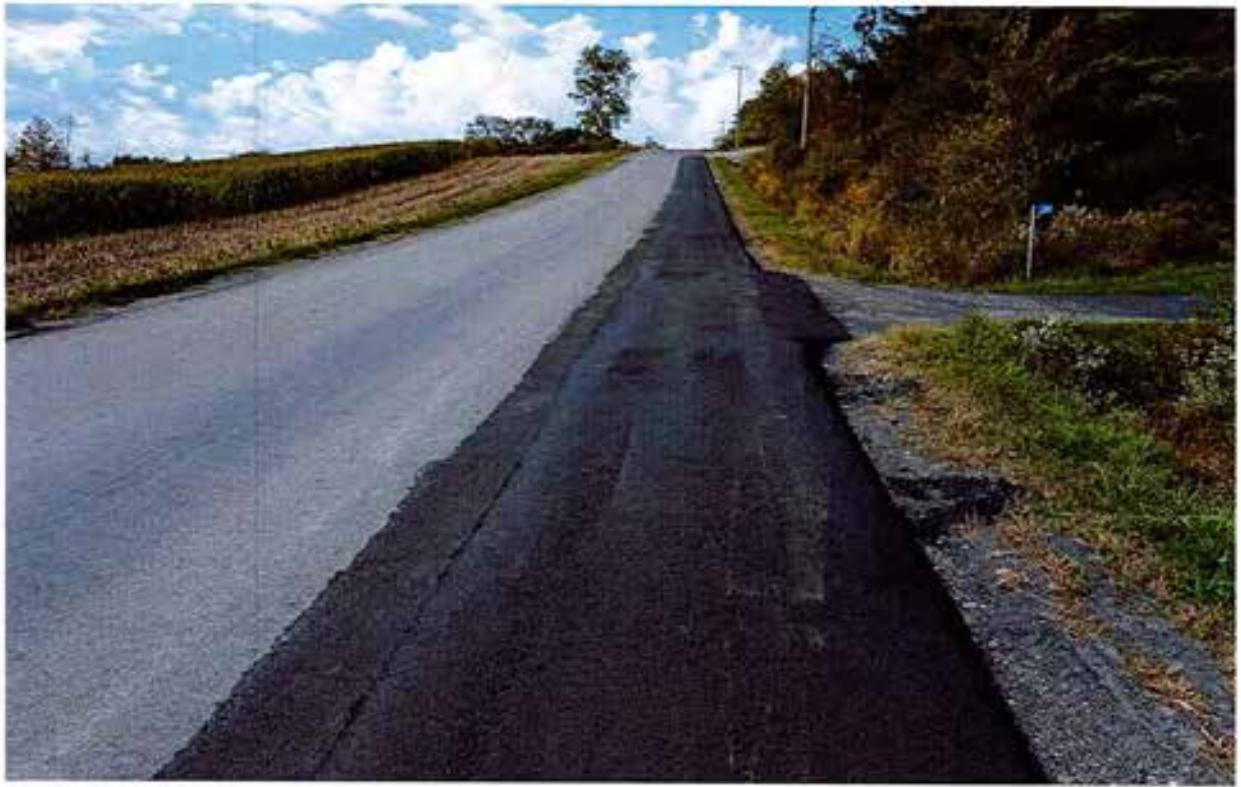
Bray Road North edge and lane near 2801 (#1) (REPAIRED)

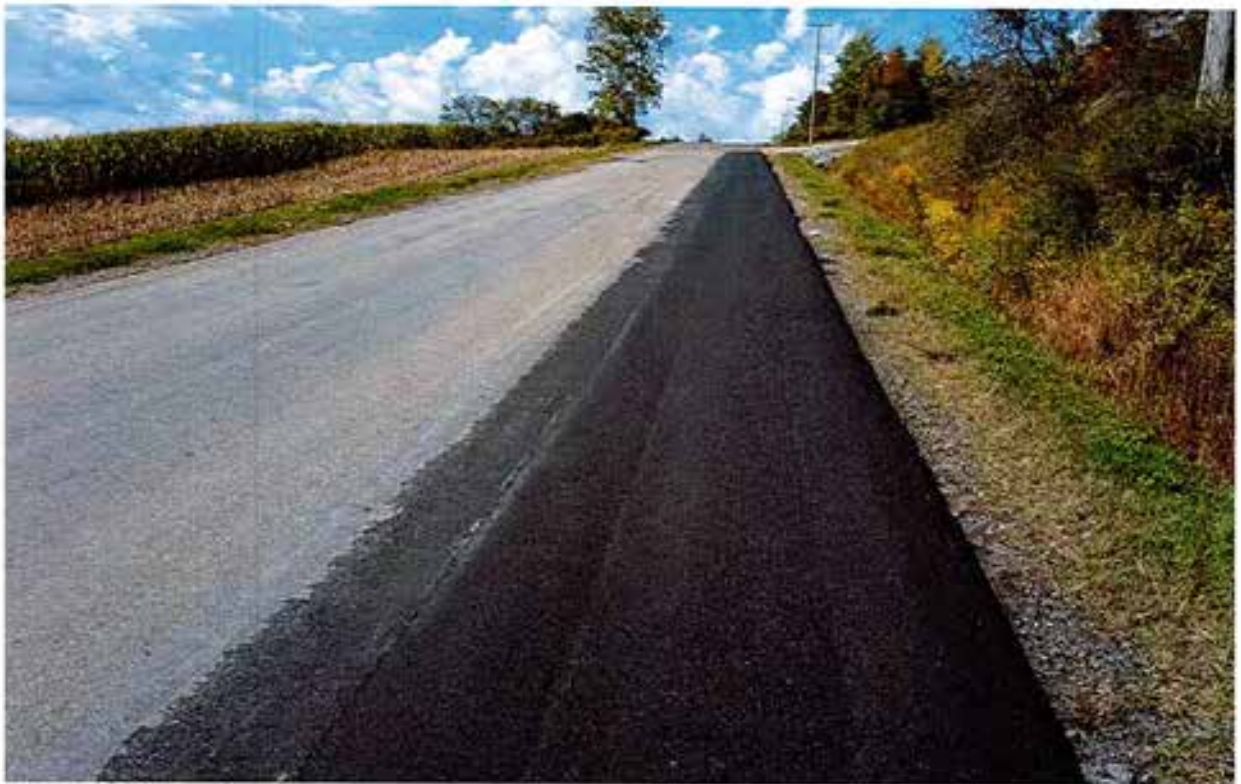
Bray Road lane near 2801 (#2) (REPAIRED)

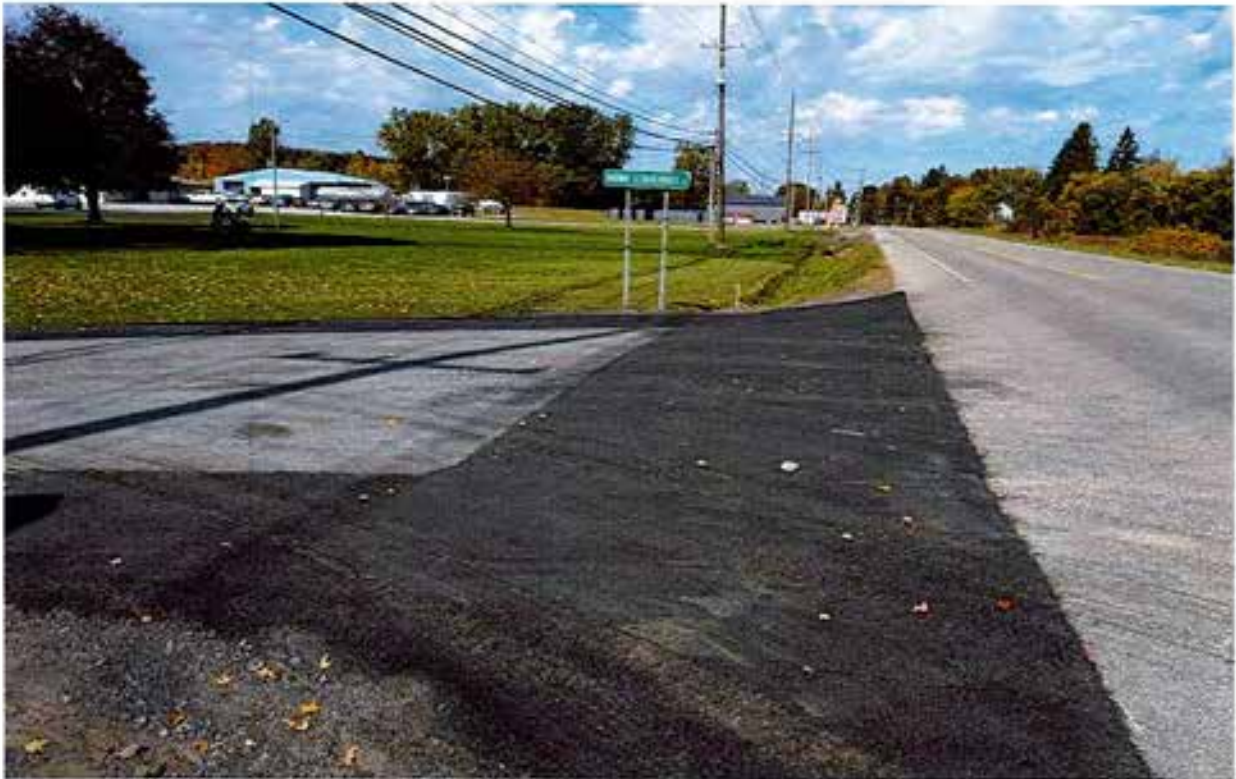
Brown Schoolhouse Road lane near intersection with Route 98 (REPAIRED)

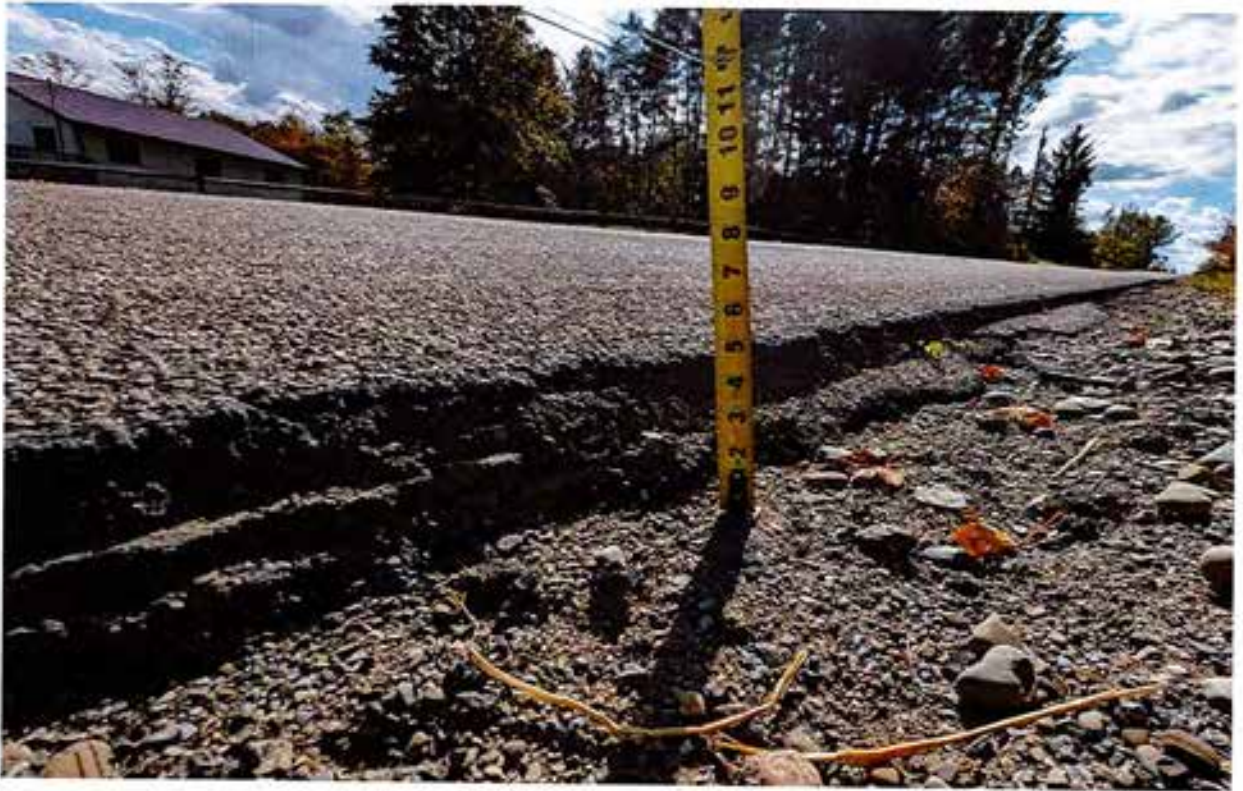
| Hazards Identified: | - Shoulder deficiencies on East and West edge of road |

Brown Schoolhouse Road West shoulder near 11770

| Maintenance Needed: | - Repair shoulders |

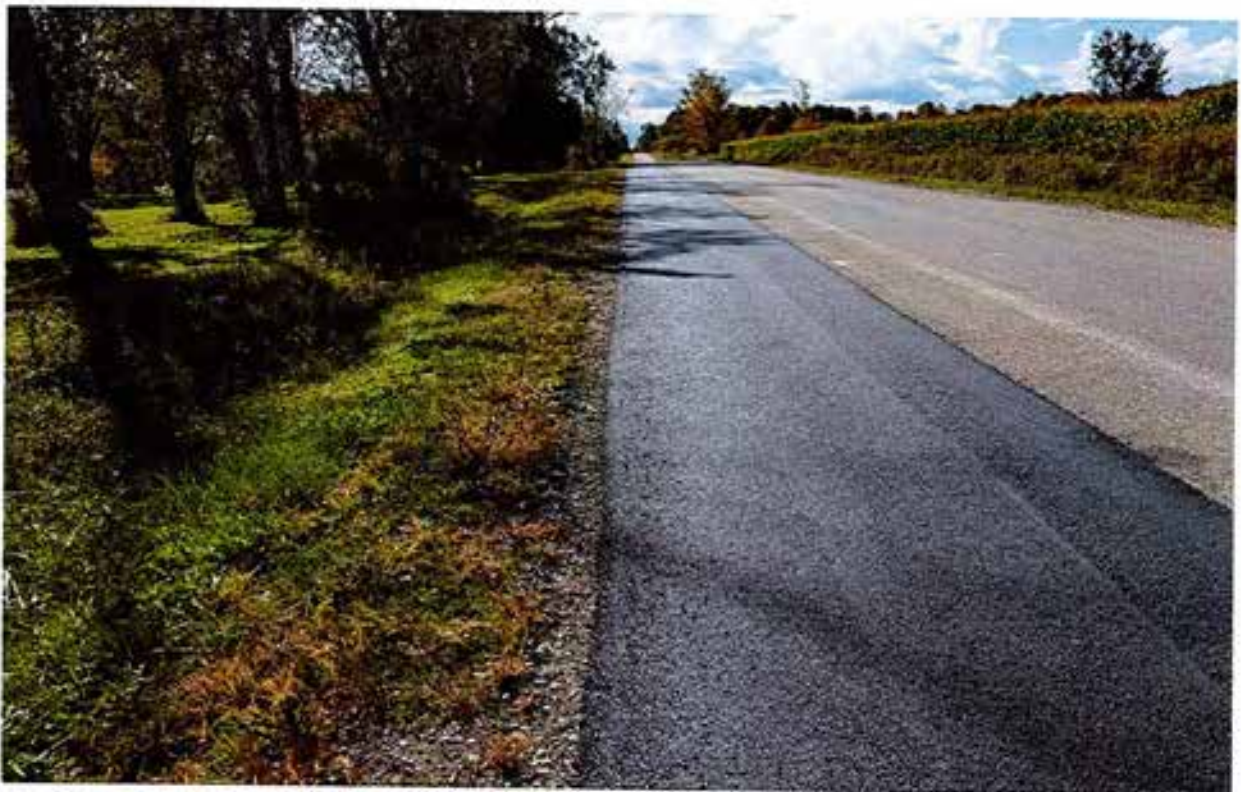
Brown Schoolhouse Road East shoulder South of 11748 (REPAIRED)

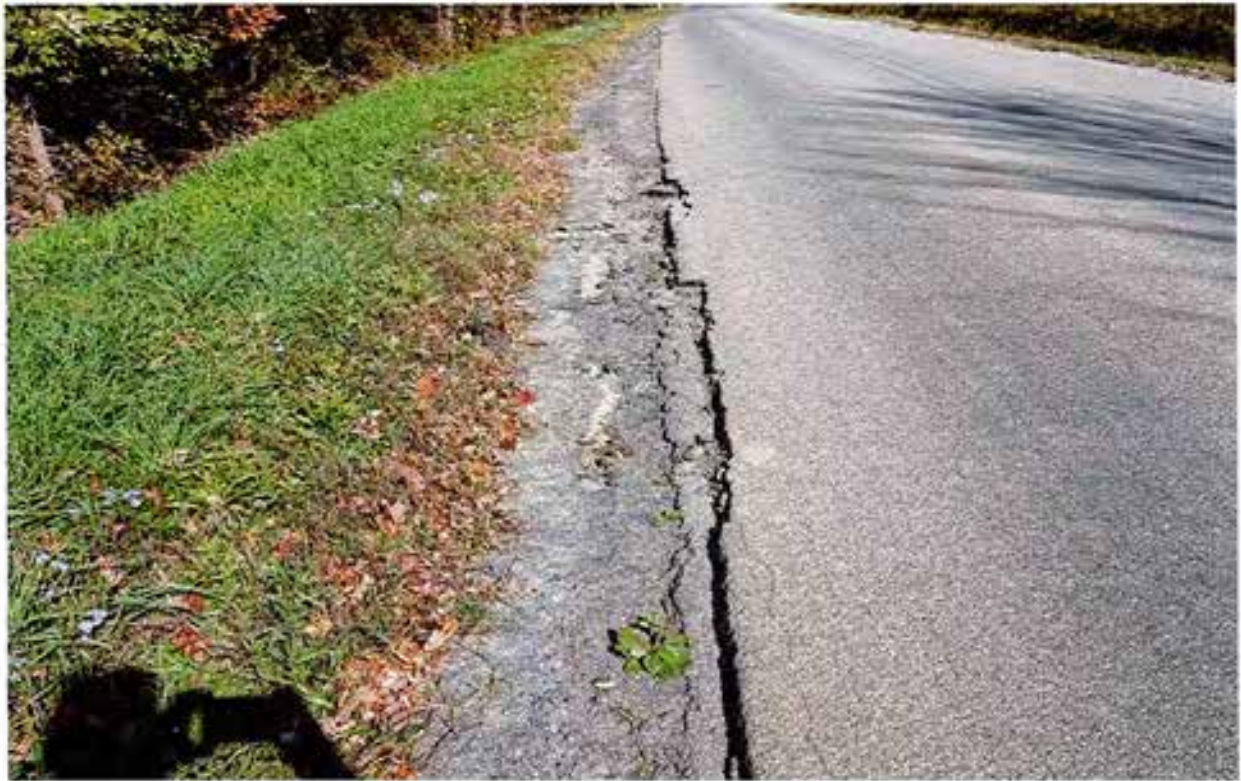
Brown Schoolhouse Road West shoulder North of 11448

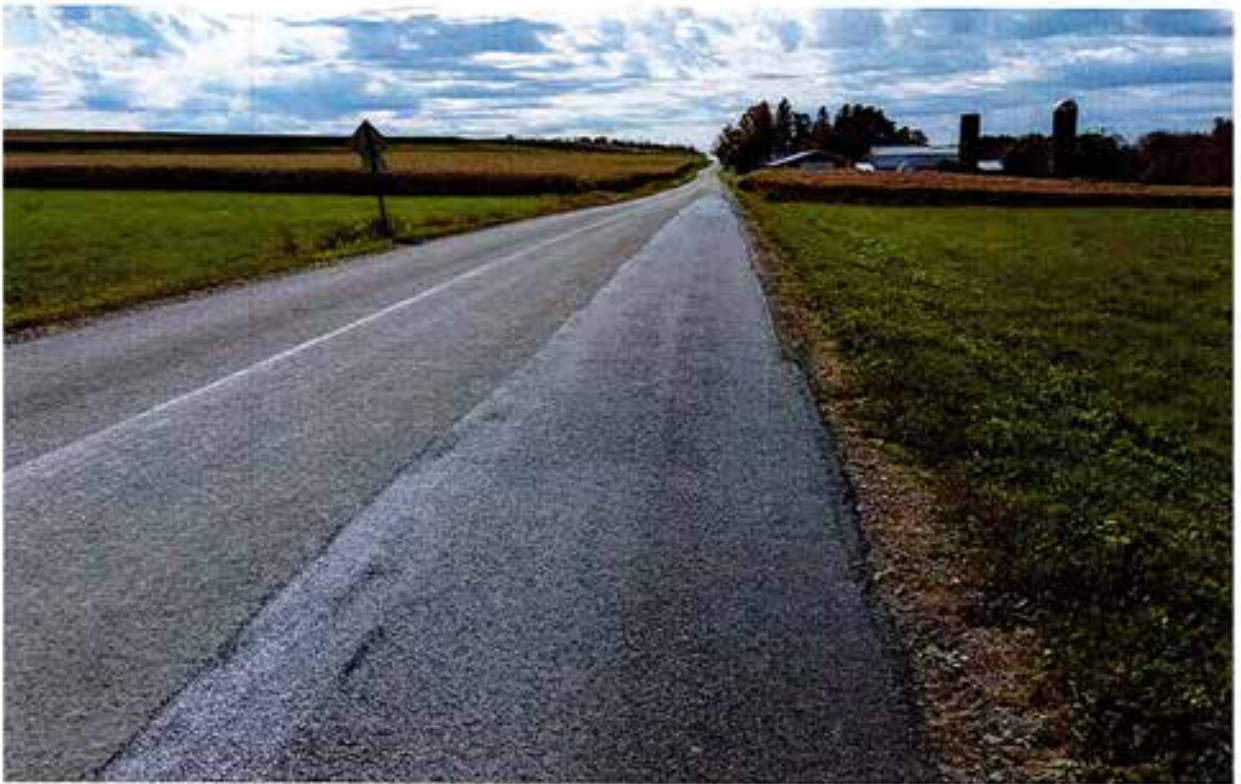
Brown Schoolhouse Road West shoulder from 11214 to 11123 (REPAIRED)

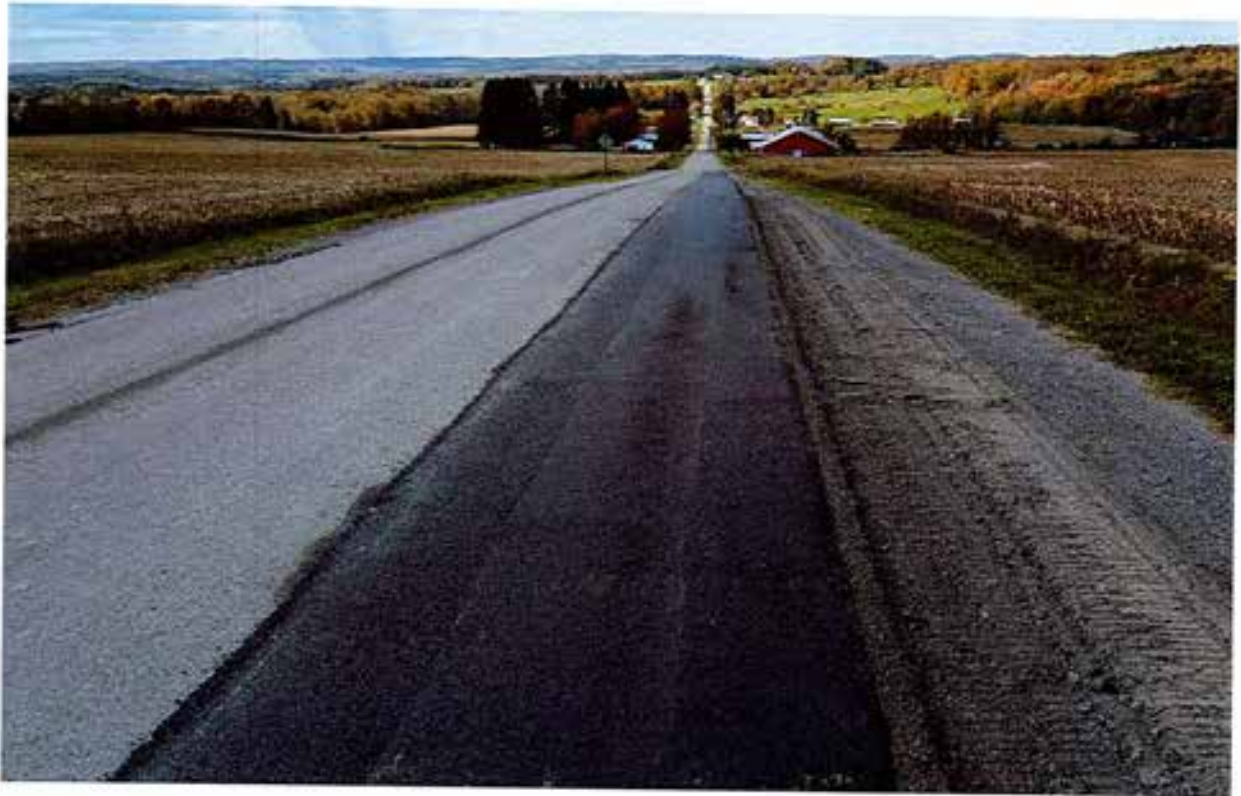
Fisher Blake Road North edge and shoulder near intersection with Brown Schoolhouse Road  
(REPAIRED)

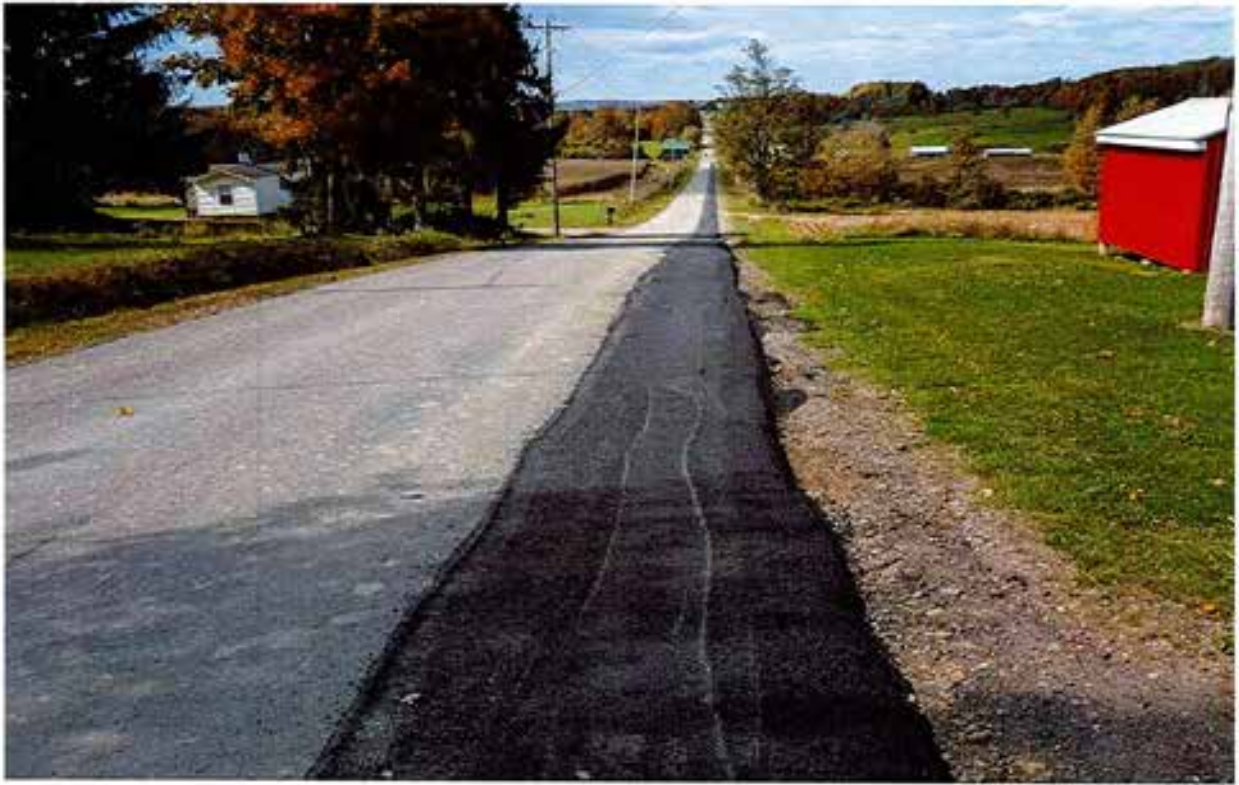
Fisher Blake Road edge and shoulder near 2177 (REPAIRED)
