## Road Condition & Vehicle Compliance Report

| Report # | 60 |
| Project Name | Alle-Catt Wind |
| Location | Town of Freedom |

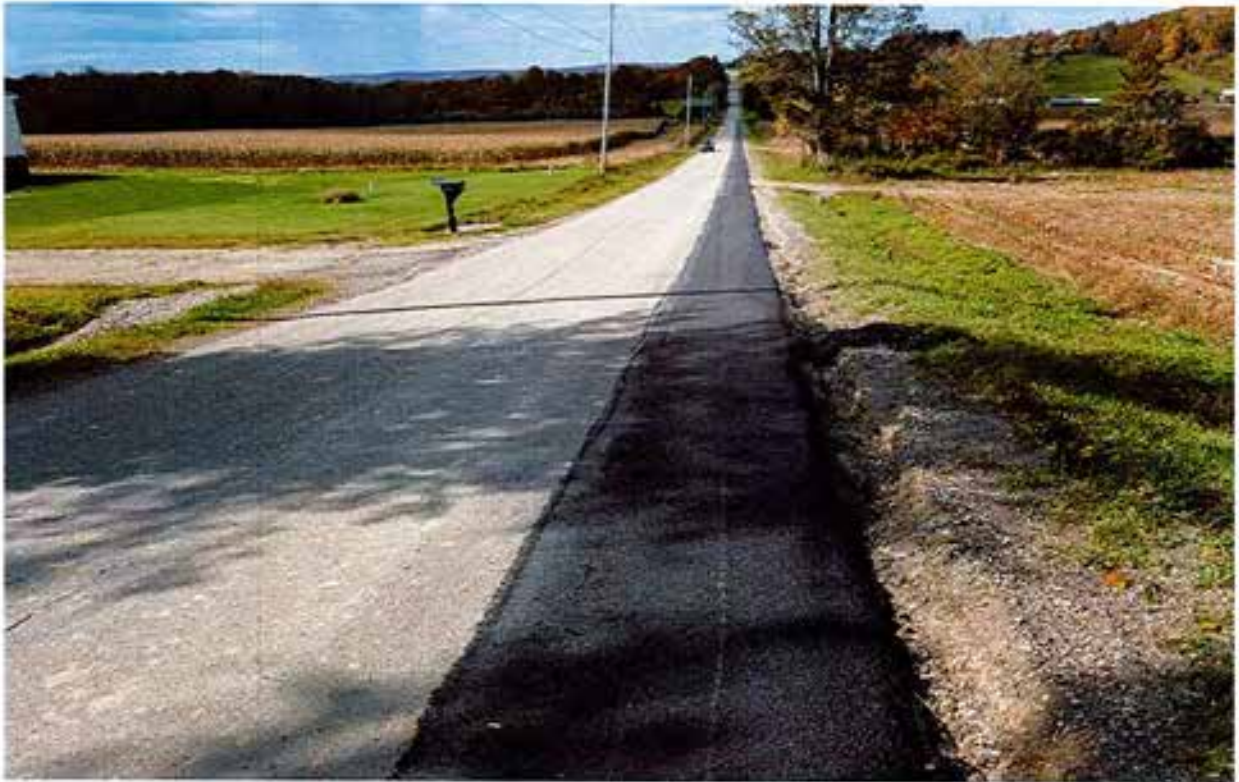
Fisher Blake Road North edge and shoulder near 2195 (REPAIRED)

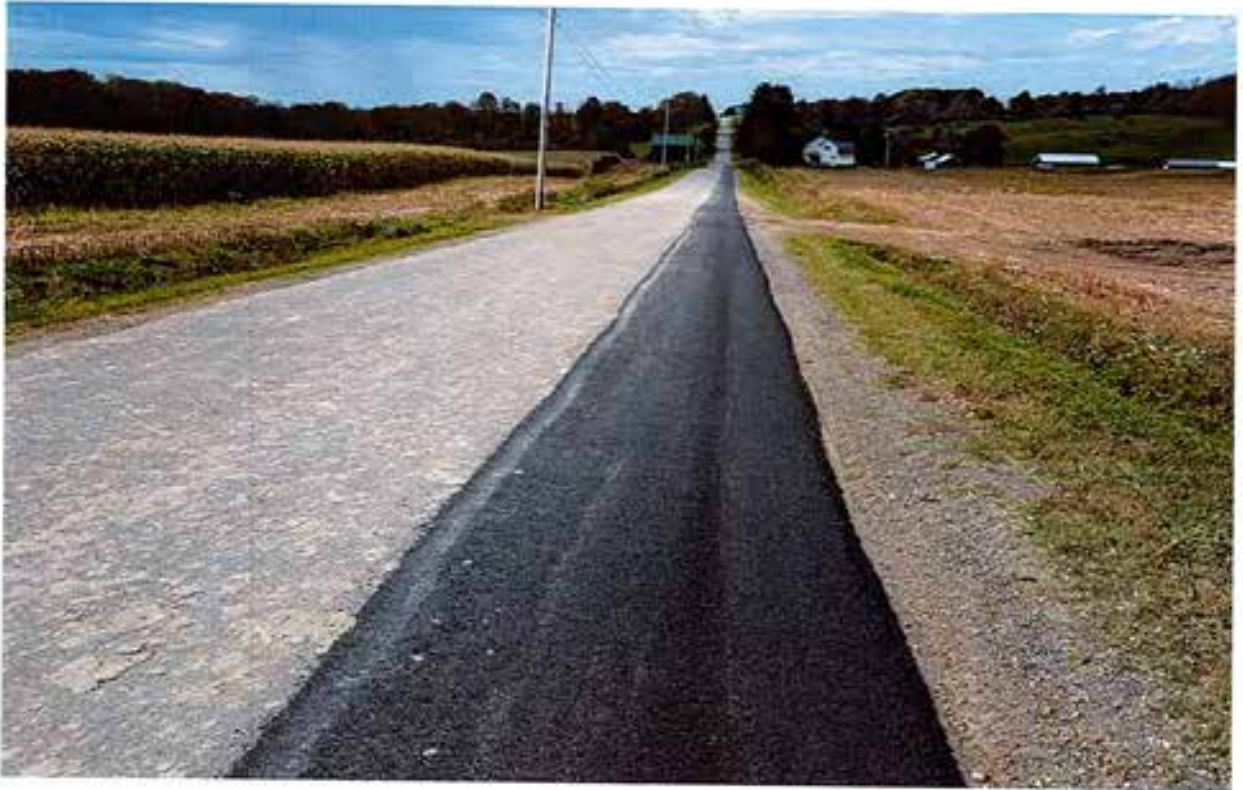
Fisher Blake Road North edge and shoulder from 2195 to +/- 2272 (REPAIRED)

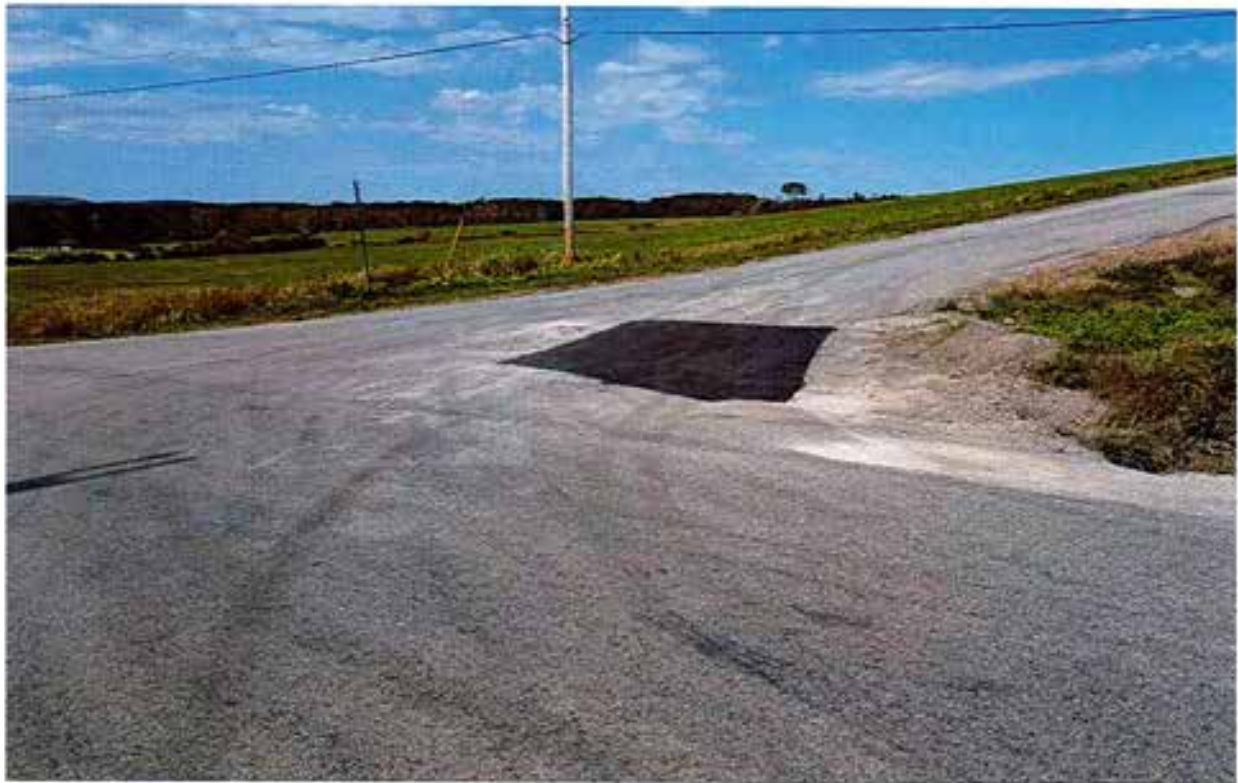
Edmunds Road intersection of Brown School House (REPAIRED)

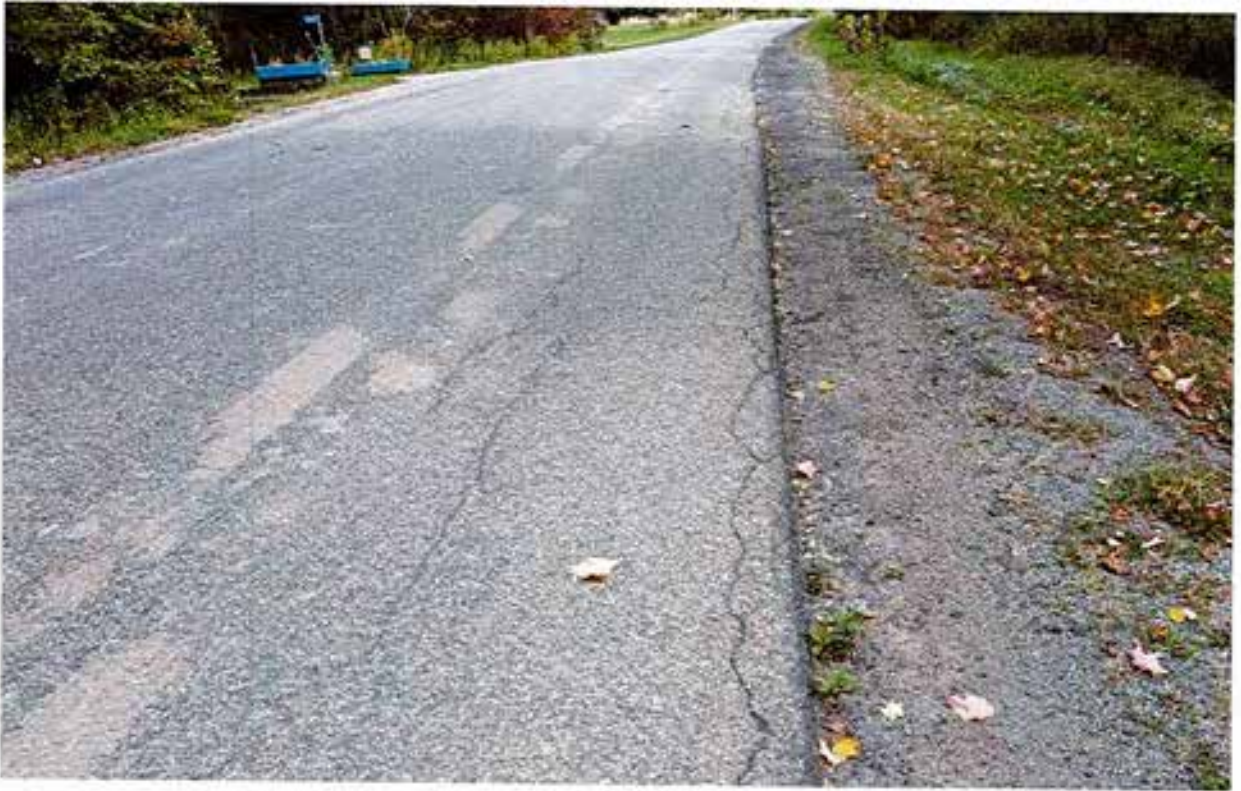
Edmunds Road South edge and shoulder 1940 to 1850

| Maintenance Needed: | - Repair intersection<br>- Repair shoulder |

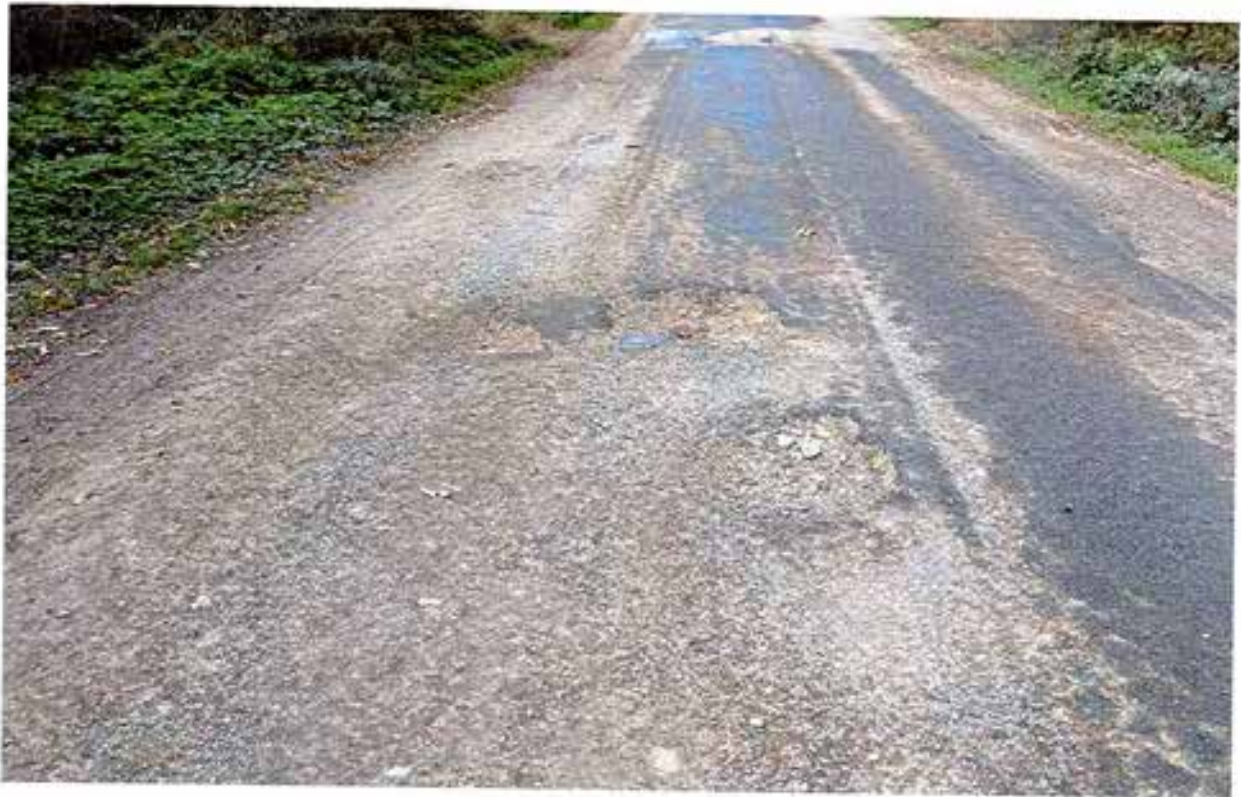
| Hazards Identified: | - Multiple deficiencies in paved sections of road |

Strong Road deficiencies

| Maintenance Needed: | - Repair deficiencies |

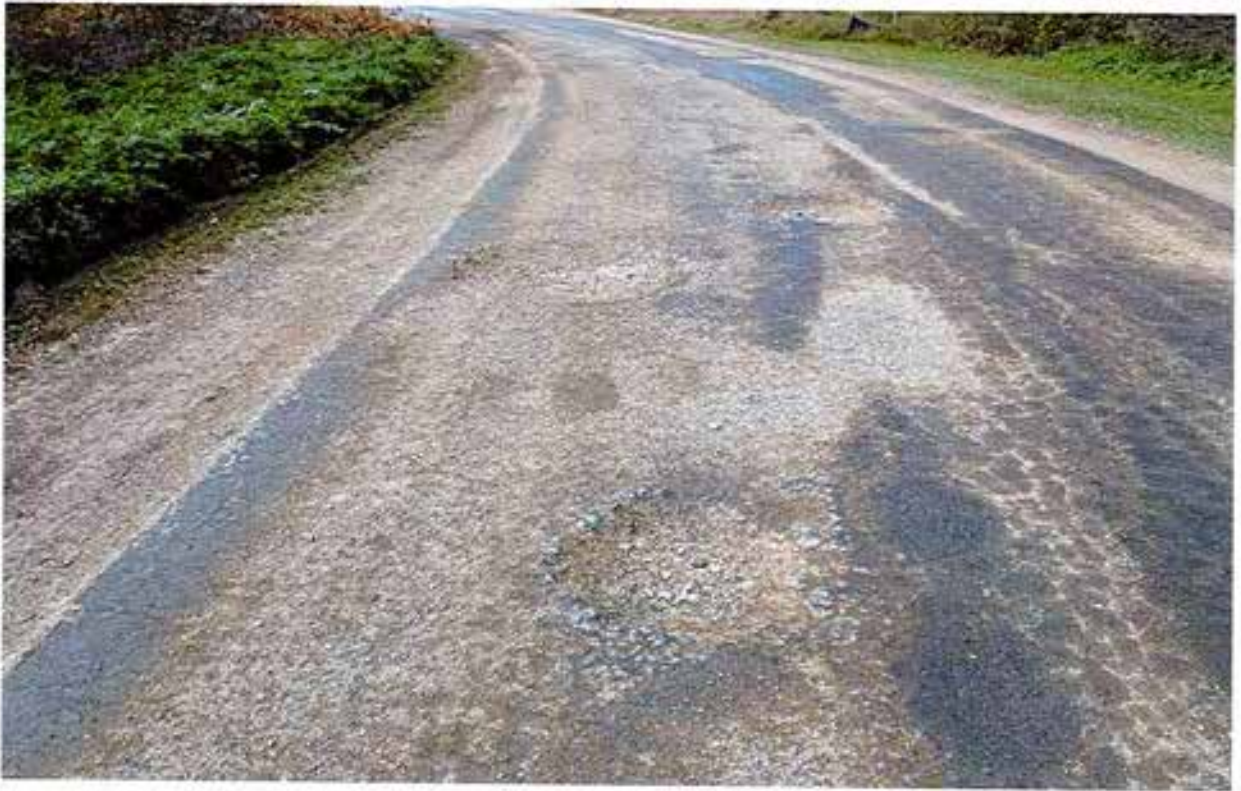
Strong Rd deficiencies

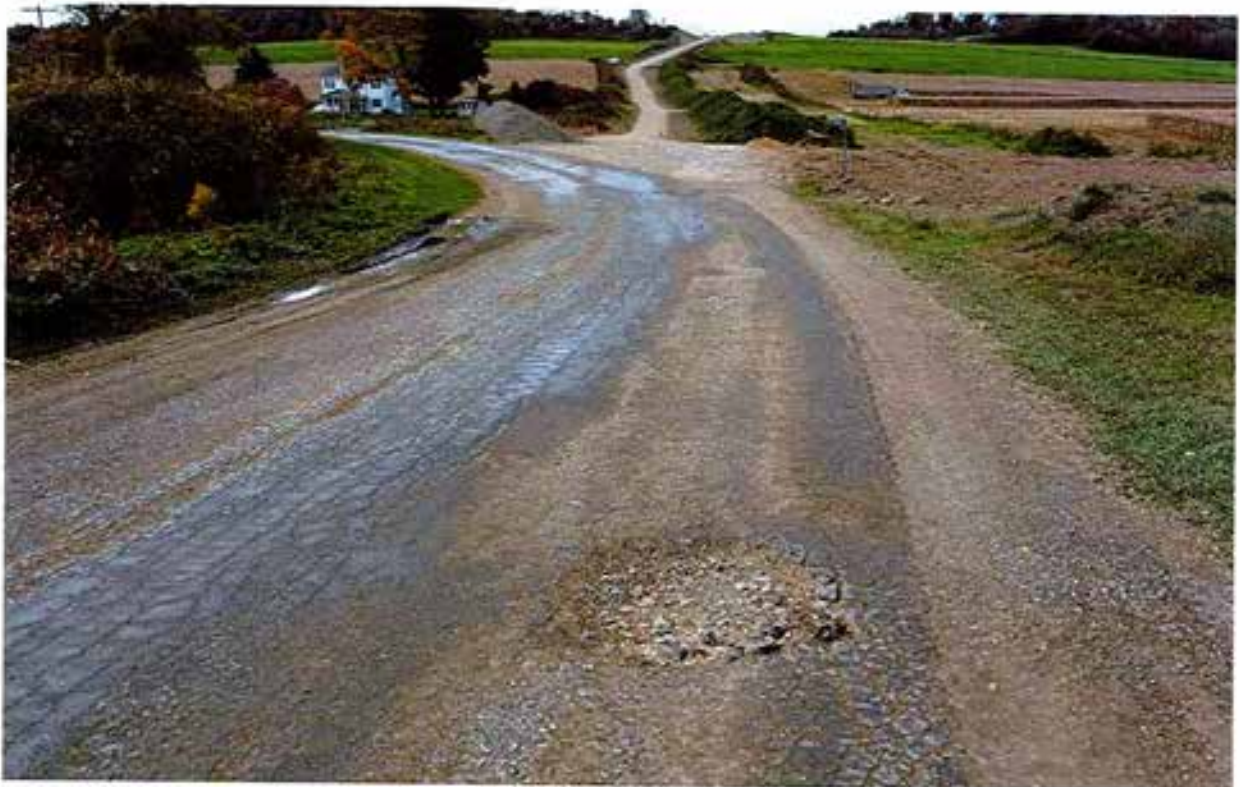
Strong Road deficiencies

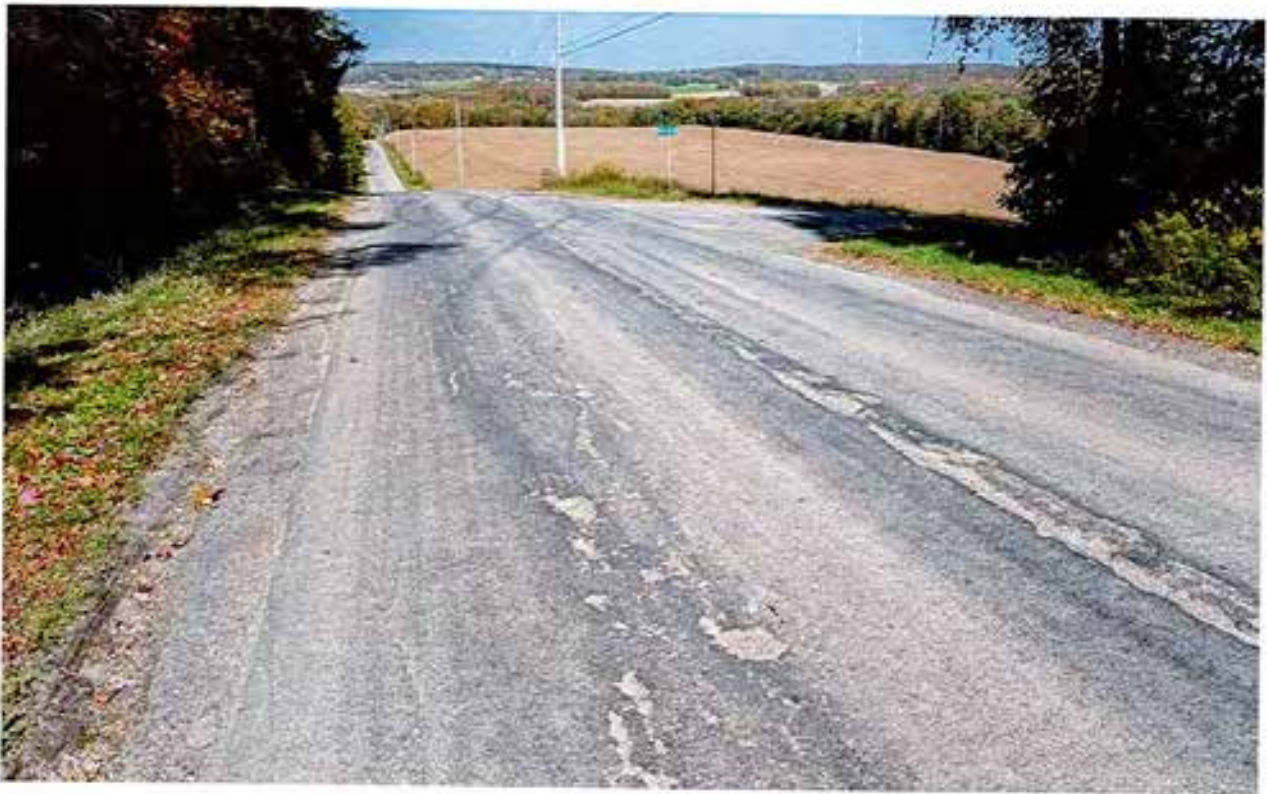
Galen Hill Road intersection with Phillippi Rd lane

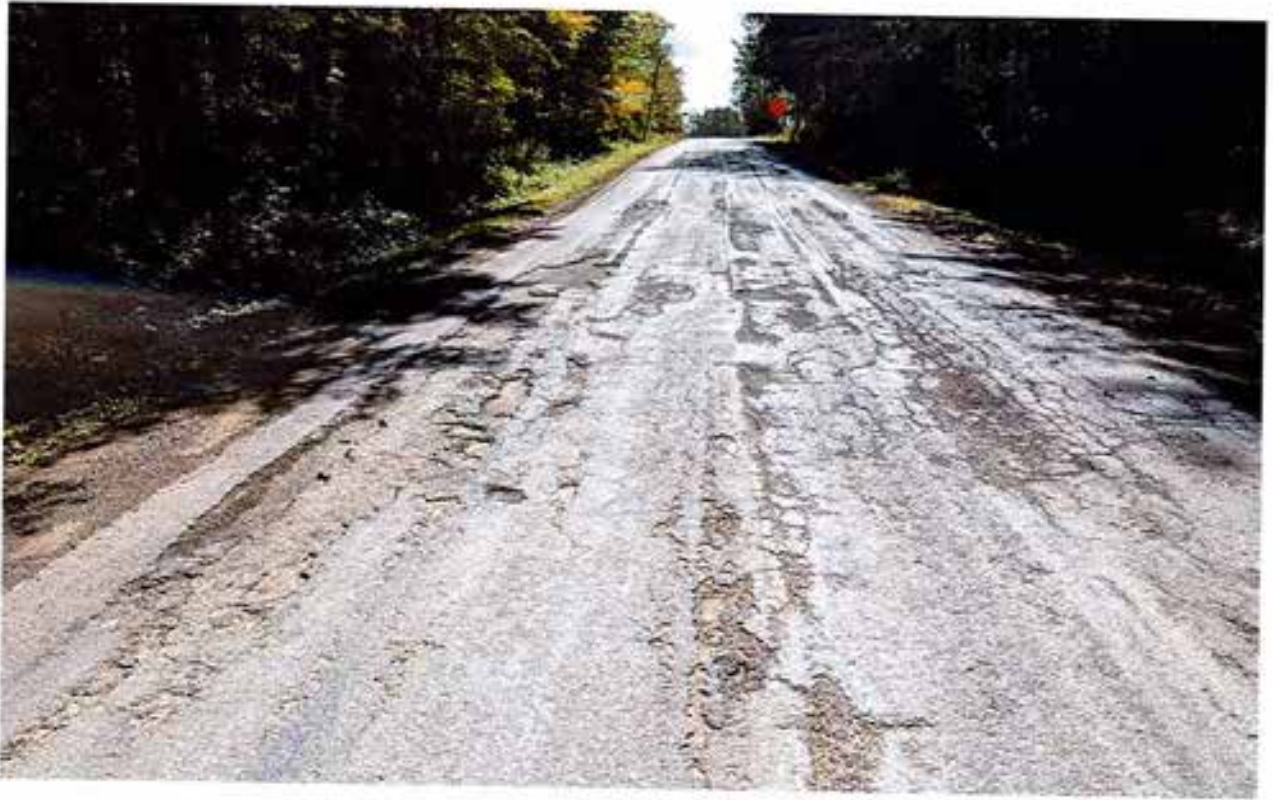
Galen Hill Road lane from Phillippi Rd to 10553

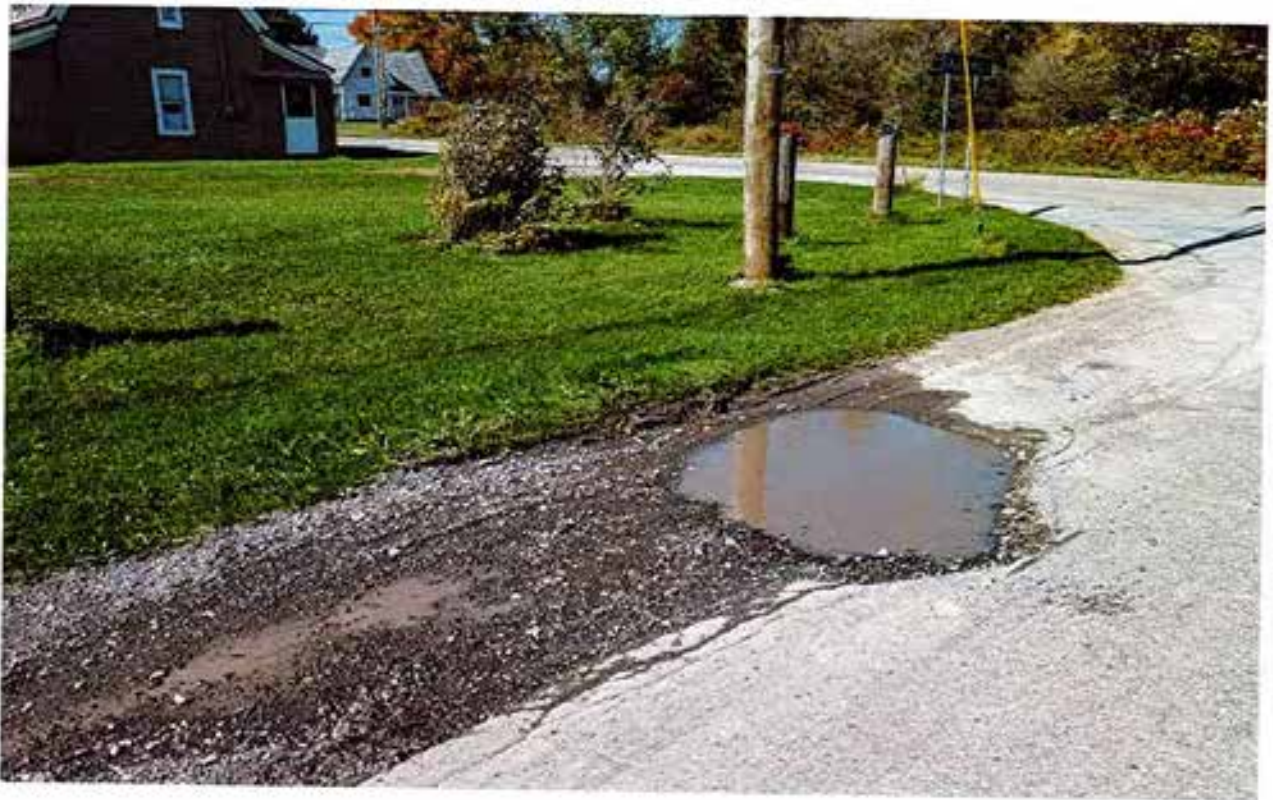
Galen Hill Rd at intersection of Route 98

| Maintenance Needed: | <ul style="list-style-type: none"> <li>- Deficiency at Galen Hill Rd and 98 intersection, repairs needed.</li> <li>- Repair lane from Phillippi Rd to 10553 Galen Hill</li> </ul> |

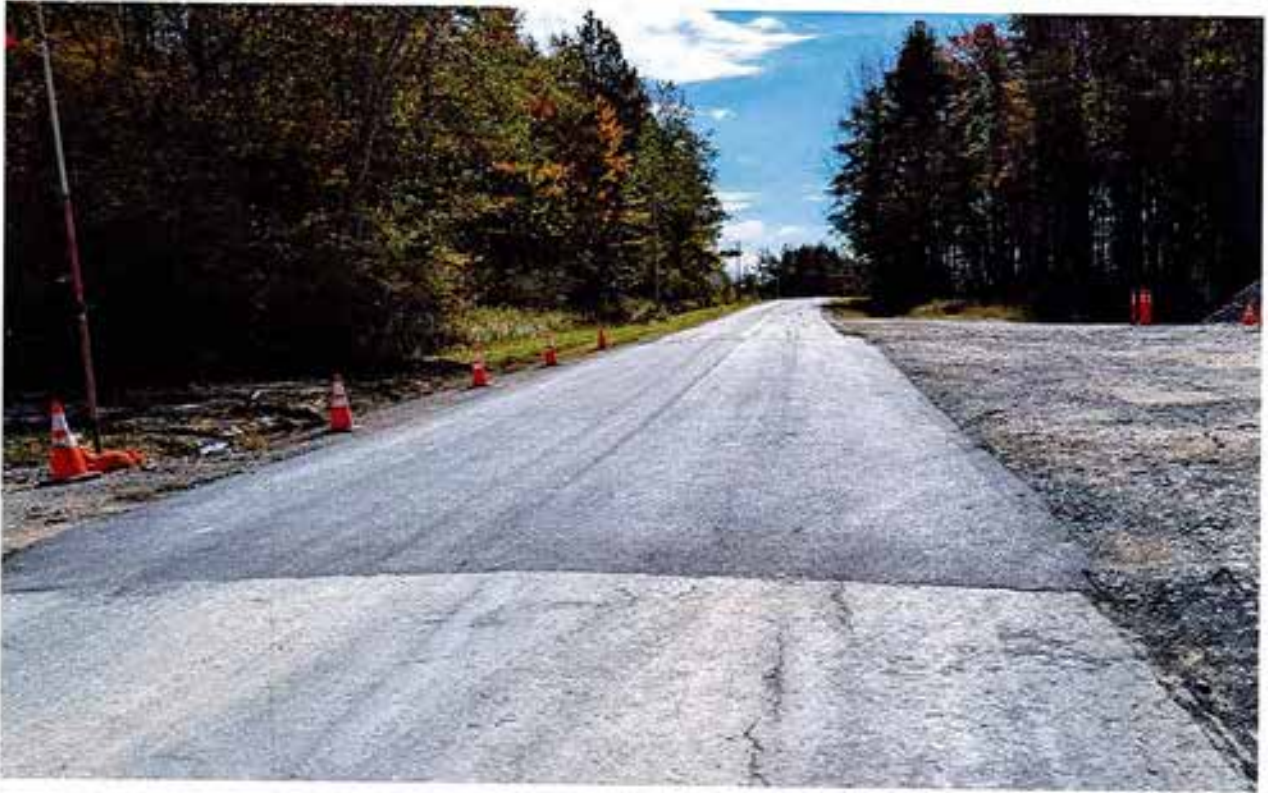
Galen Hill Rd pavement repair between construction entrances (REPAIRED)

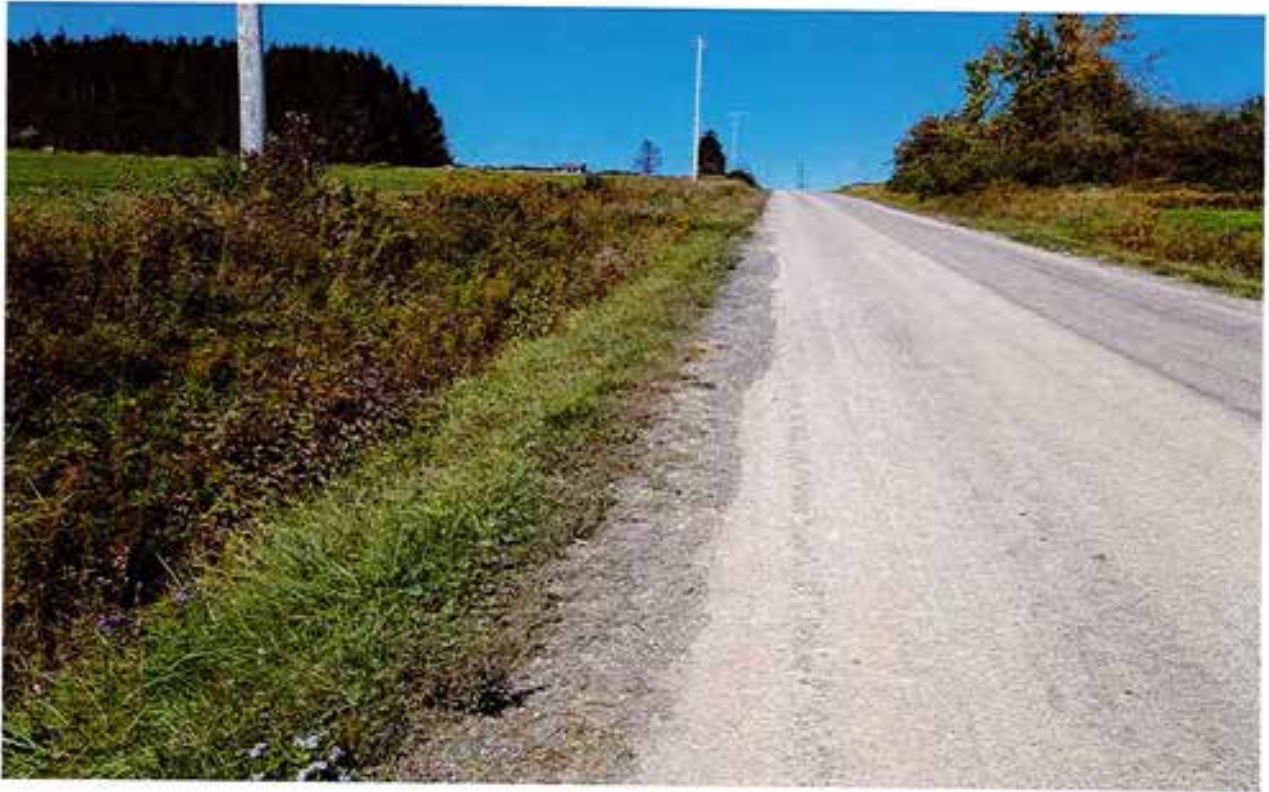
Galen Hill West edge and shoulder North of 10075

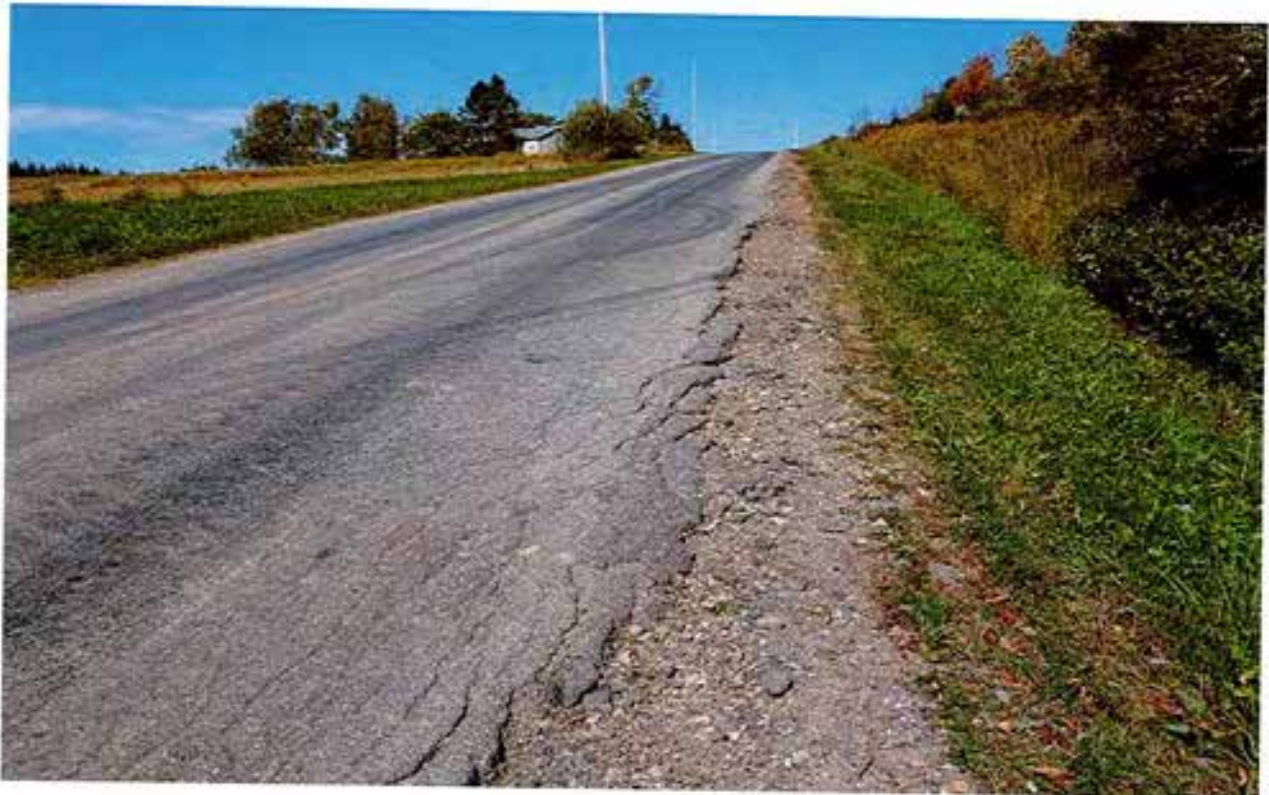
| Hazards Identified: | - Lane and edge deficiencies (see photos) |

Sandbank Road East edge and shoulder near 9999

| Maintenance Needed: | - Repair lane and edge |

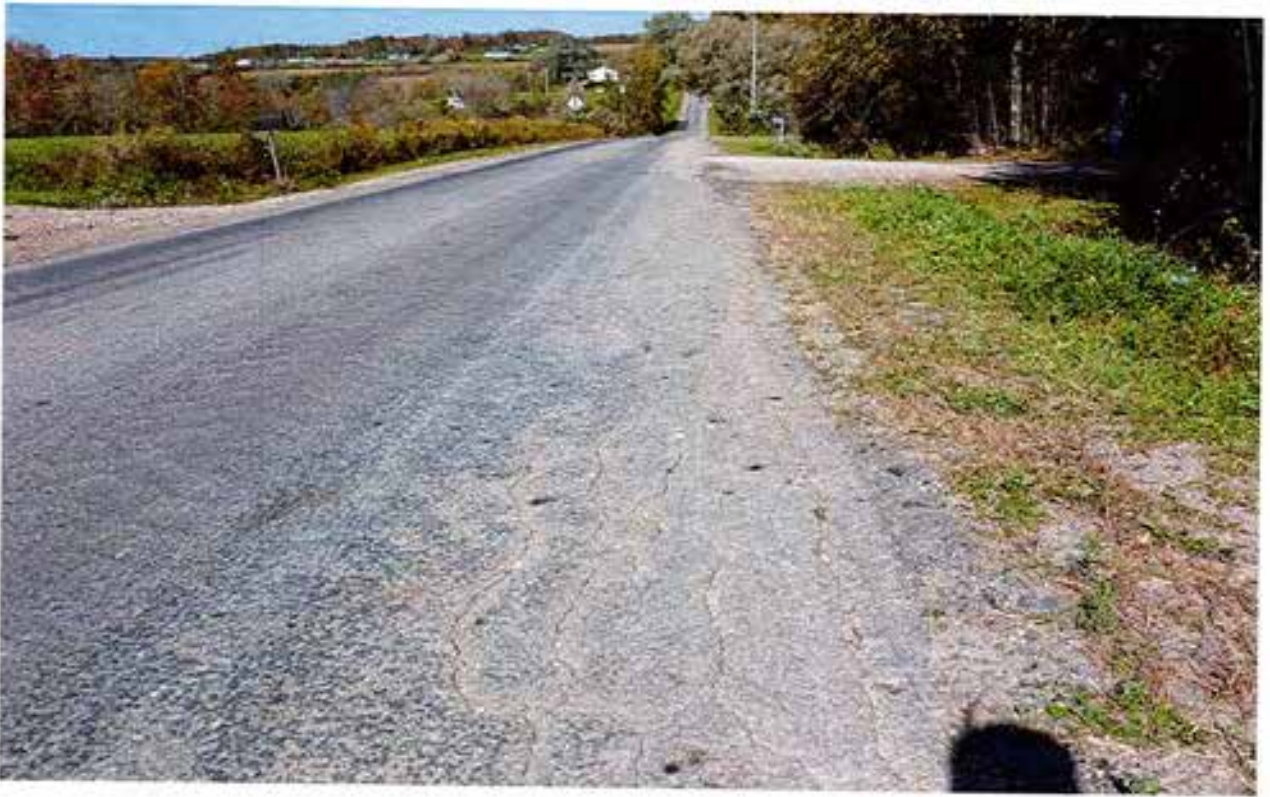
Sandbank Rd East and West edge North and South of 10157 to +/- 10220

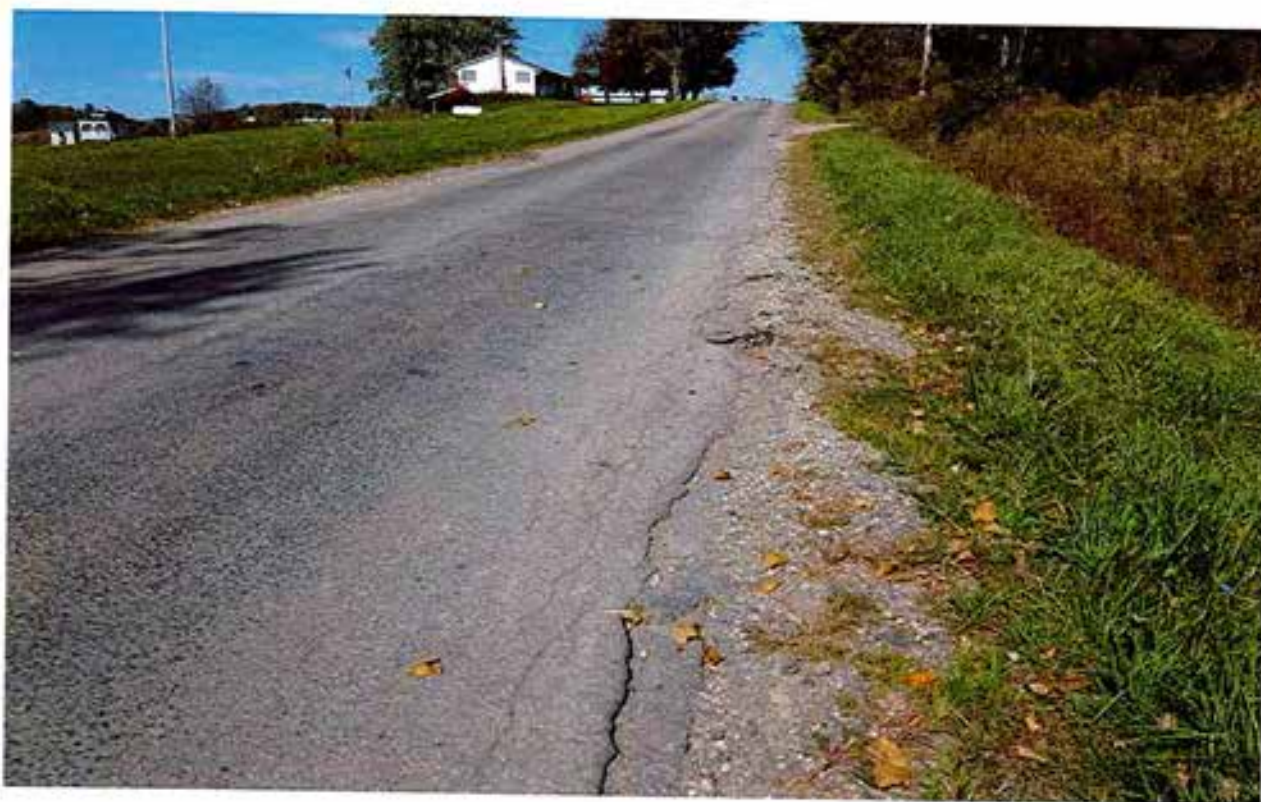
Sandbank Rd East lane and edge South of 10317

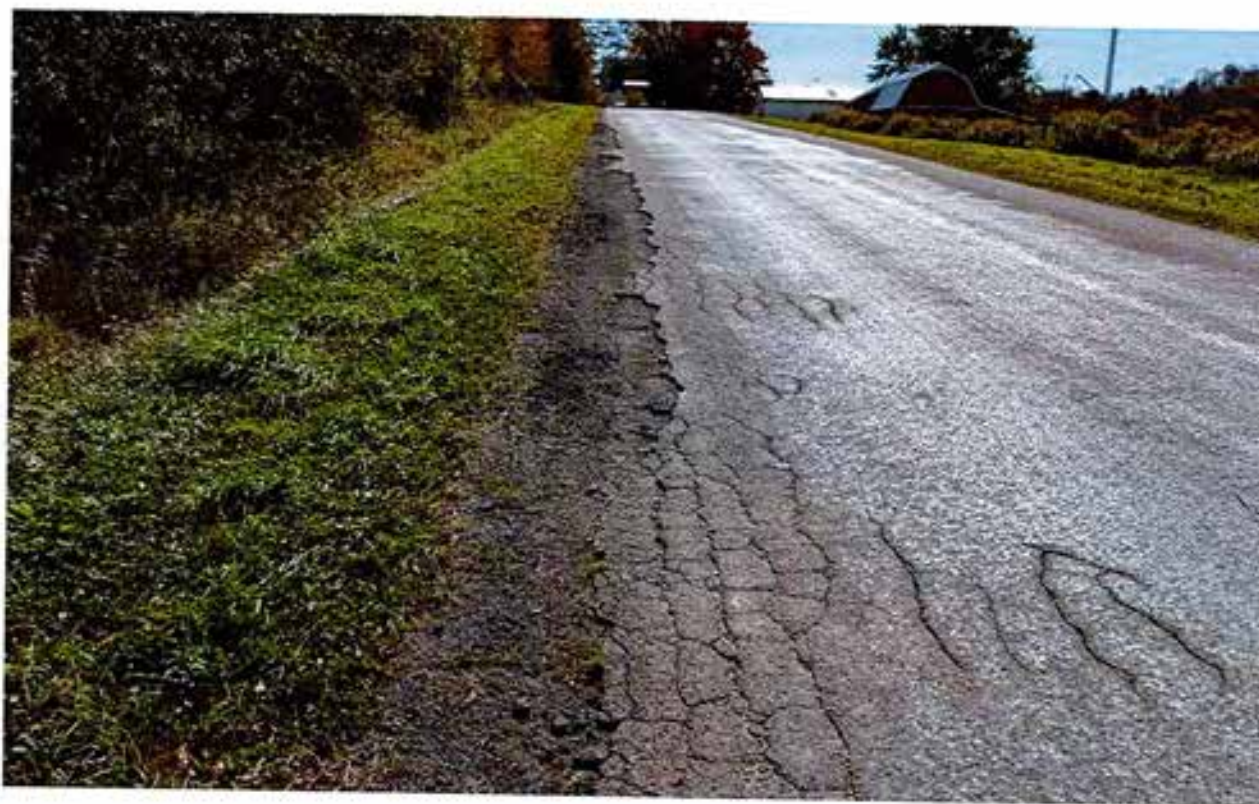
Sandbank Road East edge South of 10368

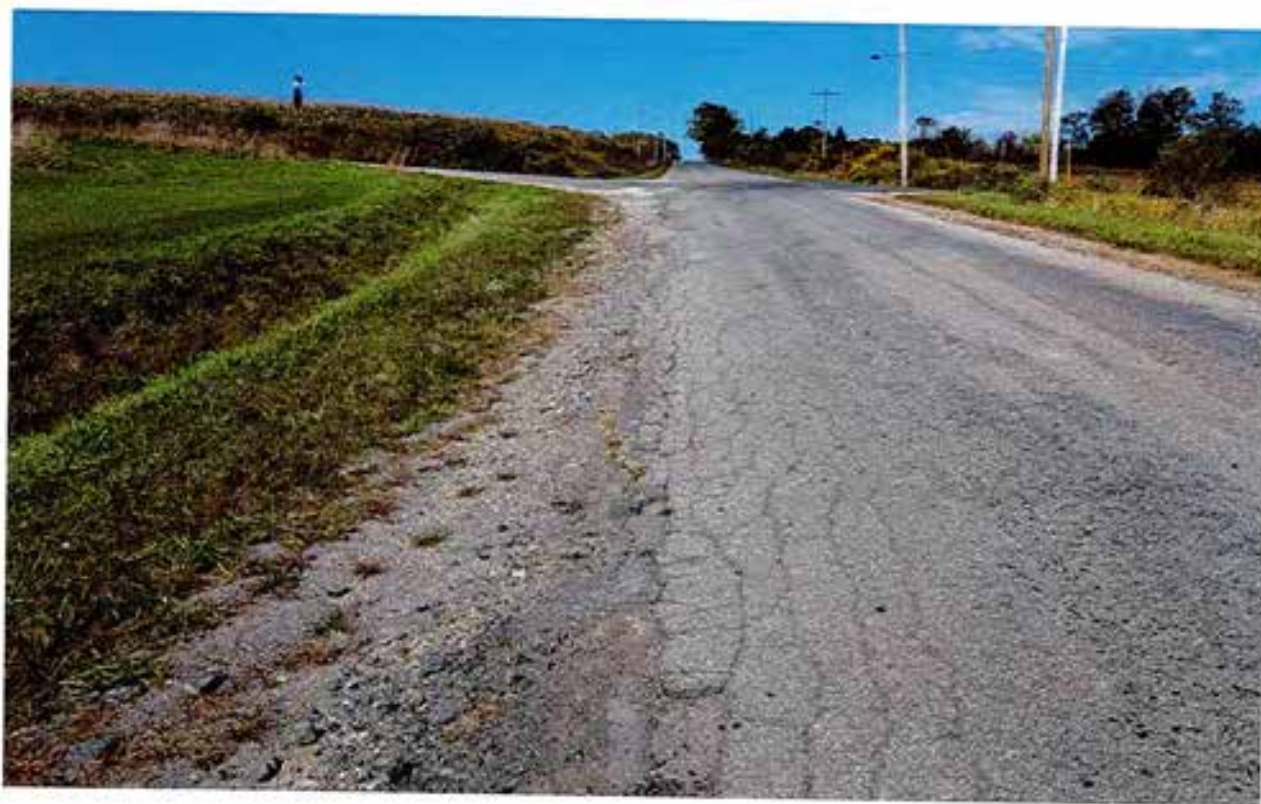
Sandbank Road (East and West) edge and shoulder near intersection with Cross Road

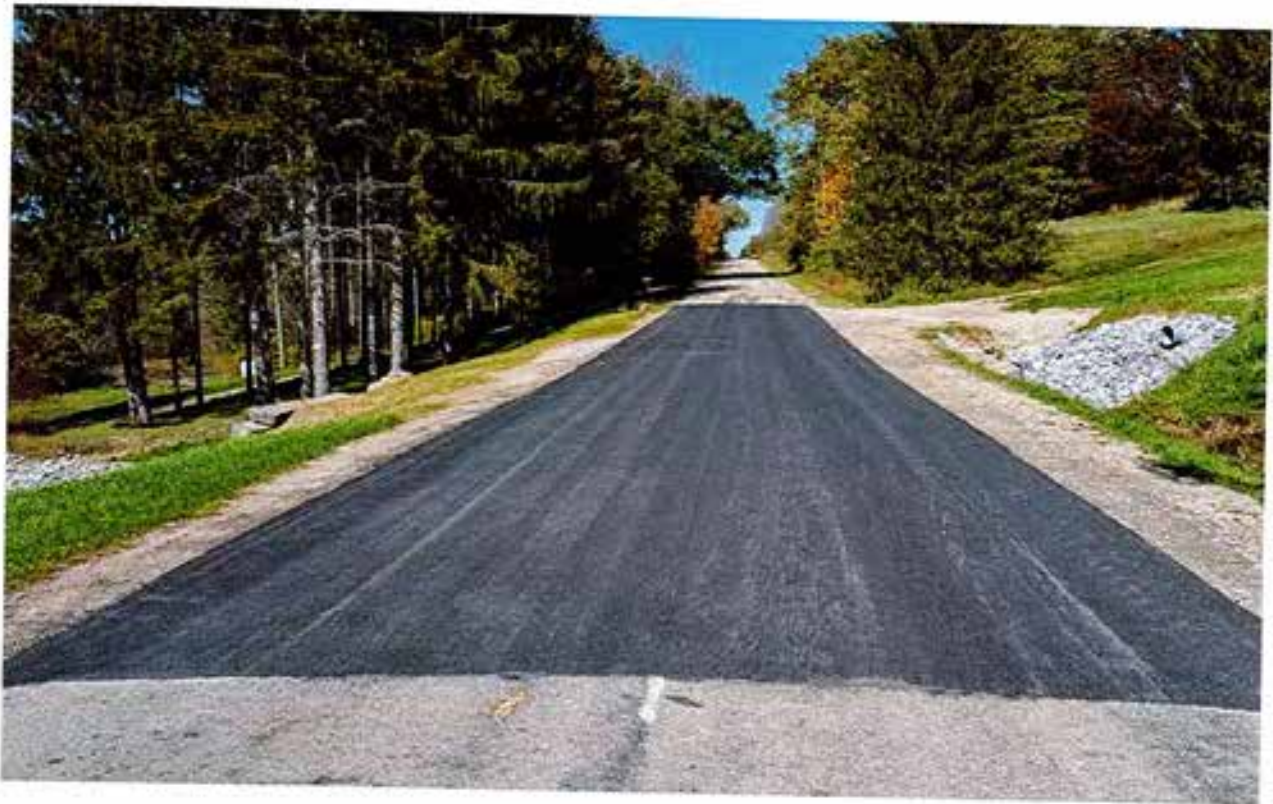
Osmun Rd: Road over Culvert near 10379 facing North (REPAIRED)

| Maintenance Needed: | <ul style="list-style-type: none"> <li>- Maintain diversion ditch and install additional erosion control measures near 10379 Osmun</li> </ul> |

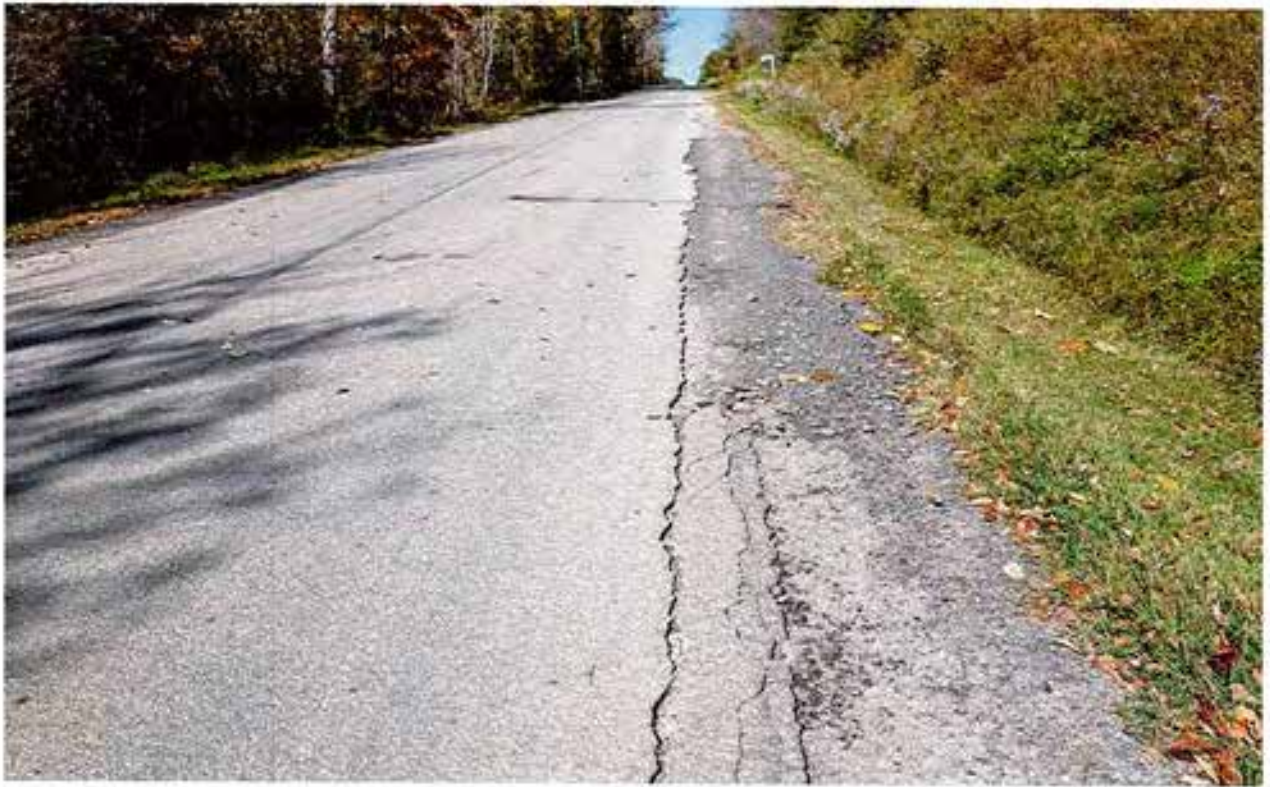
| Hazards Identified: | <ul style="list-style-type: none"> <li>- Lane/edge/shoulder deficiency near 10410</li> </ul> |

Osmun Rd East side lane, edge, and shoulder North and South of 10410

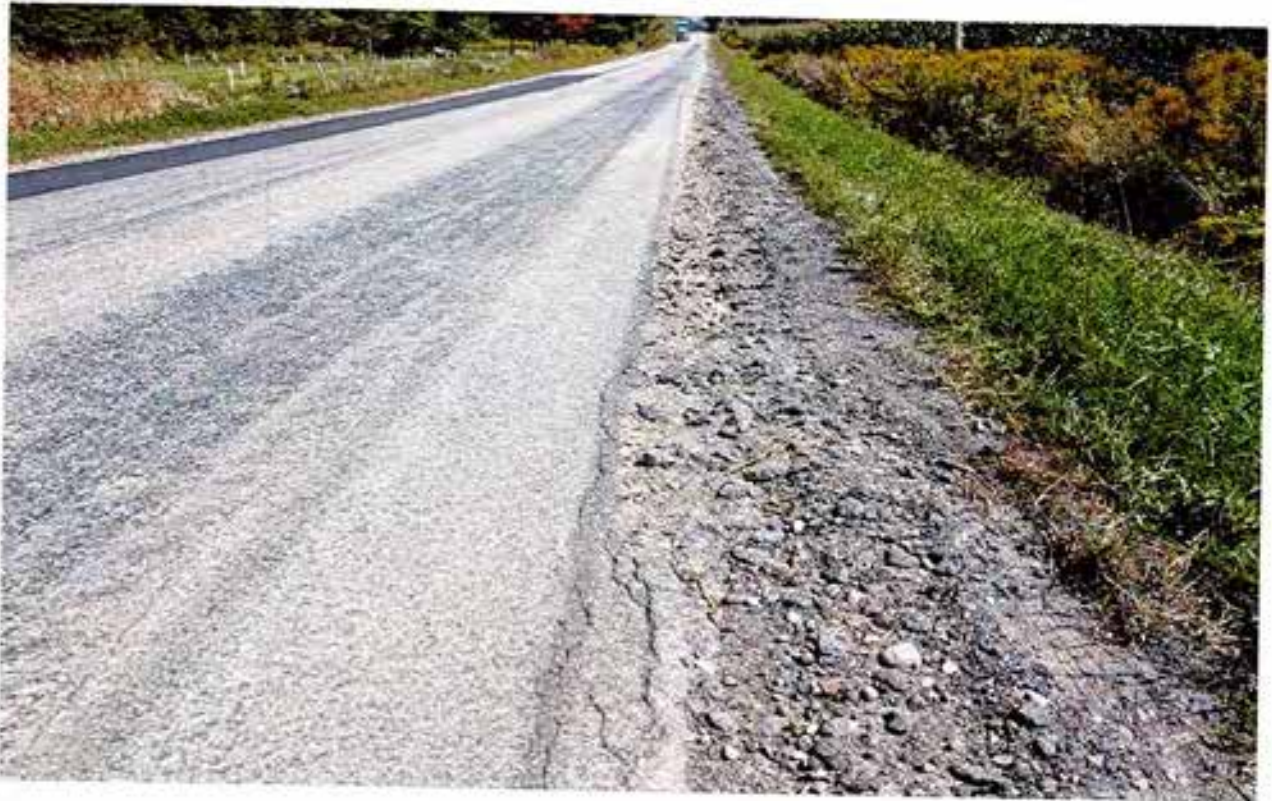
Baird Road South edge from +/- 379 to +/- 253

| Maintenance Needed: | <ul style="list-style-type: none"> <li>- Repair shoulder and lane</li> </ul> |

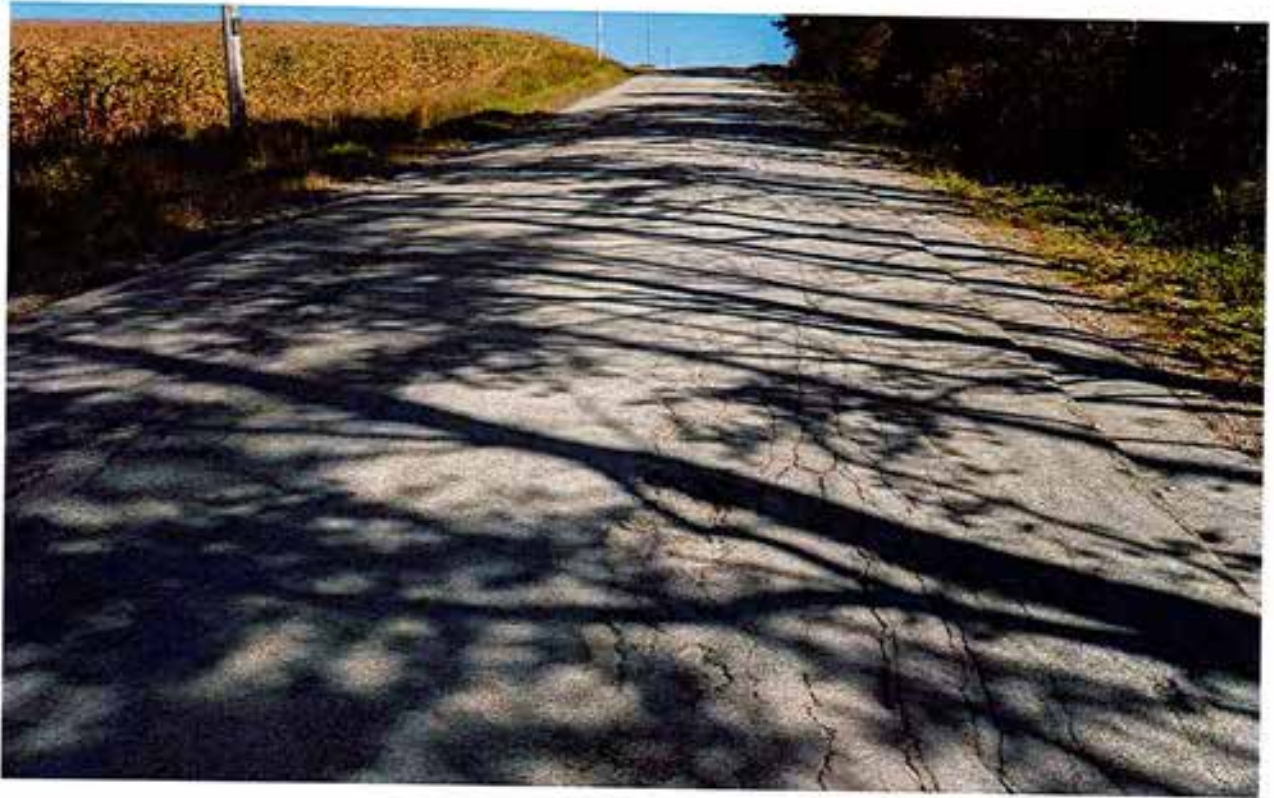
Baird Road lane from +/-253 to +/-187
