## Road Condition & Vehicle Compliance Report

| Report # | 58 |
| Project Name | Alle-Catt Wind |
| Location | Town of Freedom |

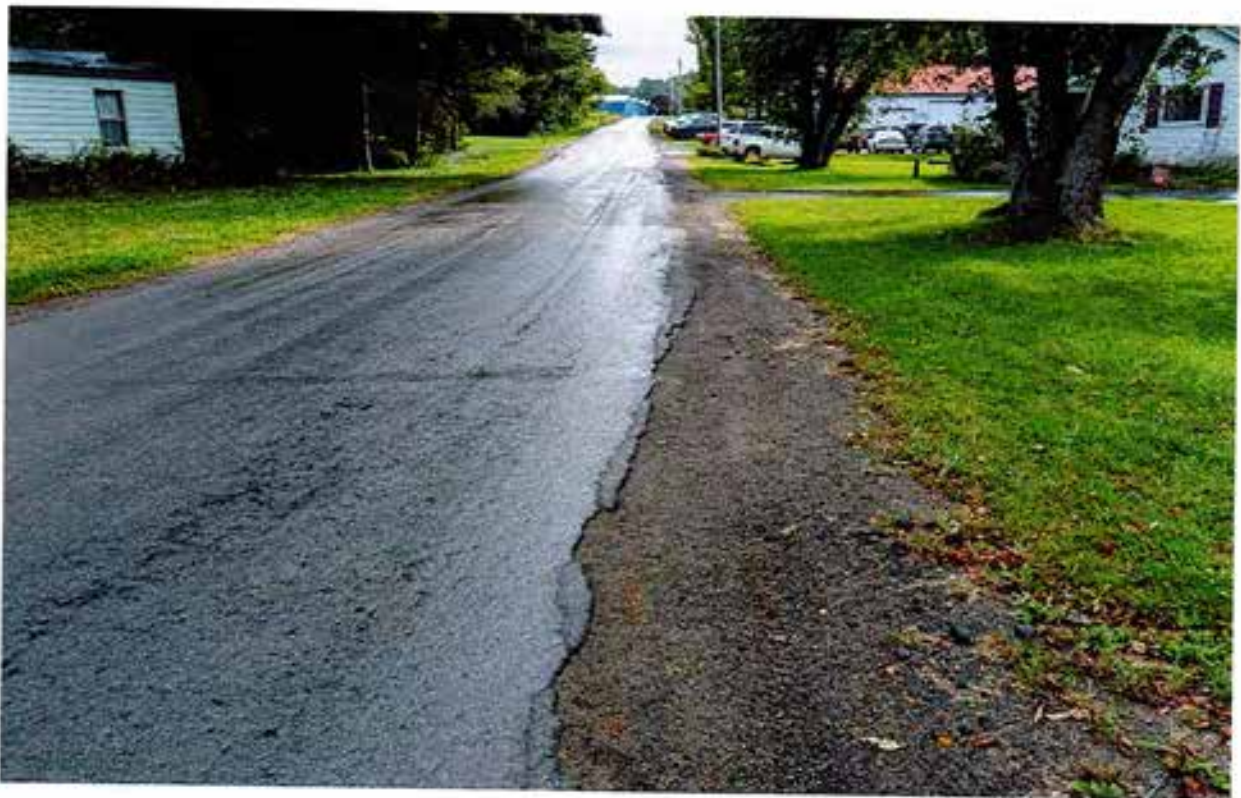
Eagle Street lane and edge deterioration near 1253

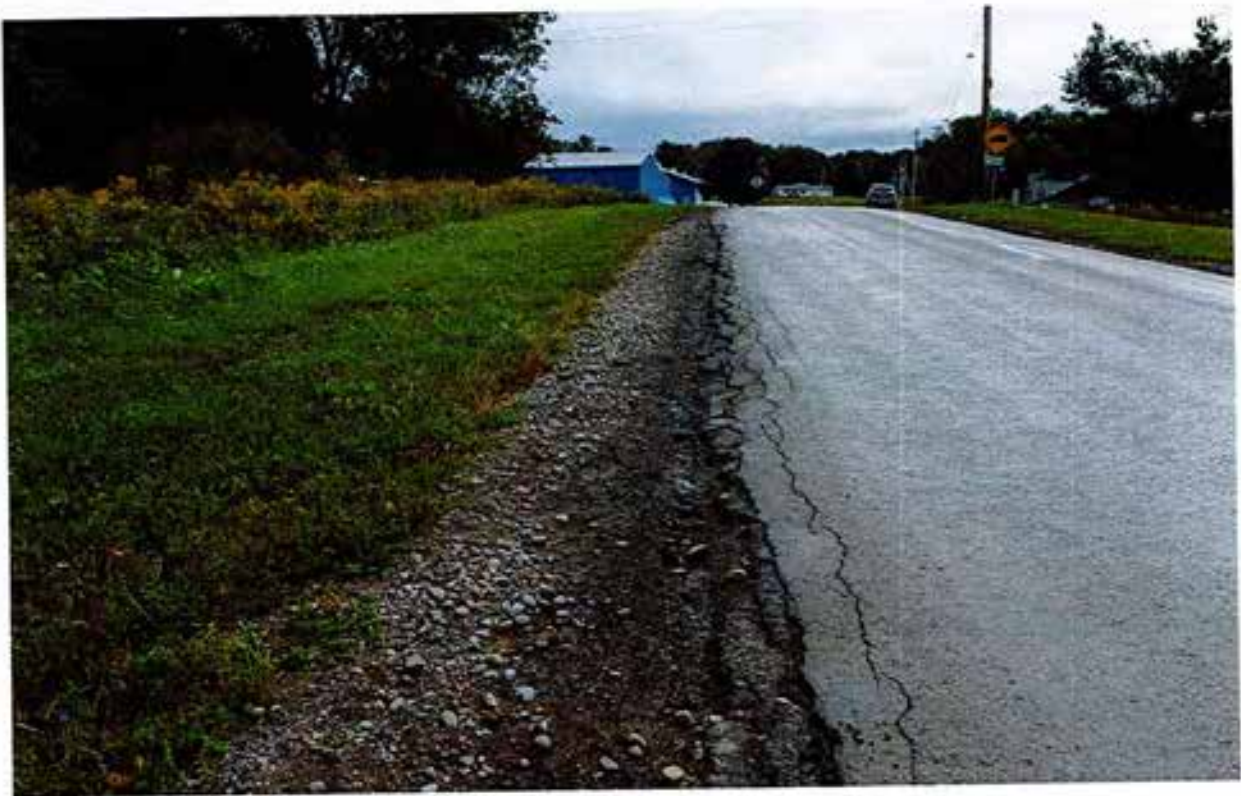
Eagle Street North and South side lane and edge deterioration near 1219

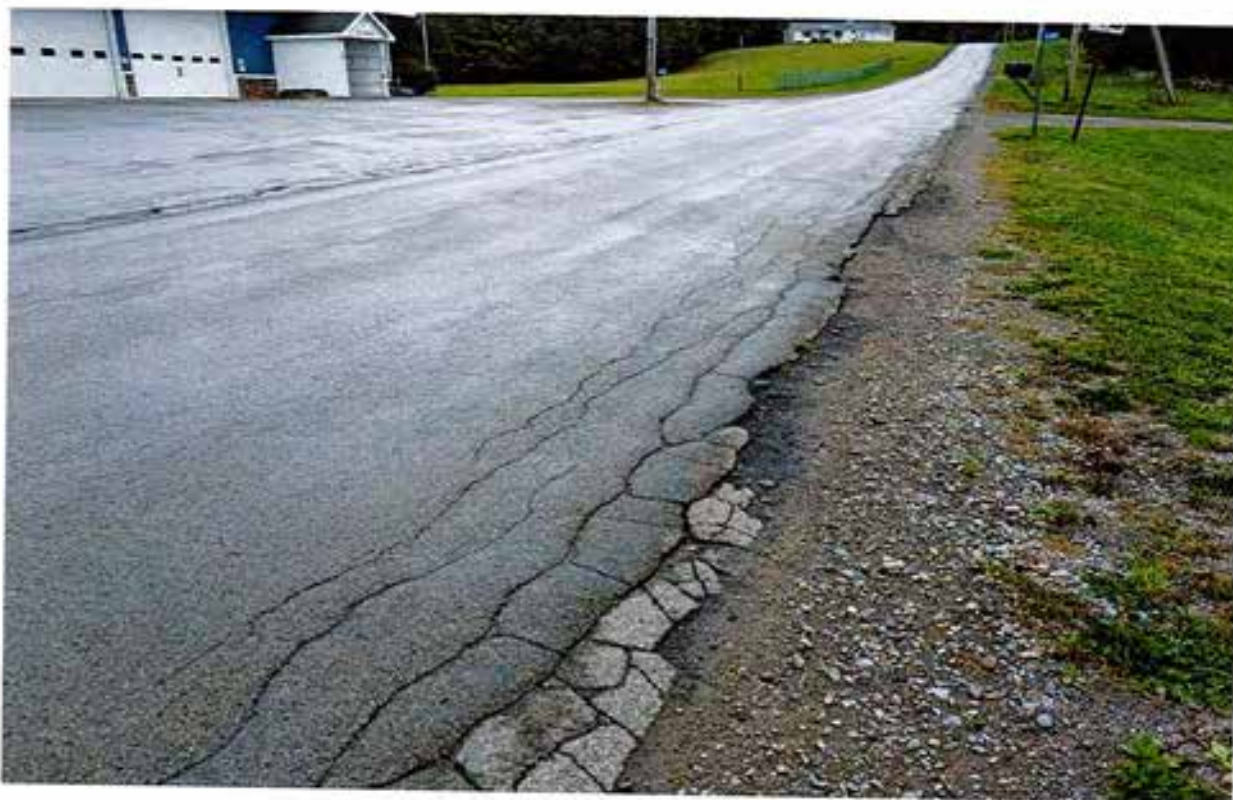
Eagle Street South side lane and edge deterioration near 11405

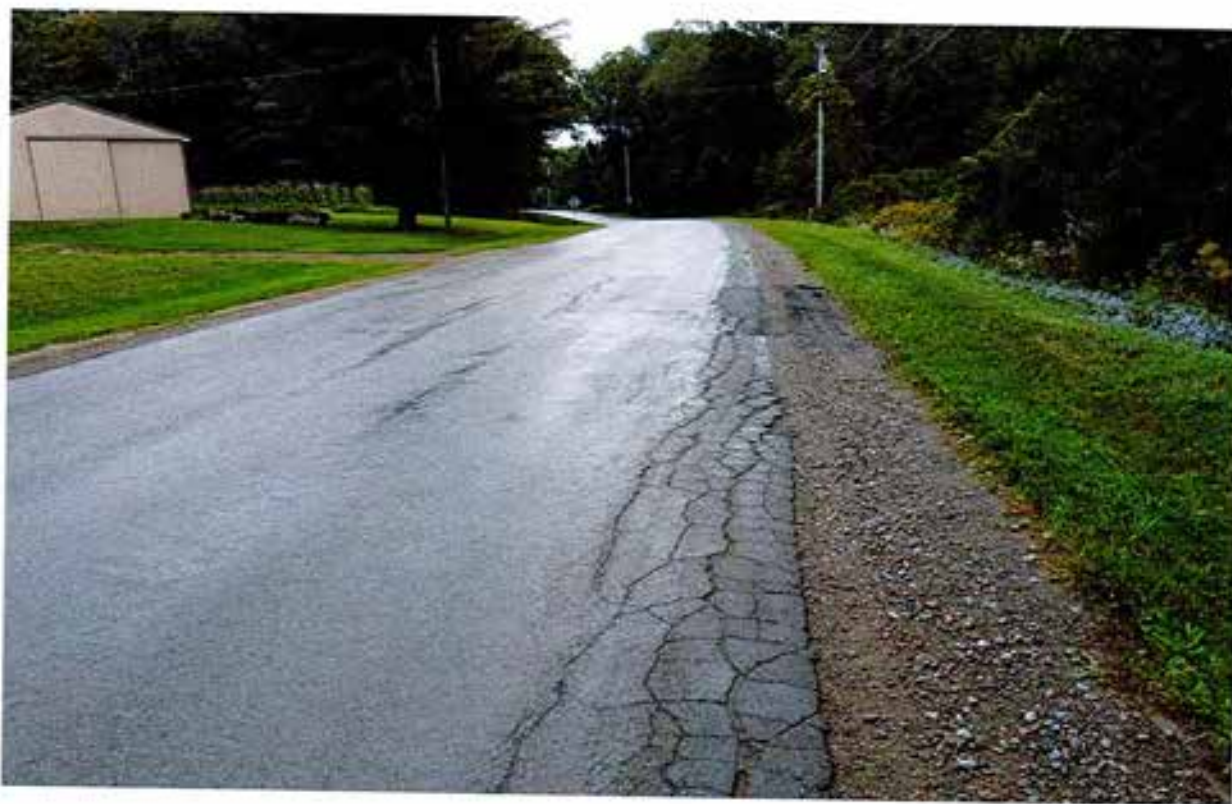
Eagle Street lane and edge deterioration near 1152

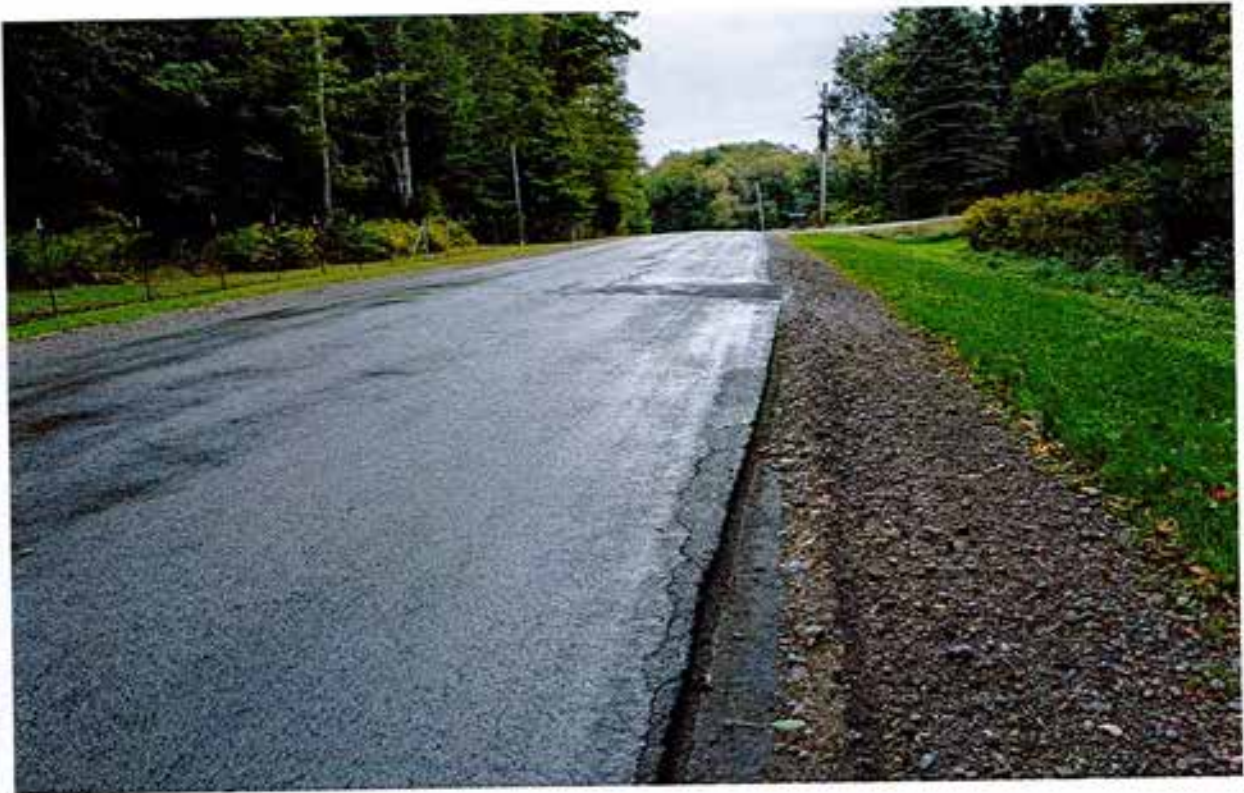
Eagle Street lane and shoulder deterioration near 1111

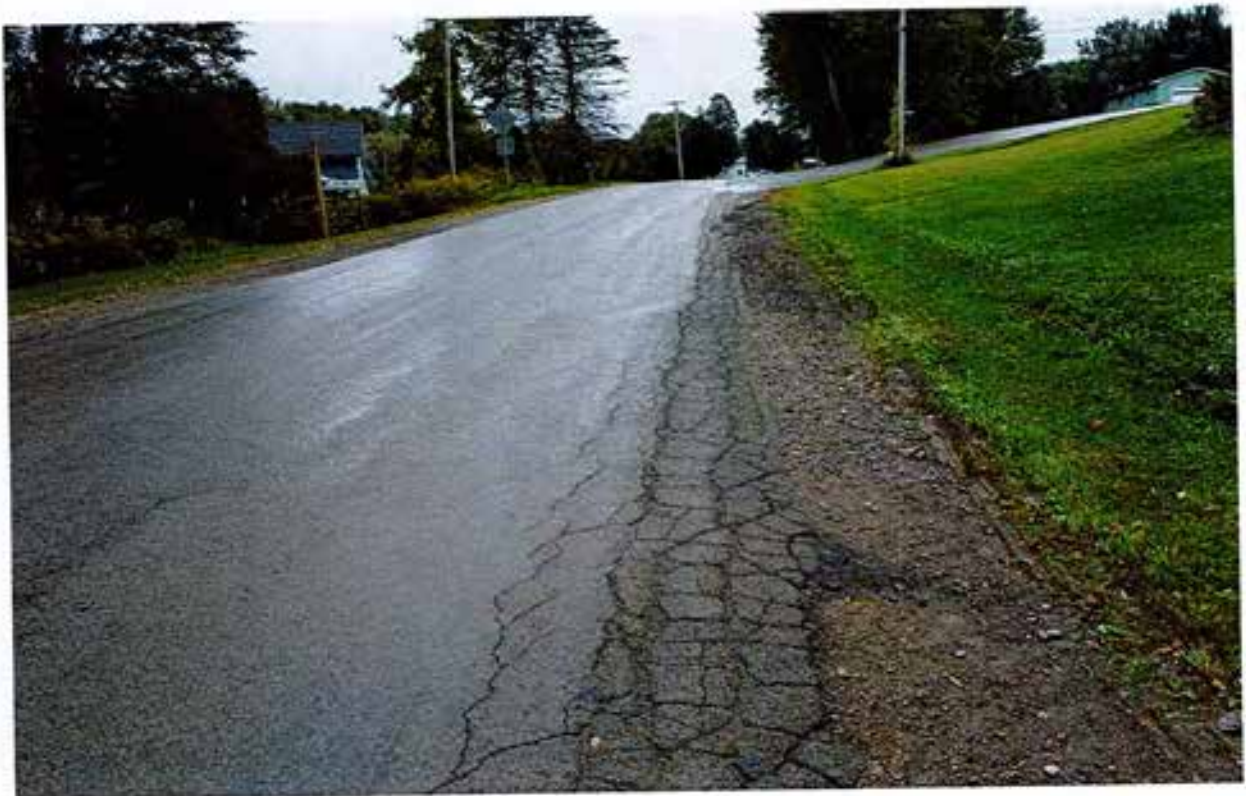
Eagle Street East edge deterioration near Hughes

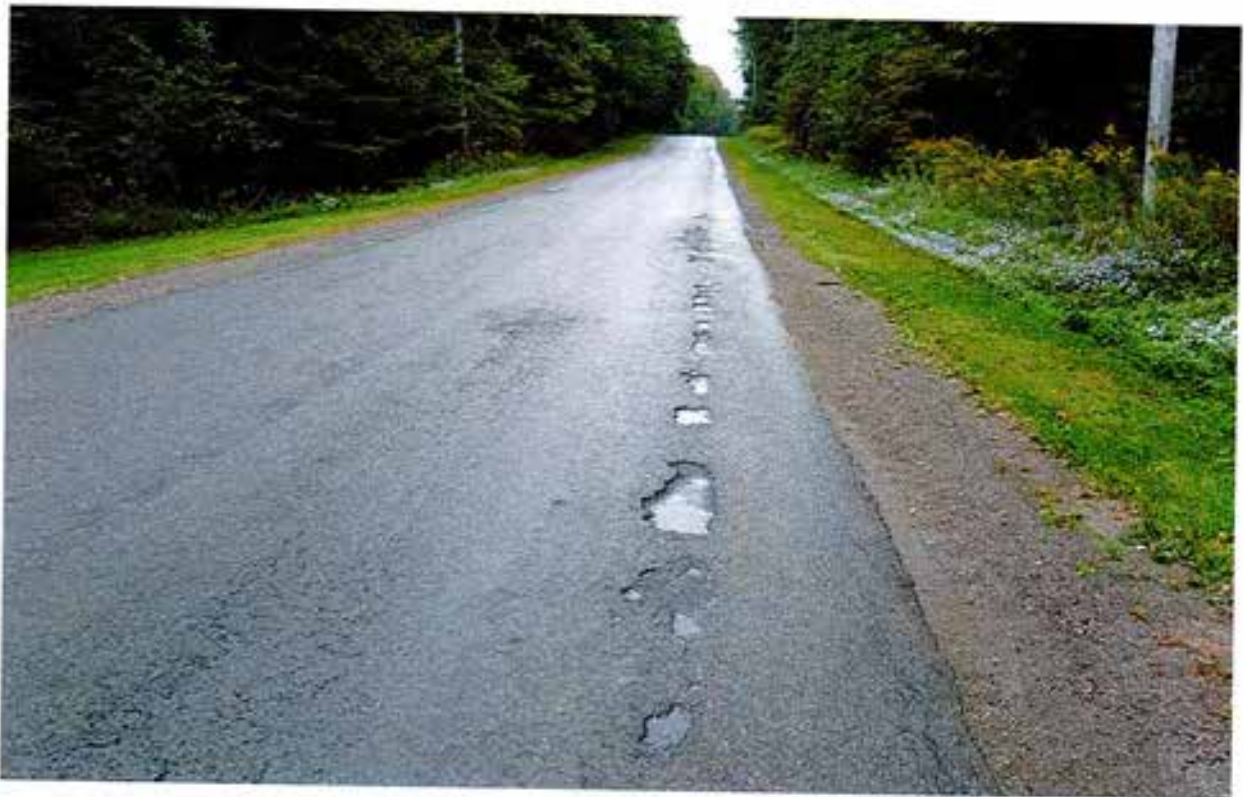
Eagle Street lane deterioration near 1000

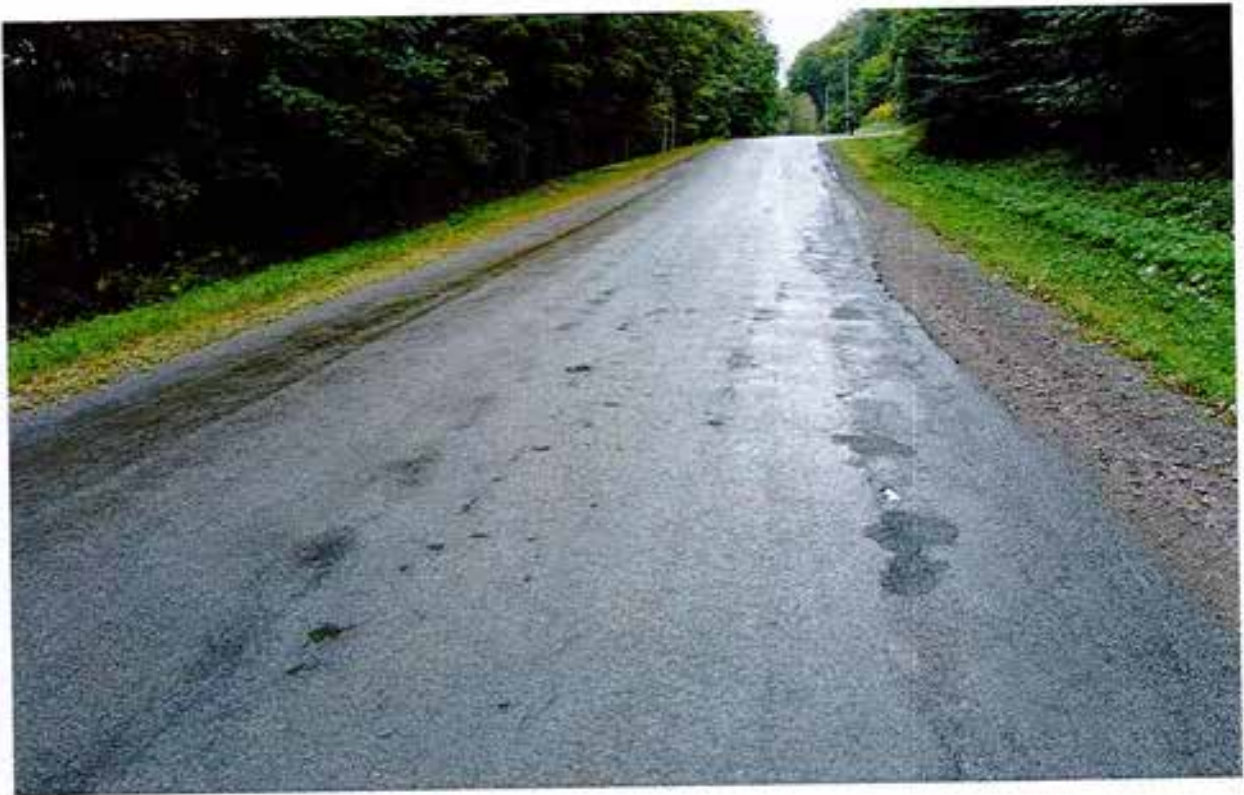
Eagle Street lane and edge deterioration near 931

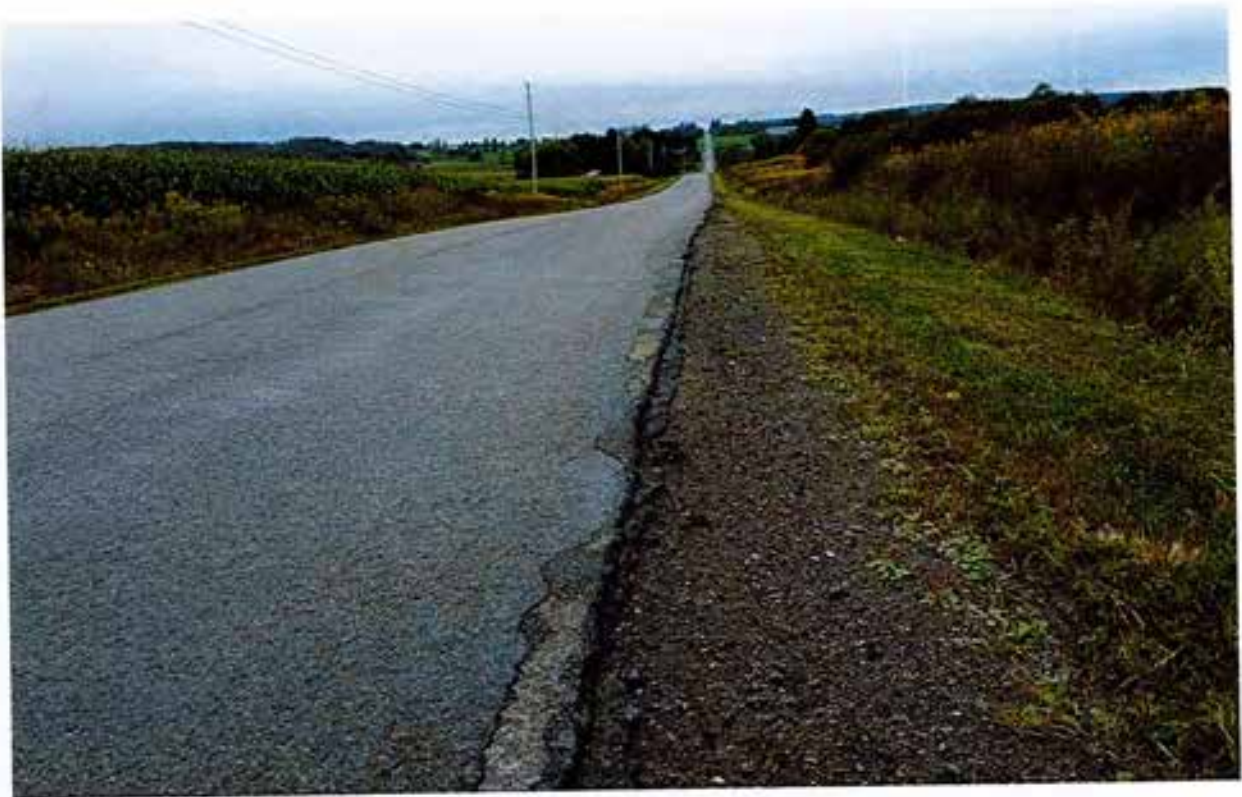
Bray Road North edge and shoulder deteriorating from gas pipeline #57 to +/- House 113

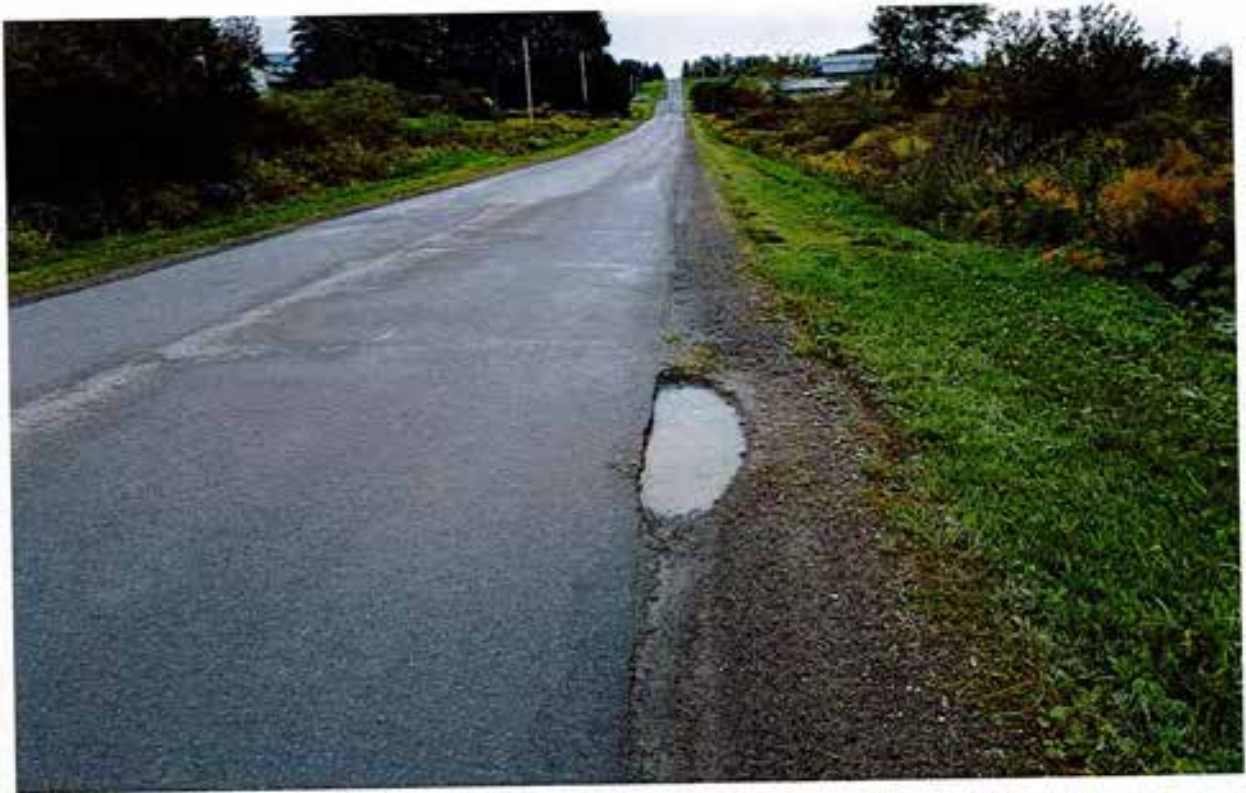
Bray Road North edge and shoulder deteriorating with Pothole near 2407

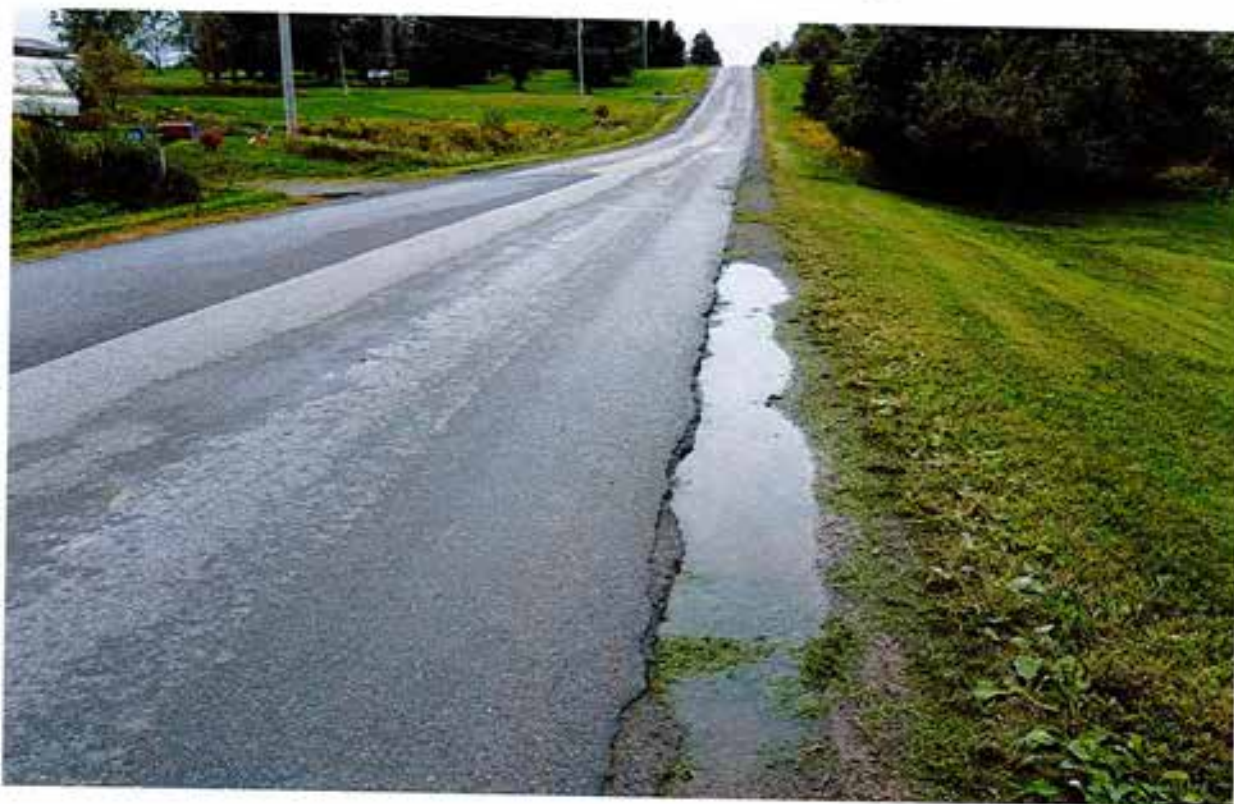
Bray Road North edge and shoulder deteriorating near 245

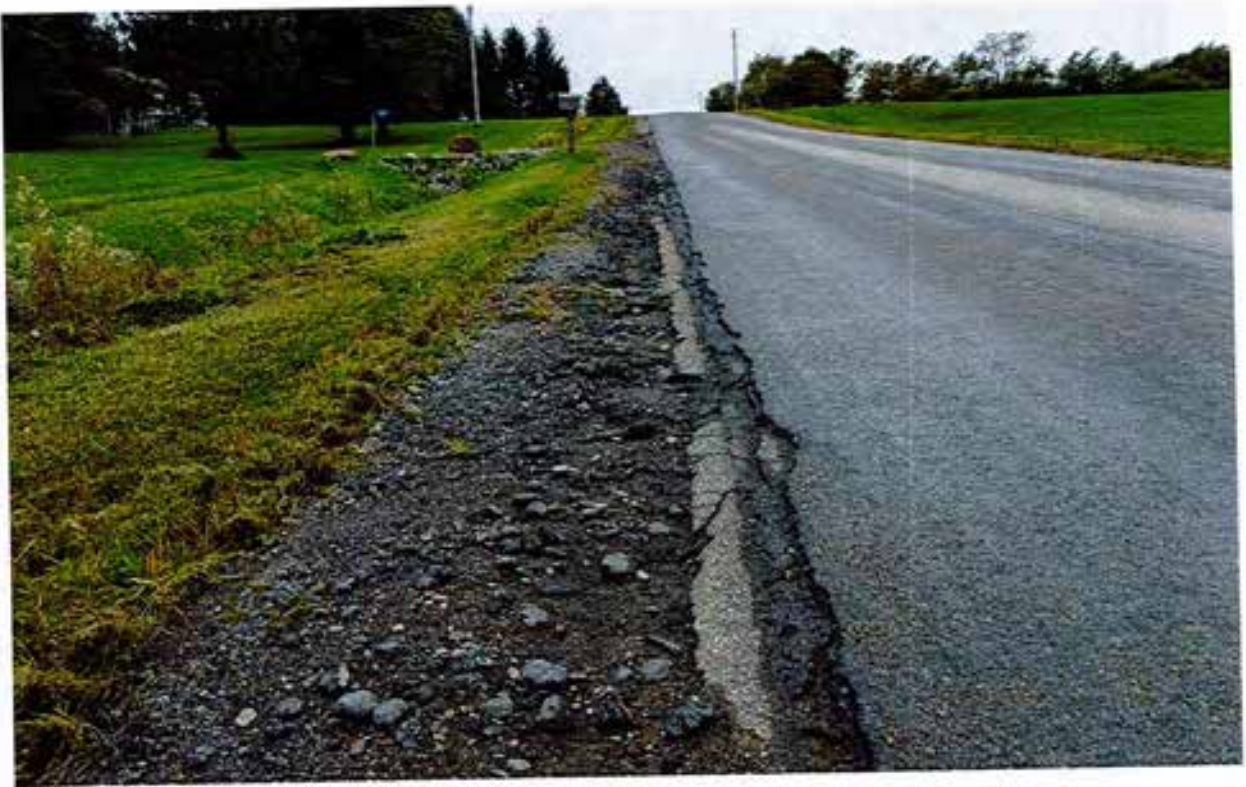
Bray Road South edge and shoulder deteriorating near 259

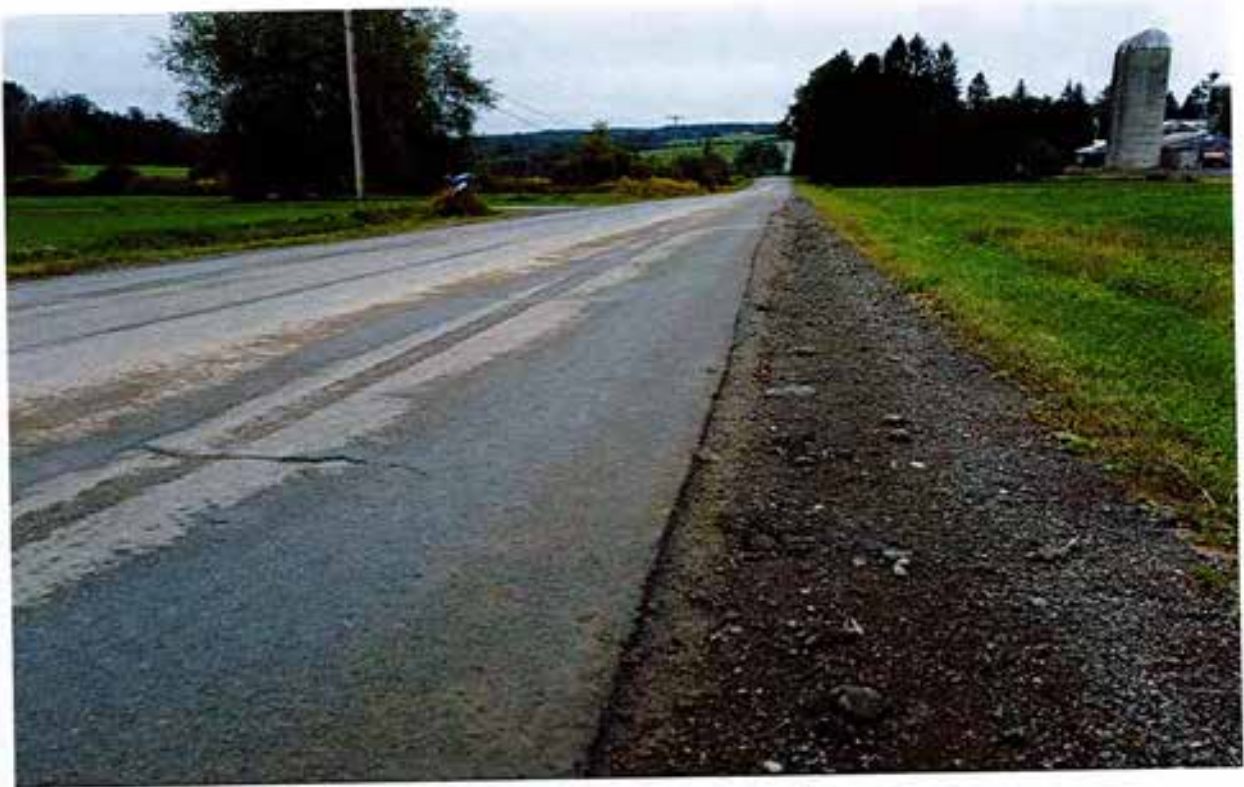
Bray Road North edge and shoulder deteriorating from 445 to 475

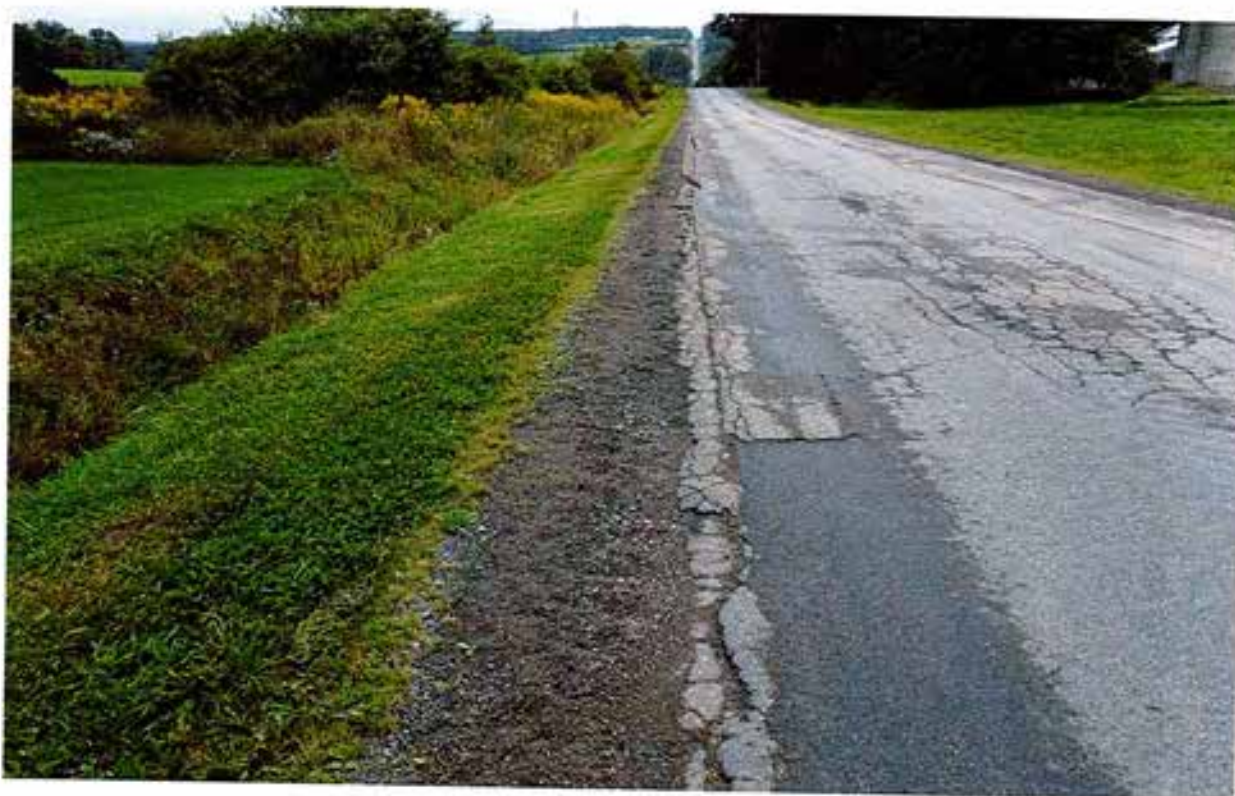
Bray Road South edge and shoulder deteriorating from 475 to Eagle Street

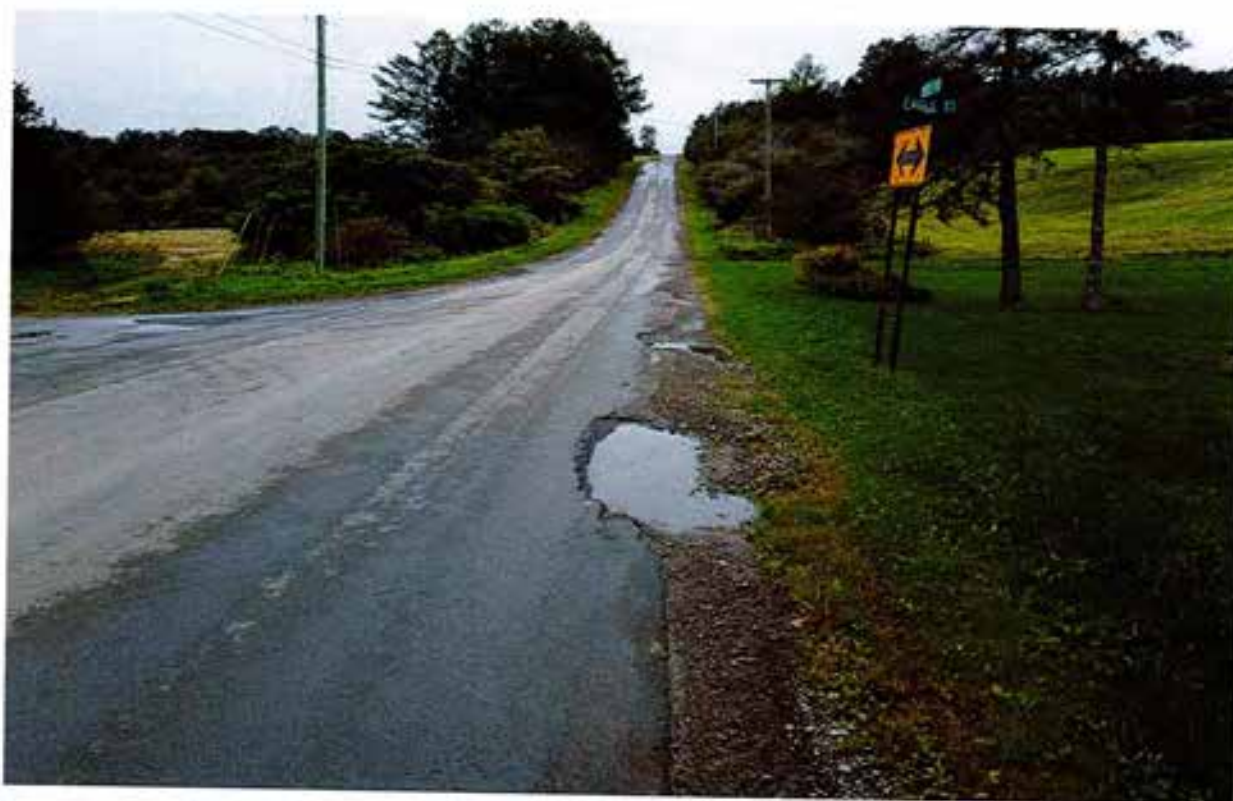
Bray Road Edge Deterioration at Eagle Street Intersection

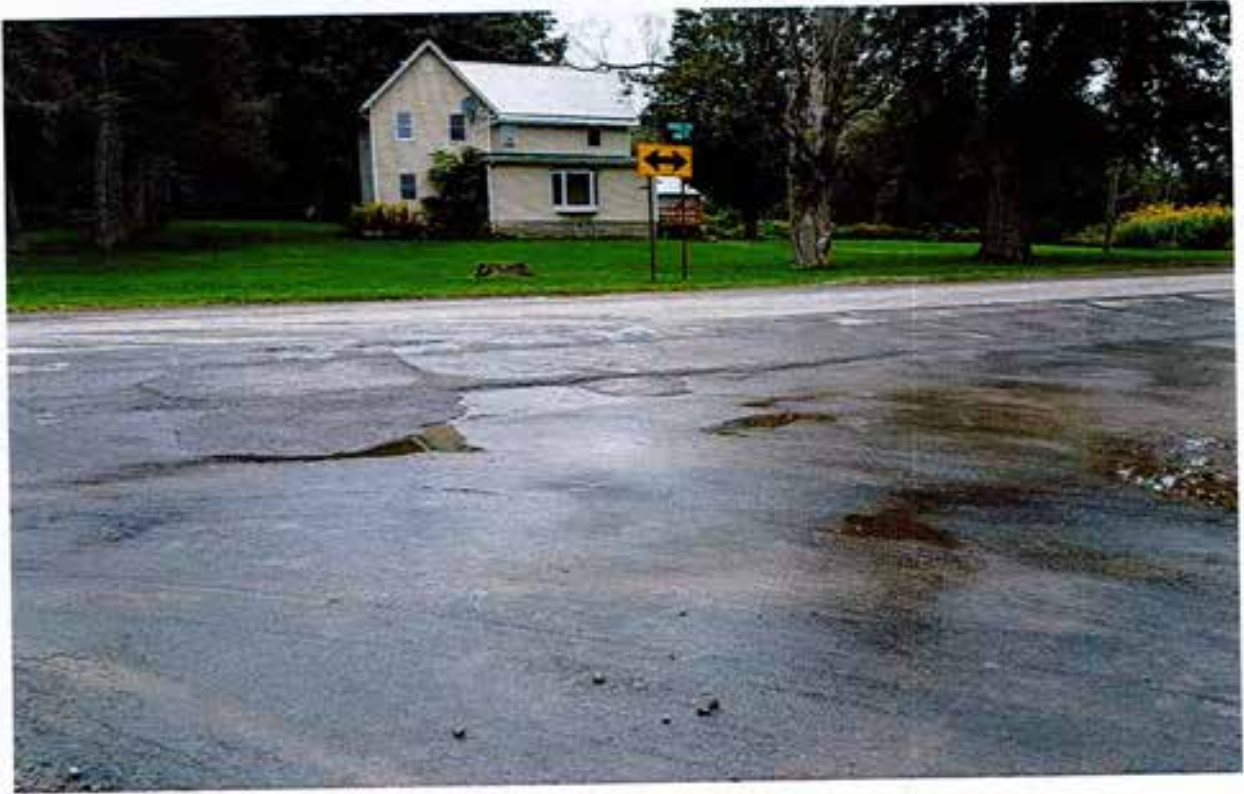
Bray Road lane deterioration near intersection with Eagle St

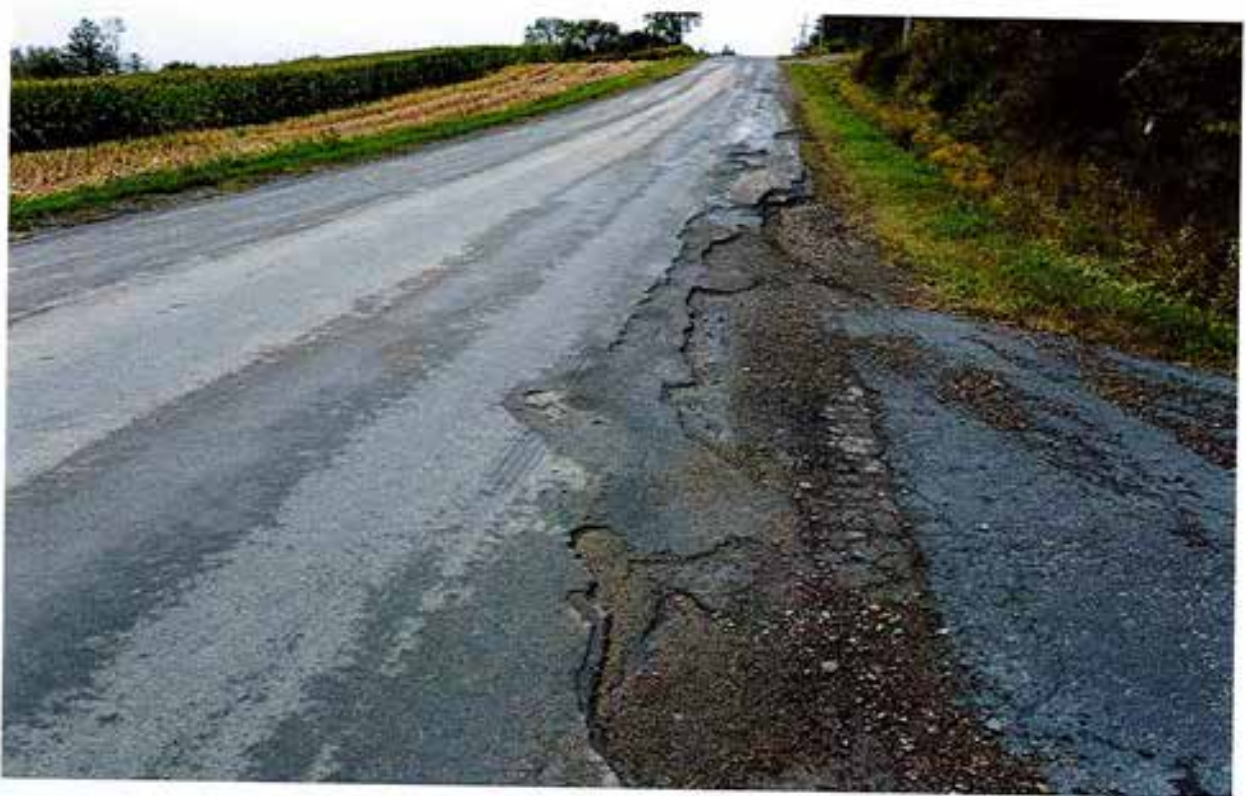
Bray Road North edge and lane deterioration near 2801 (#1)

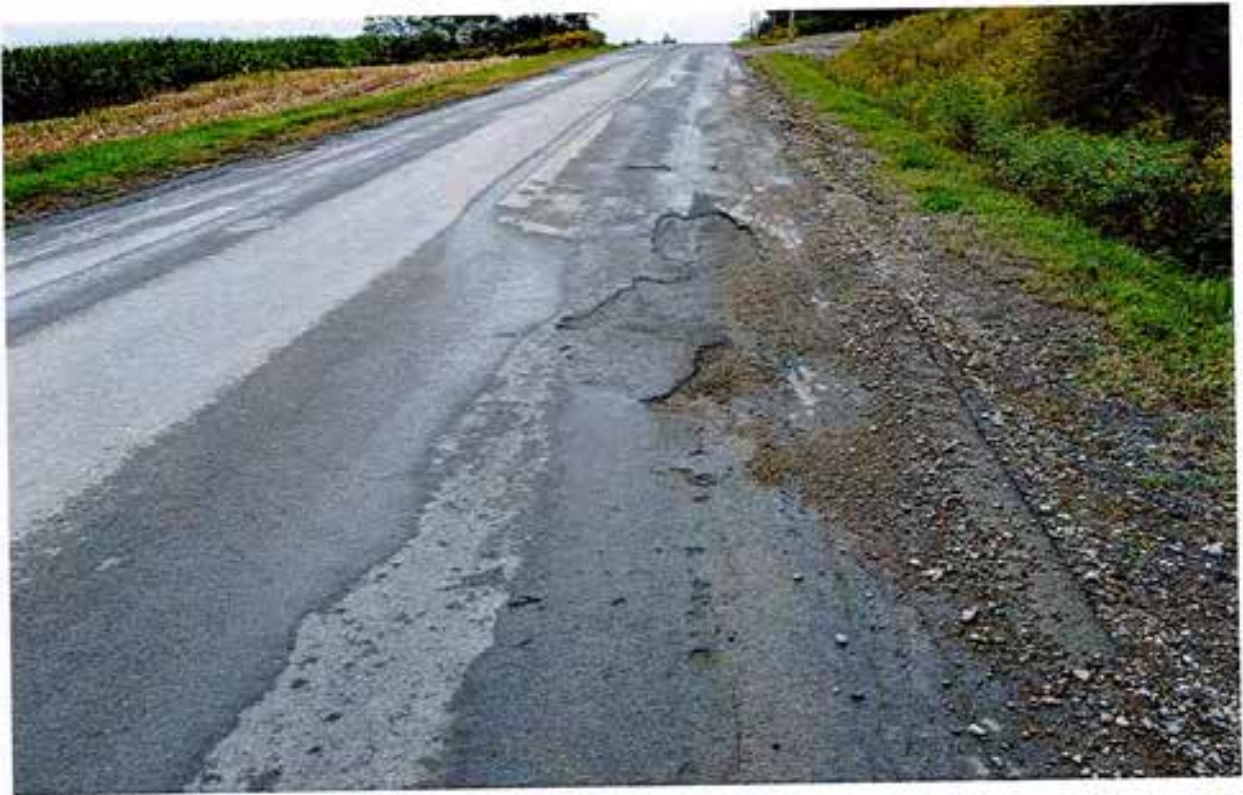
Bray Road lane deterioration near 2801 (#2)

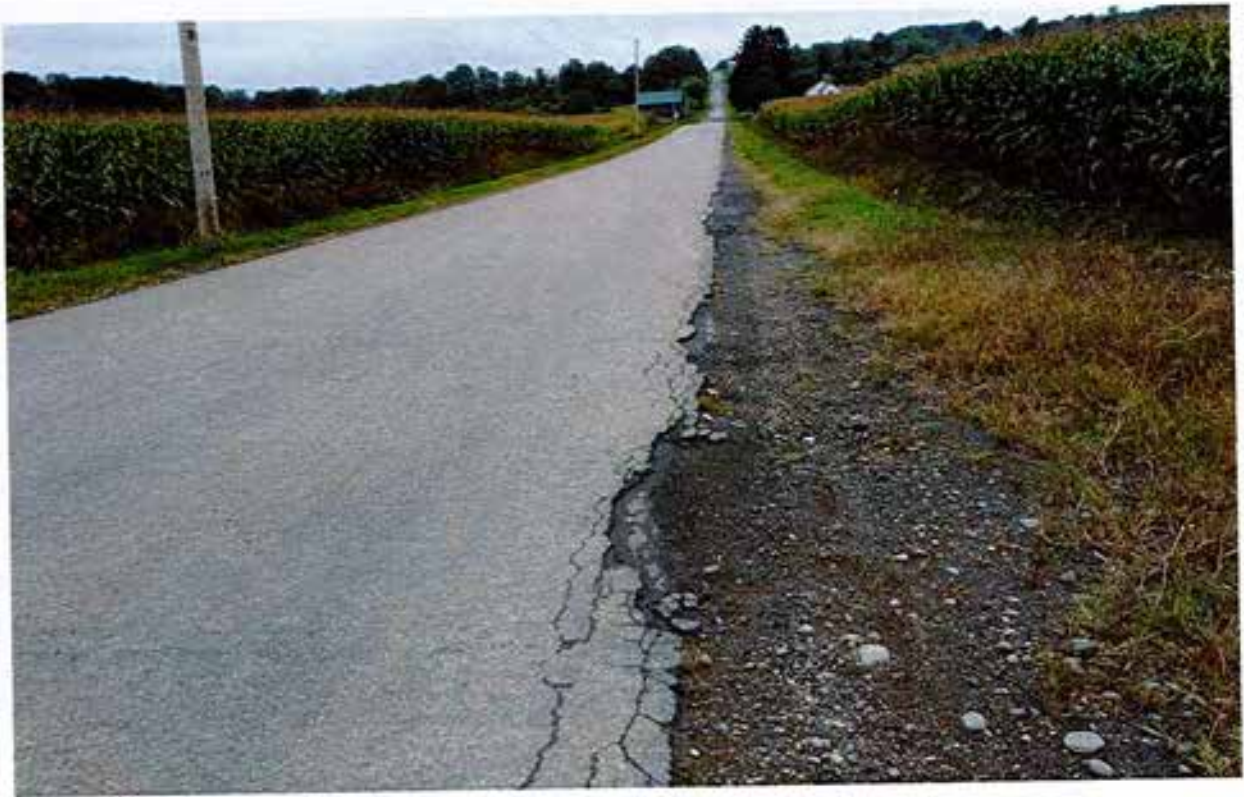
Fisher Blake Road North edge and shoulder deterioration from 2195 to +/- 2272

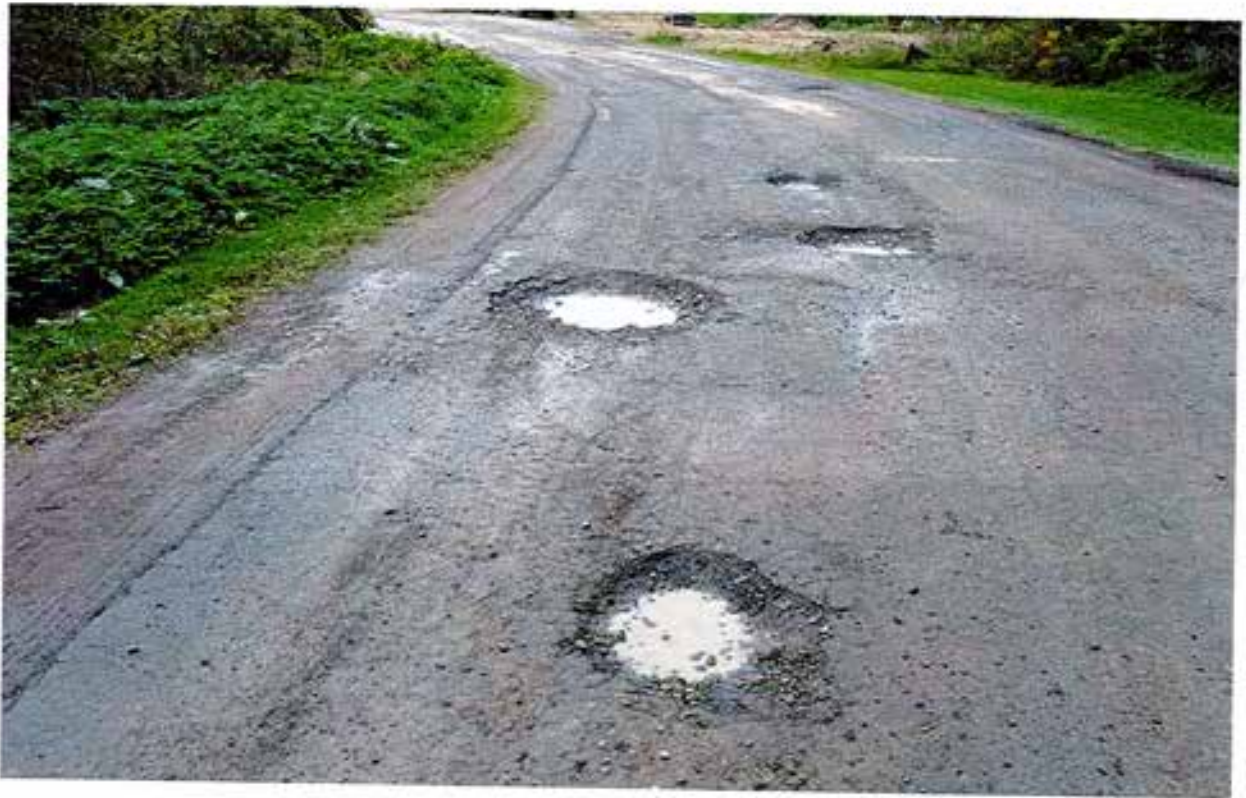
Strong Rd potholes

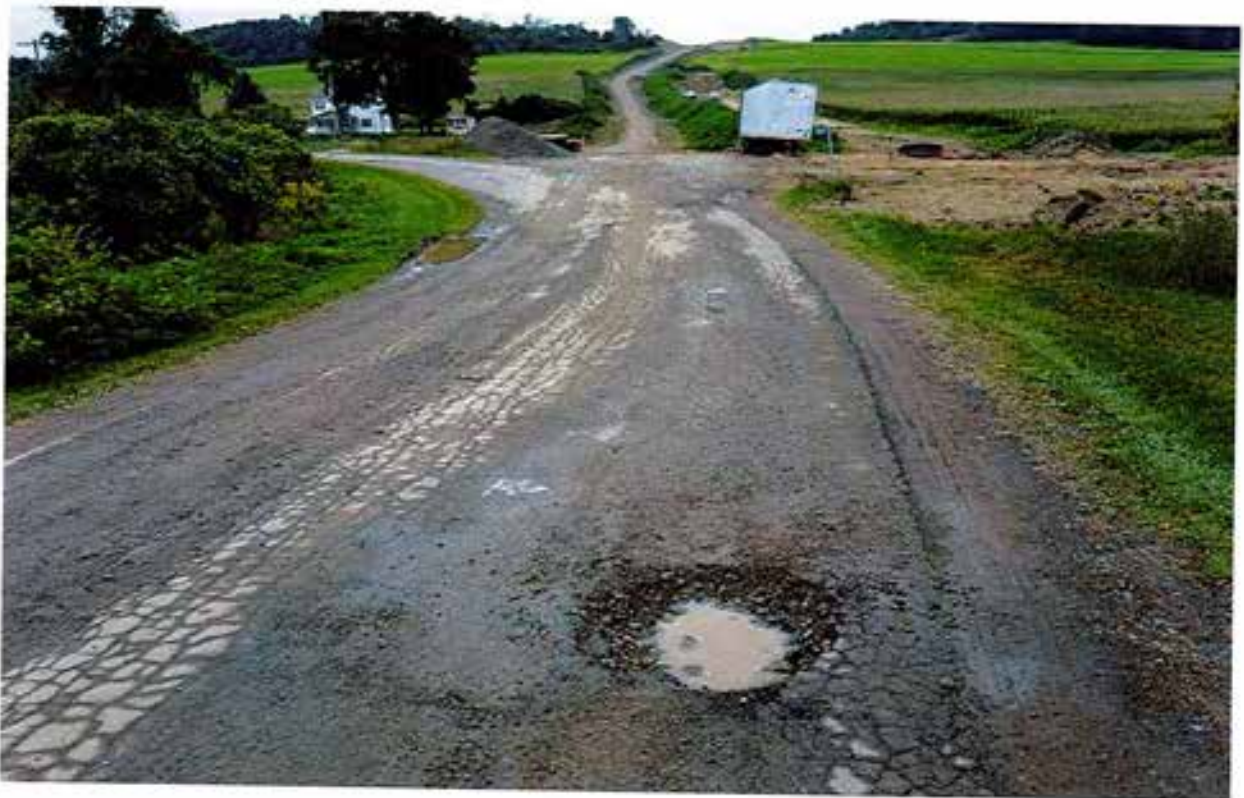
Strong Road pothole

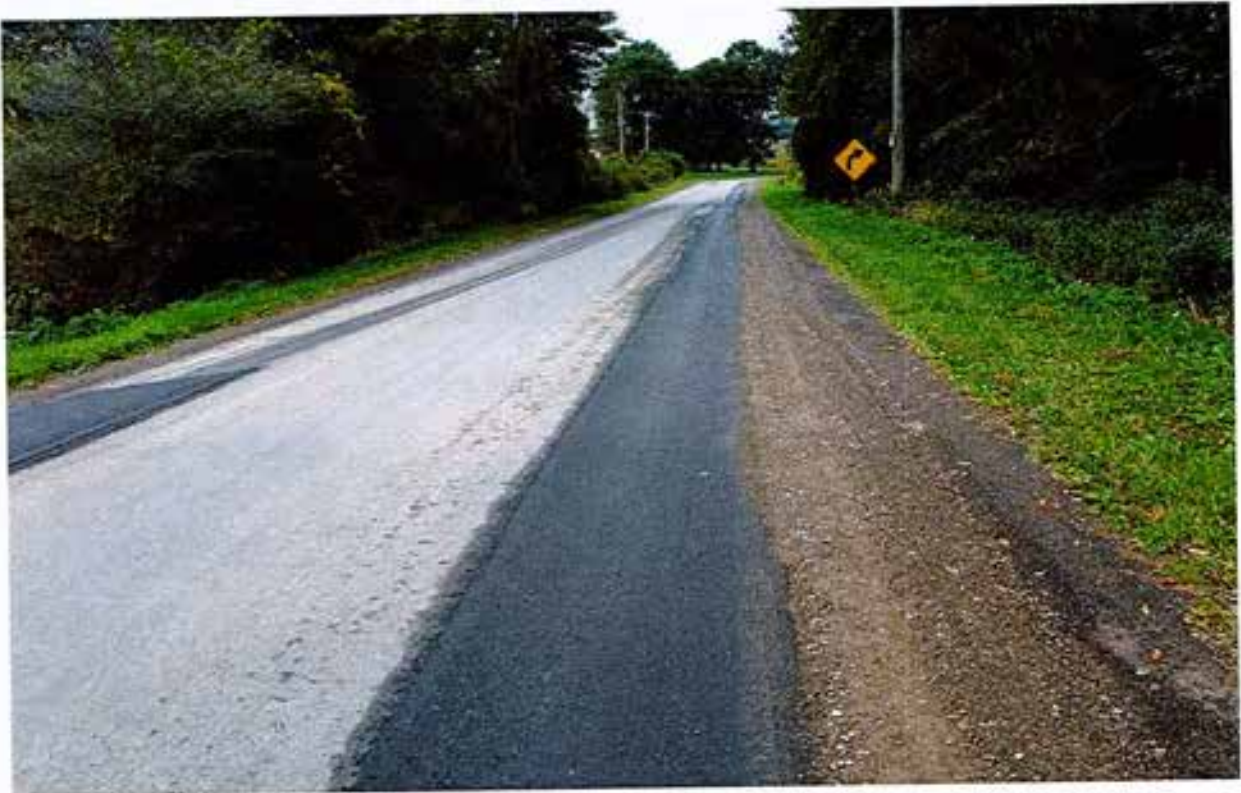
Siloam Road lane deterioration near intersection with Maple Grove (REPAIRED)

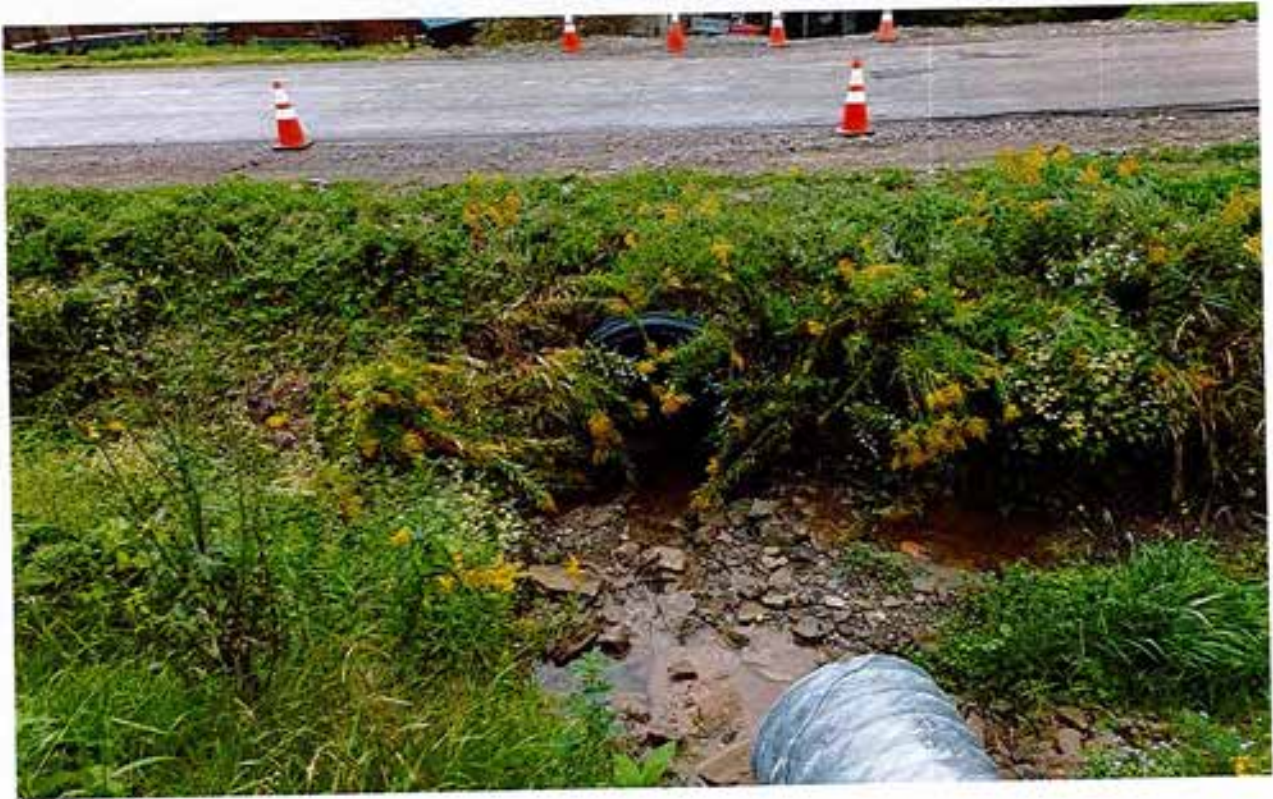
Osmun Rd: East end of 5' Dia. HDPE Culvert under Osmun Rd near 10379
