## Road Condition & Vehicle Compliance Report

| Report # | 58 |
| Project Name | Alle-Catt Wind |
| Location | Town of Freedom |

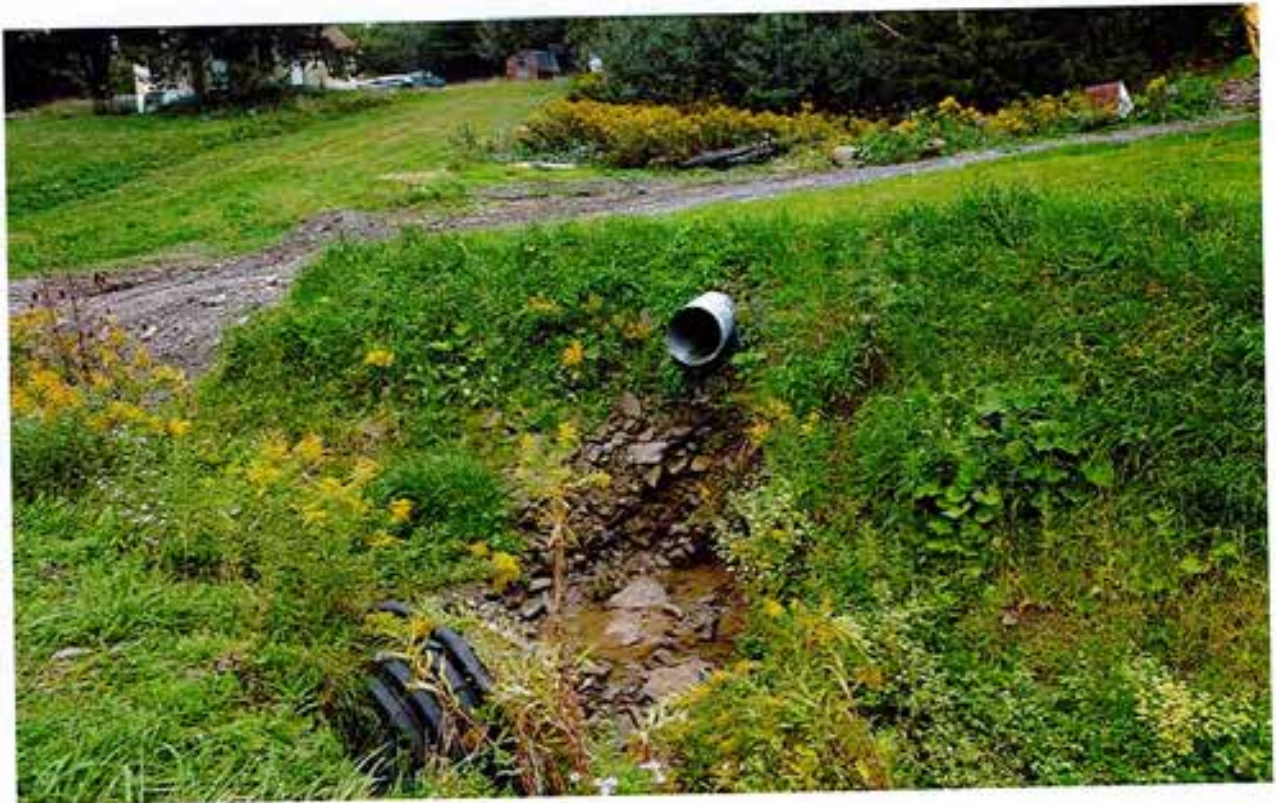
Osmun Rd: East side of 5' Dia. HDPE Culvert near 10379 facing East

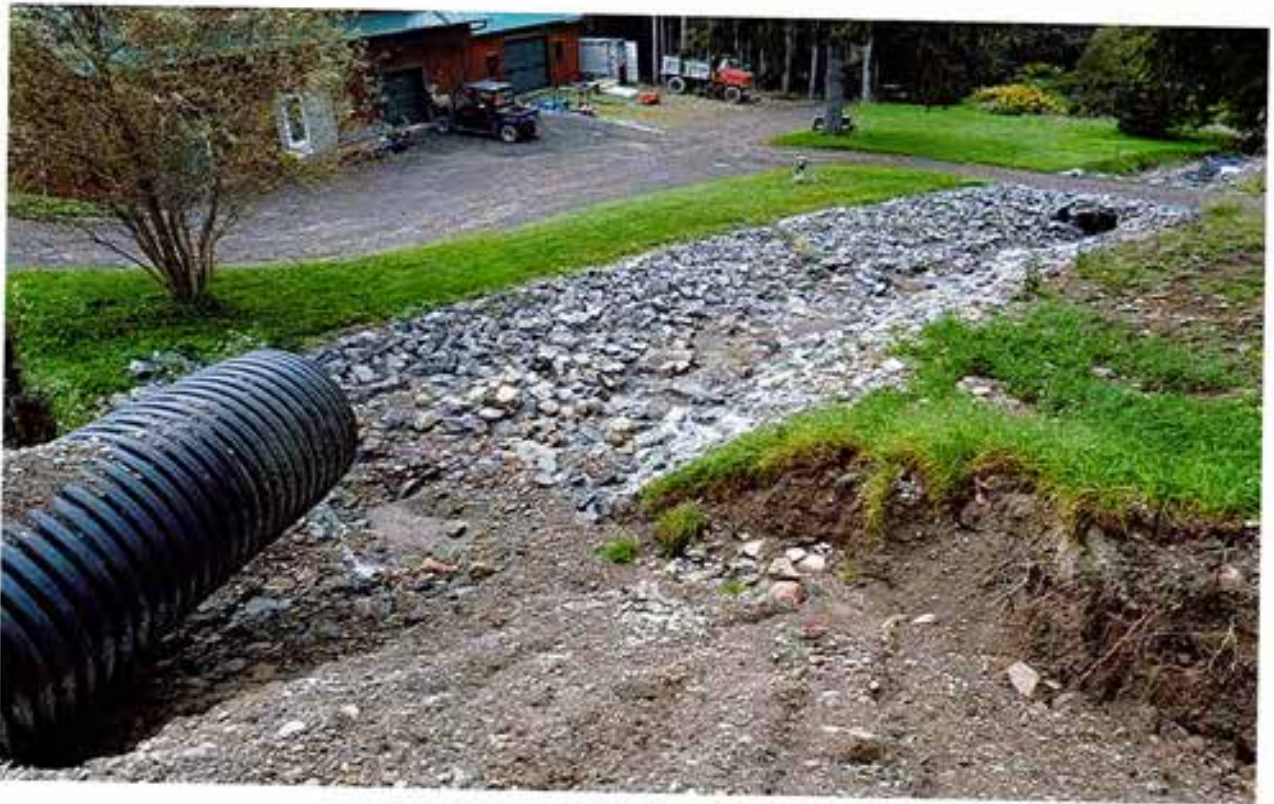
Osmun Rd: West side of Culvert near 10379. Exposed side slope subject to washout.

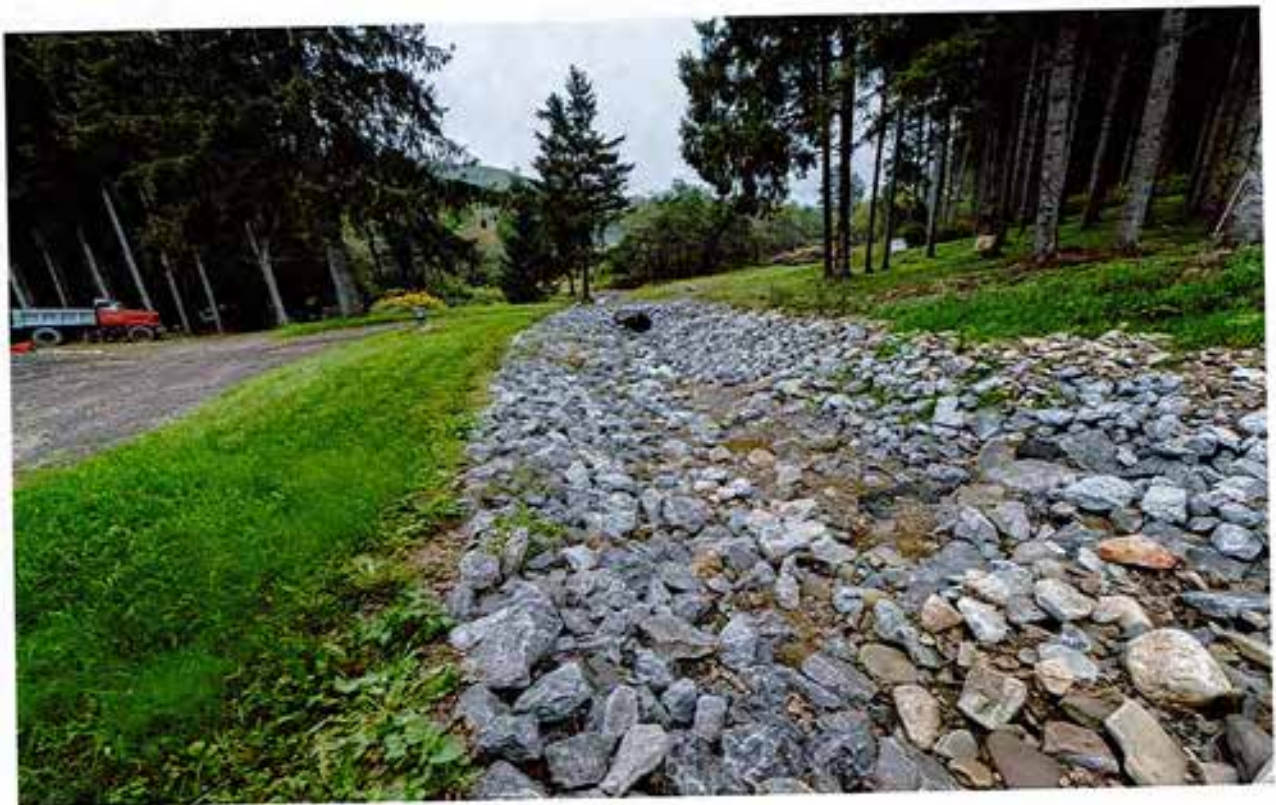
Osmun Rd: West side of Culvert near 10379 facing West

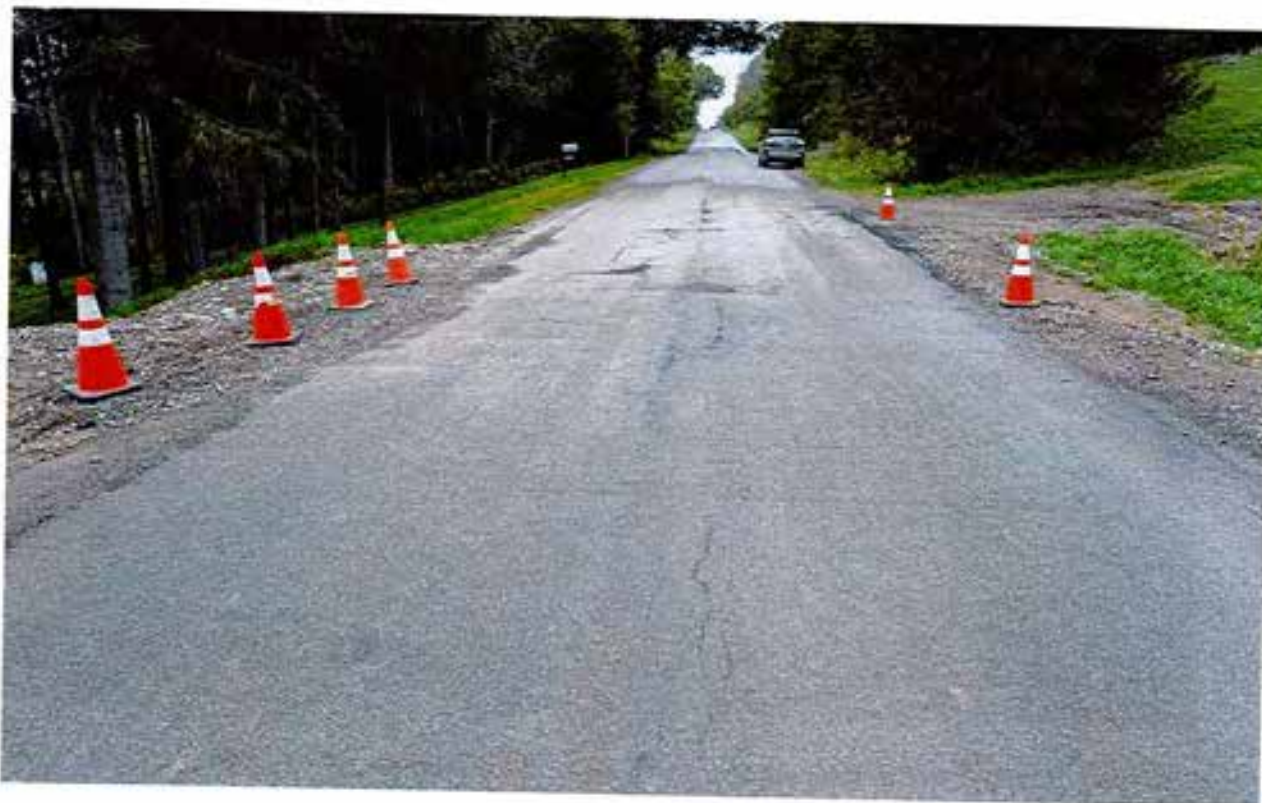
Osmun Rd: Road over Culvert near 10379 facing North

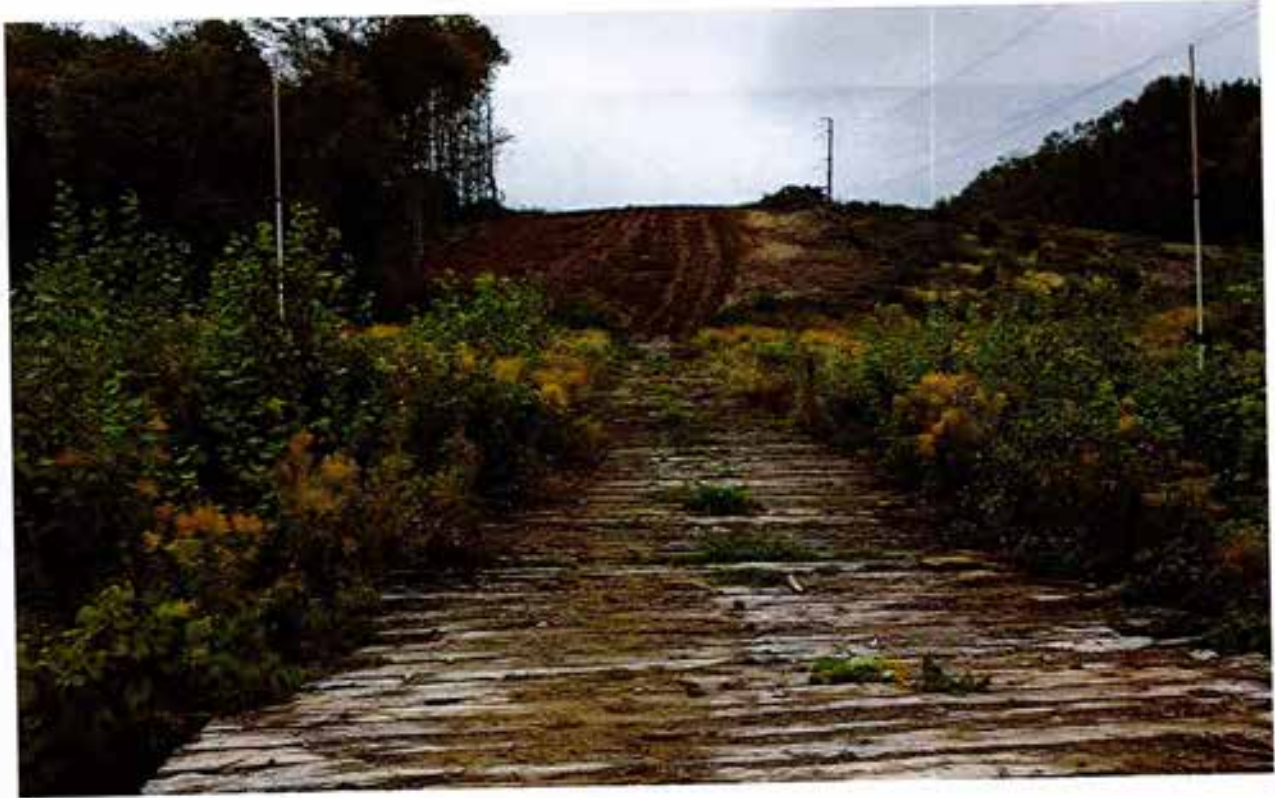
Osmun Rd: Construction Entrance nearest to Culvert @ 10379 facing East
