## Road Condition & Vehicle Compliance Report

| Report # | 59 |
| Project Name | Alle-Catt Wind |
| Location | Town of Freedom |

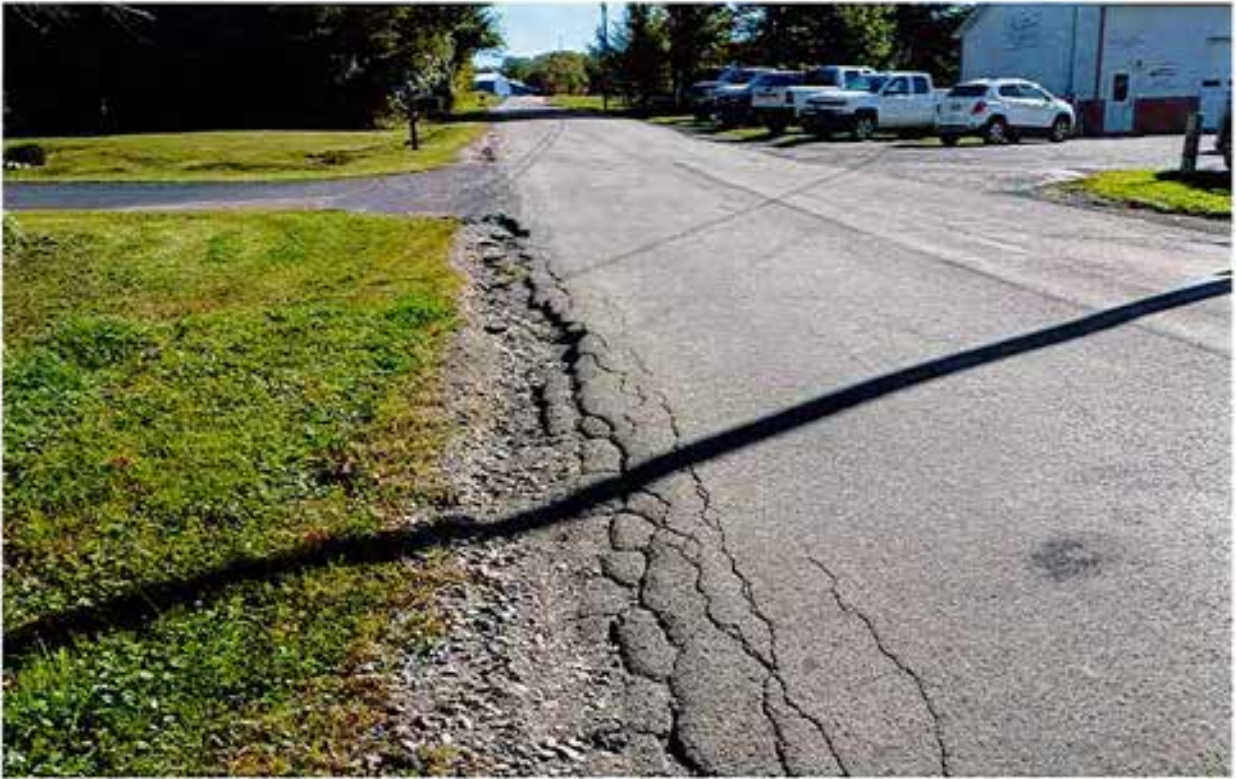
Eagle Street East and West side lane and edge deterioration near 1244

| Maintenance Needed: | <ul style="list-style-type: none"> <li>- Repair lanes and shoulders.</li> </ul> |

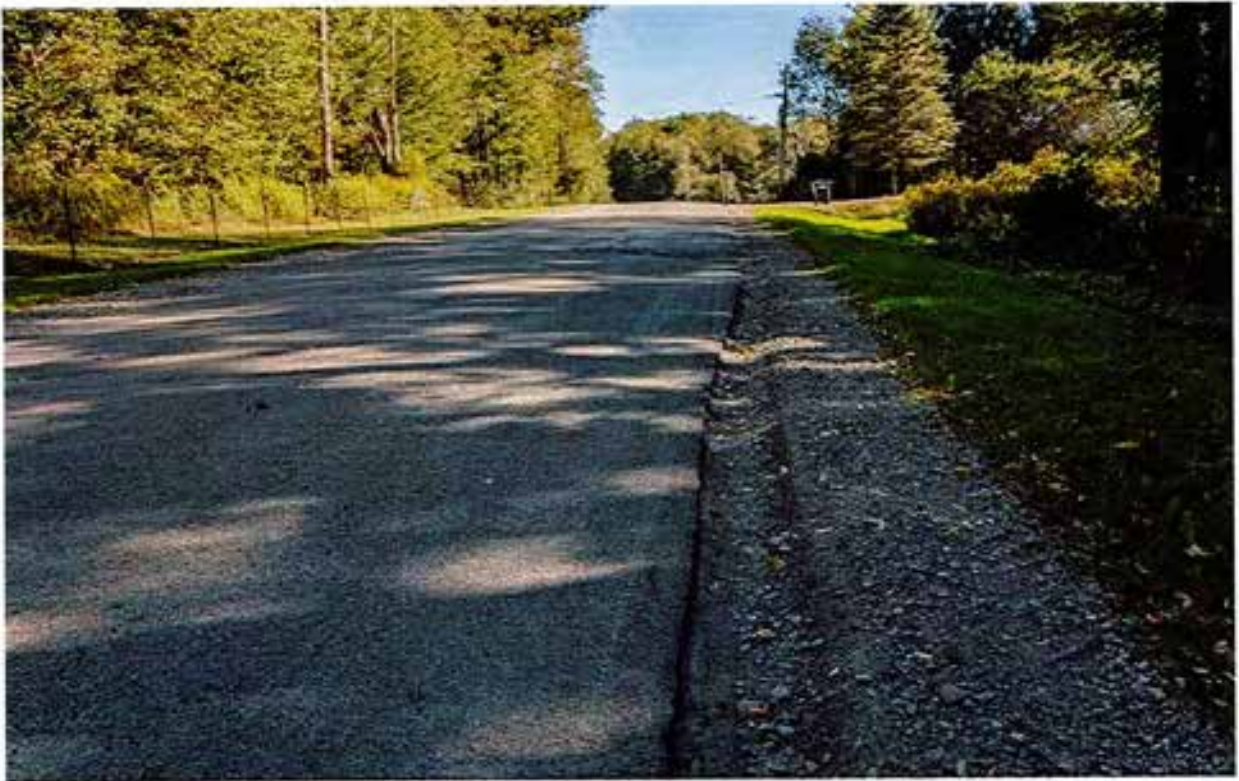
Eagle Street lane and shoulder deterioration near 1111

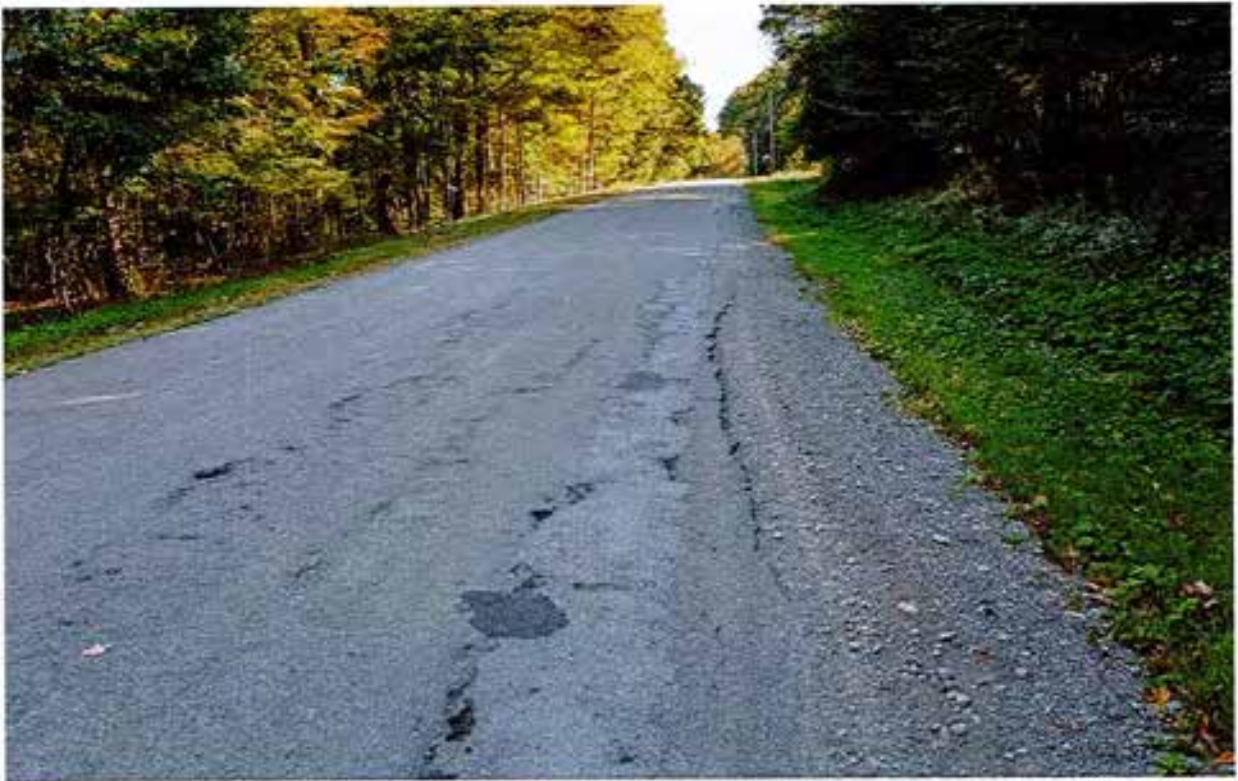
Eagle Street lane and edge deterioration near 931

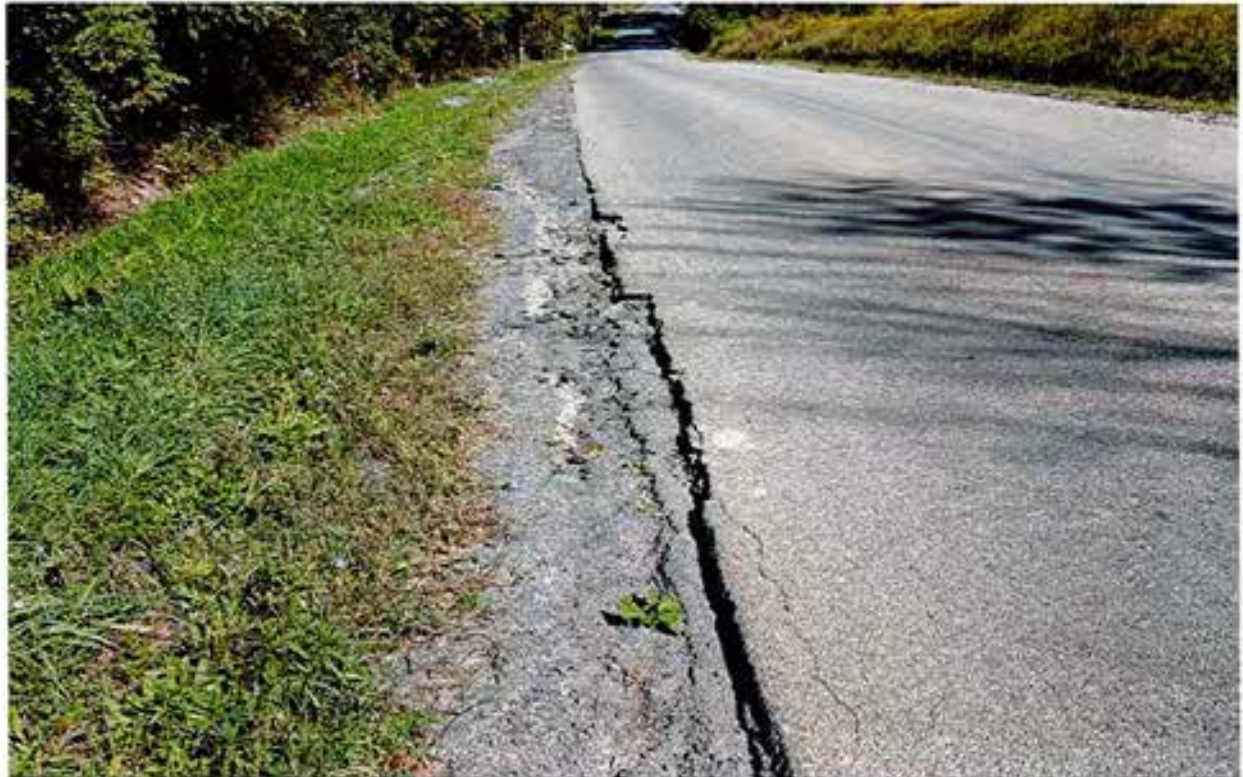
Brown Schoolhouse Road West shoulder North of 11448

| Maintenance Needed: | <ul style="list-style-type: none"> <li>- Repair shoulders</li> <li>- Repair intersection</li> </ul> |

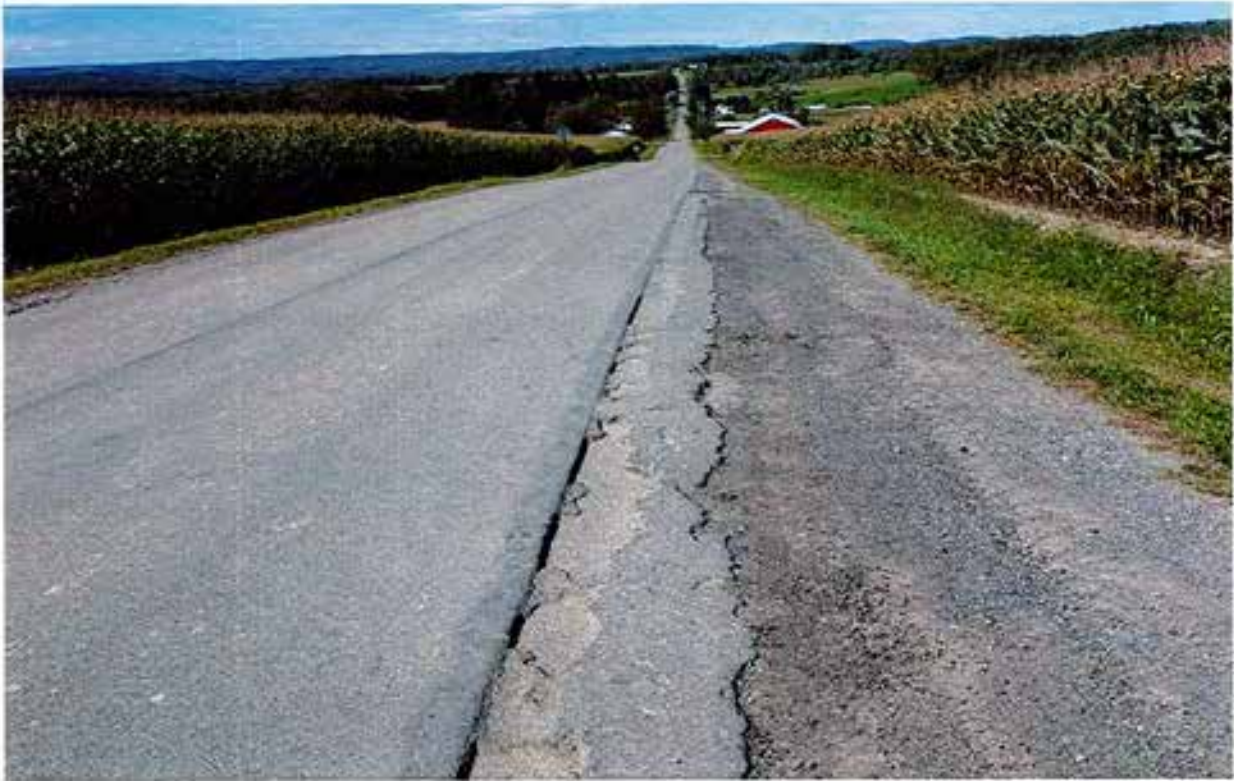
| Hazards Identified: | <ul style="list-style-type: none"> <li>- North edge of road deteriorating near 2195 to +/- 2272</li> <li>- North edge of road deteriorating near 2177</li> <li>- North edge of road deteriorating near intersection with Brown Schoolhouse Rd</li> </ul> |

Fisher Blake Road North edge and shoulder deterioration near intersection with Brown Schoolhouse Road

| Maintenance Needed: | <ul style="list-style-type: none"> <li>- Repair shoulders</li> </ul> |

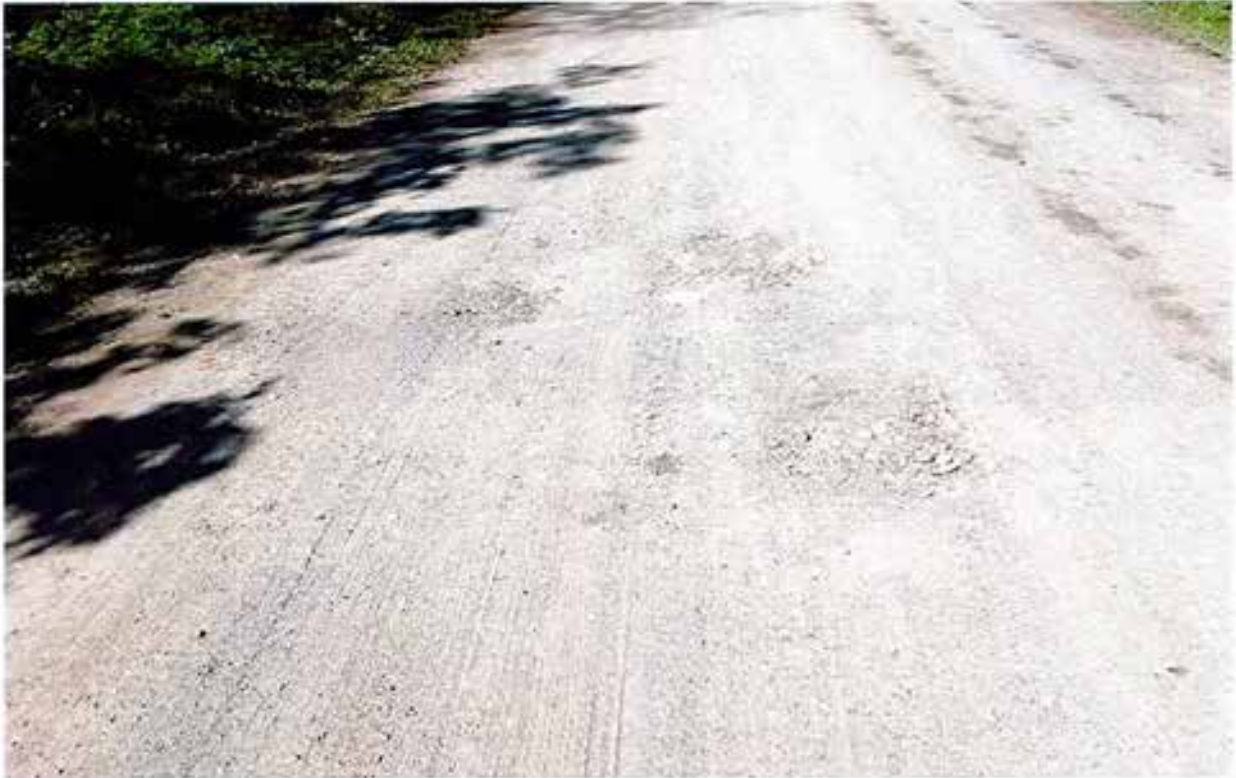
| Hazards Identified: | - Multiple potholes in paved sections of road |

Strong Road potholes

| Maintenance Needed: | - Apply QPR to significant potholes |

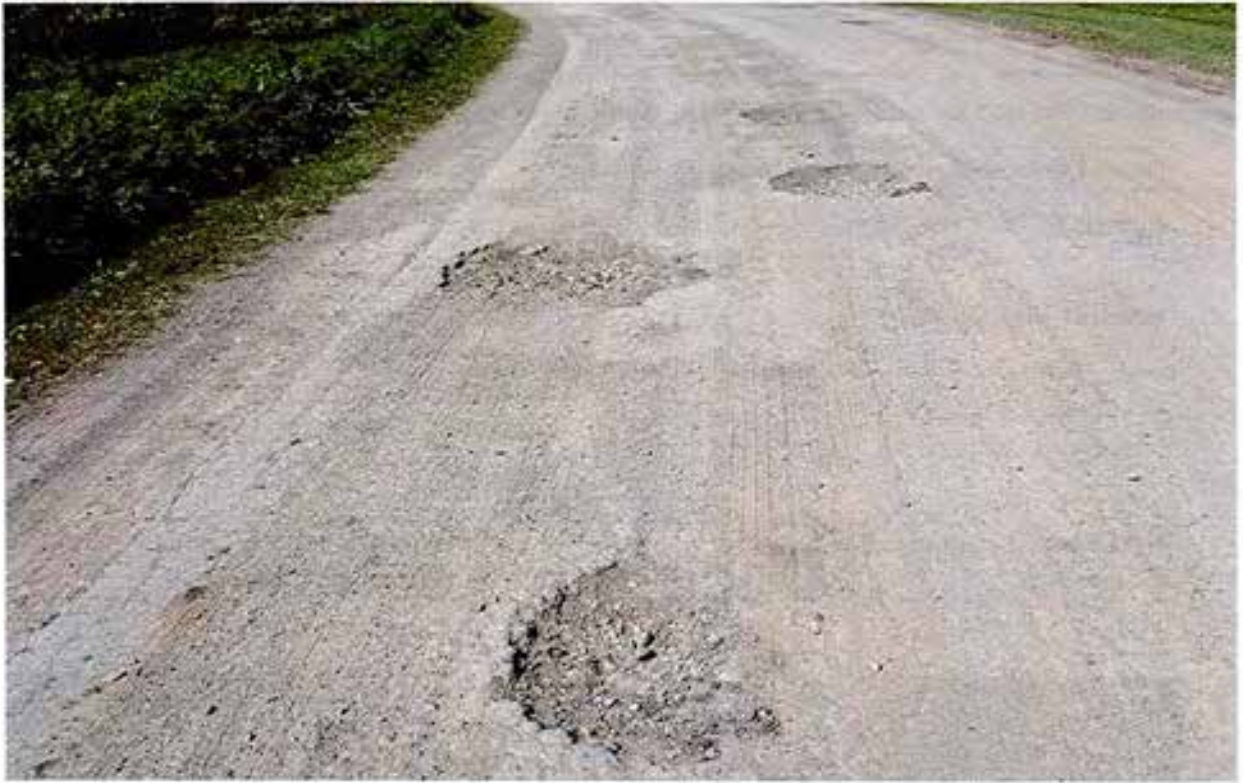
Strong Rd potholes
