## Road Condition & Vehicle Compliance Report

| Report # | 60 |
| Project Name | Alle-Catt Wind |
| Location | Town of Freedom |

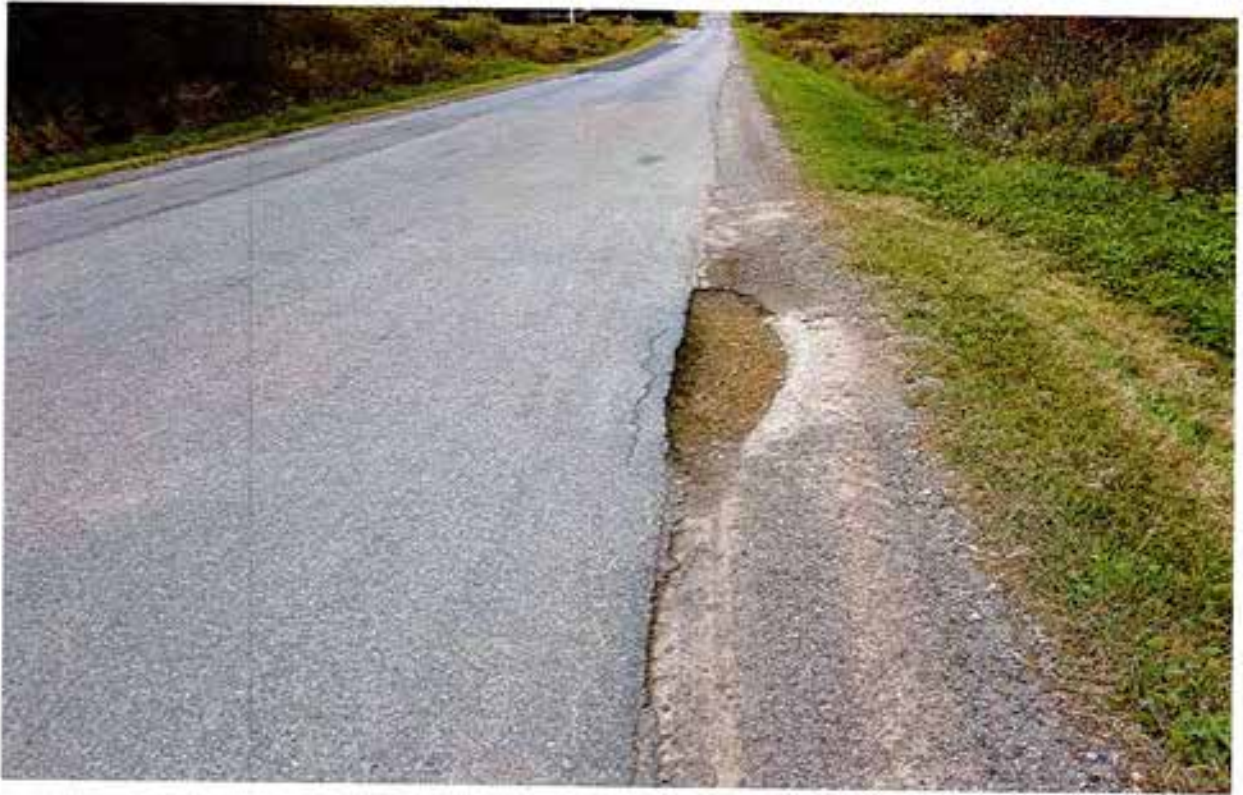
Bray Road North edge and shoulder near 2407

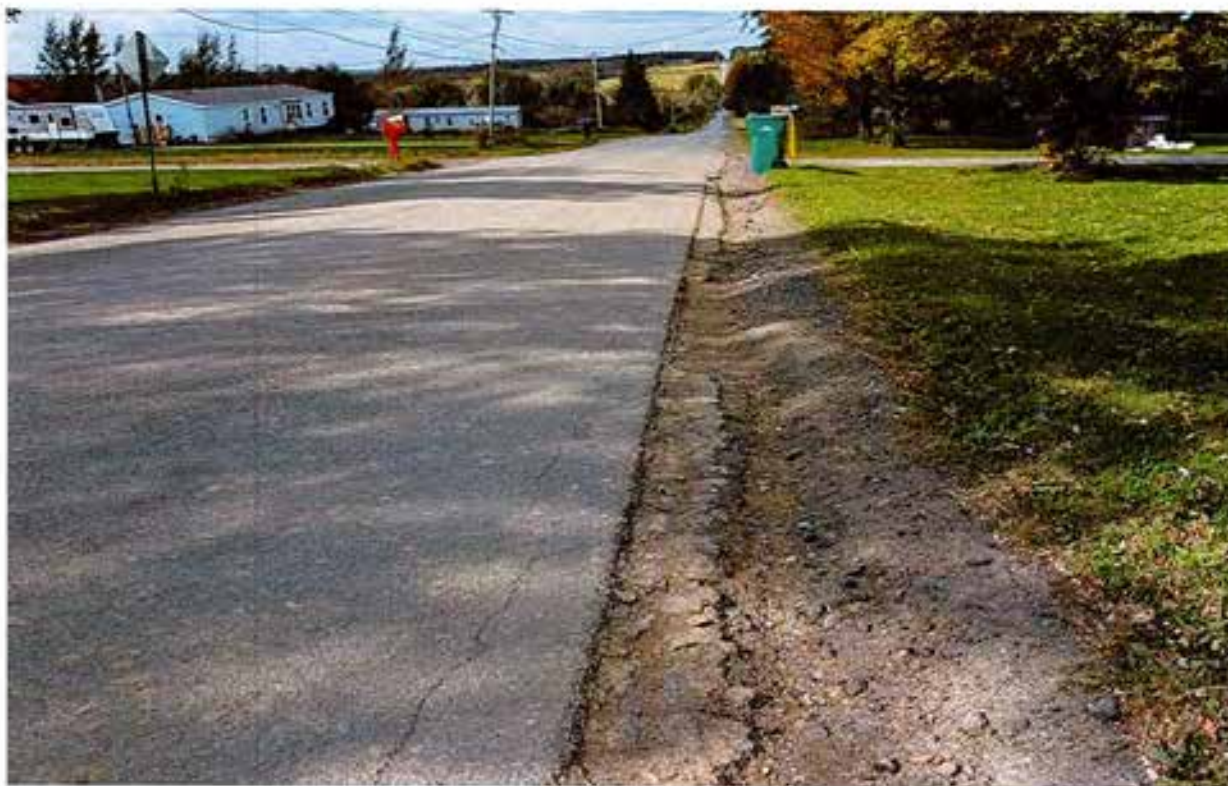
Bray Road North edge and shoulder near 2231

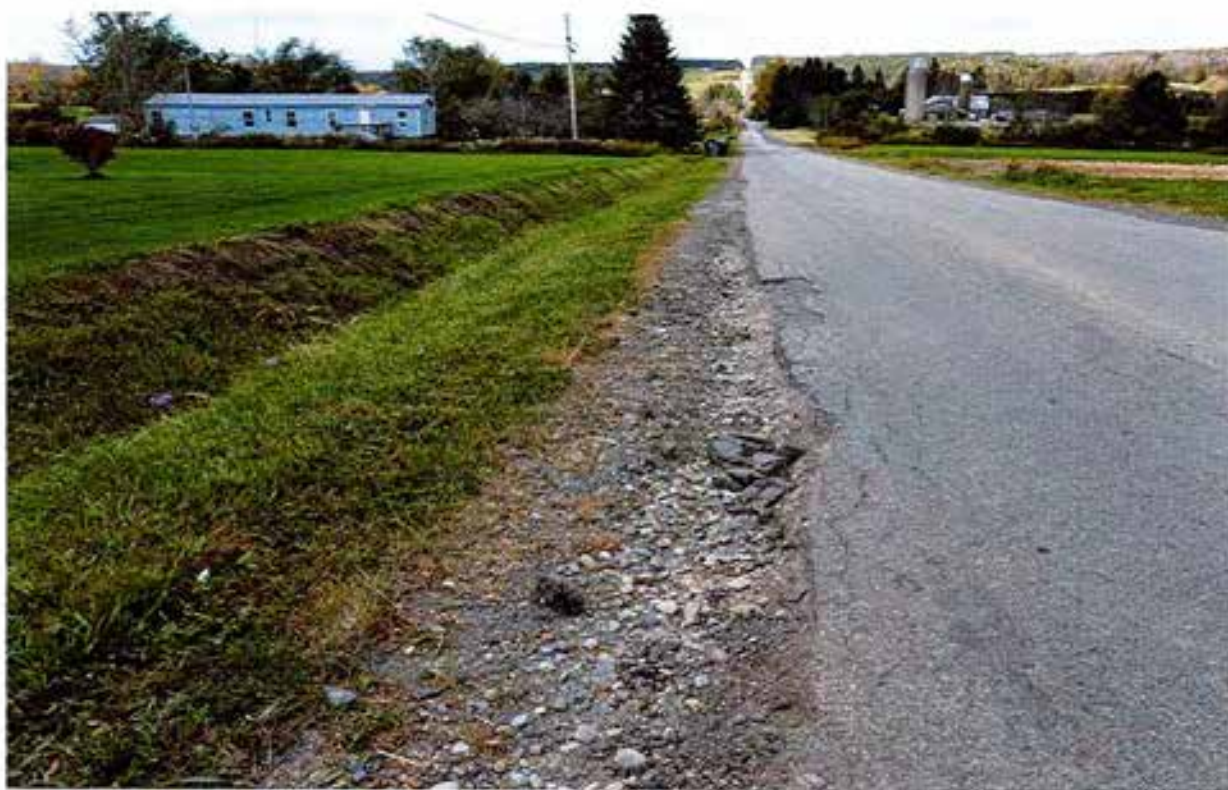
Bray Road South edge and shoulder near 409

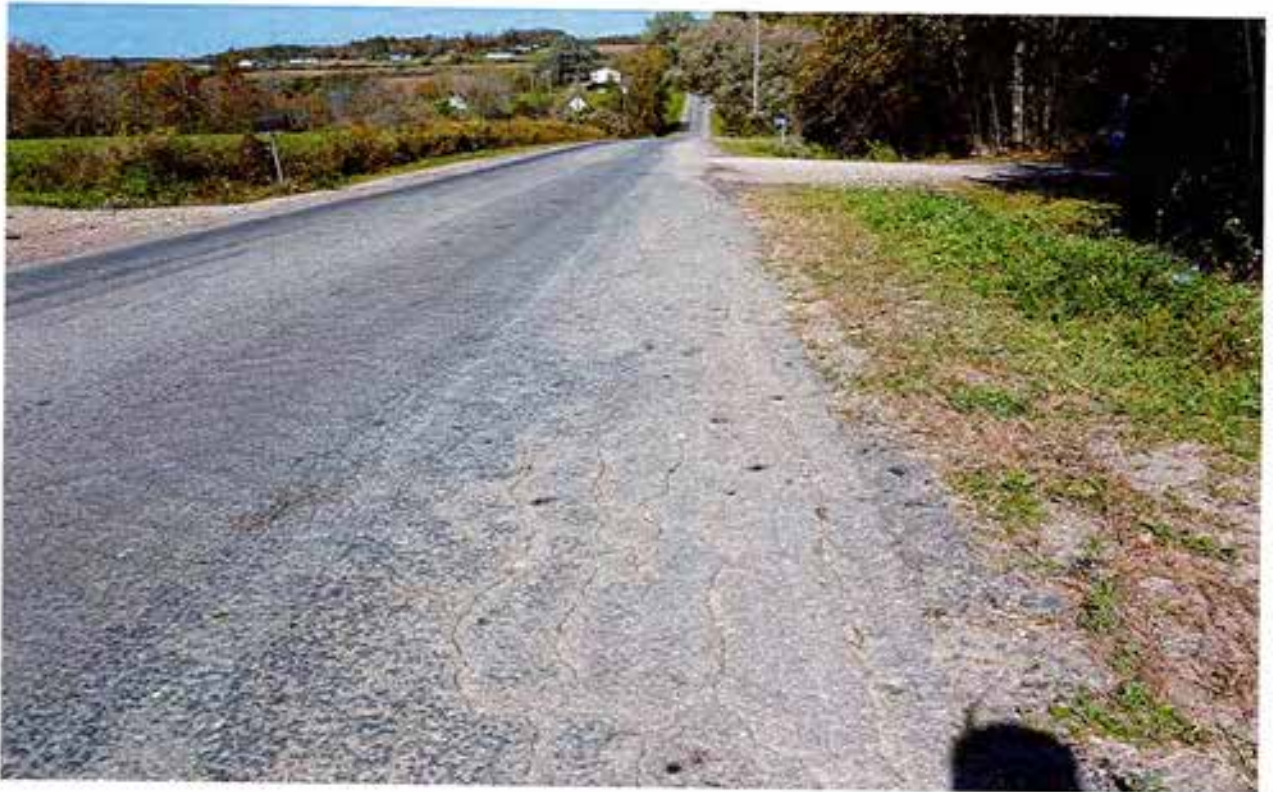
Sandbank Road East and West edge / shoulder near 10238
