## Road Condition & Vehicle Compliance Report

| Report # | 58 |
| Project Name | Alle-Catt Wind |
| Location | Town of Freedom |

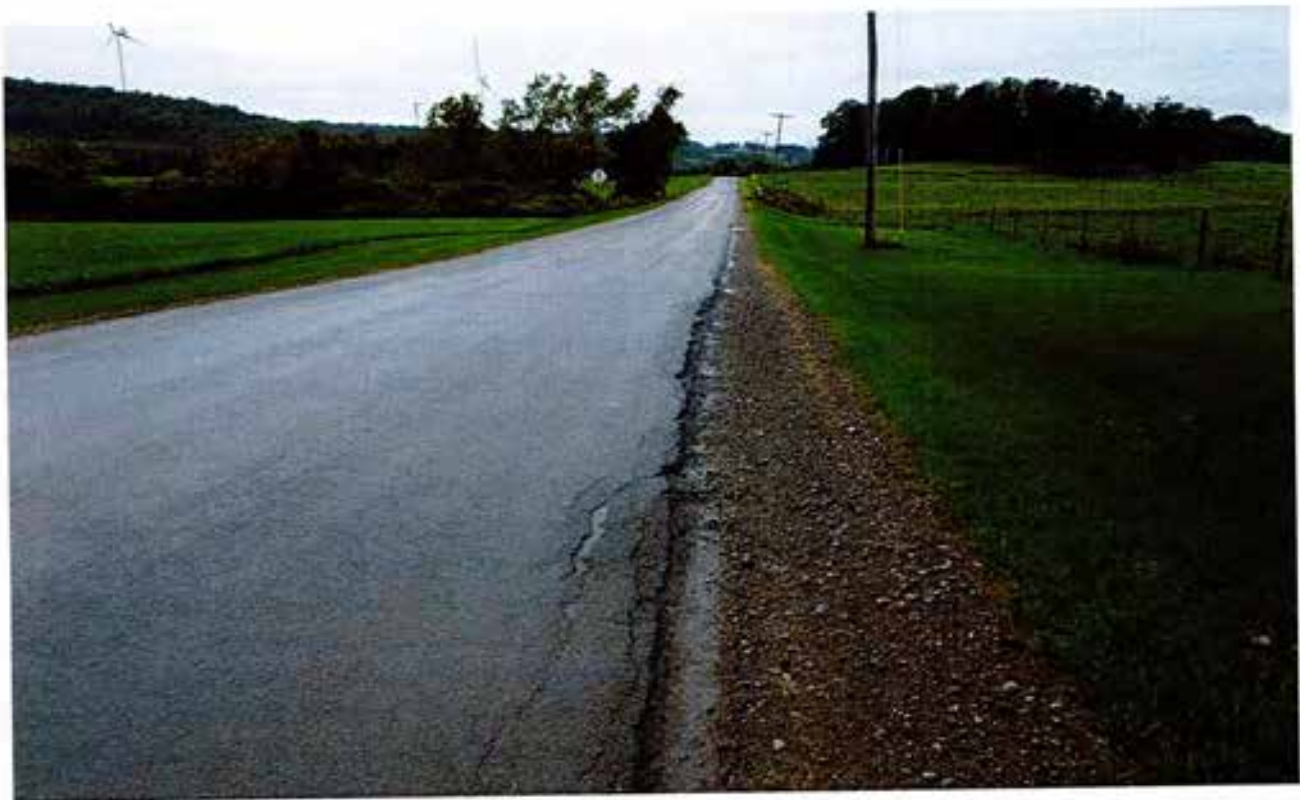
East edge of North Road

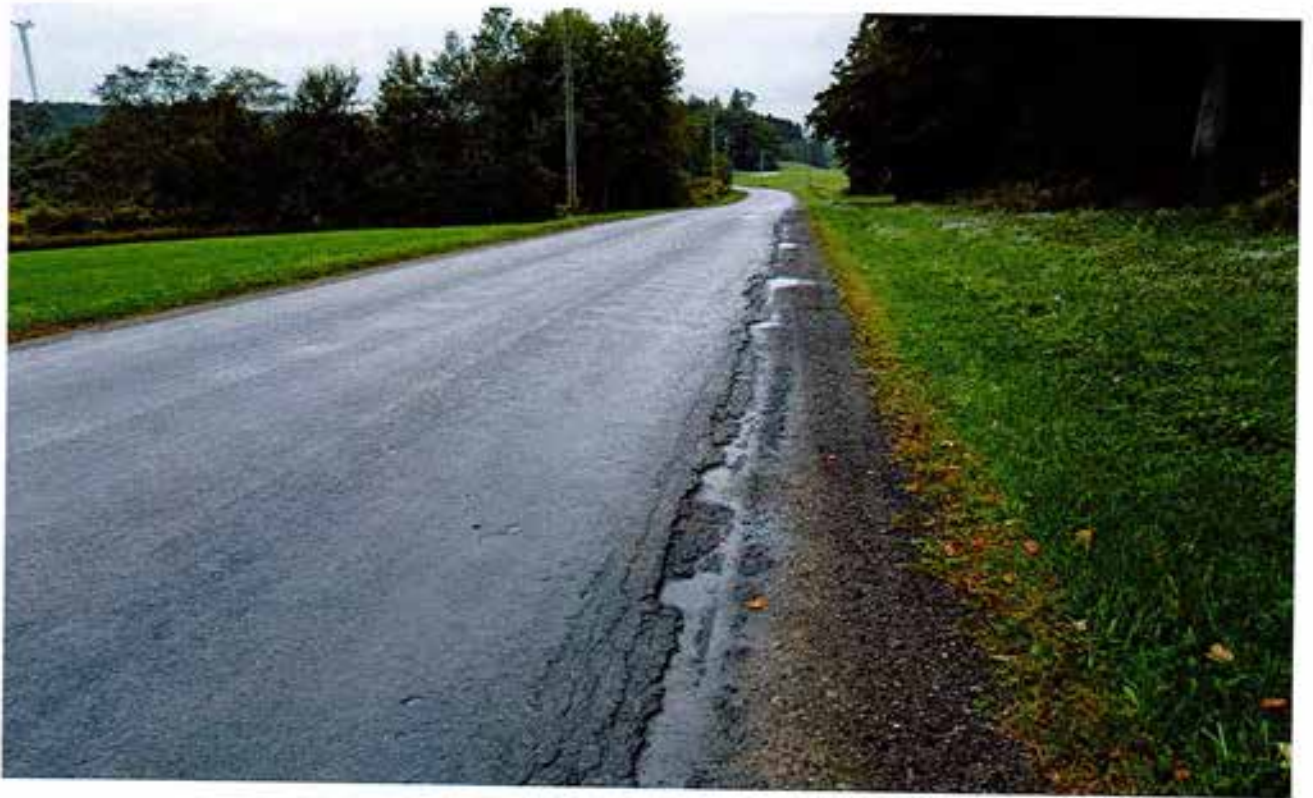
East edge of North Road

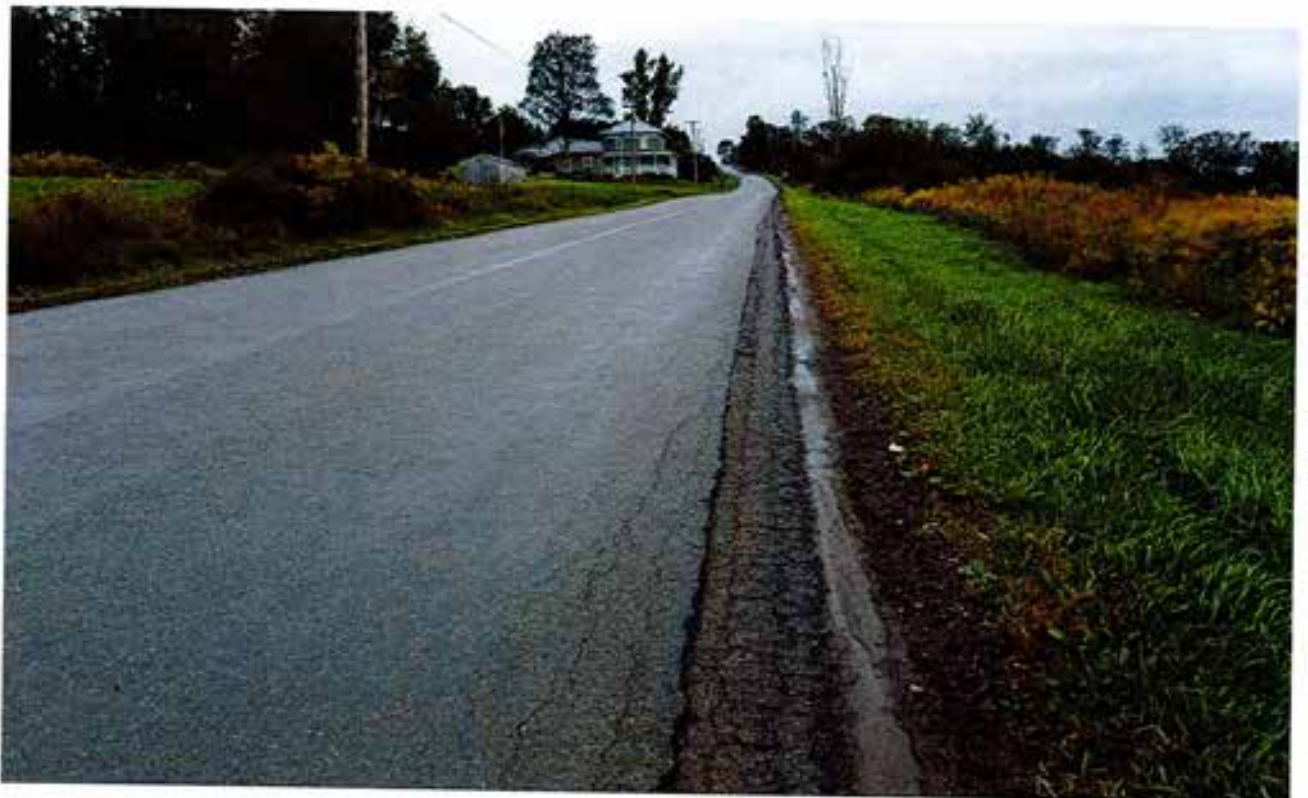
East edge of North Road

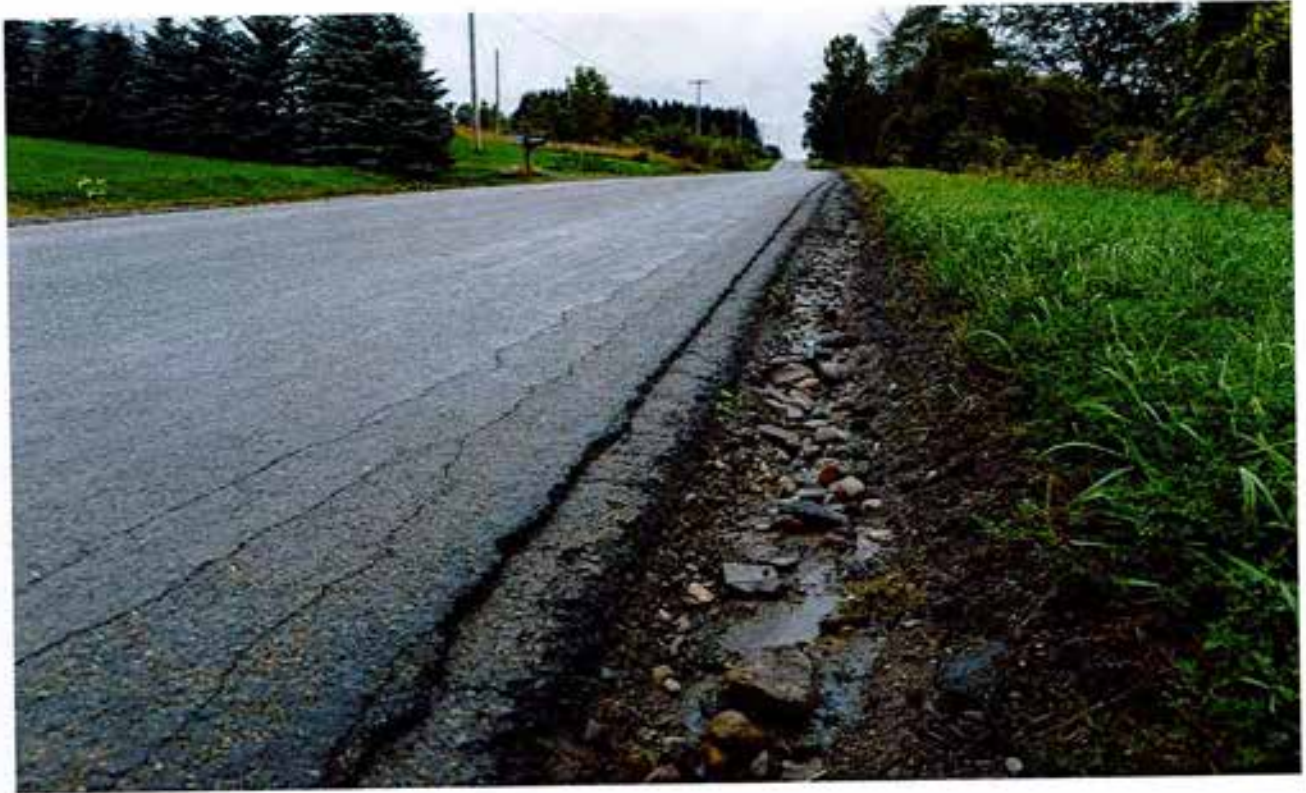
North Road East edge and shoulder near 11509

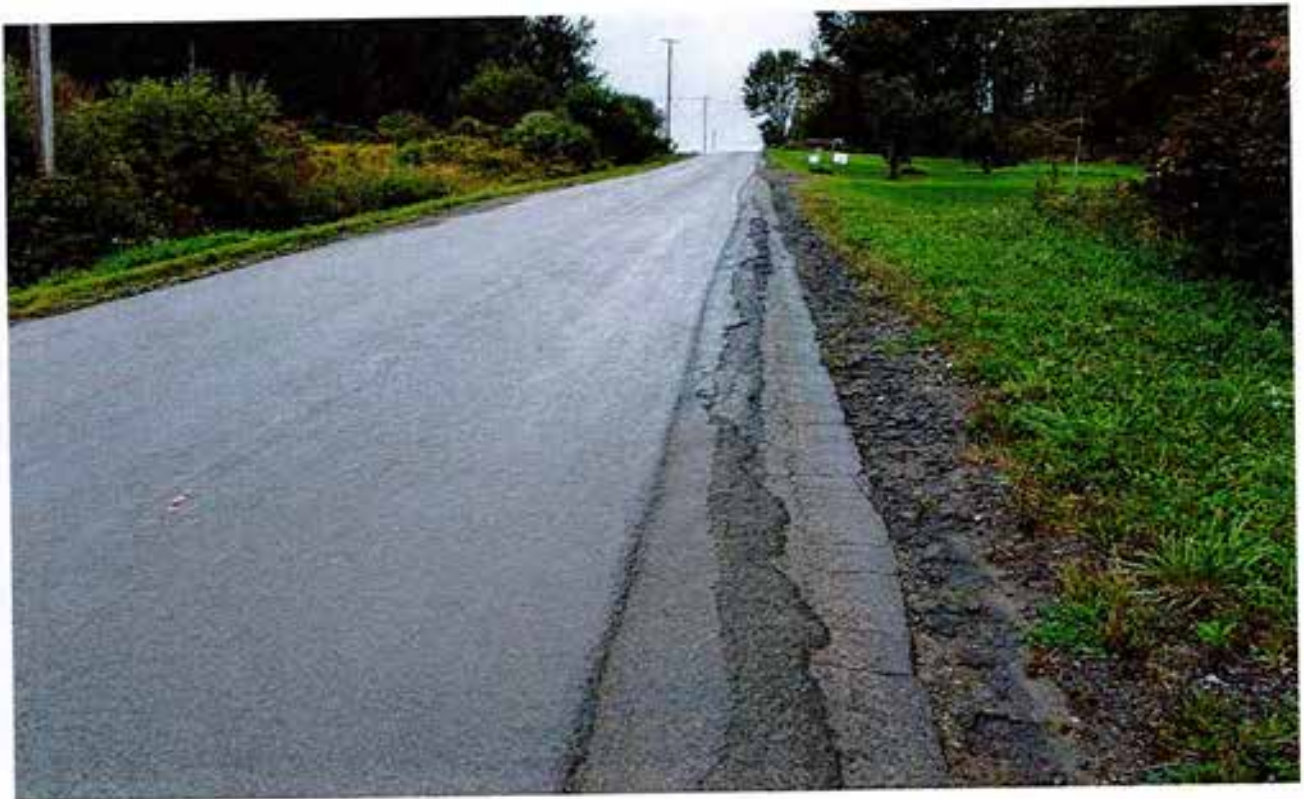
North Road East edge near 11582

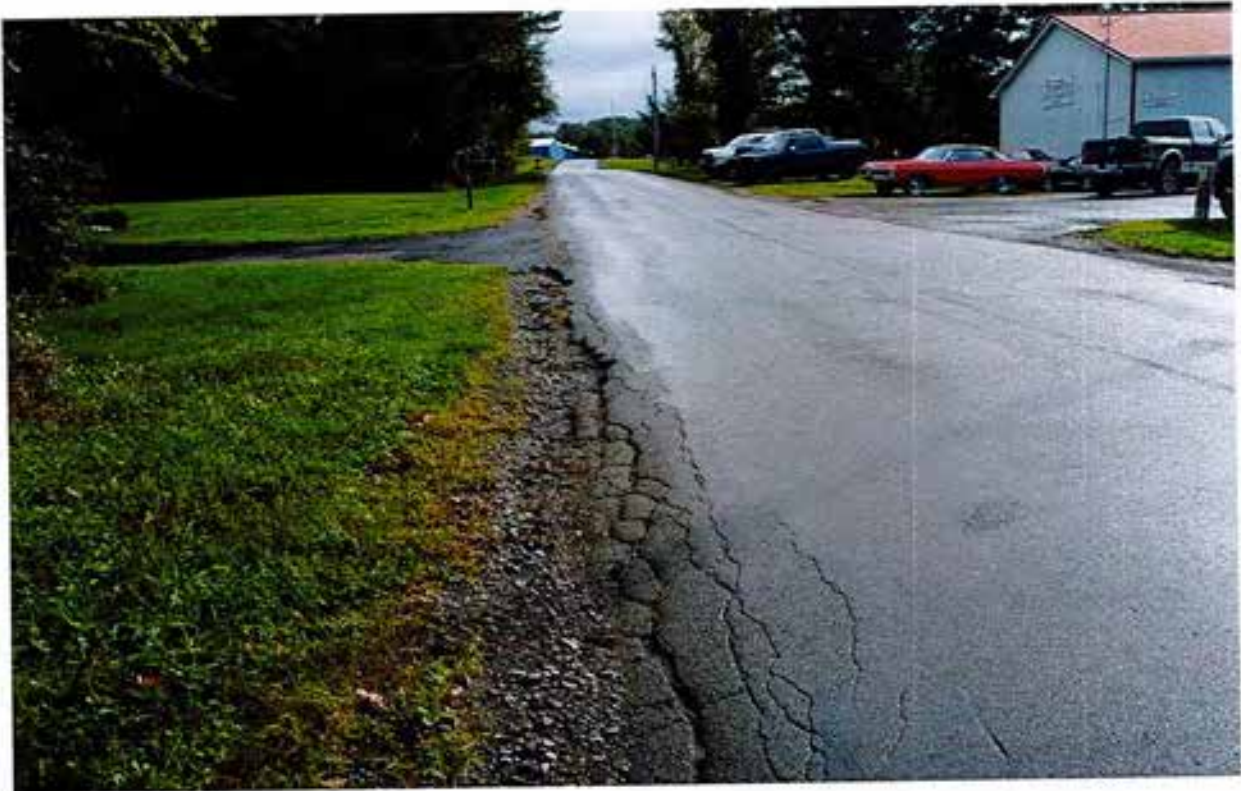
Eagle Street East and West side lane and edge deterioration near 1244

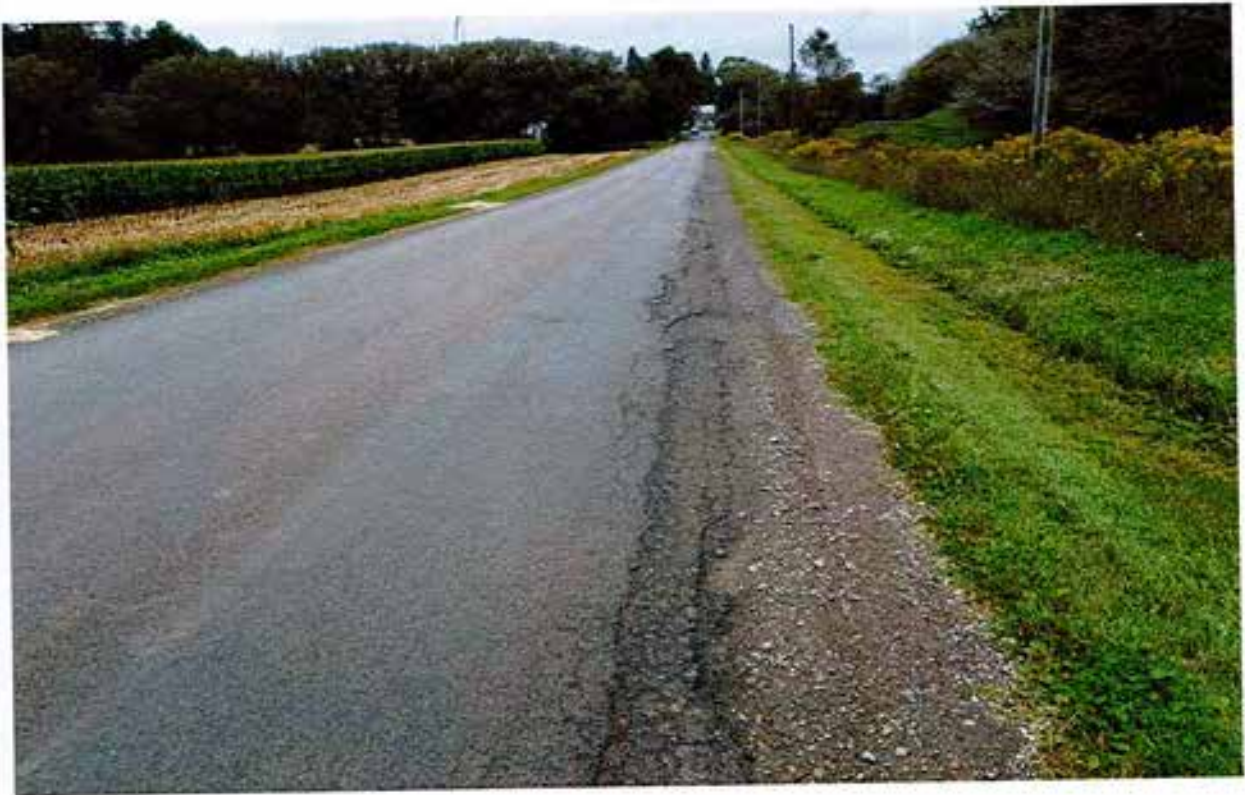
Eagle Street lane and edge deterioration North of 757

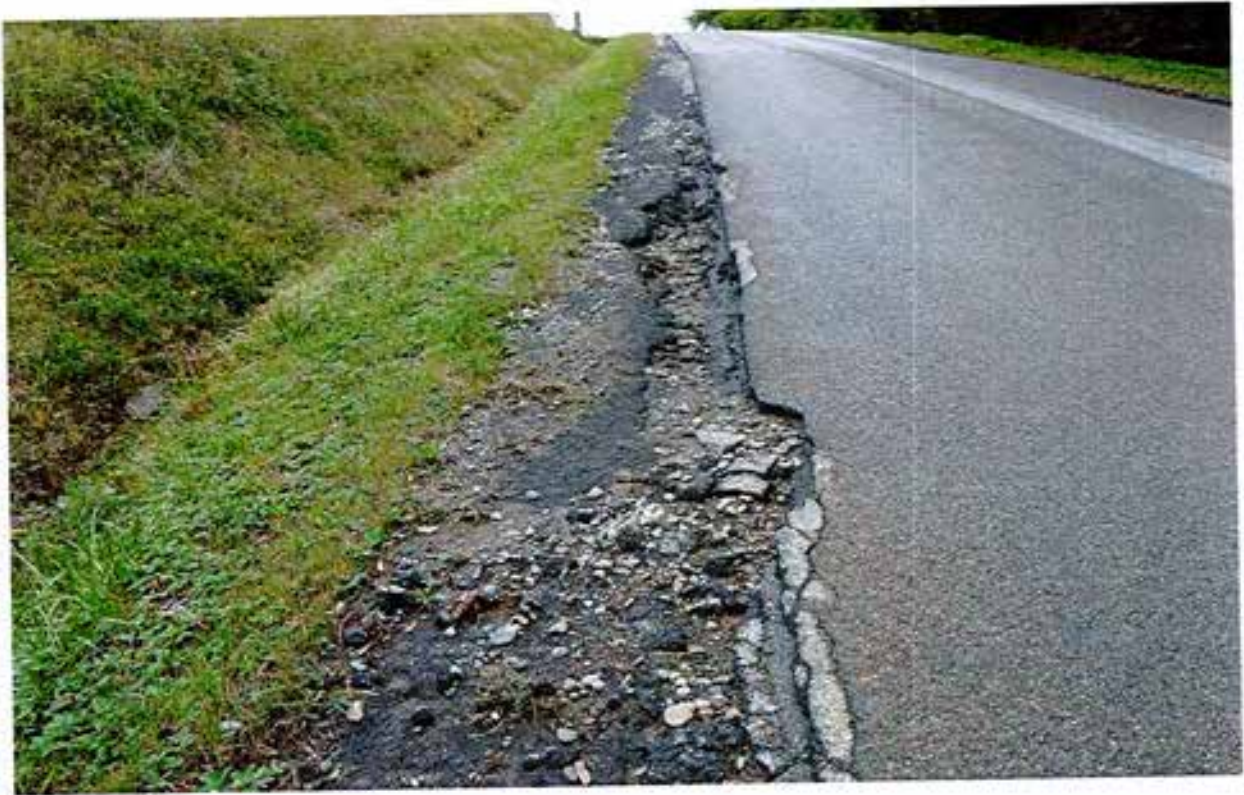
Brown Schoolhouse Road East shoulder North of 11448

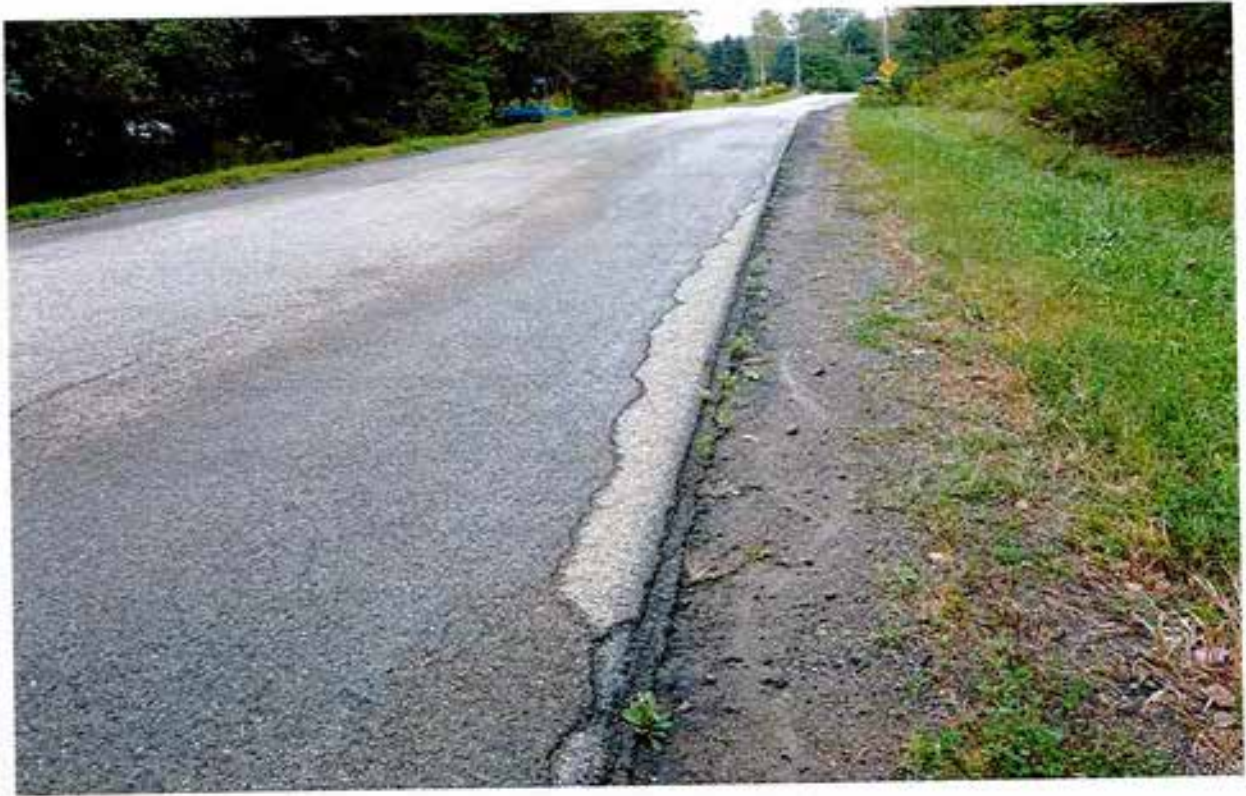
Edmunds Road South edge and shoulder deterioration 1940 to 1850

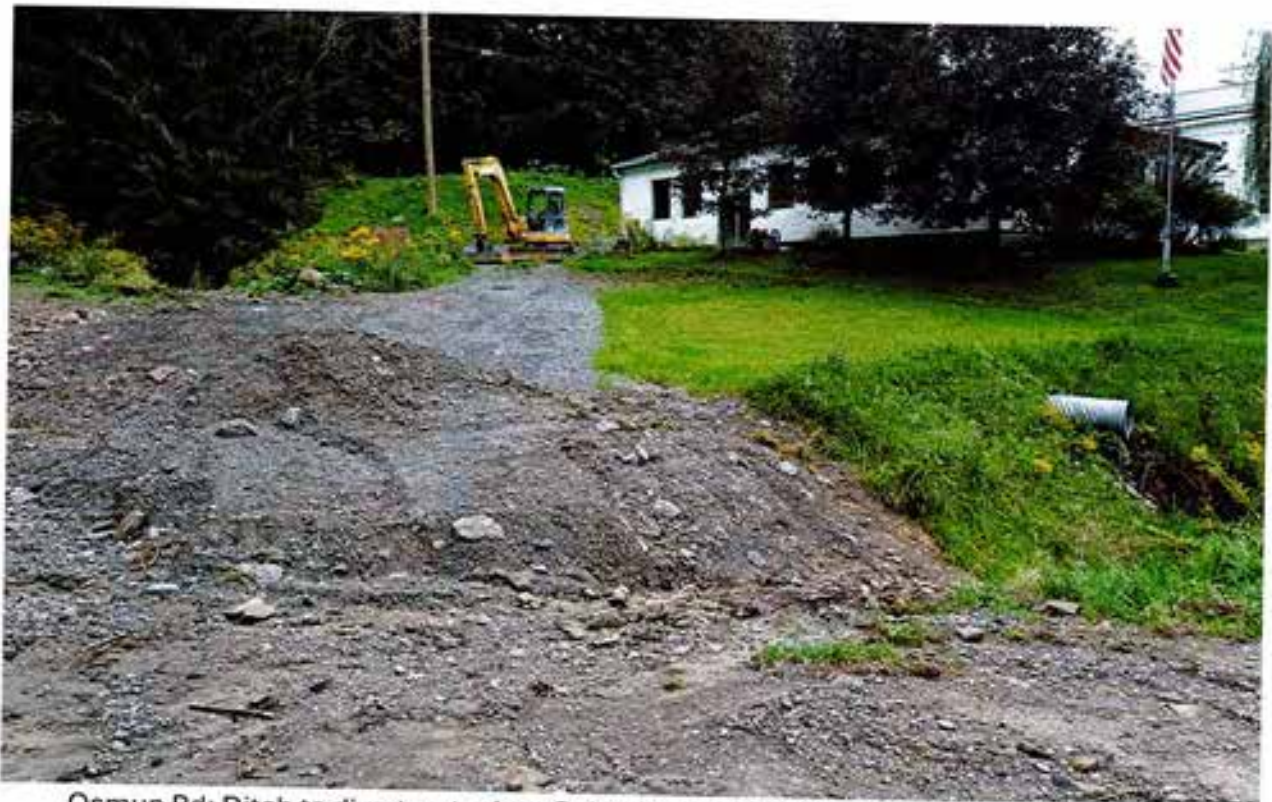
Osmun Rd: Ditch to divert water into Culvert near 10379. According to Town Highway Superintendent, the diversion ditch is helping prevent erosion. Ditch to be maintained as needed.
