## Road Condition & Vehicle Compliance Report

| Report # | 59 |
| Project Name | Alle-Catt Wind |
| Location | Town of Freedom |

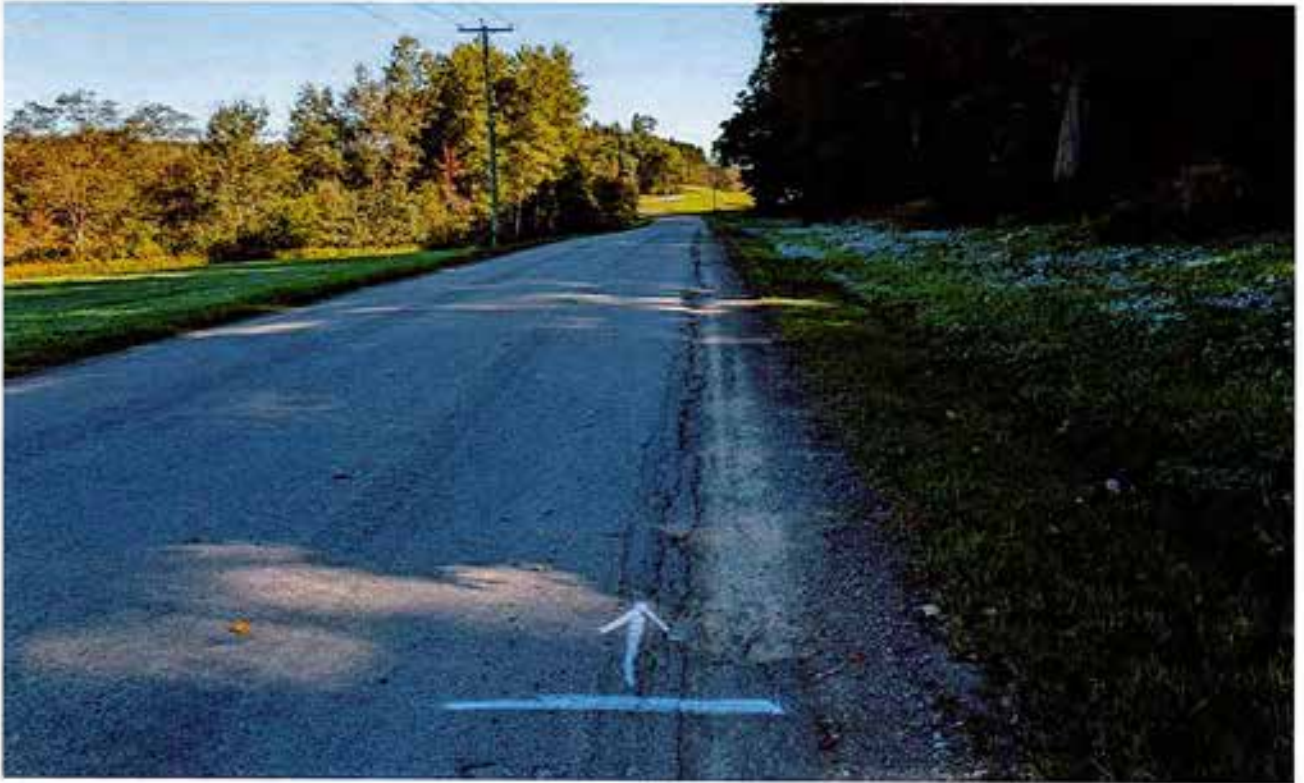
| Hazards Identified: | <ul style="list-style-type: none"> <li>- North Road is showing deterioration along the East edge of the road</li> <li>- North Road East edge and shoulder near 11509</li> <li>- North Road is showing lane and edge deterioration South of 11875</li> <li>- North Road is showing lane deterioration near Bray Road</li> </ul> |

East edge of North Road

| Maintenance Needed: | <ul style="list-style-type: none"> <li>- Apply QPR to significant potholes</li> <li>- Repair shoulders</li> </ul> |

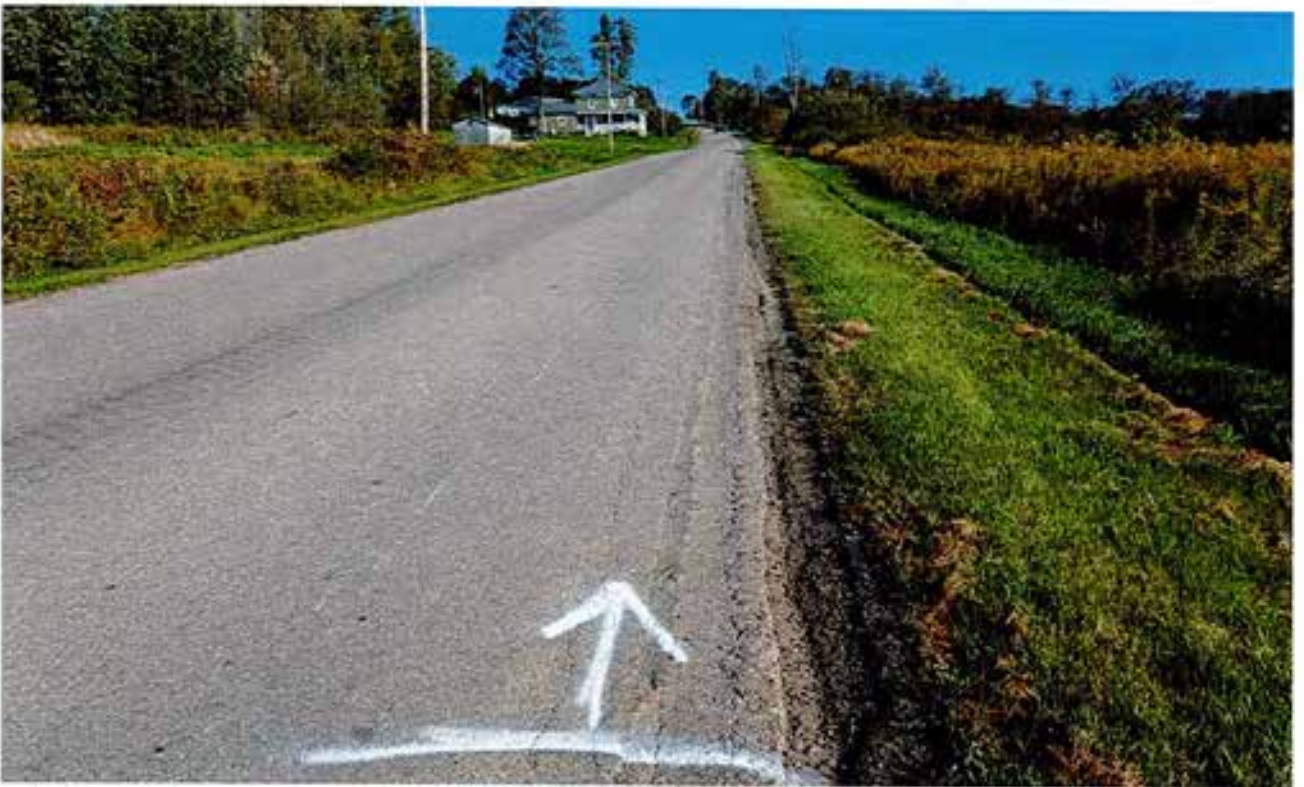
East edge of North Road

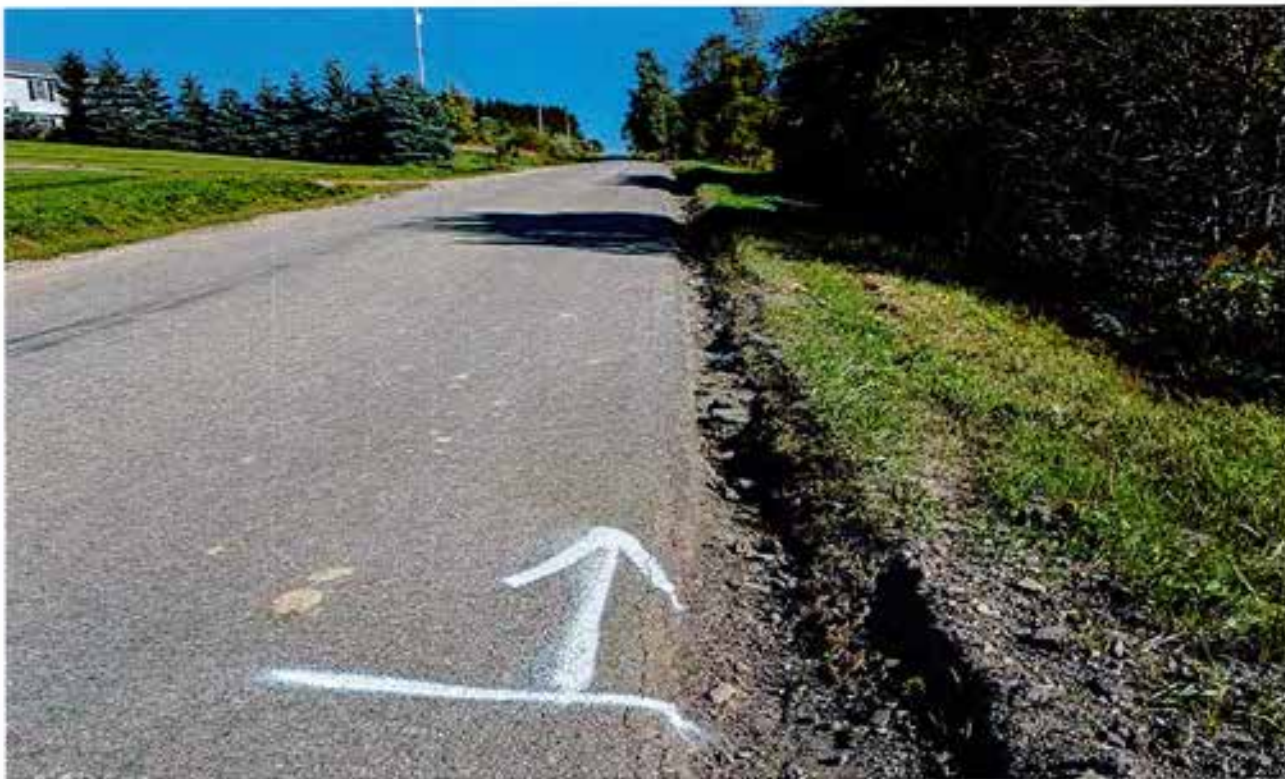
North Road East edge and shoulder near 11509

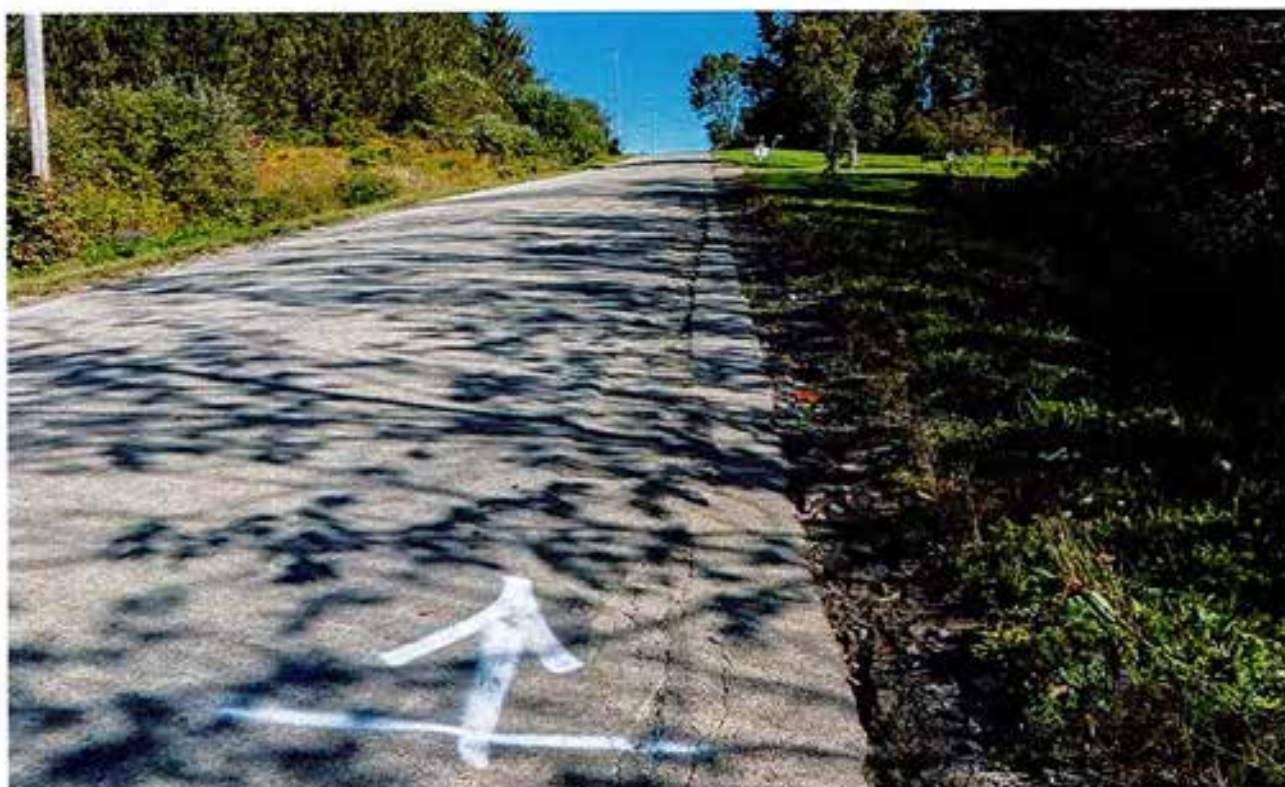
North Road East edge near 11582

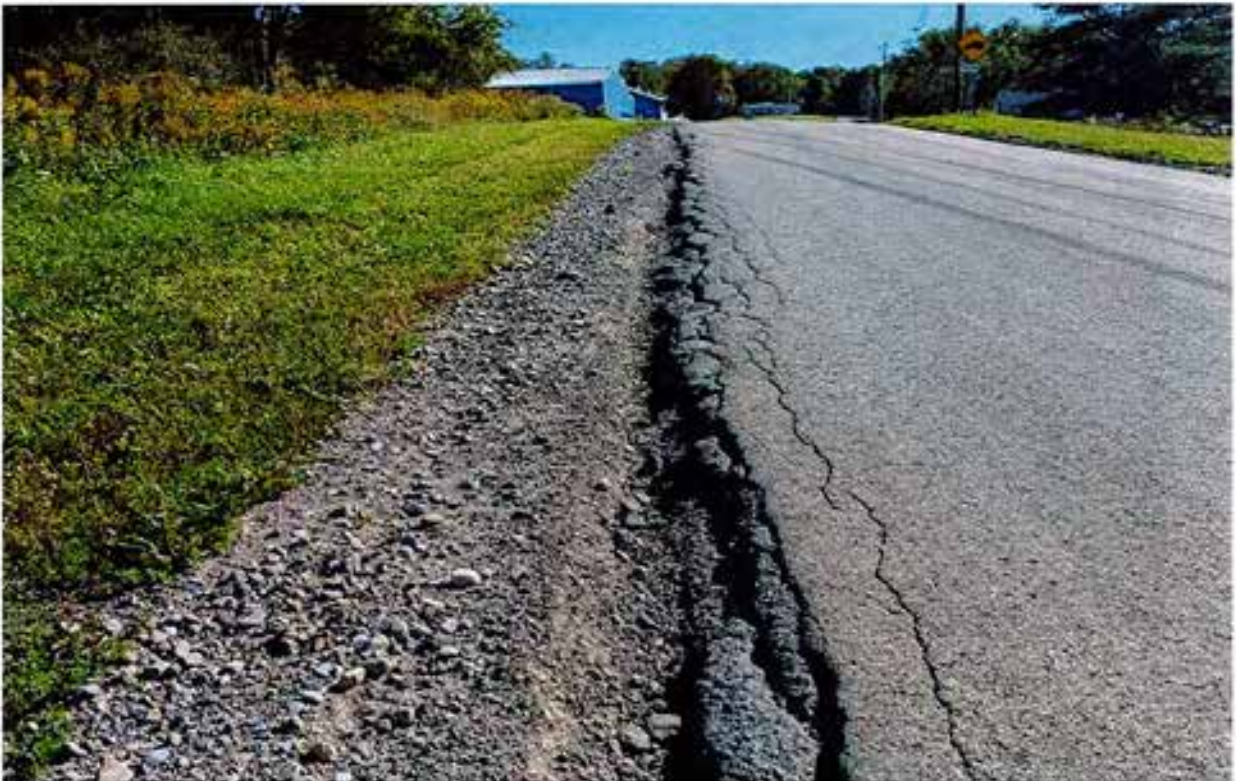
Eagle Street North and South side lane and edge deterioration near 1219

| Maintenance Needed: | <ul style="list-style-type: none"> <li>- Repair lanes and shoulders.</li> </ul> |

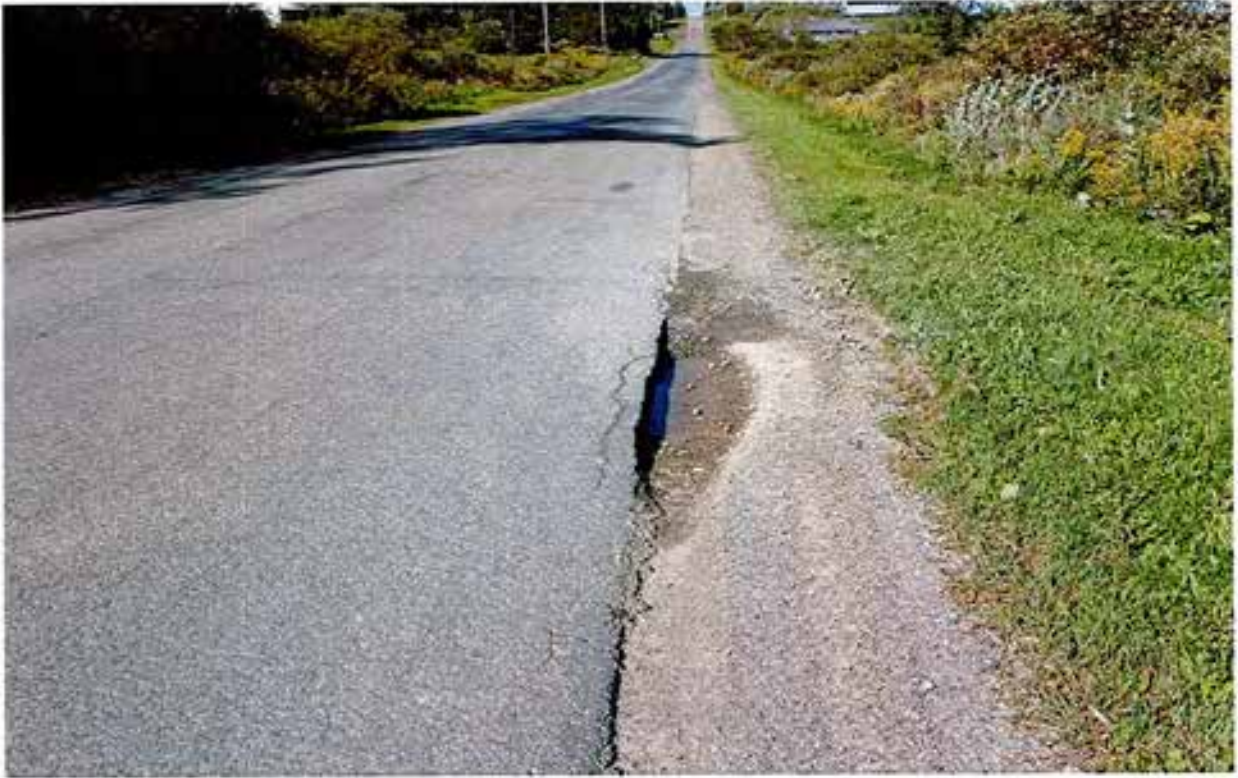
Bray Road North edge and shoulder deteriorating with Pothole near 2407

| Maintenance Needed: | <ul style="list-style-type: none"> <li>- Repairs should be made for lane and shoulder deterioration.</li> </ul> |

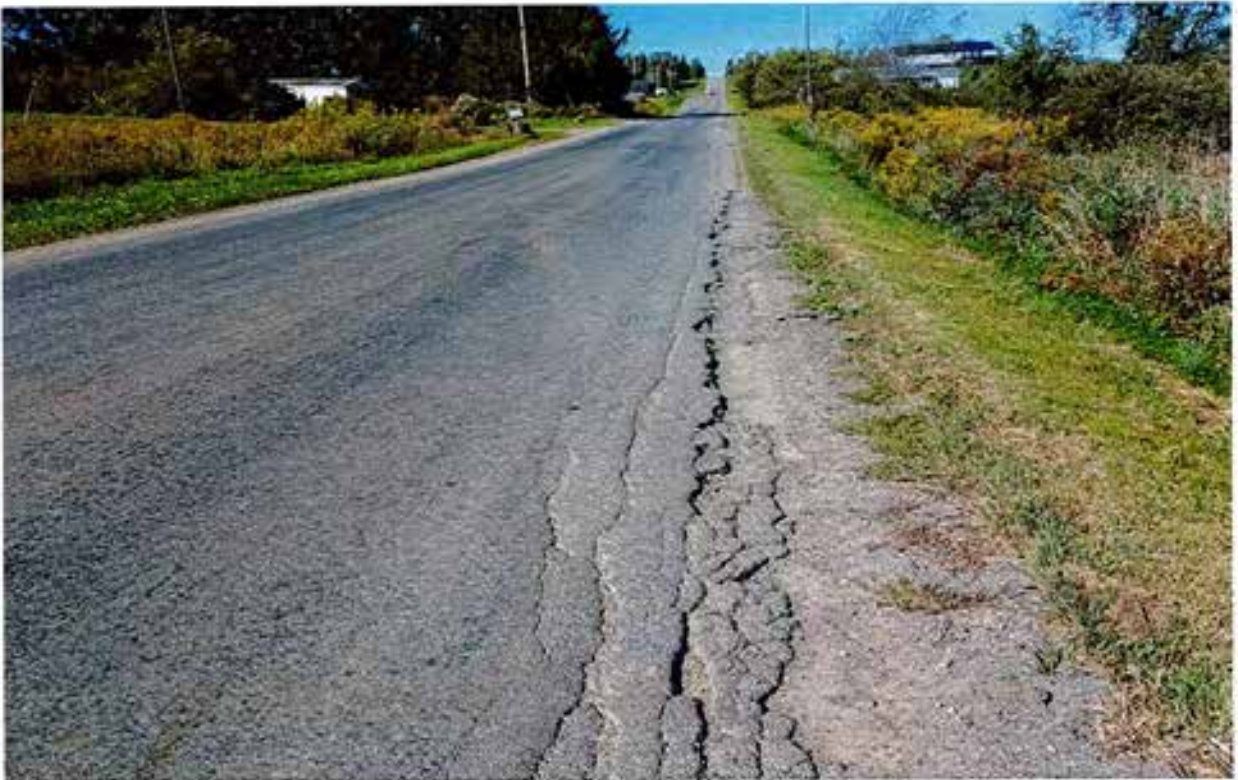
Bray Road North edge deteriorating near 223

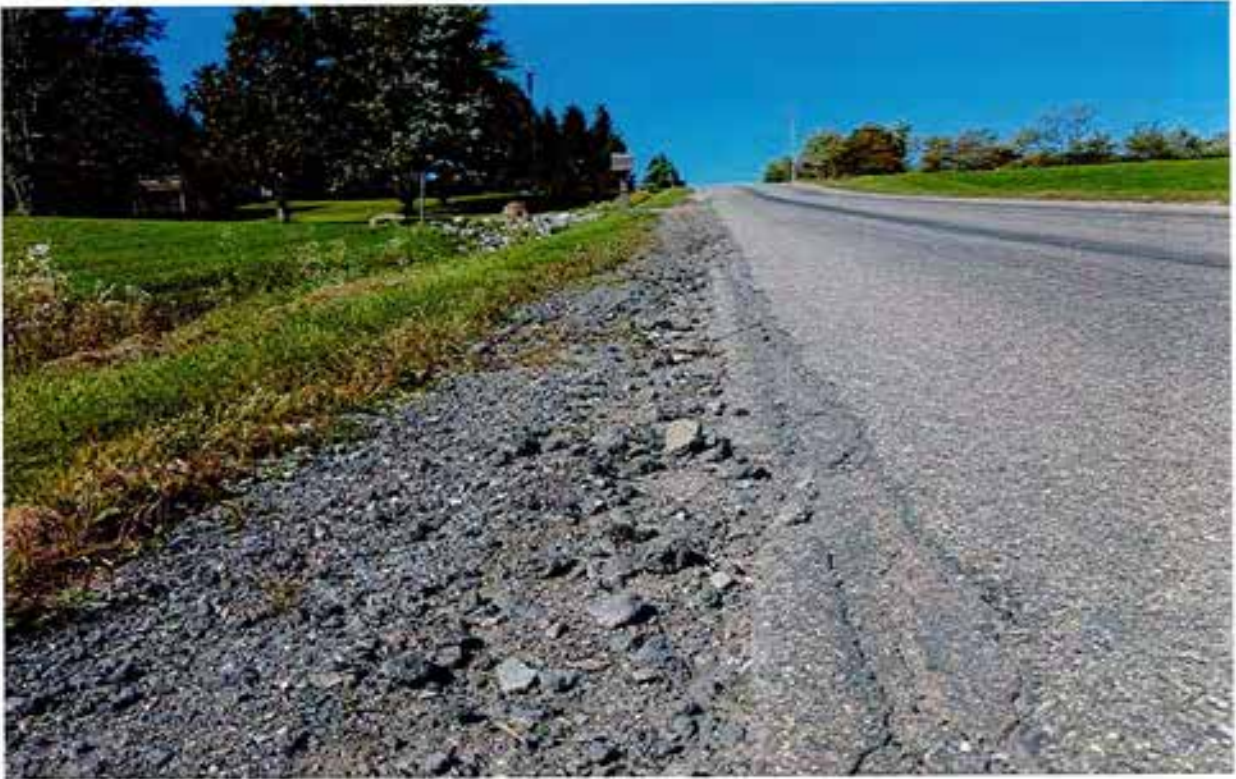
Bray Road South edge and shoulder deteriorating near 259

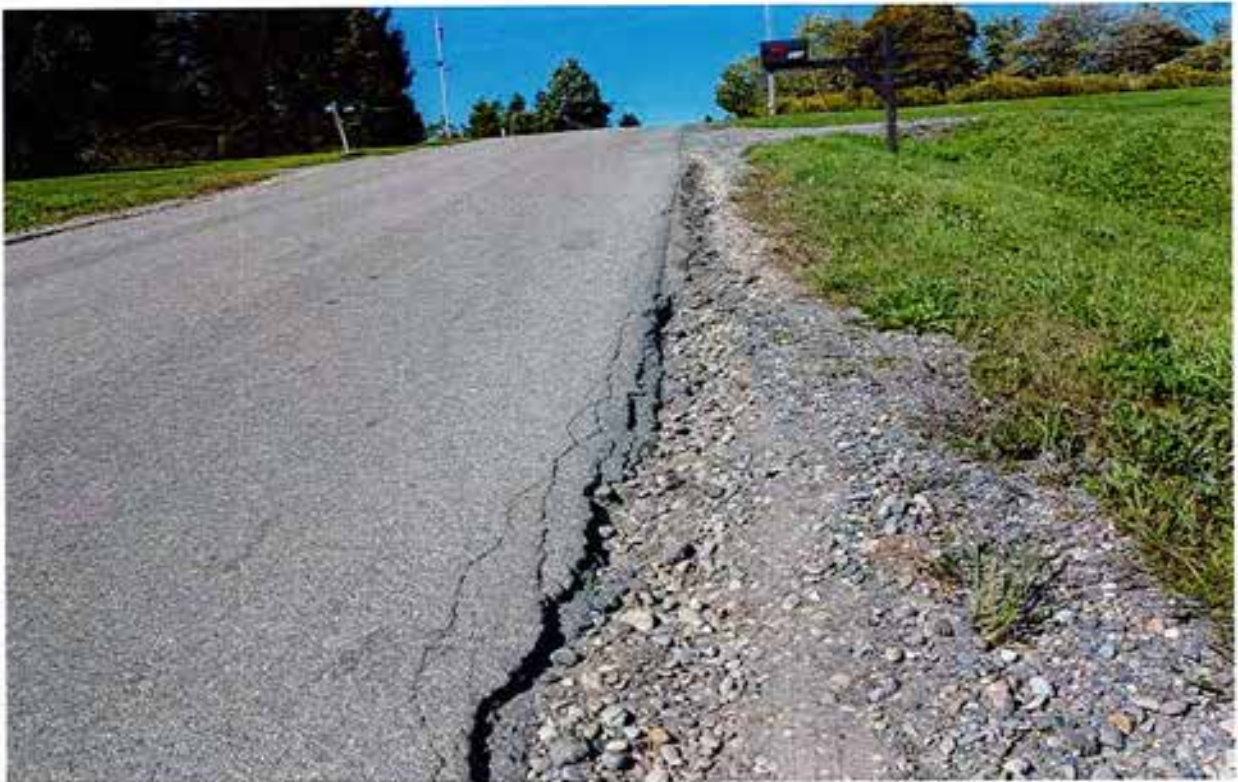
Bray Road North and South edge and shoulder deteriorating near 2317

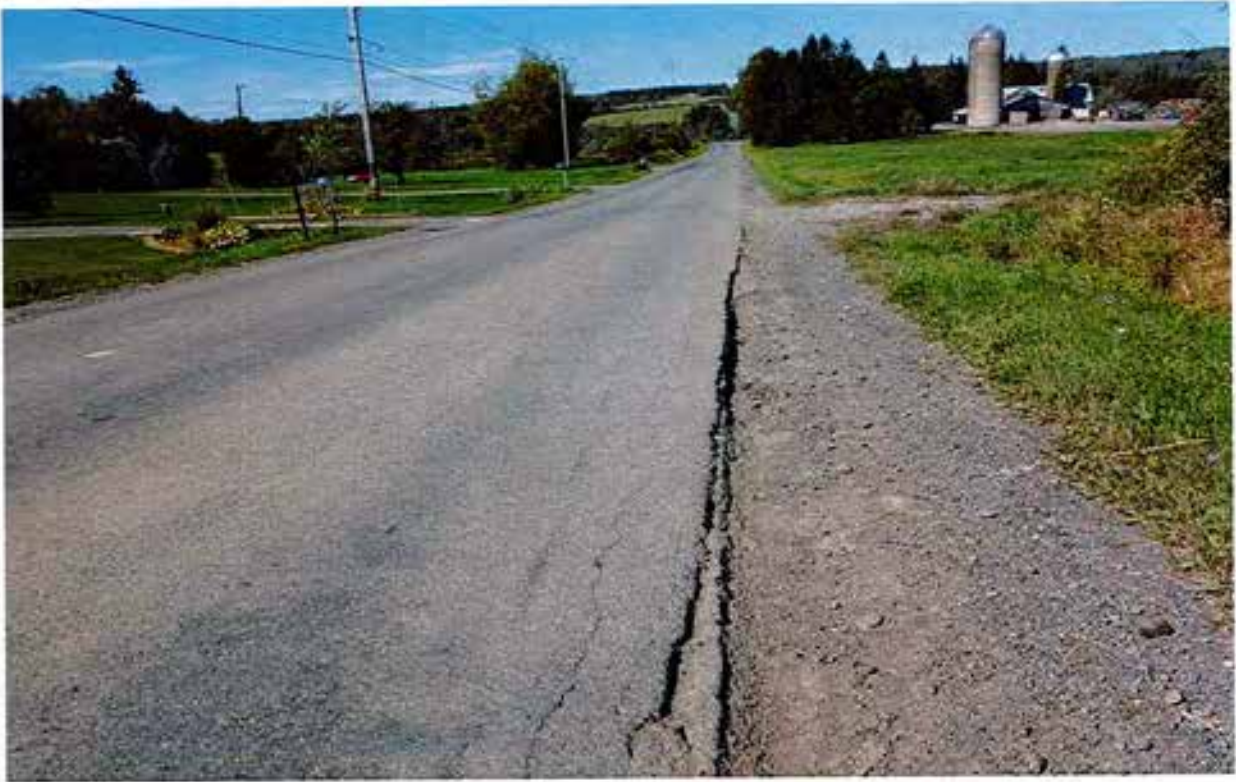
Bray Road North edge and shoulder deteriorating from 409 to 475

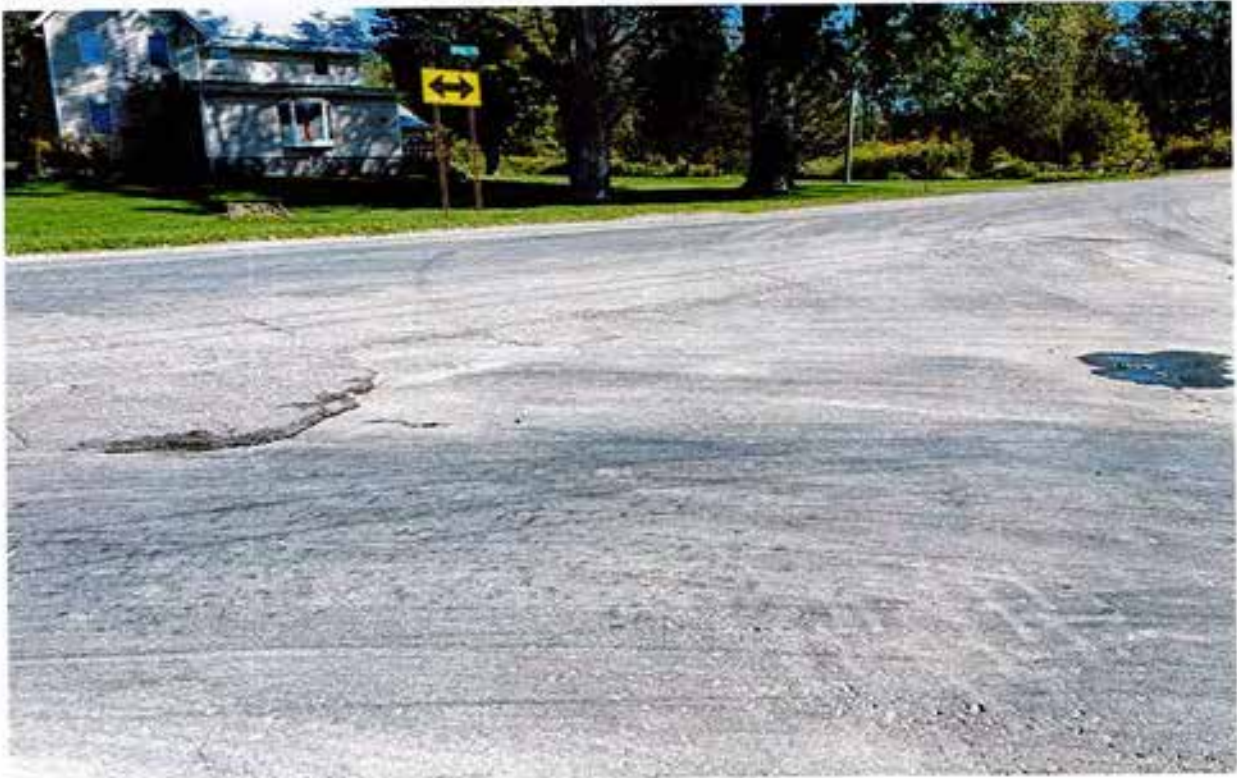
Bray Road lane deterioration near intersection with Eagle St

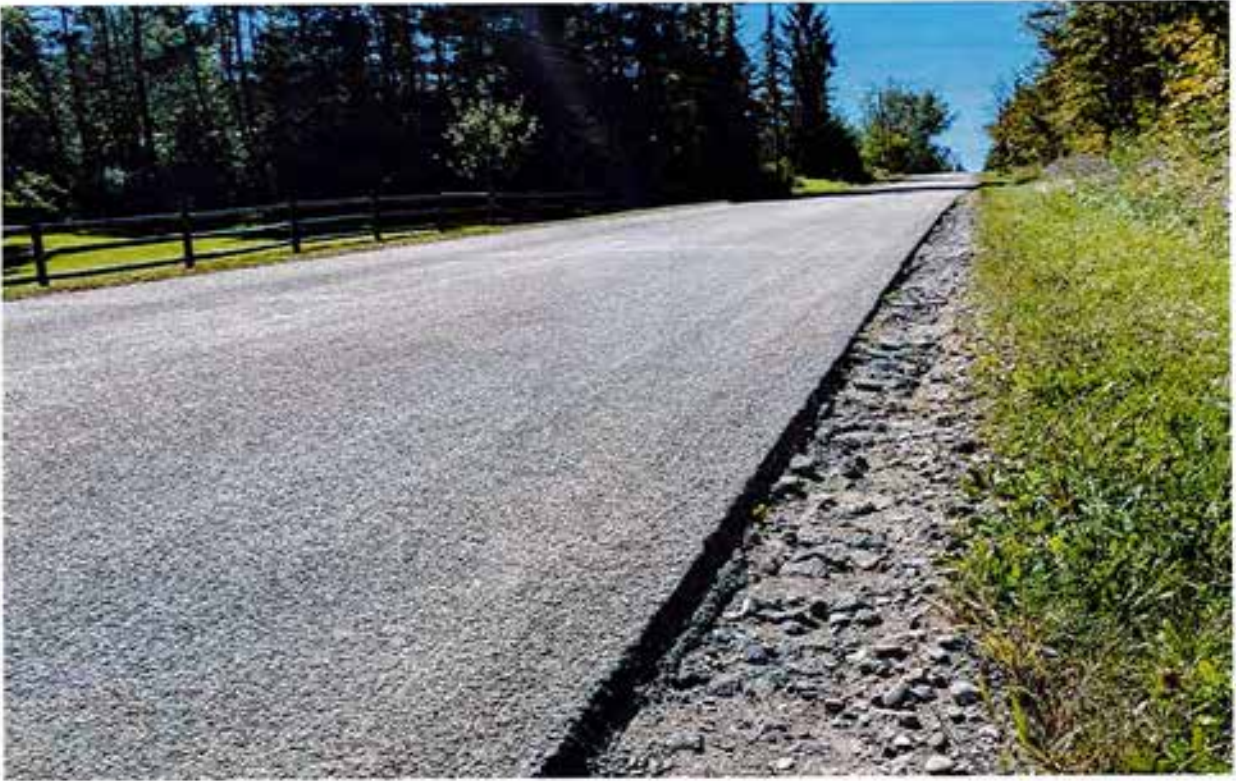
Brown Schoolhouse Road West shoulder near 11770

| Maintenance Needed: | <ul style="list-style-type: none"> <li>- Repair shoulders</li> <li>- Repair intersection</li> </ul> |

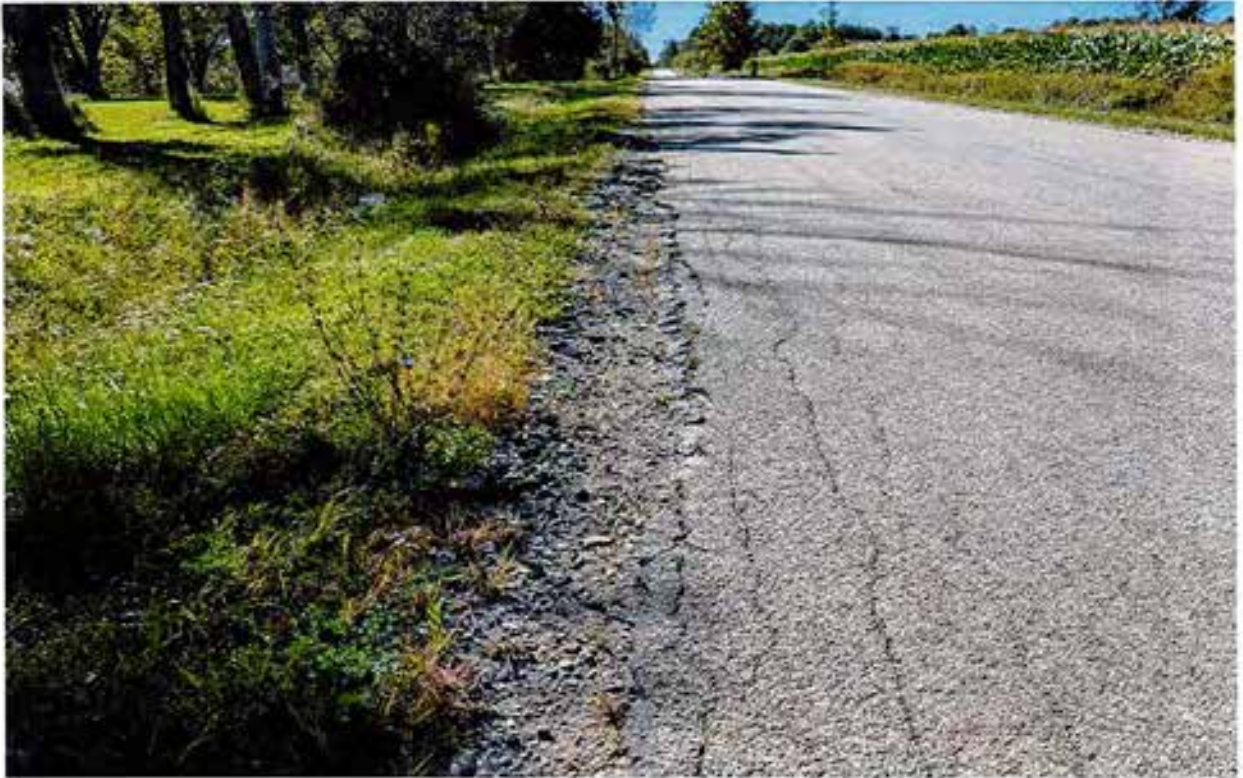
Brown Schoolhouse Road East shoulder deterioration South of 11748

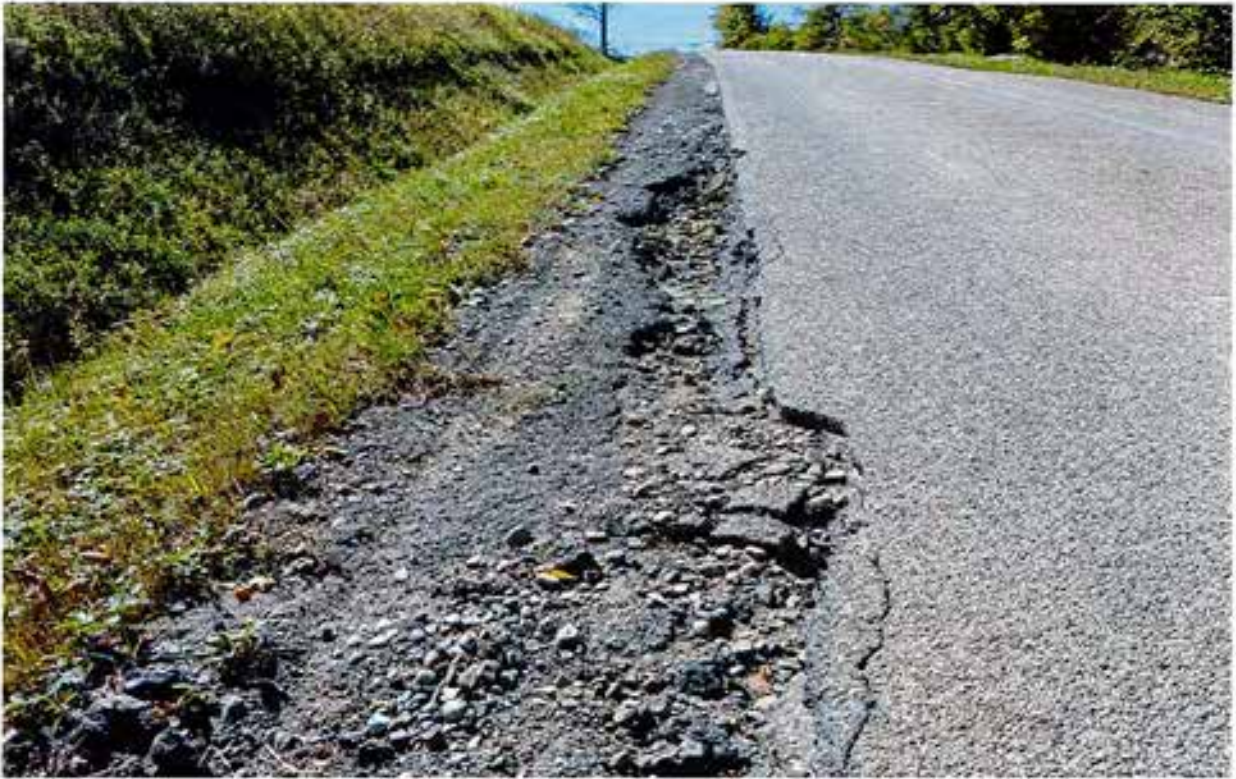
Brown Schoolhouse Road East shoulder North of 11448

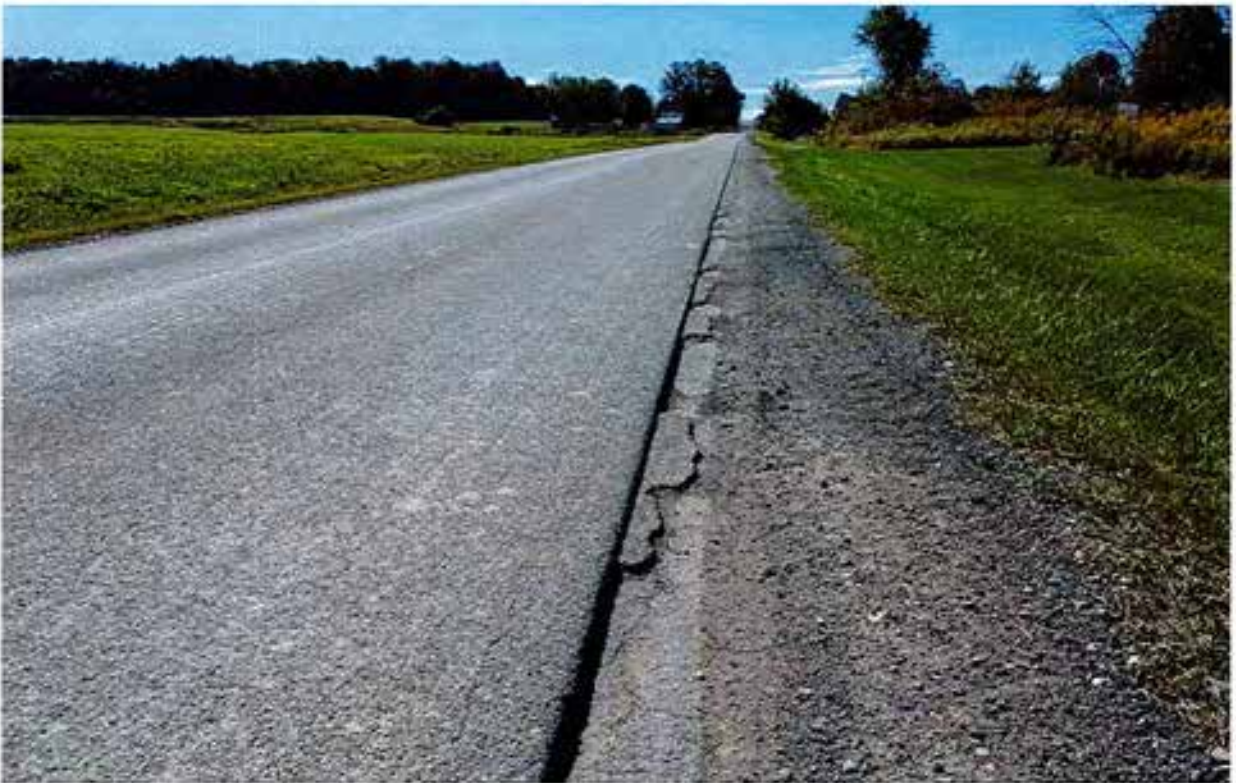
Brown Schoolhouse Road West shoulder deterioration from 11354 to 11258

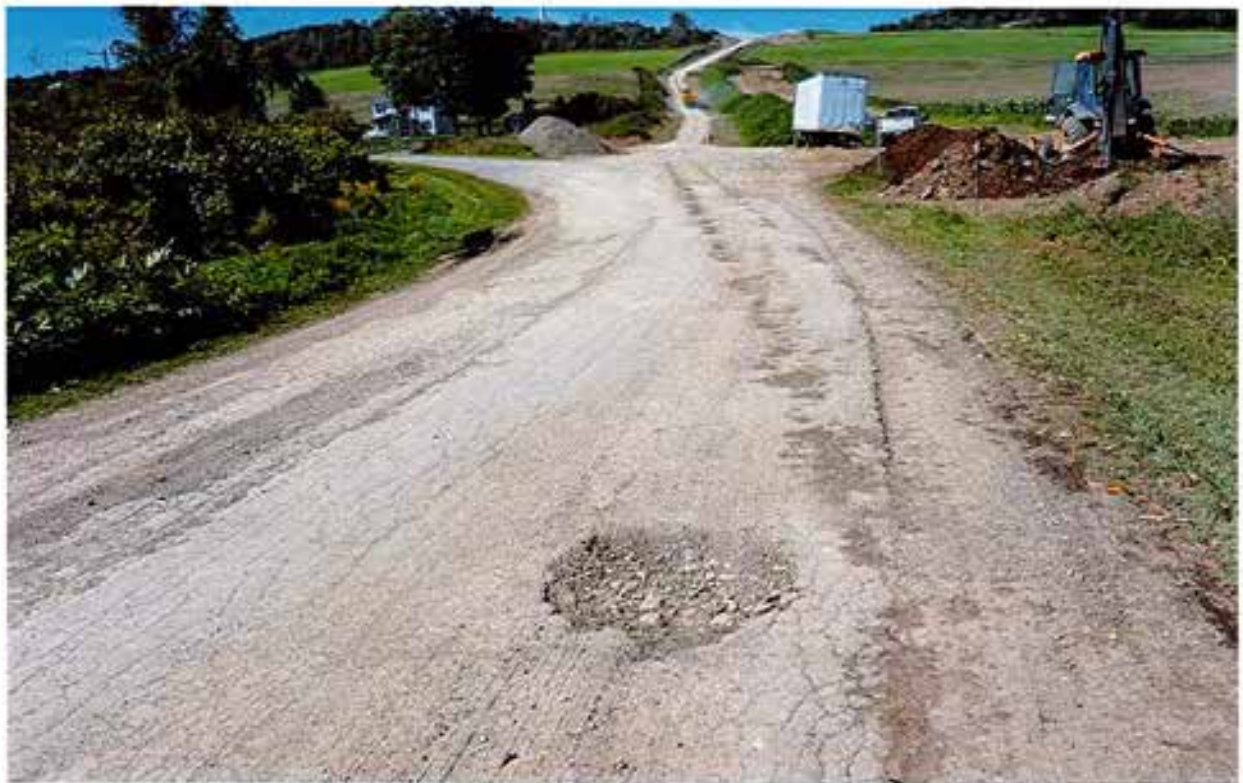
| Hazards Identified: | - Multiple potholes in paved sections of road |

Strong Road pothole

| Maintenance Needed: | - Apply QPR to significant potholes |
