## Road Condition & Vehicle Compliance Report

| Report # | 60 |
| Project Name | Alle-Catt Wind |
| Location | Town of Freedom |

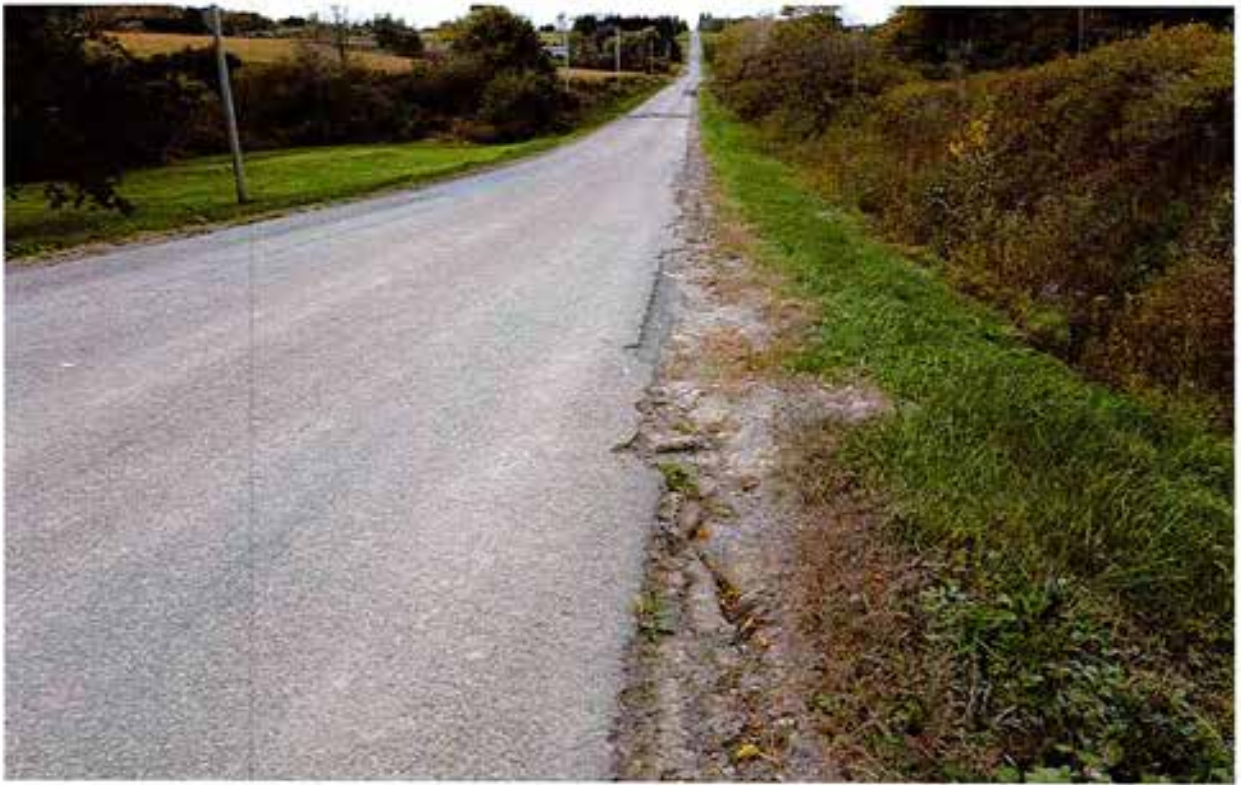
Bray Road North edge and shoulder from +/-113 to +/-2473

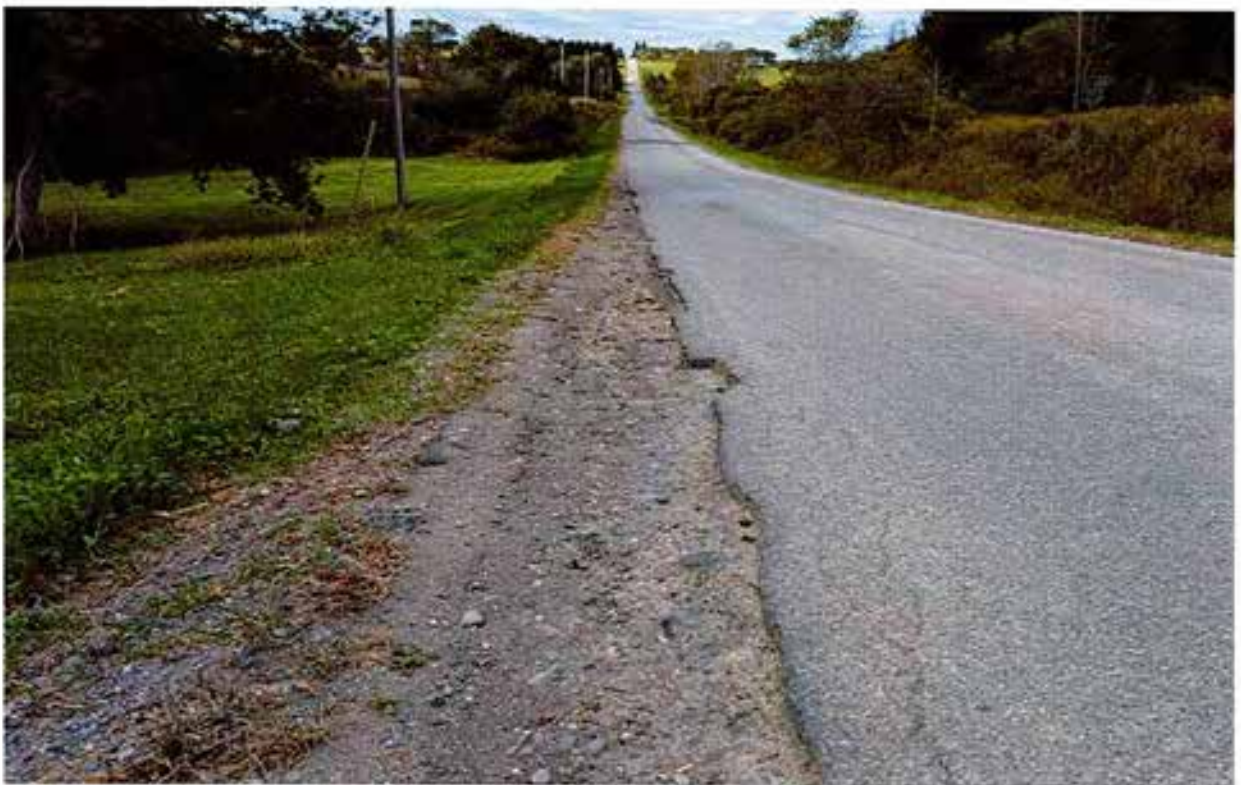
Bray Road South edge and shoulder West of 113

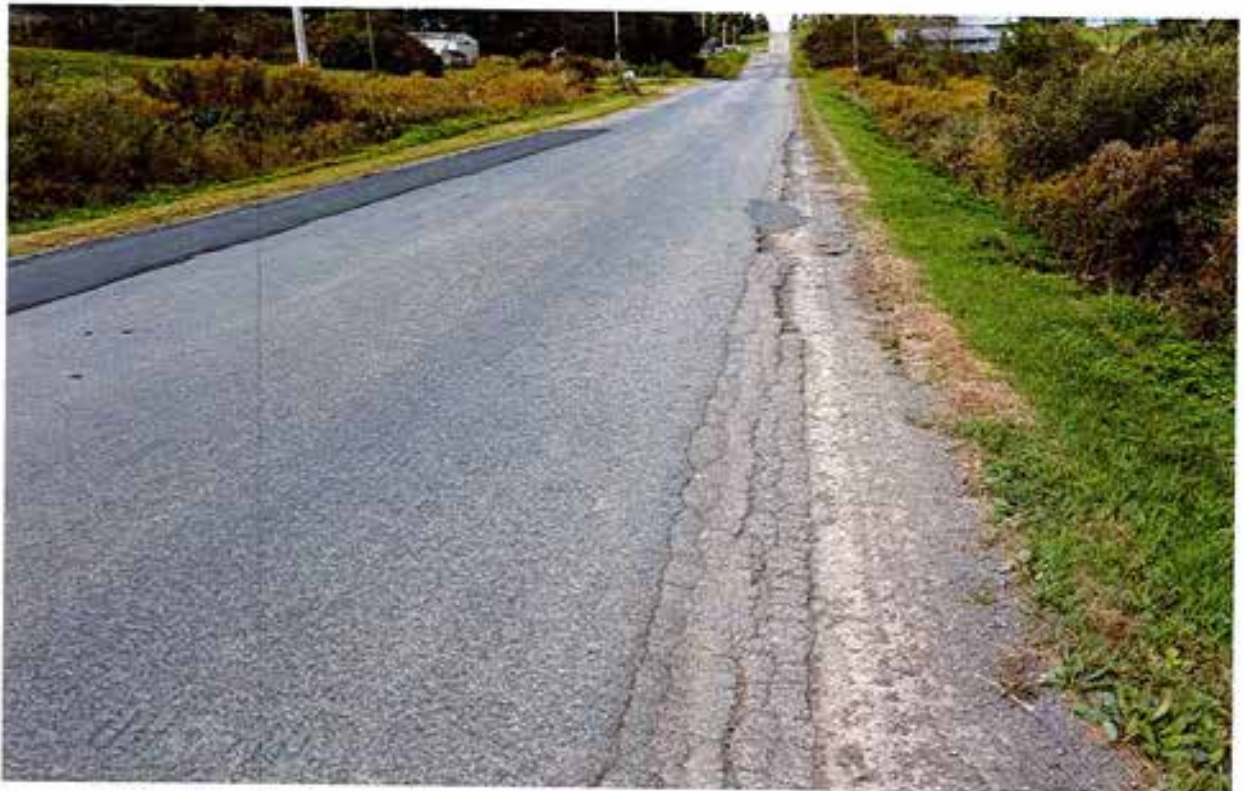
Bray Road North edge near 223

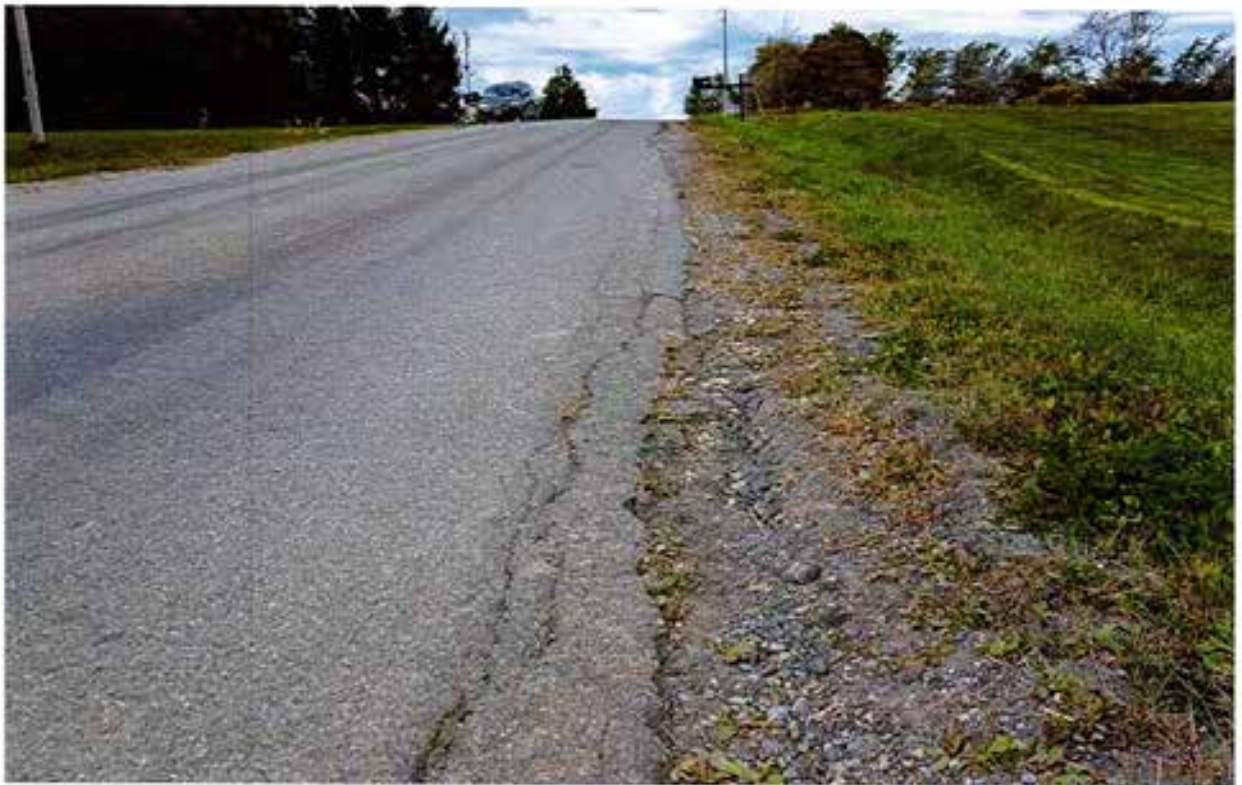
Bray Road North and South edge and shoulder near 2317

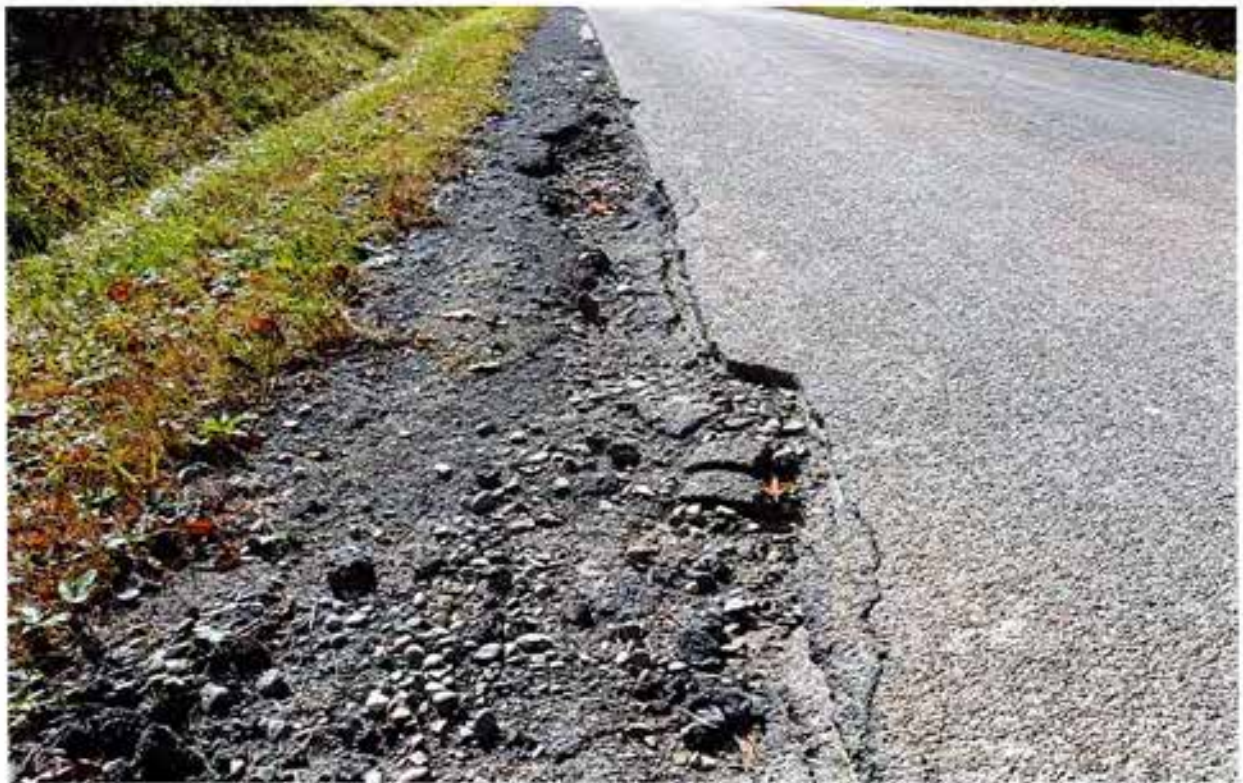
Brown Schoolhouse Road East shoulder North of 11448

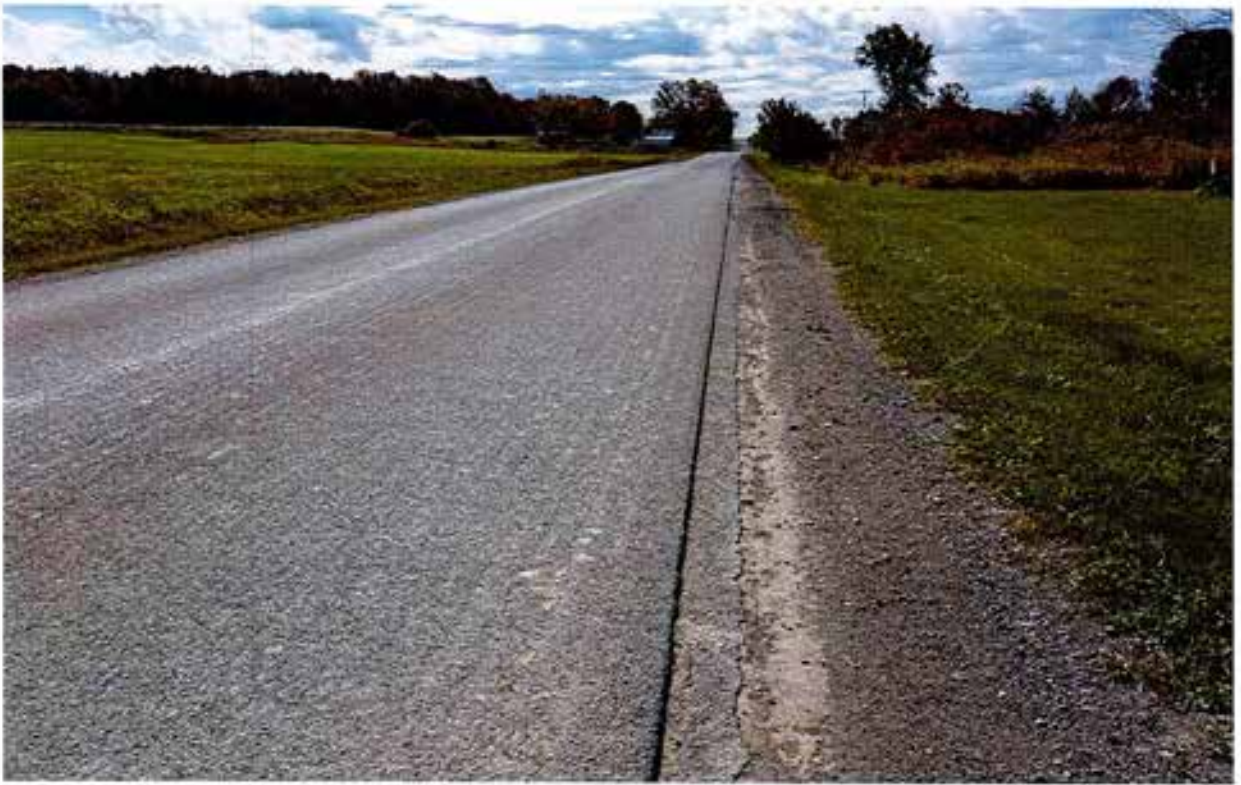
Brown Schoolhouse Road West shoulder from 11354 to 11258

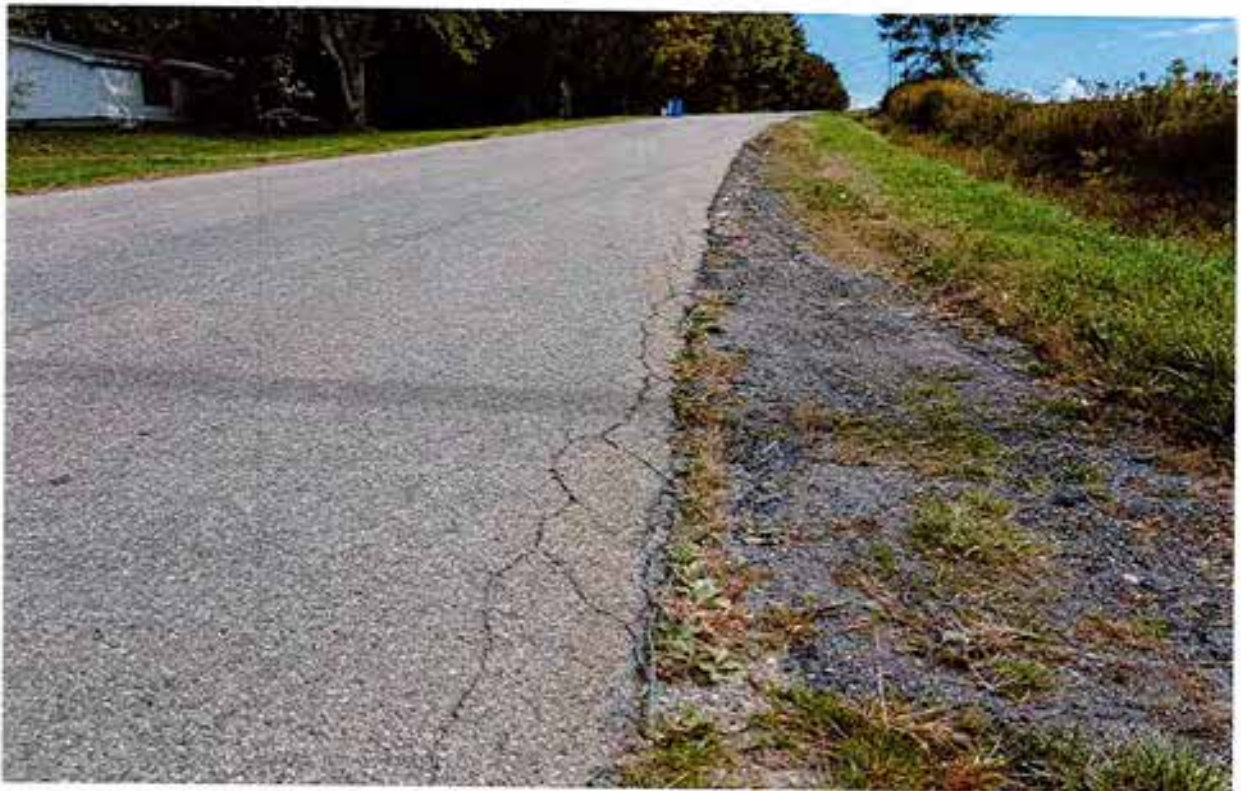
Edmunds Rd Southeast edge and shoulder near 1812

| Maintenance Needed: | - Repair intersection<br>- Repair shoulder |

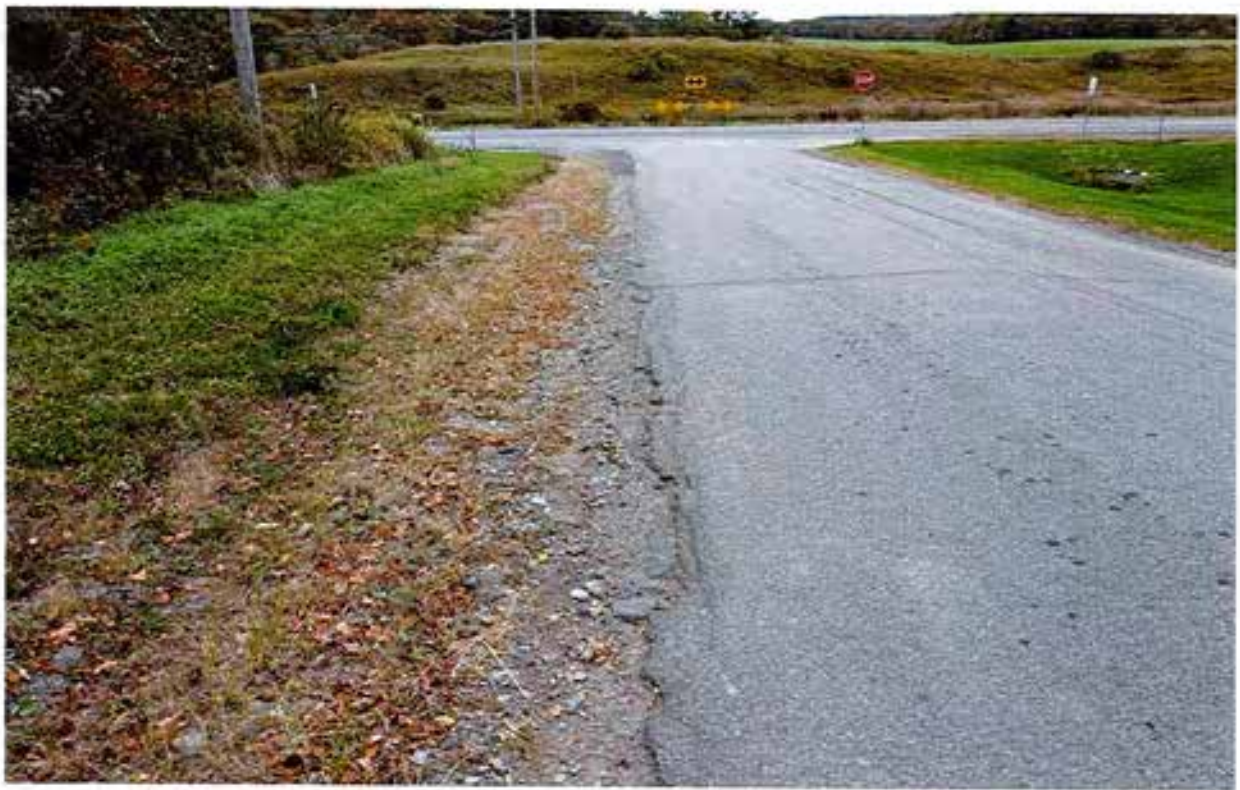
Edmunds Rd lane and shoulder on North and South sides of road near intersection with  
Maple Grove

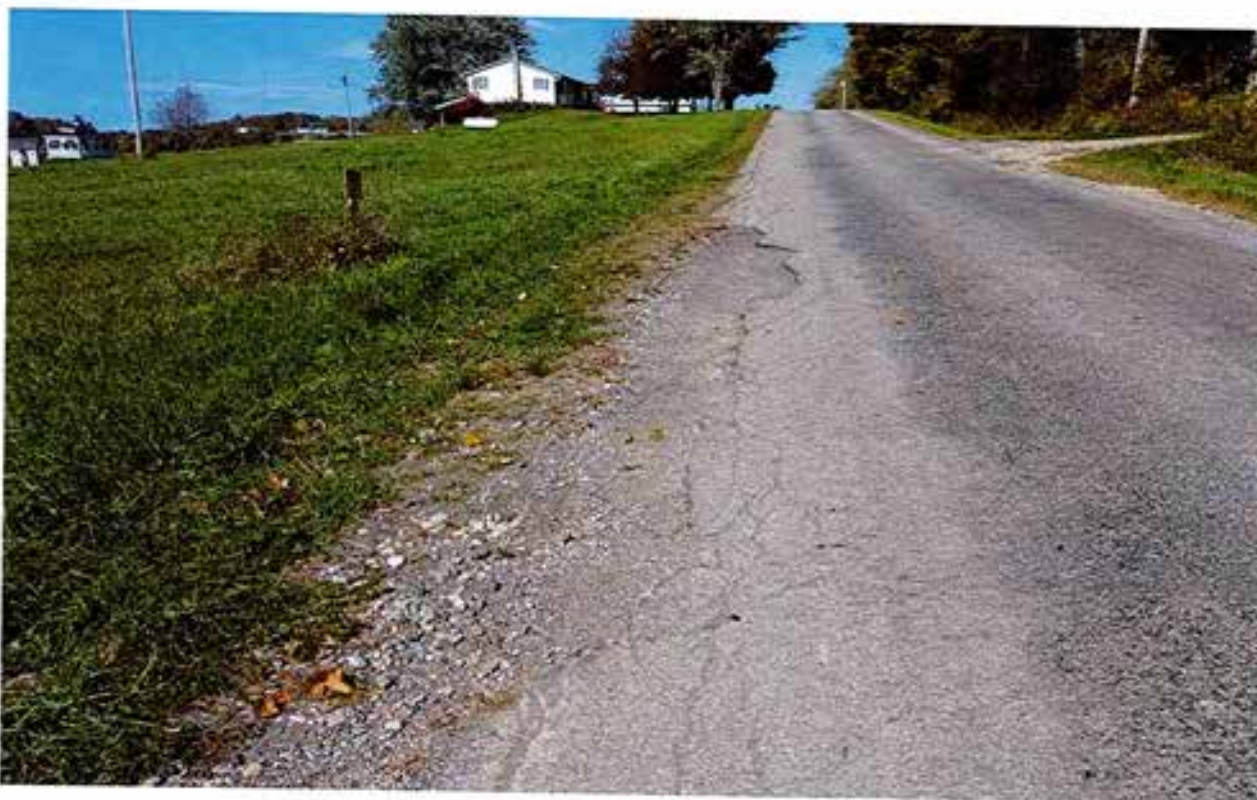
Sandbank Rd West lane and edge South of 10317

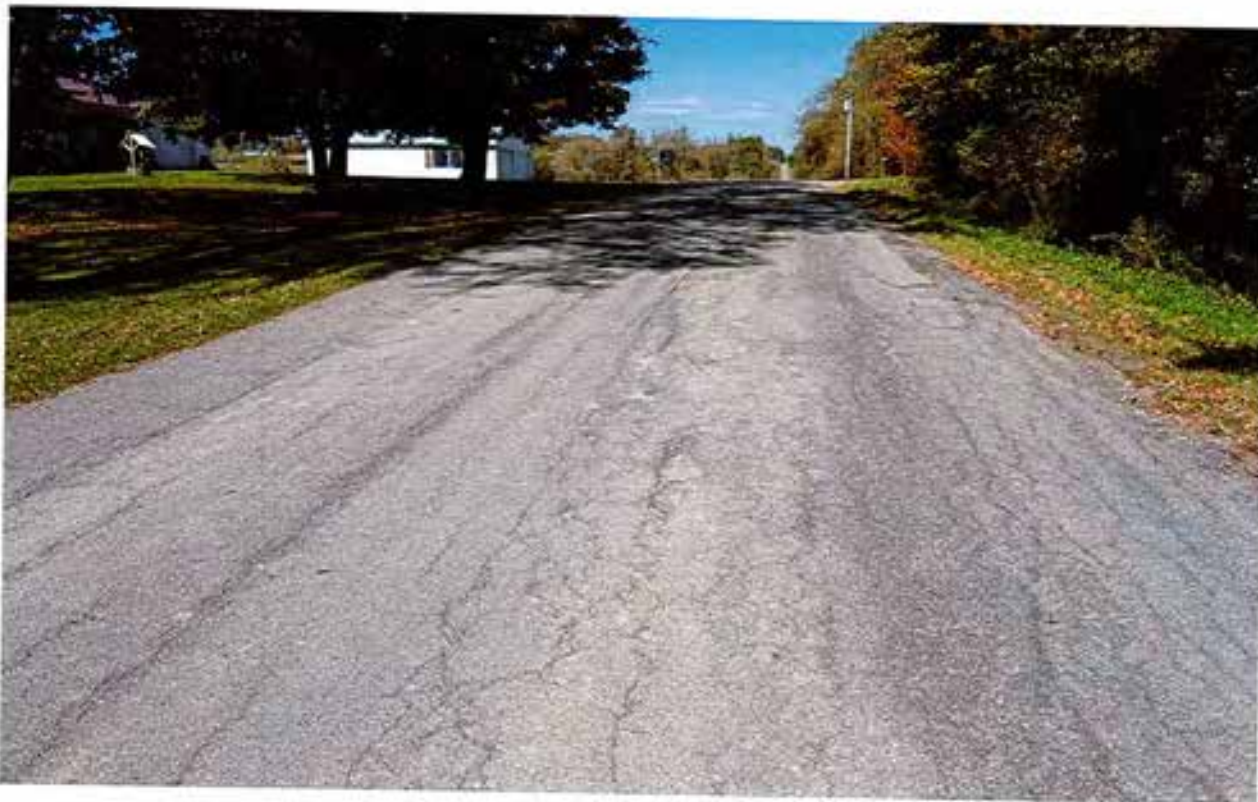
Sandbank Rd lane near 10317

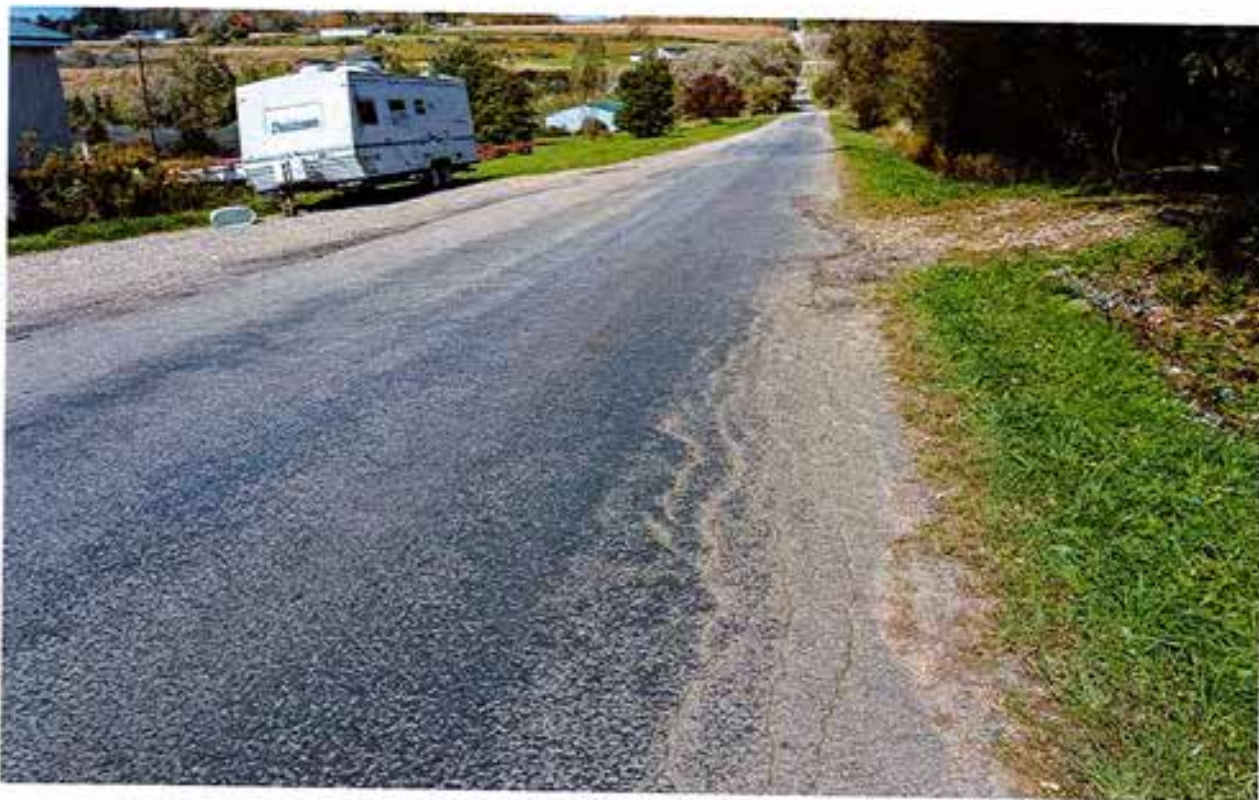
Sandbank Rd East and West side shoulder near 10442
